Ryan Chouest daily data transmission and report

Period covered: 21.00 06/10/2010 -21.00 06/11/2010

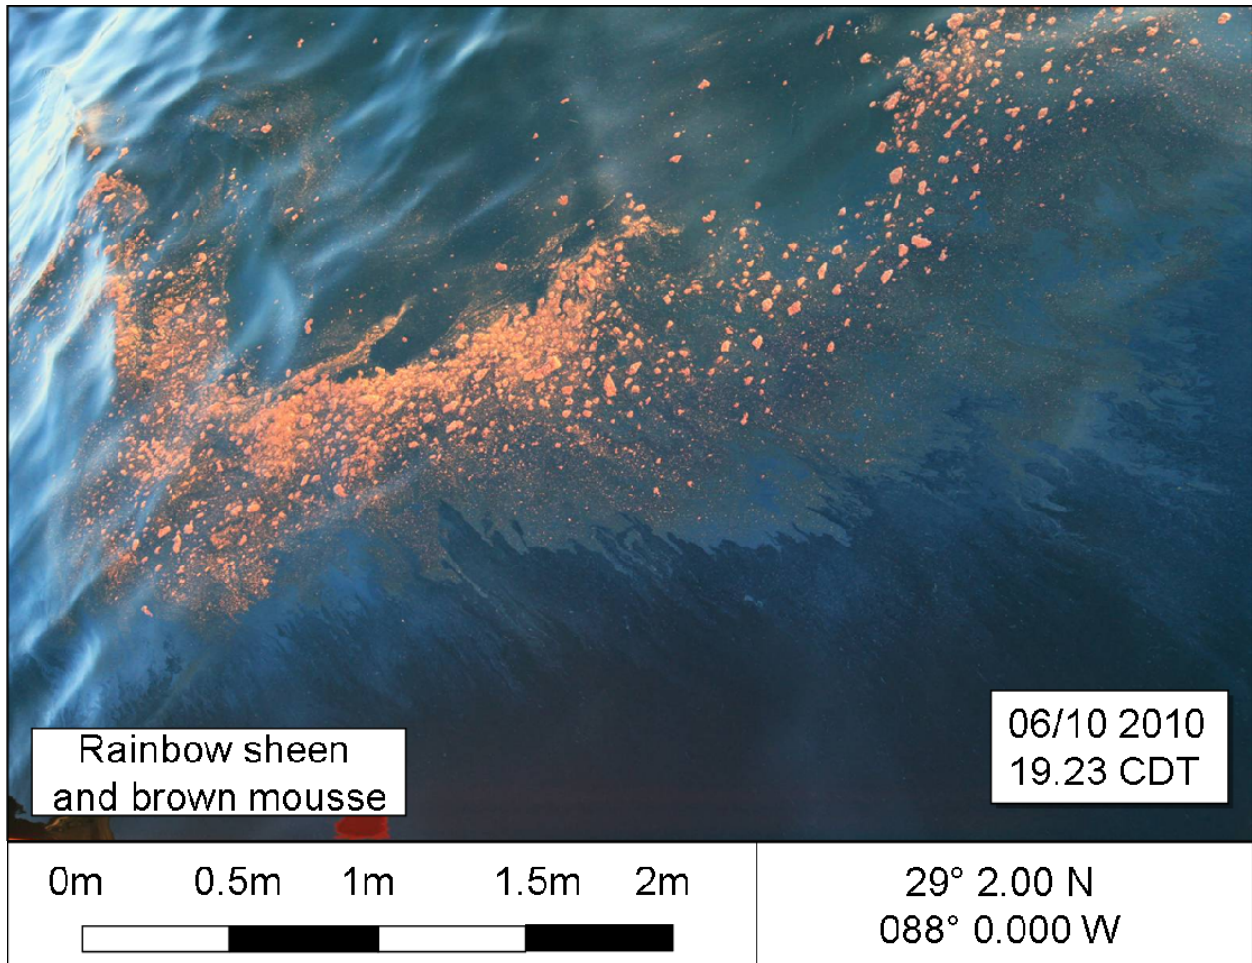
Figure 2. Observed mousse and rainbow sheen at the Weatherbird station.
