## 4.0 Solitude Bay Watershed

### 4.1 General Description

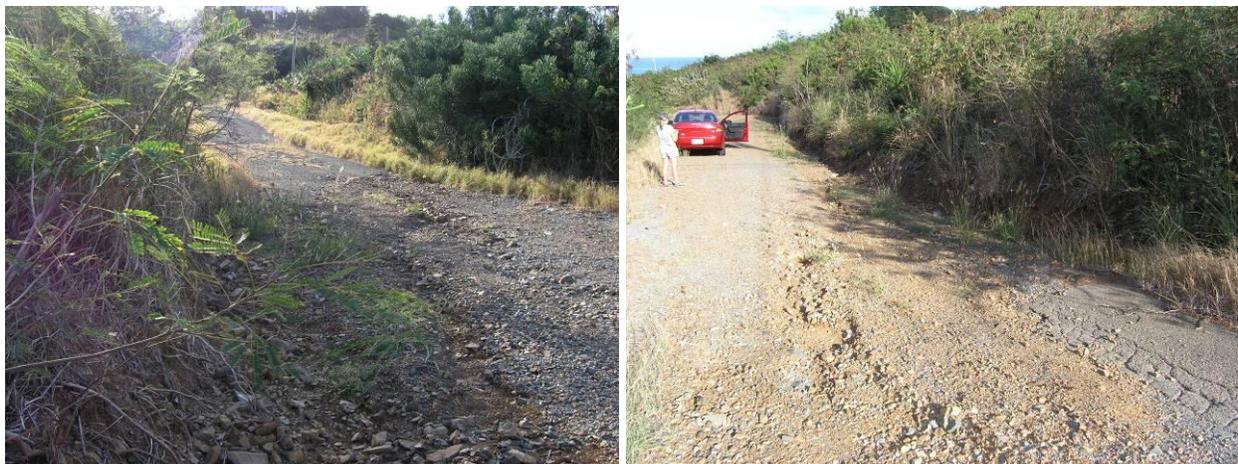
**Figure 4.3.** Erosion gully at the transition from paved driveway to unpaved private road looking up-gradient (left) and down-gradient (right).

Some minor, low maintenance improvements could be conducted along the road. A water bar and stabilized swale along each side of the road would reduce erosion and, therefore, the associated potential sediment load from this area would be reduced.

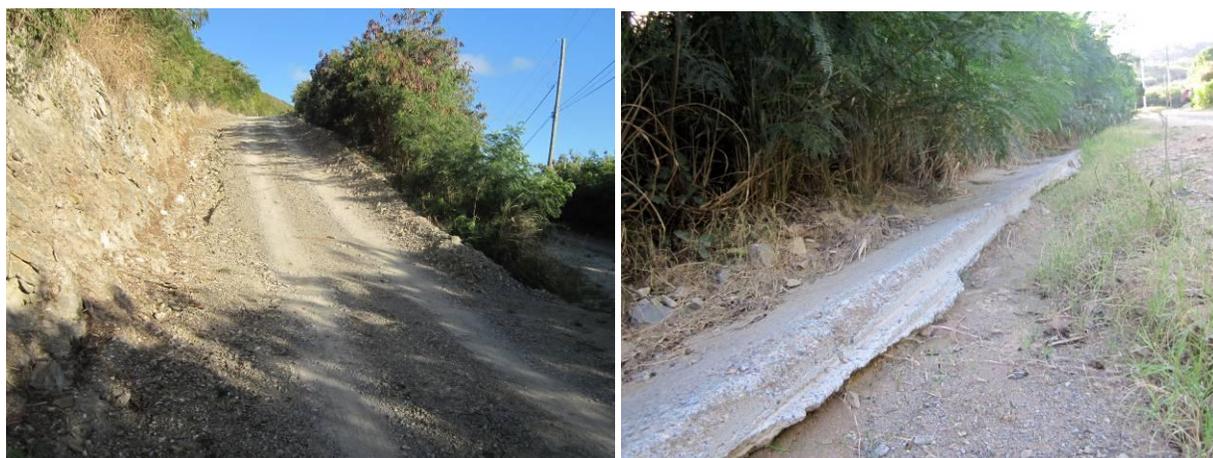
In general, the roads in this neighborhood likely provide a large sediment source to the gut, the associated ponds, and eventually Yellowcliff Bay. These steep roads are ideal candidates for paving to stabilize the roads and reduce the sediment load to the gut. Drainage infrastructure should be constructed at the time of paving.

**Figure 4.4.** Roads in the Hope and Carton Neighborhood are unpaved and very steep (left). Runoff from this road bypasses and undermines the paved swale (right).

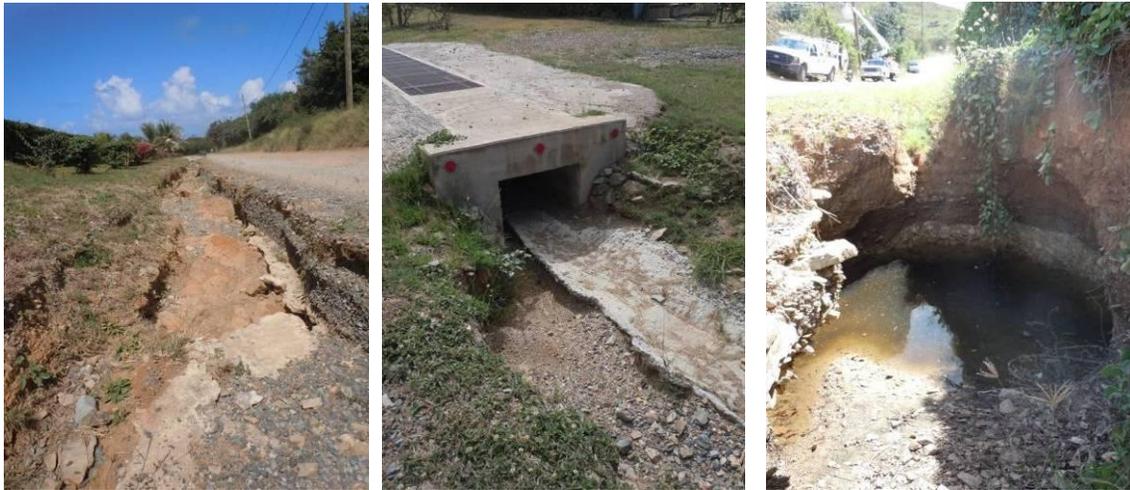
**Figure 4.5.** Erosion gullies are undermining the unpaved Seven Flags Rd. (left), scouring around and under existing infrastructure (middle), and creating dangerous public hazards (right).

This stretch of road is an ideal candidate for paving and constructing proper stormwater infrastructure. The culverts under East End Rd. and at the corner of Cotton Valley and Seven Flags should be replaced with properly sized pipes. In addition, the gut behind the new houses should be retrofitted into a series of stepped depressions to allow for more storage and reduced velocities to help protect the downstream road and infrastructure.

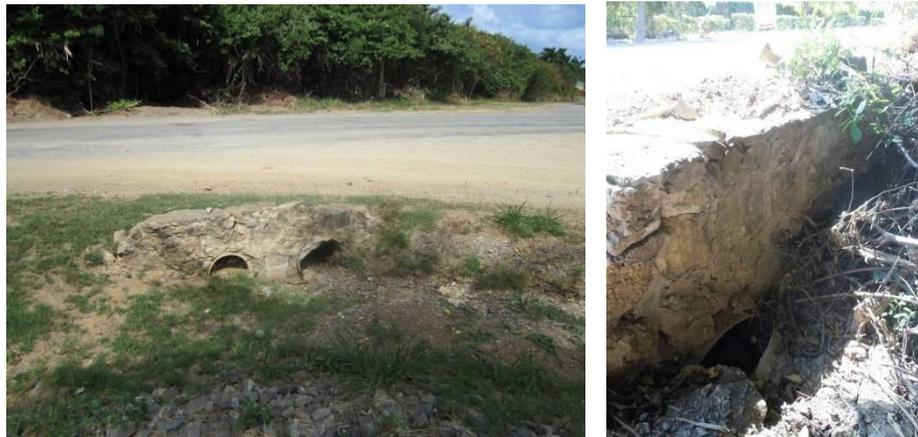
**Figure 4.6.** The two culverts that carry flow from Seven Flags Rd. and a portion of East End Rd. to Solitude Bay blocked with sediment on both the upstream (left) and downstream ends (right).

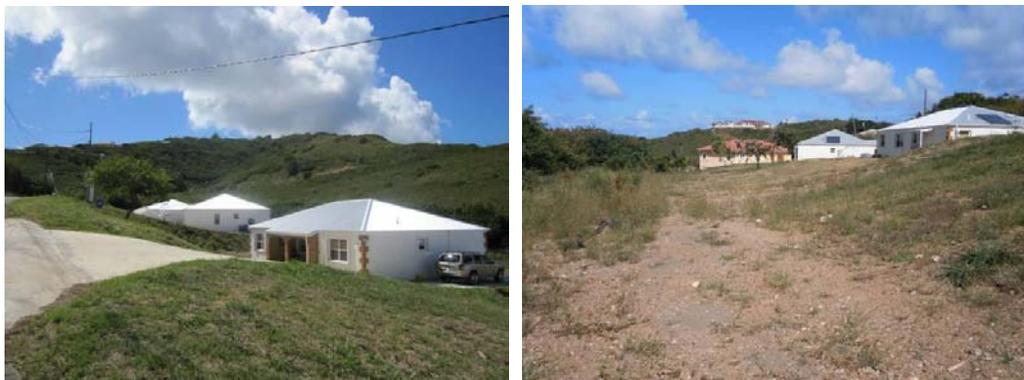
**Figure 4.7.** New homes were built in the gut upstream from the Seven Flags Rd. erosion (left). The areas behind the houses should be retrofitted to create a series of terraced depressions to help provide more storage and decrease velocities (right).

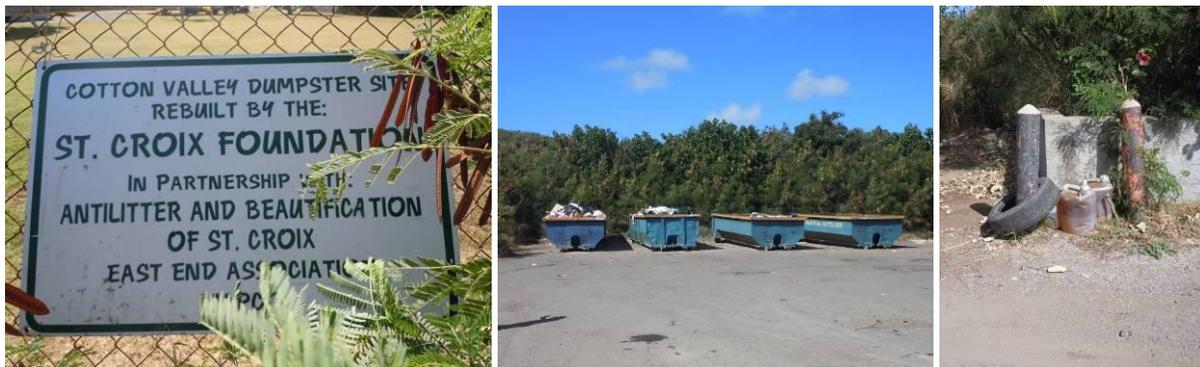
**Figure 4.8.** The rebuilt dumpster site is an important resource for the community (left). However, the dumpsters are uncovered, overflowing, and located directly adjacent to a gut (middle). Potentially hazardous materials are left in this area (right).

The retrofit for the site is comprised of four parts: 1) a bioretention facility located in front of the bus stop to treat runoff from up-gradient roads and to provide an education opportunity with signage (Figure 4.9); 2) a linear bioretention between the fire station property and the dumpster area to manage runoff from the fire station driveway, building, and some of the roadway (Figure 4.9); 3) covered lean-tos for the dumpsters as well as for an official “swap shop” area and educational signage about pollution prevention and the adjacent gut; and 4) repairing/replacing the culverts and stabilizing the gut.

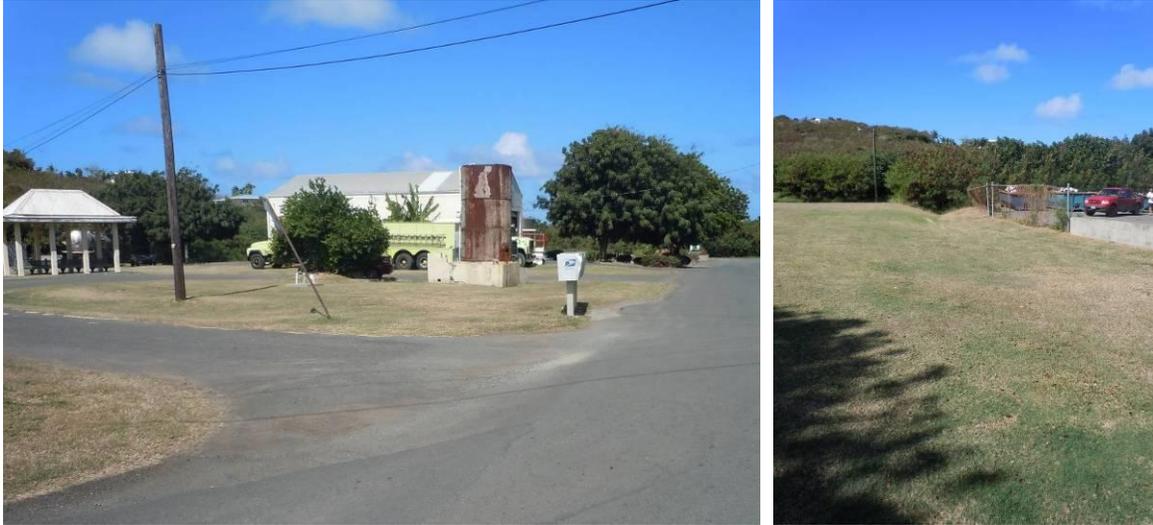
**Figure 4.9.** The area in front of the bus stop could be retrofitted to manage stormwater from the roadway (left). Stormwater from the fire station could be managed in a retrofitted bioretention system in the existing depression before discharging into the gut behind the property (right).

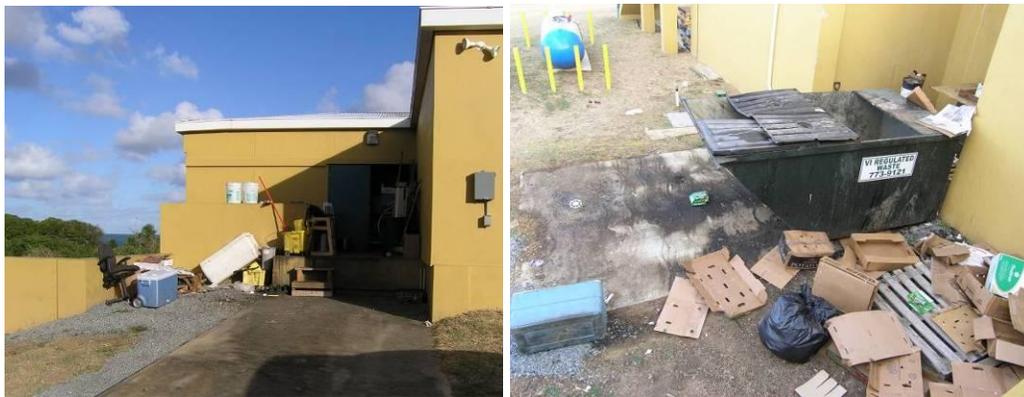
**Figure 4.10.** Blue Water Terrace has an uncovered area where cleaning products appear to be rinsed (left) and an uncovered dumpster/materials storage area with evident leaking and staining (right).

The proposed retrofit at the site includes directing runoff from the southern entrance and parking area into a bioretention facility constructed in an existing grassy area alongside the gut. In addition, runoff from the roadside parking, the parking in front (north) of the building, and the driveway along the west of the building can be directed into a shallow grass swale leading to a bioretention facility (Figure 4.11). Soils in this area do not appear to be highly infiltrative, so overflow from the bioretentions would flow into the adjacent gut. Since the contributing drainage area is unpaved, these stormwater retrofits would need frequent maintenance (removal of sediment) to ensure long-term viability. Paving of the parking lot and driveways would reduce this sediment source. The hotspot issues at the site should be addressed by educating the staff on the proper pollution prevention procedures related to cleaning products, washwater, and storage of hazardous materials; as well as ensuring that the dumpster is covered at all times.

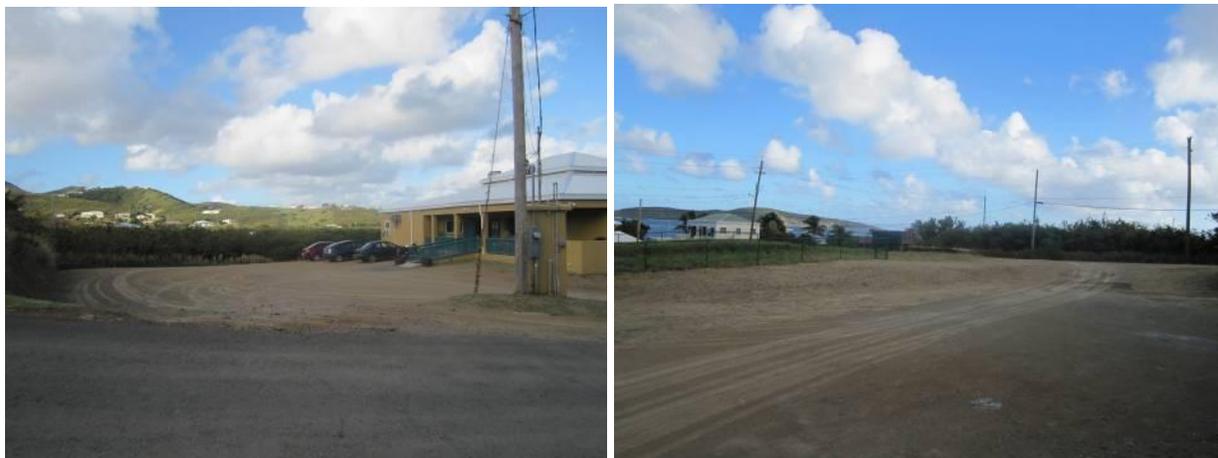
**Figure 4.11.** The grassy area in the far left of this photograph is a good location for a bioretention facility for runoff from the parking area (left). This depression on the north side of the building could also be converted to manage stormwater from the property (right).

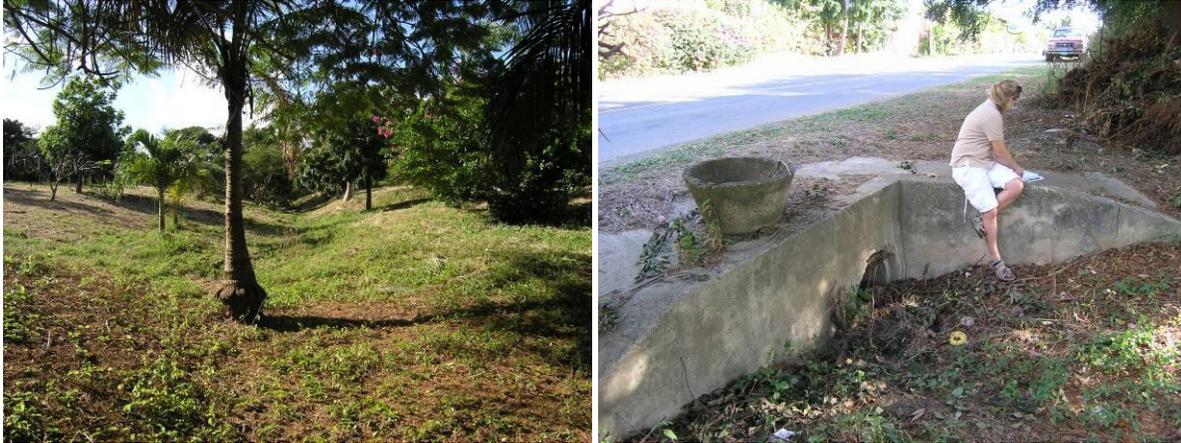
**Figure 4.12.** View upstream along one fork of the gut system (left). Concrete headwall for 15-inch reinforced concrete culvert (right).

Possible options for this site are to 1) create additional storage in the gut upstream of the culvert, allowing sediment to settle out before flowing to the bay; and 2) repair and/or enlarge existing culvert and concrete swale by working with the adjacent homeowners who are affected by this problem.

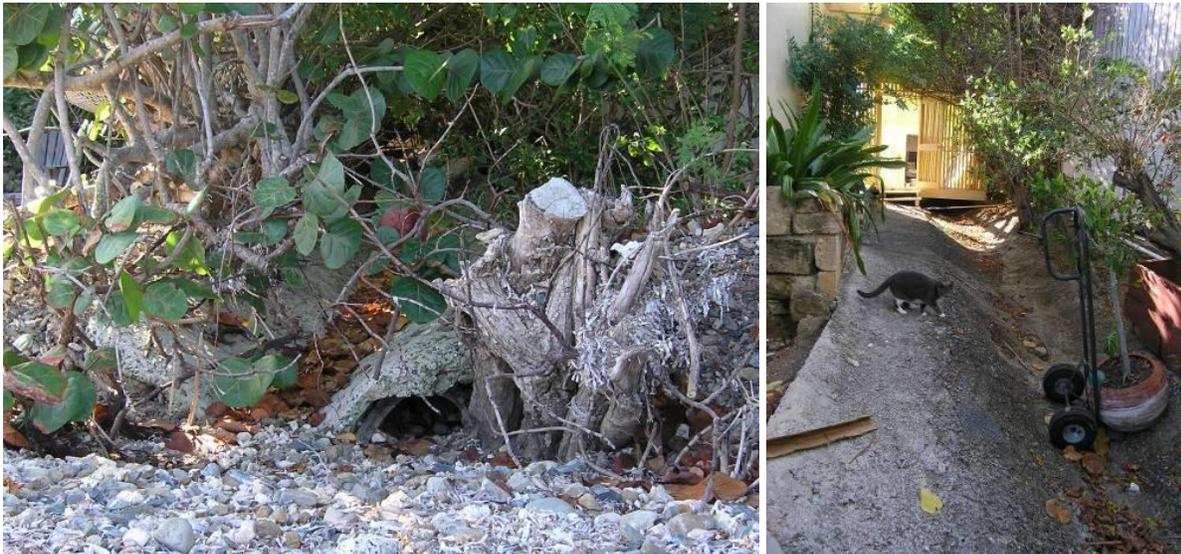
**Figure 4.13.** The outlet of the culvert is barely visible from the beach, with a crumbling concrete swale on top of it (left). Better view of the concrete swale constructed to convey runoff that overflows over East End Rd. between two private residences, bypassing the culvert (right).

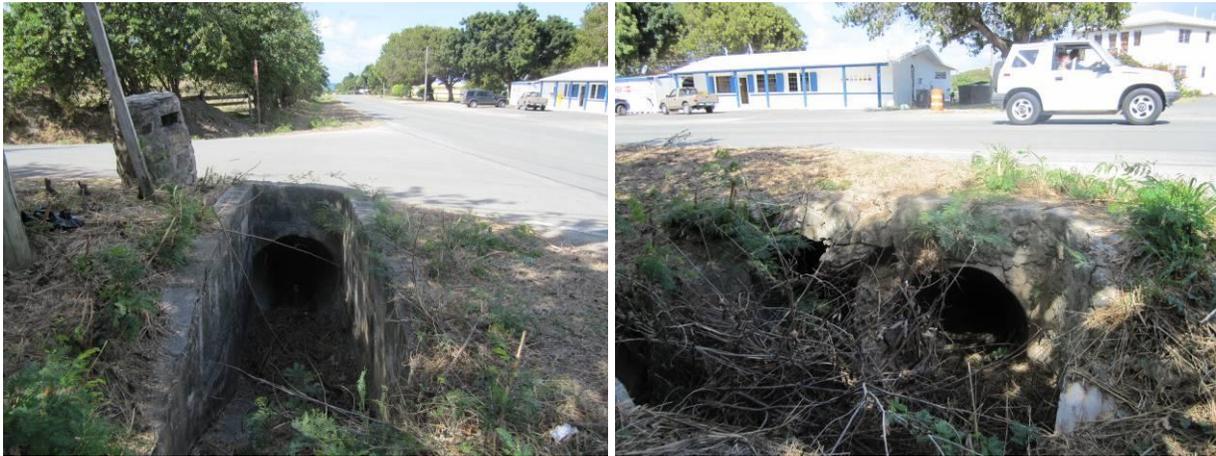
**Figure 4.14.** 30-inch culvert under Solitude Rd (left) and two 30-inch culverts under East End Rd., leading to a 48-inch culvert that discharges to Coakley Bay (right).

Regular maintenance is needed at these culverts to prevent flooding and keep sediment out of Coakley Bay. The manholes along the 48-inch culvert should be repaired as soon as possible. In addition, there is an opportunity to retrofit Ziggy's Island Market in a highly visible location where public education would be possible. As shown in Figure 4.15, a strip of pavement in front of the site could be removed to construct a treatment swale for this drainage area, creating two discrete access points for the market. In this way, sediment and other pollutants could be removed prior to discharging into the existing catch basin.

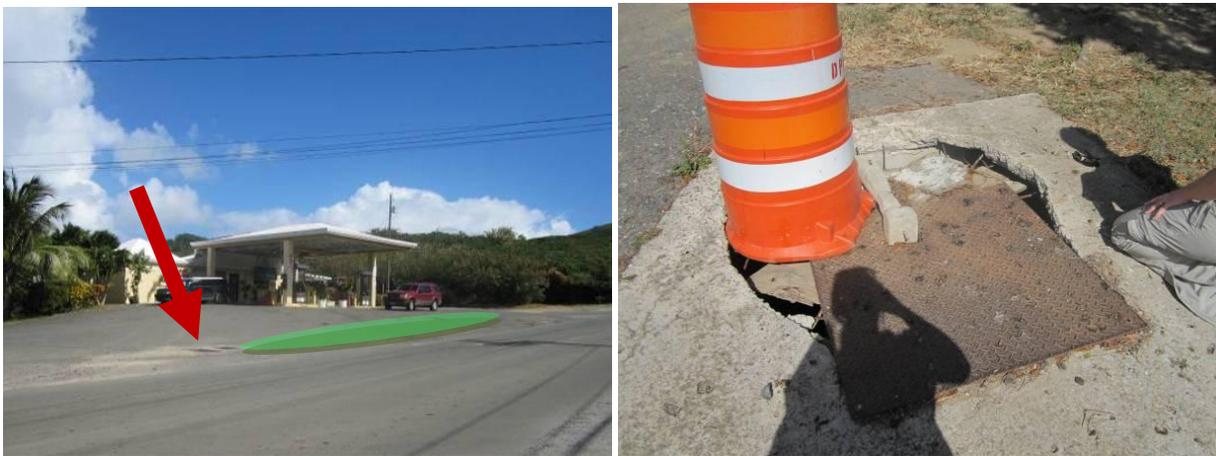
**Figure 4.15.** Some pavement could be removed at the gas station to create a treatment swale (shown in green) up-gradient from the existing catch basin indicated with an arrow (left). Manhole covers are missing all along the 48-inch culvert leading out to Coaklely Bay, creating a safety hazard (right).

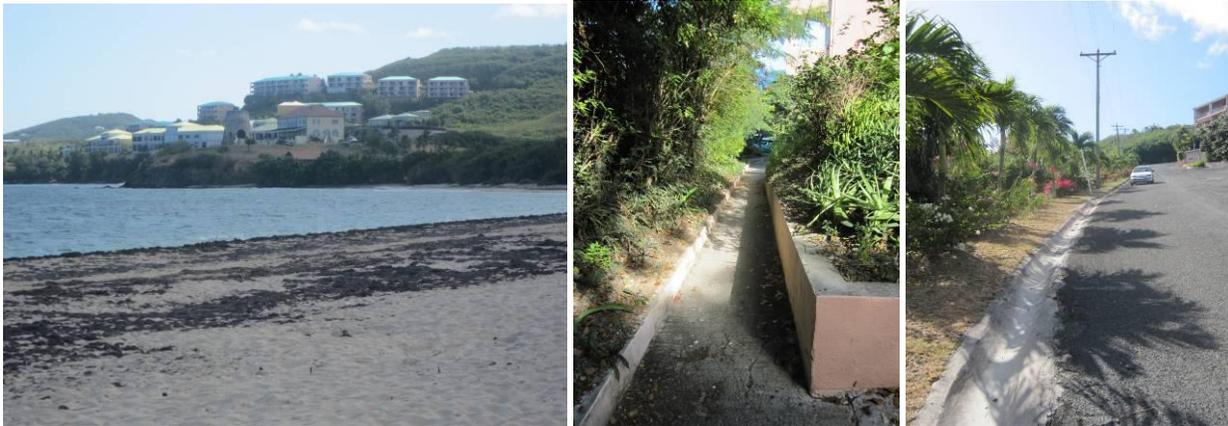
4.16). Some of the runoff is directed into the vegetation on either side of the development, but the majority of runoff is carried down to the entrance and discharged into the shallow roadside swale on the south side of East End Rd. (Figure 4.17). Stormwater retrofits should be implemented throughout this site to direct runoff into stabilized treatment areas along the pavement edges.

**Figure 4.16.** Coakley Bay condos are located on a steep hillside overlooking Coakley Bay (left). Stormwater is conveyed through the site via paved swales (middle and right).

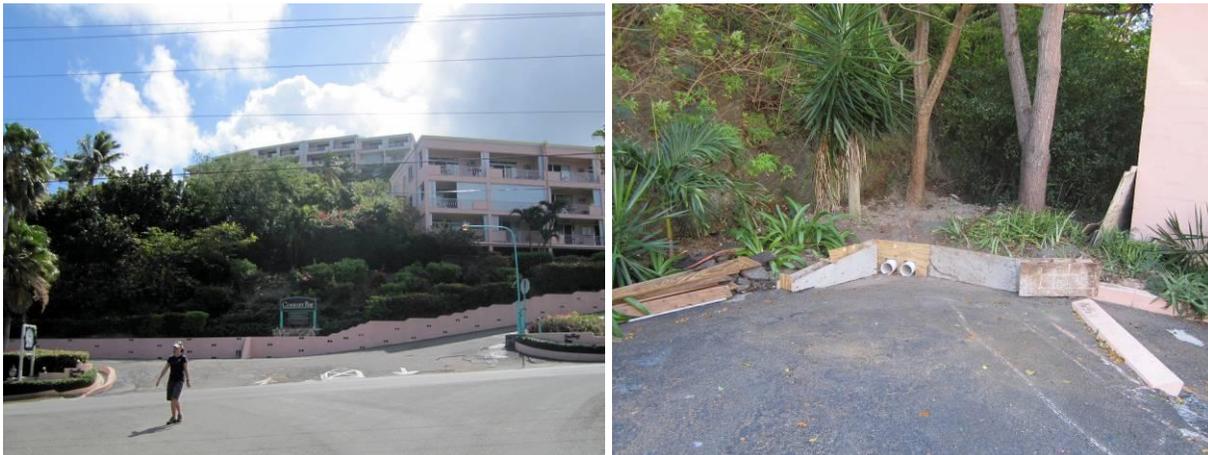
**Figure 4.17.** The majority of uncontrolled stormwater from the site flows down to the entrance and then along the edge of East End Rd. (left). This is an area in the southwest corner of the upper parking area where water would puddle after rain events. Small PVC pipes have recently been added to drain this area, creating an ideal location for a retrofit BMP (right).

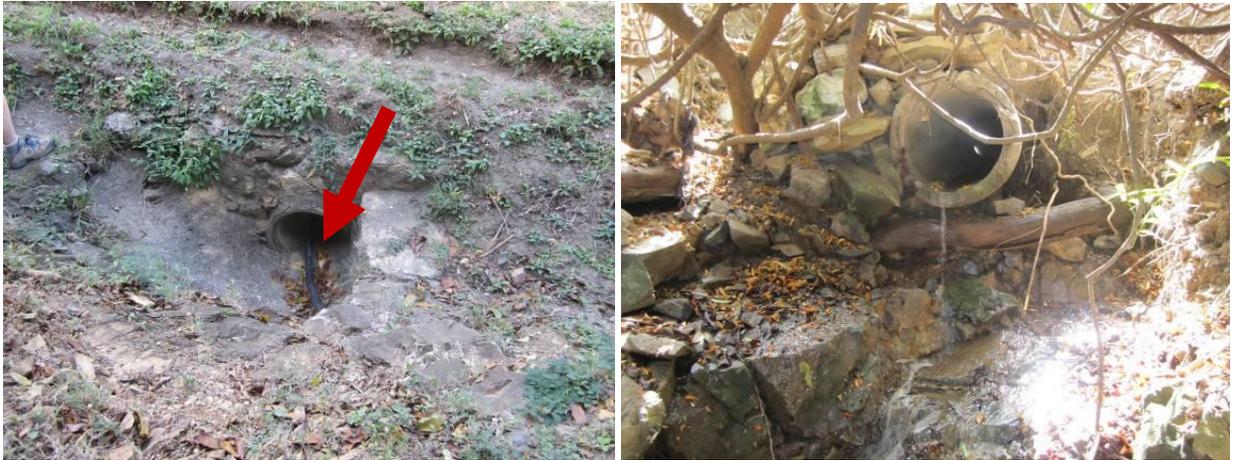
**Figure 4.18.** Arrow indicates PVC pipe discharging dry weather flow into culvert (left). Dry weather flow observed at downstream end (right).

The retrofit for this site should include the construction of a stabilized conveyance swale on the south side of East End Rd. to carry runoff down to the culvert (SB-RC-16) instead of the beach access road. The access road itself should be stabilized using large boulders to prohibit vehicular entrance, but encouraging pedestrian access. The existing culvert should be replaced by a new culvert sized properly for the contributing drainage area, and should have a stabilized outlet. In addition, we observed a black plastic pipe discharging dry weather flow into this culvert (Figure 4.18): this pipe should be investigated to find the owner and source of flow.

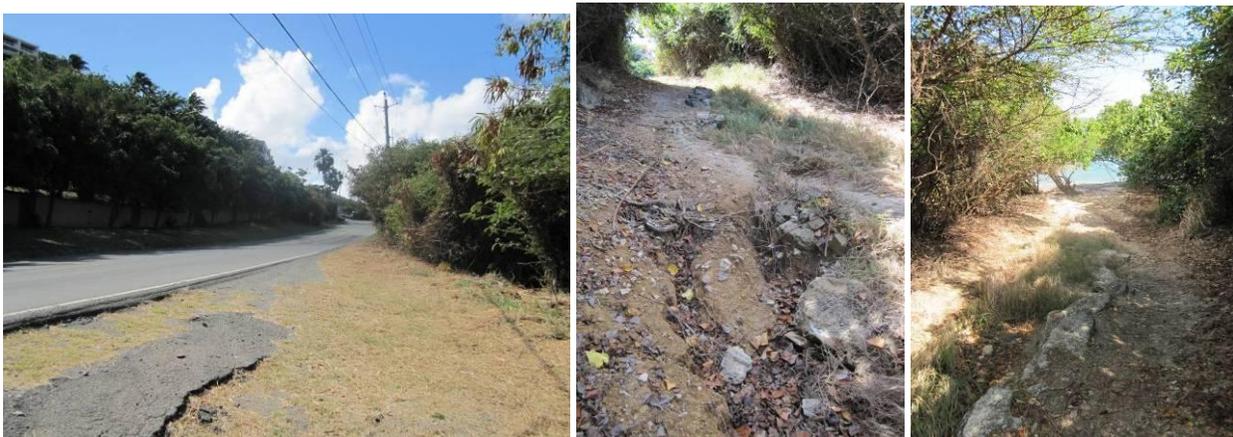
**Figure 4.19.** Runoff from Coakley Bay Condos flows across East End Rd. and down a beach access road (left) causing erosion gullies (middle), and this sediment-laden runoff enters Coakley Bay (right).

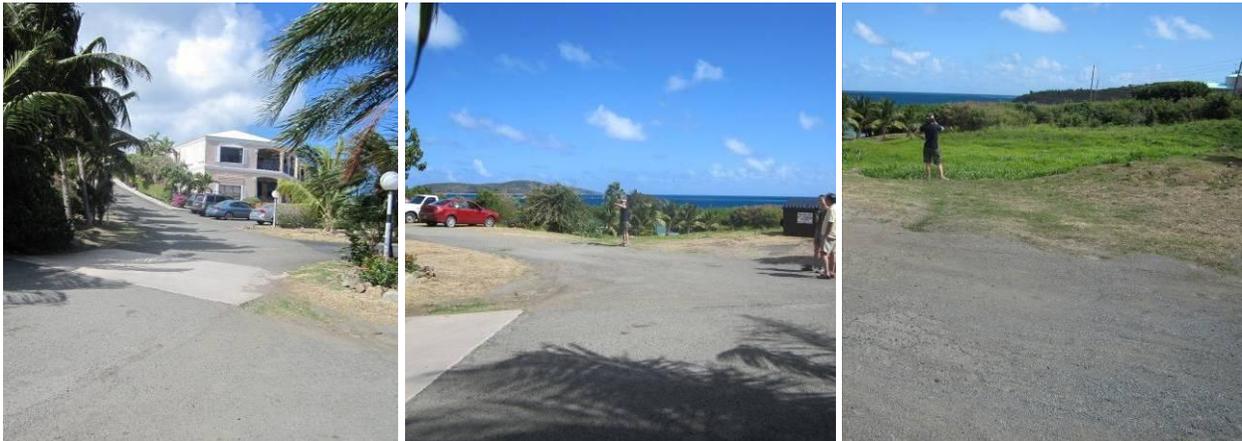
**Figure 4.20.** Stormwater runoff is conveyed across the entrance road with a shallow water bar (left) and continues towards the parking area near the dumpster (middle), eventually, flowing down into a grassy depression that exists in an undeveloped lot (right).

Recommendations for this site are to 1) construct a bioretention facility at the edge of the parking area near the dumpster to treat flows from that area; 2) perform regular maintenance at the sediment forebay in the riprap-channel; 3) stabilize the channel to prevent further erosion along the sides; and 4) protect the existing grassy area from future development, preserving it for stormwater treatment and storage.

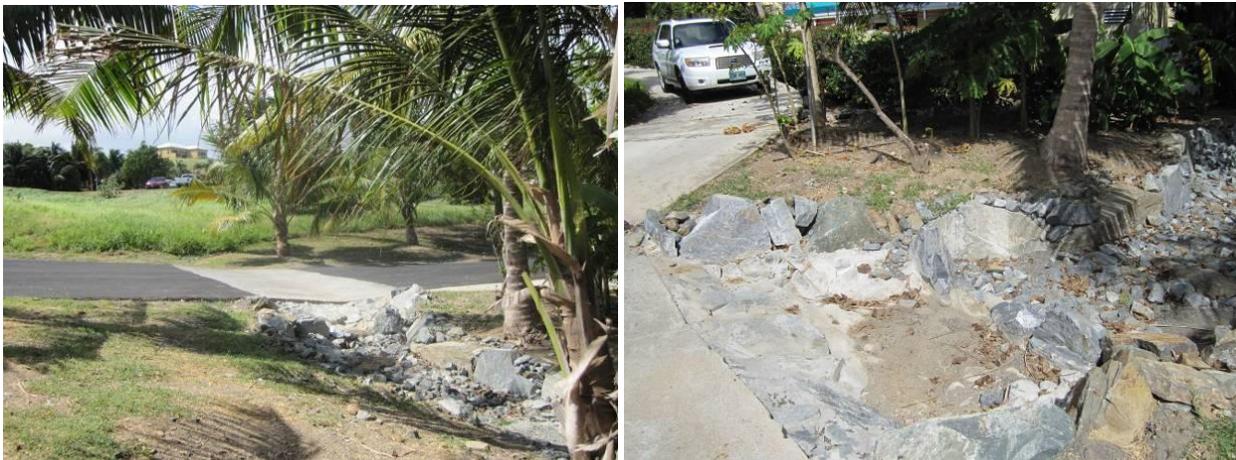
**Figure 4.21.** Stormwater flows from the grass depression and the cul-de-sac to a riprap-lined channel (left). A sediment forebay was constructed with a rock weir (right).

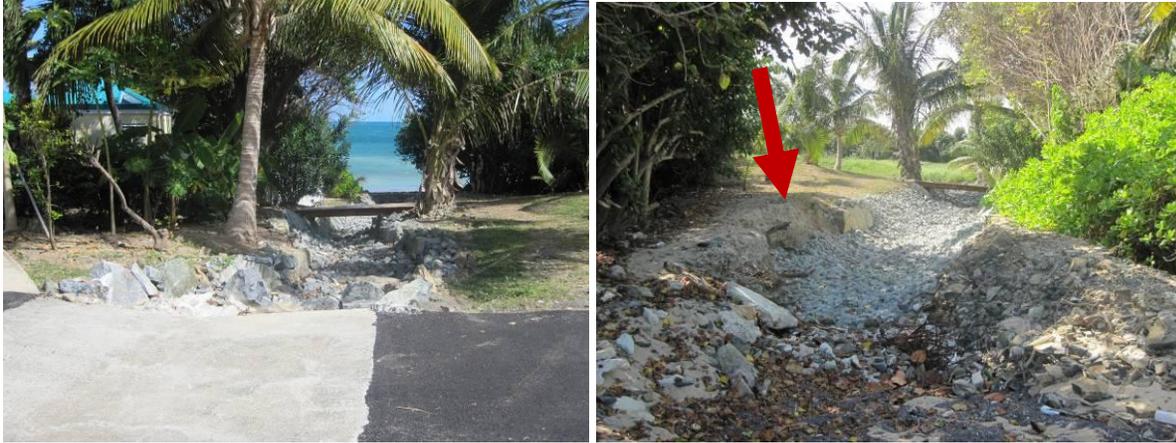
**Figure 4.22.** The channel flows directly to Coakley Bay (left). A portion of the downstream end of the channel has eroded (right).

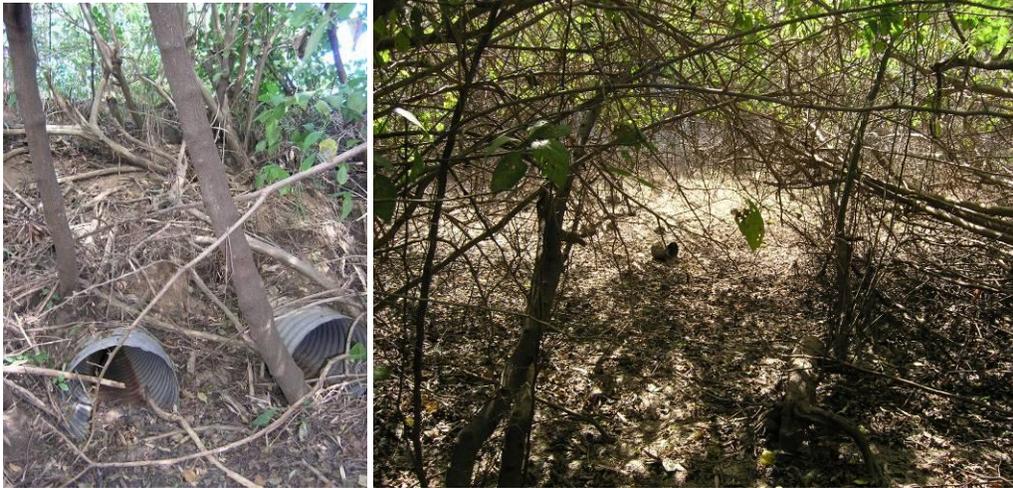
An unpaved private road that connects the Sierra Verde and Yellow Cliff Neighborhoods crosses a gut with a drainage area of roughly 60 acres of mostly farmland and low-density residential lots. There are two 24-inch CMP culverts (see Figure 4.24) that are in relatively good condition with little blockage and only slight scouring at the downstream end. The upstream end is a depression that dries out in the dry season. While these culverts are not currently a significant problem, issues could arise if the upstream watershed becomes more developed.

**Figure 4.24.** Two 24-inch CMP culverts that cross an unnamed road (left). A depression exists at the upstream end that only holds water in the wet season (right).

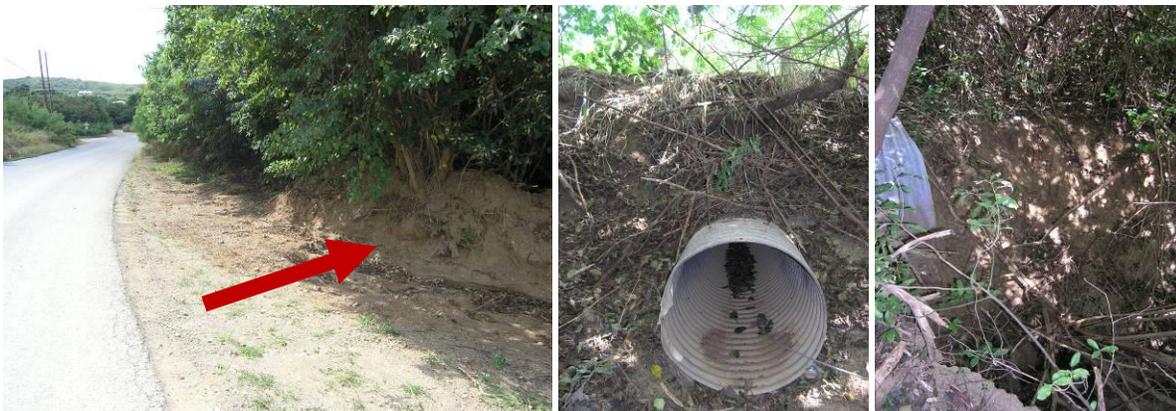
The Pony Club Trail culvert is located at a major crossing point of the main gut in this area. It is a 30-inch CMP that appears to be greatly undersized given the large upstream drainage area (450 acres) and resulting large scour hole at the downstream end (15 ft deep, 20 ft wide, and 50 ft long). This is also an area where a great deal of sediment is deposited from the up-gradient Hope and Carton Neighborhood road network (SB-RC-8). Sediment builds up on the road at this low point and is then pushed off into the gut to clear the road (see Figure 4.25). Tire dumping was also observed at the site. The recommended actions at this site are to 1) replace the damaged, undersized culvert with one appropriately sized for the drainage area and gut characteristics; 2) provide a stabilized outfall on the downstream end of the culvert to reduce further erosion in this area; and 3) perform regular road maintenance that removes sediment from the area rather than depositing it directly into the gut. Educational signage in this area could also help reduce dumping.

**Figure 4.25.** The arrow shows the sediment that gets cleared off Pony Club Trail and pushed into the gut (left). The upstream end of the culvert is clear of debris and is in generally good shape (middle); however, a large scour hole has formed at the downstream end (right).

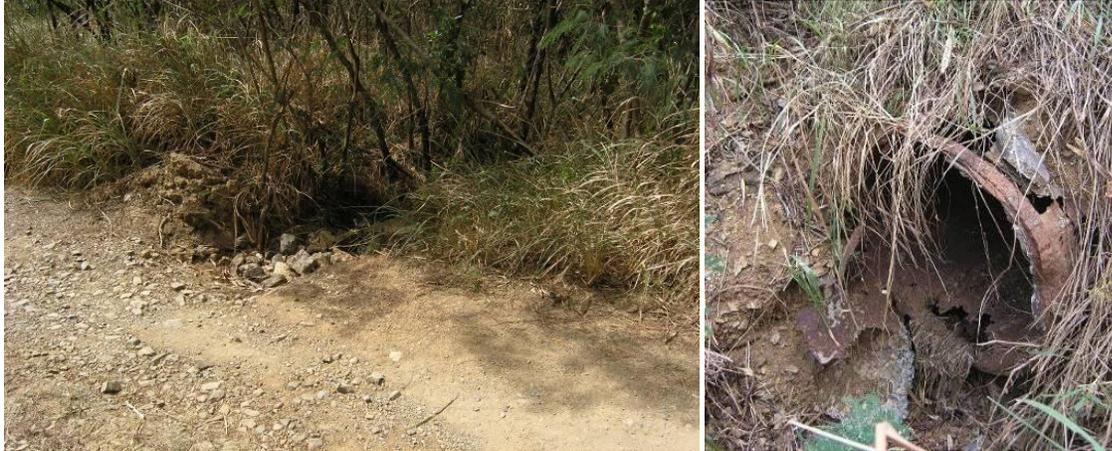
The Cotton Valley Neighborhood Southeast Culvert is a 24-inch ductile iron pipe that carries flow from an unnamed gut underneath an unpaved road and discharges to a pond that holds water year-round. This culvert has corroded and deformed over time (see Figure 4.26). This culvert should be replaced by an appropriately sized culvert, and the outlet should be stabilized.

**Figure 4.26.** The upstream end of this ductile iron culvert is completely blocked (left). The downstream end is corroded and disintegrating (right).

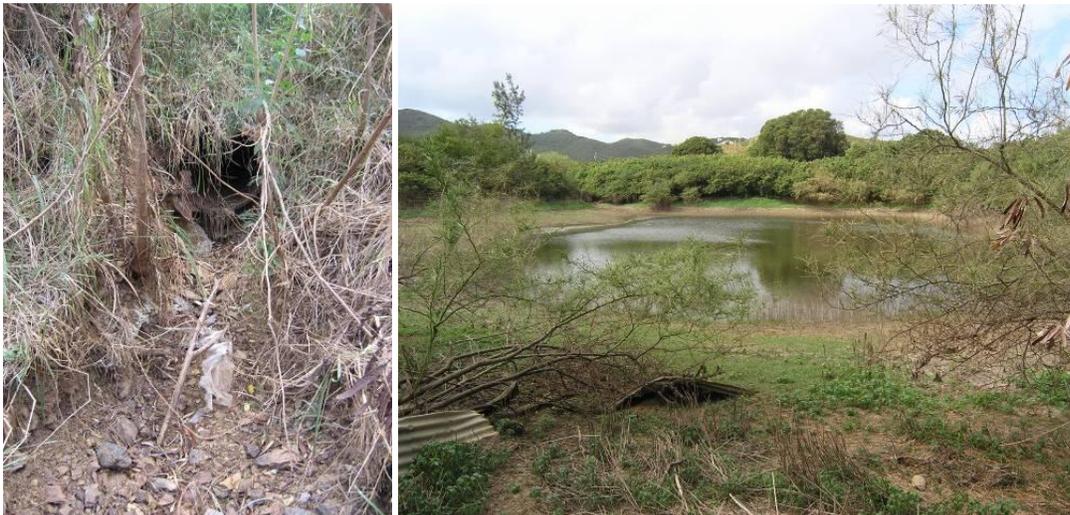
**Figure 4.27.** Scouring was observed downstream of this culvert (left), which leads to sedimentation of the large pond downstream (right).

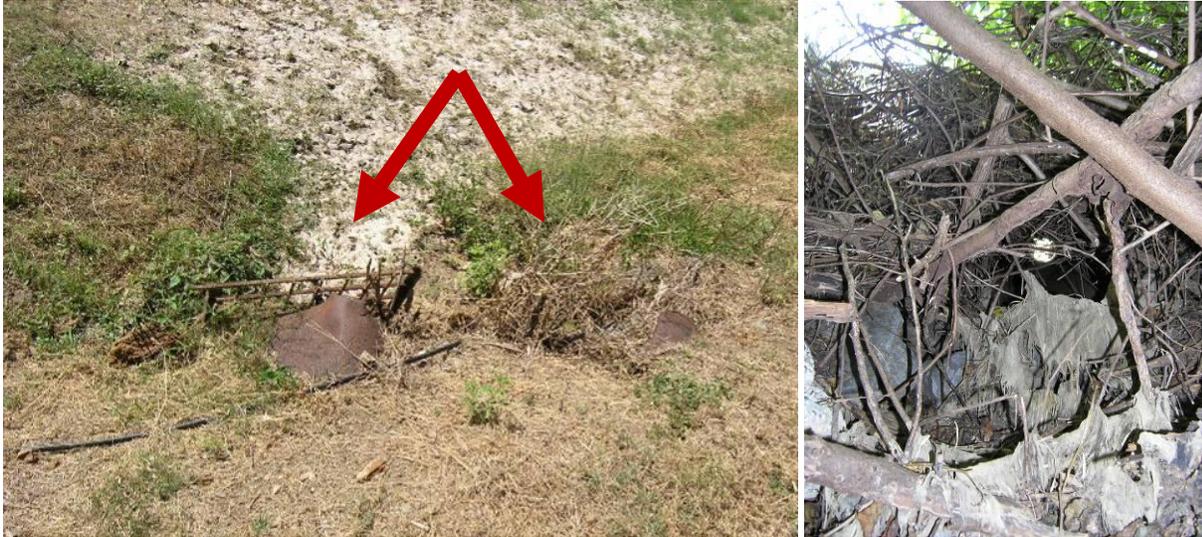
The Cotton Valley Neighborhood Northeast Culvert consists of two 24-inch ductile iron pipes that carry flow from the major gut in this area underneath a partially paved road. These pipes have corroded and deformed over time and have become clogged with sediment and vegetation (see Figure 4.28). A small pond that dries out during the dry season is located upstream from the culverts (Figure 4.29). A scour hole has formed downstream. The road in

**Figure 4.28.** The two 24-inch ductile iron culverts have damaged trash racks – one made of rebar grate and one made of wire fencing and sticks (left). The downstream end is clogged with vegetation (right).

this area is deteriorating, creating a sediment source to the gut. The culverts should be replaced by appropriately sized culverts that maintain or increase the amount of storage in the upstream pond system. Regular road and culvert maintenance should be performed in this area to reduce the sediment load into the gut.

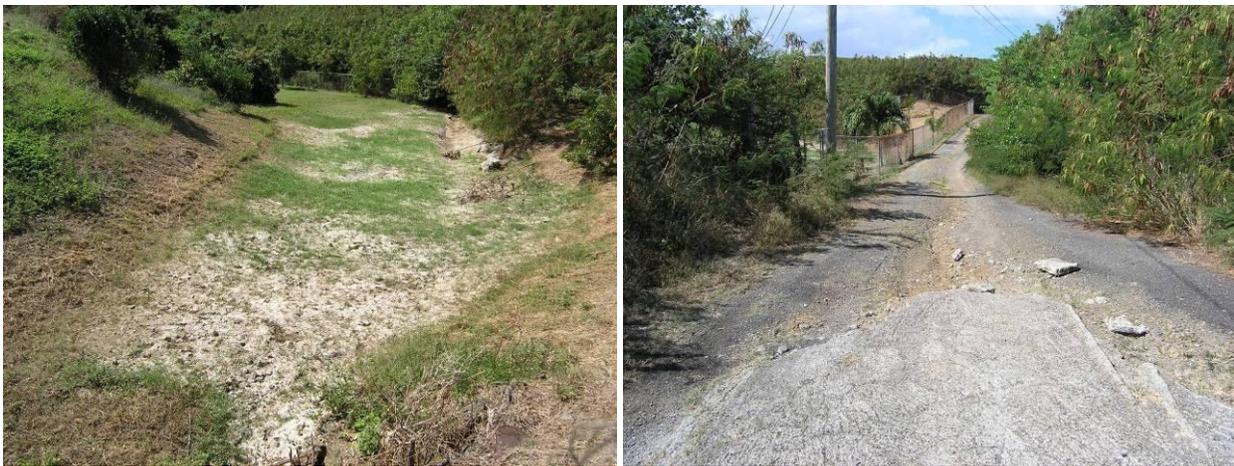
**Figure 4.29.** A pond is located upstream from the culverts – dry at the time of observation (left). The road itself is deteriorating and providing a sediment load to the gut (right).

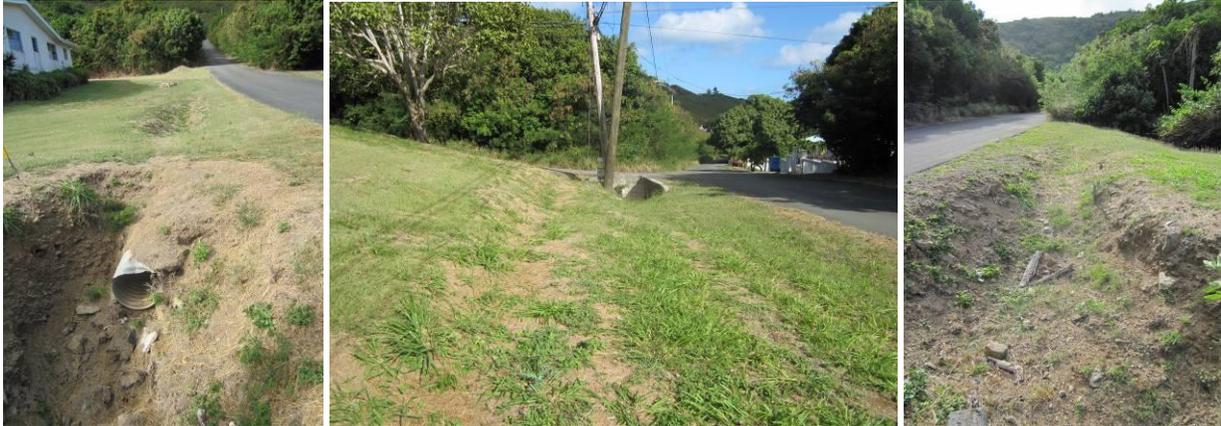
The Solitude Rd. Culverts consist of two 30-inch corrugated metal pipes that carry flow from the southern portion of the Pleasant Valley Neighborhood into a gut. These pipes have corroded and deformed over time and have caused substantial erosion along the road in these areas (see Figure 4.32). The culverts should be replaced by appropriately sized culverts and be maintained regularly.

**Figure 4.32.** Erosion caused by deteriorating culverts in the southern portion of Pleasant Valley.

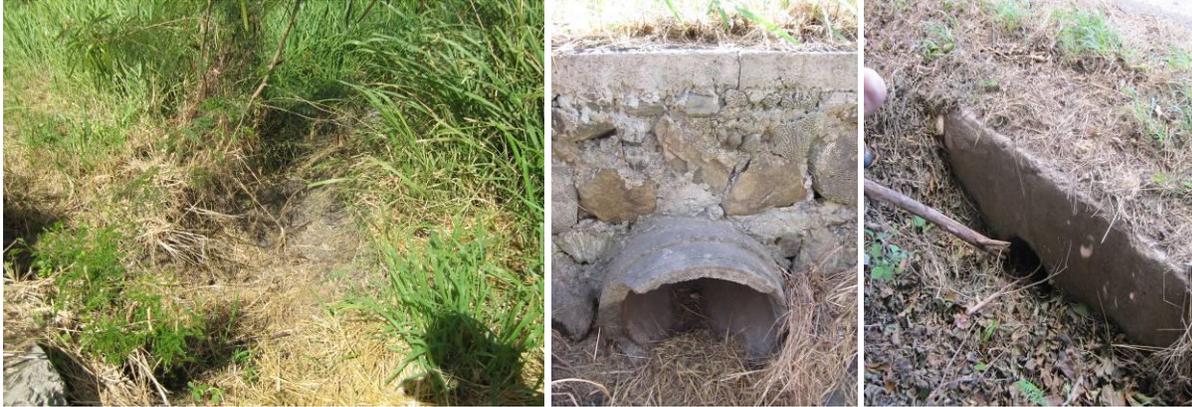
The East End Rd. Culverts - West consist of three RCP culverts between Prune Bay and Coakley Bay Condos. The first (starting from the west), an 18-inch culvert, has some downstream scouring that needs to be stabilized. The second, an 18-inch culvert, is deteriorating and needs maintenance to remove sediment and vegetation. The third, a 15-inch culvert, needs maintenance to clear blockages on the upstream end (see Figure 4.33).

**Figure 4.33.** Erosion downstream from the first culvert (left); the second, chipped culvert (middle); and the partially blocked third culvert (right).

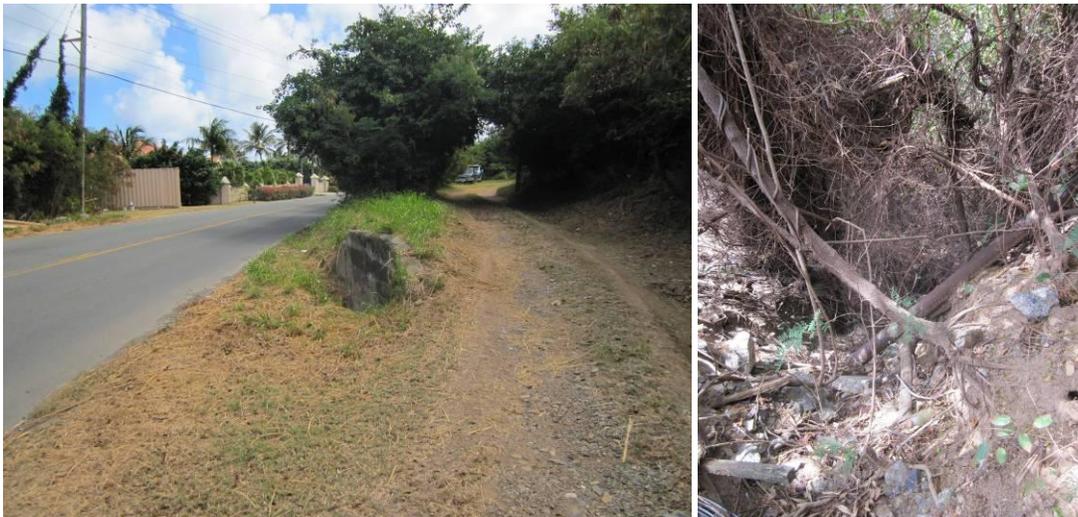
**Figure 4.34.** Upstream end of culvert has large headwall separating it from an unpaved drive (left); the downstream end is scoured out and clogged with vegetation (right).

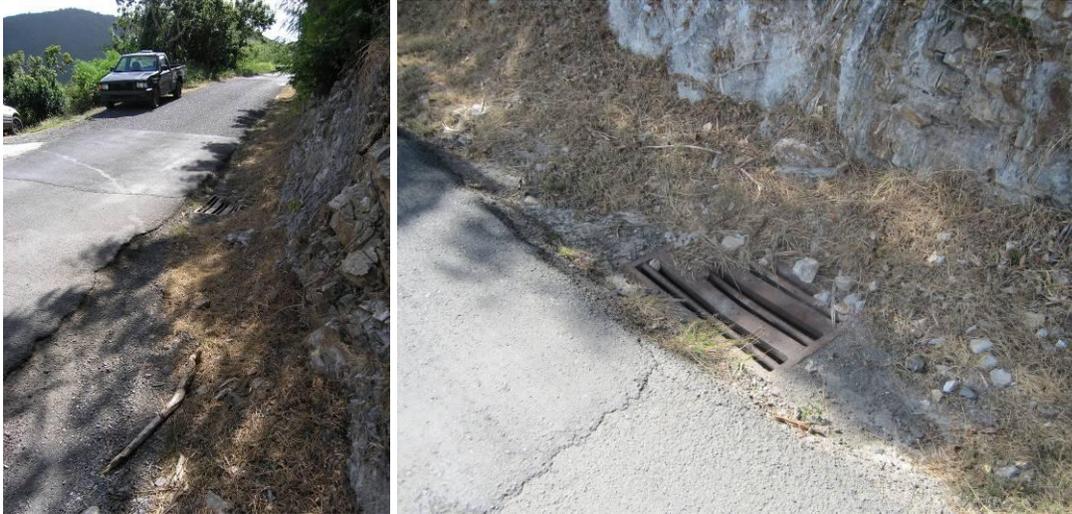
This culvert is a 12-inch CMP culvert that appears to be completely blocked. In addition, the downstream end of this culvert should be located and stabilized. This culvert should have regular maintenance to prevent complete bypass, which would cause further erosion problems down-gradient on Seven Flags Rd. (see Figure 4.35).

**Figure 4.35.** Blocked inlet to this culvert on Seven Flags Rd.

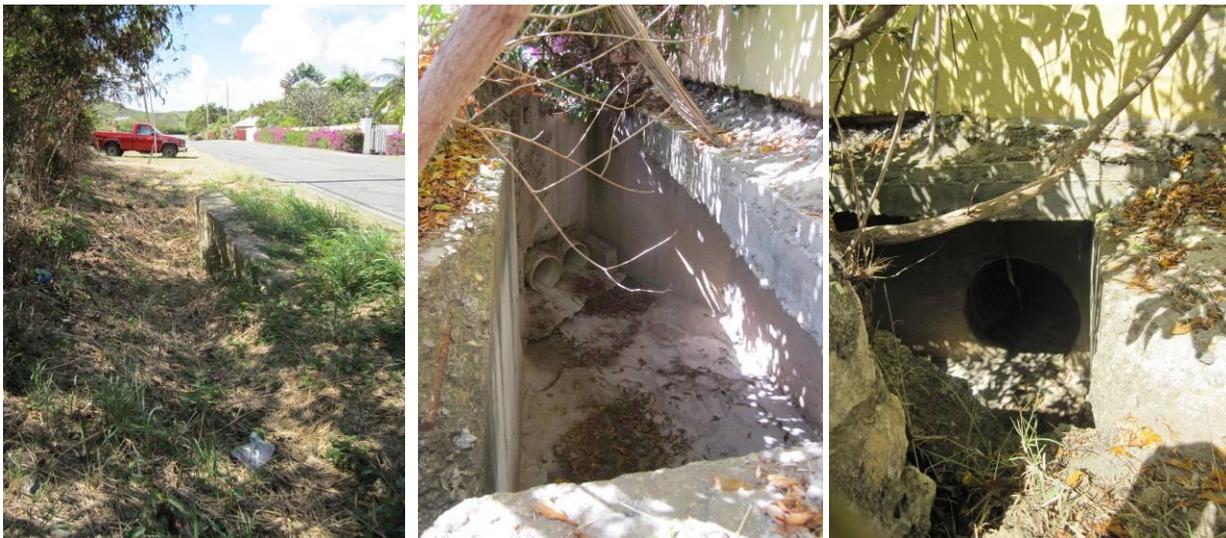
The East End Rd. Culvert - East consist of one culvert and two additional pipes near the intersection with Sierra Verde Rd. The main culvert is a 24-inch CMP culvert for road runoff. In addition, two 8-inch PVC pipes were observed, as well as a strong septic odor, at the downstream end of the culvert (see Figure 4.36). The ultimate discharge to Yellowcliff Bay was not observed. The PVC pipes should be inspected for illicit discharges from upstream septic systems and disconnected as necessary.

**Figure 4.36.** Upstream end of 24-inch culvert and headwall; Sierra Verde Rd. in the background (left); the two PVC pipes in the drainage structure at the downstream end of the culvert (middle); and the ultimate discharge pipe to the bay where runoff leaves the drainage structure (right).

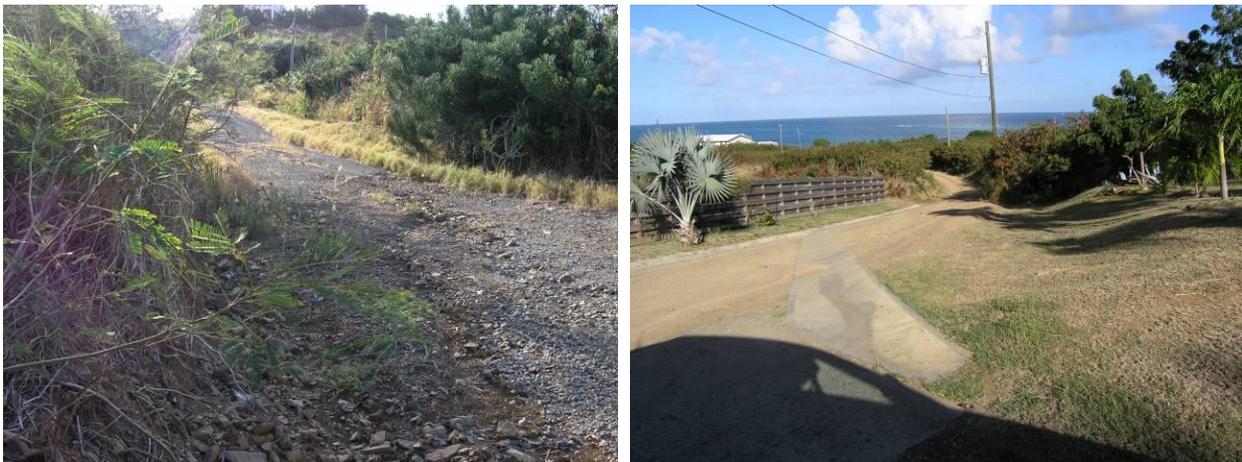
**Figure 4.37.** Erosion along private road within Sierra Verde neighborhood at meeting point between paved and gravel roadways (left) and water bar installed along main dirt road in Sierra Verde neighborhood.

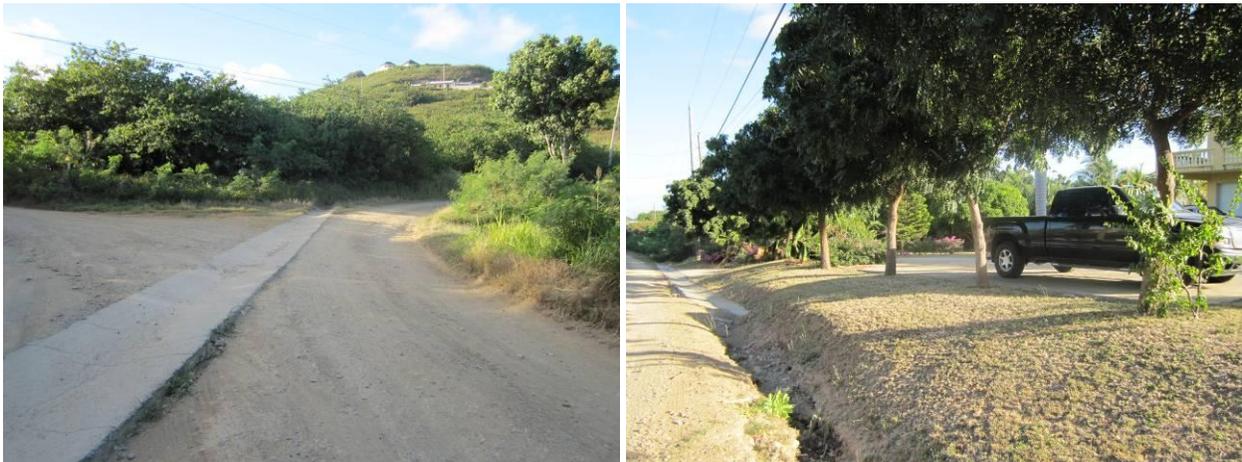
**Figure 4.38.** Concrete swale installed along dirt road in Hope and Carton Hill neighborhood (left) and erosion along dirt road where a paved swale ends (right).
