Site Name/ID: Fire Station

Watershed: Solitude

Date: 1/25/11

EXISTING SITE/STORMWATER MANAGEMENT

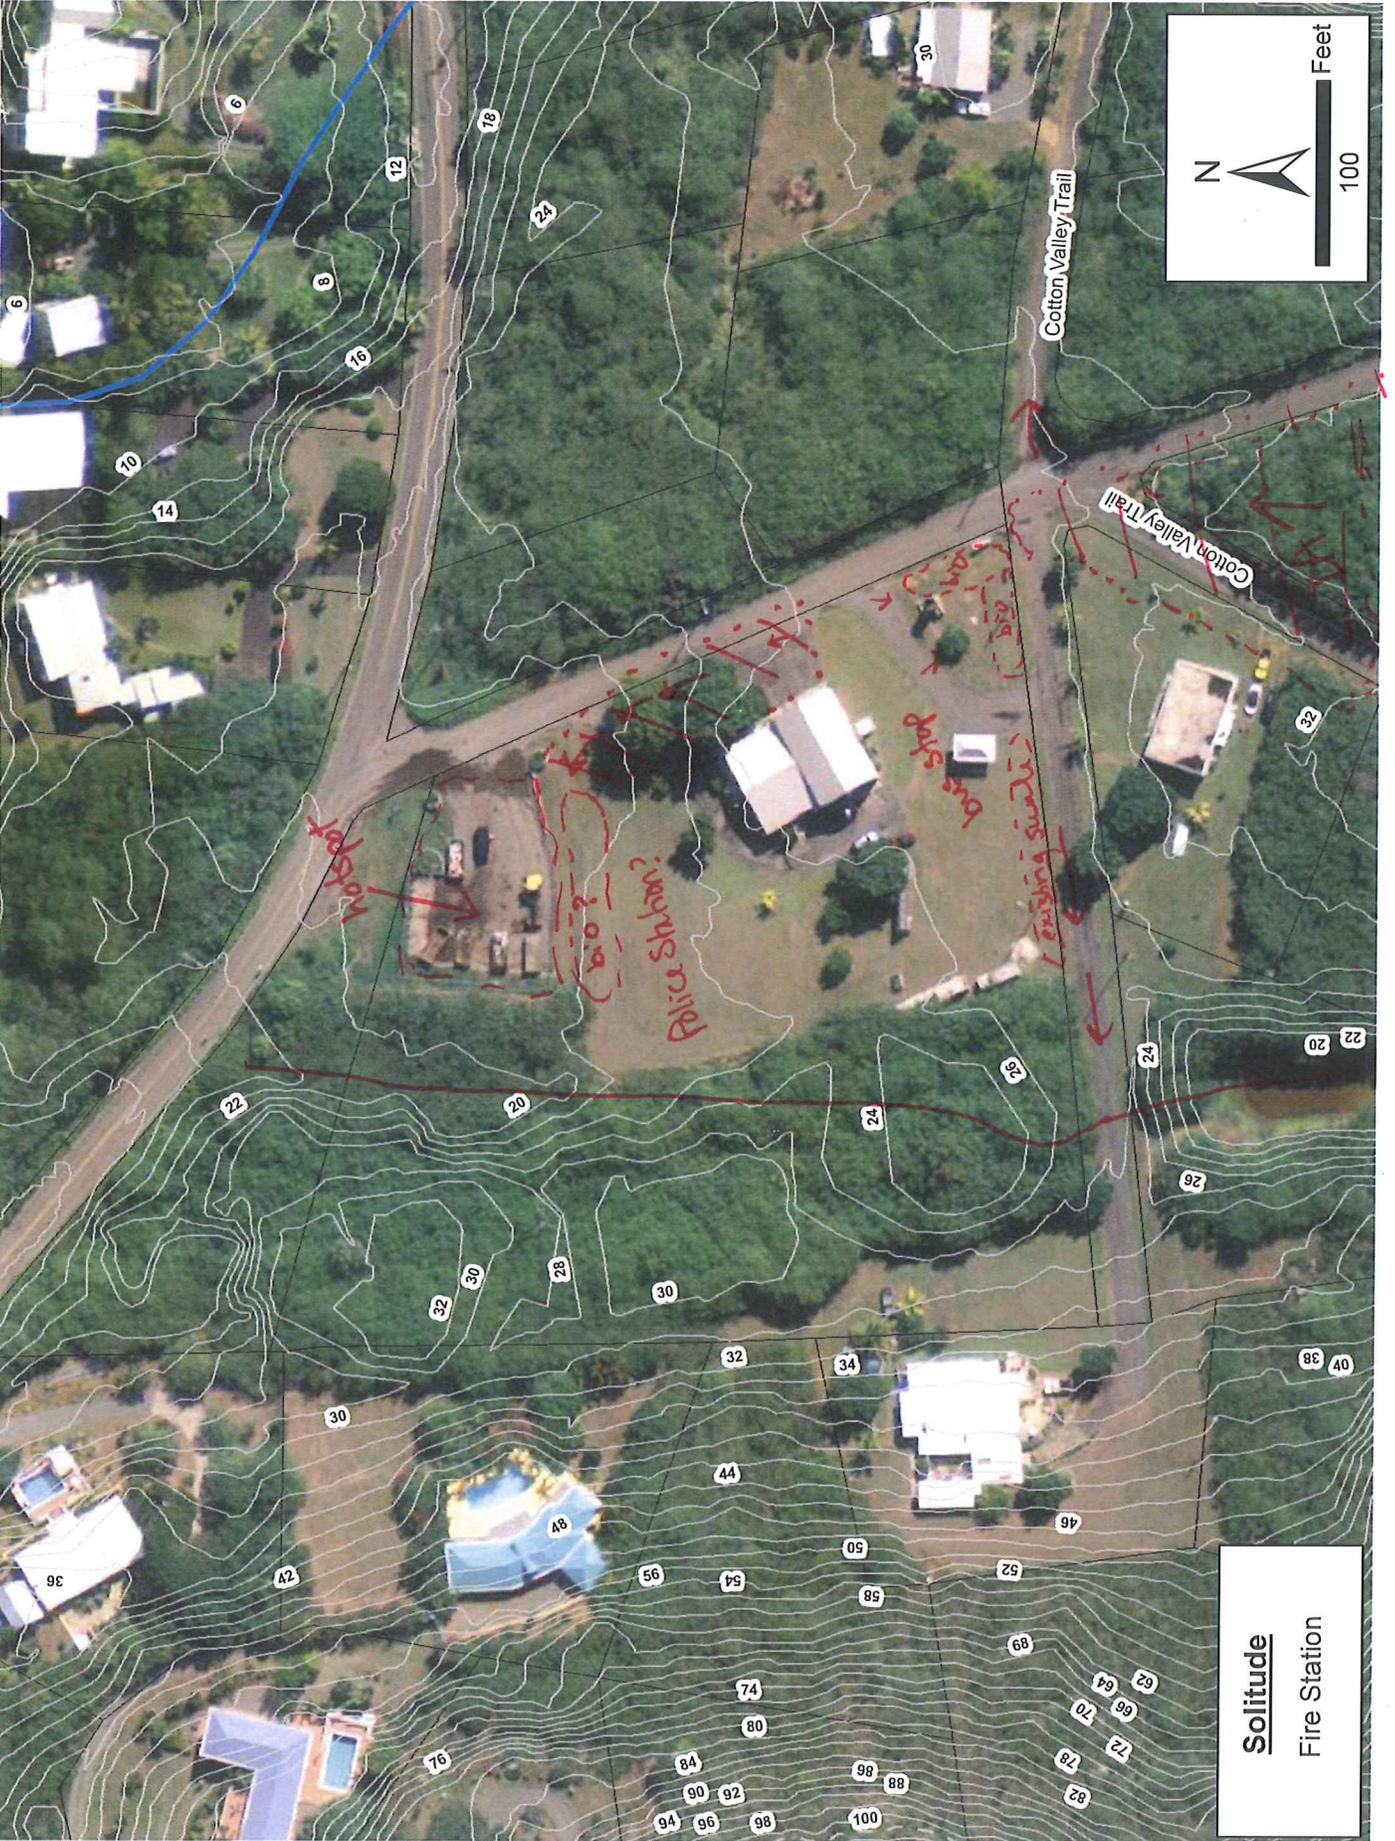
Solitude
Fire Station

Describe Existing Stormwater Conditions, Including Existing Site Drainage and Conveyance:
- Noted rec facility - Ball onsite, went to do a community center
- Police Substation to be constructed?
- very flat area at bottom of watershed. Gut directly adjacent to property

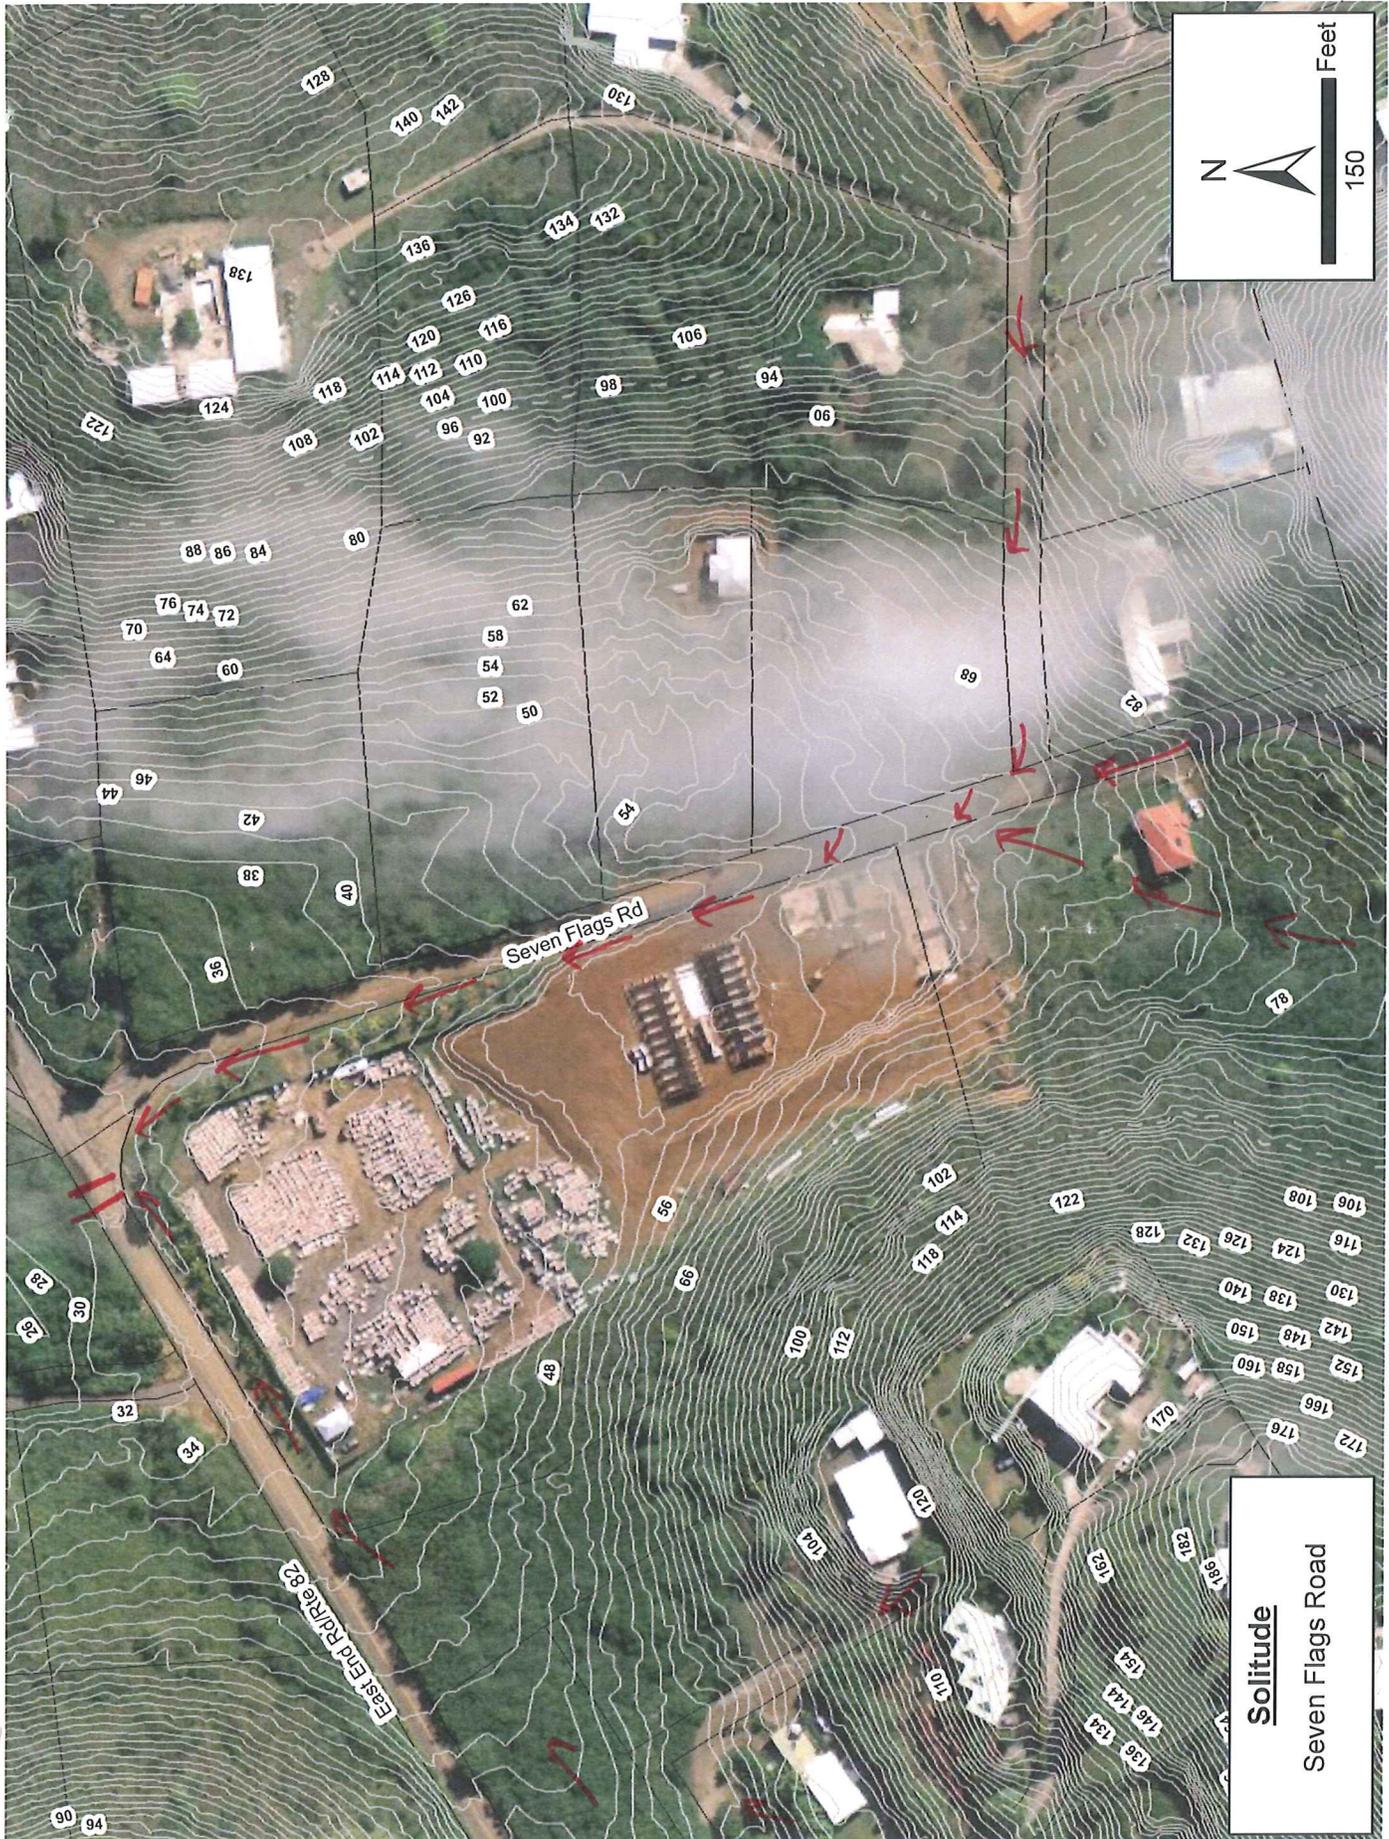
Solitude
Seven Flags Road

Describe Existing Stormwater Conditions, Including Existing Site Drainage and Conveyance:
Gut follows along road -> major erosion, road is threatened
Blocked culverts at downstream end, convergence of 2
guts
Potential area behind ^{new} upstream lets for storage

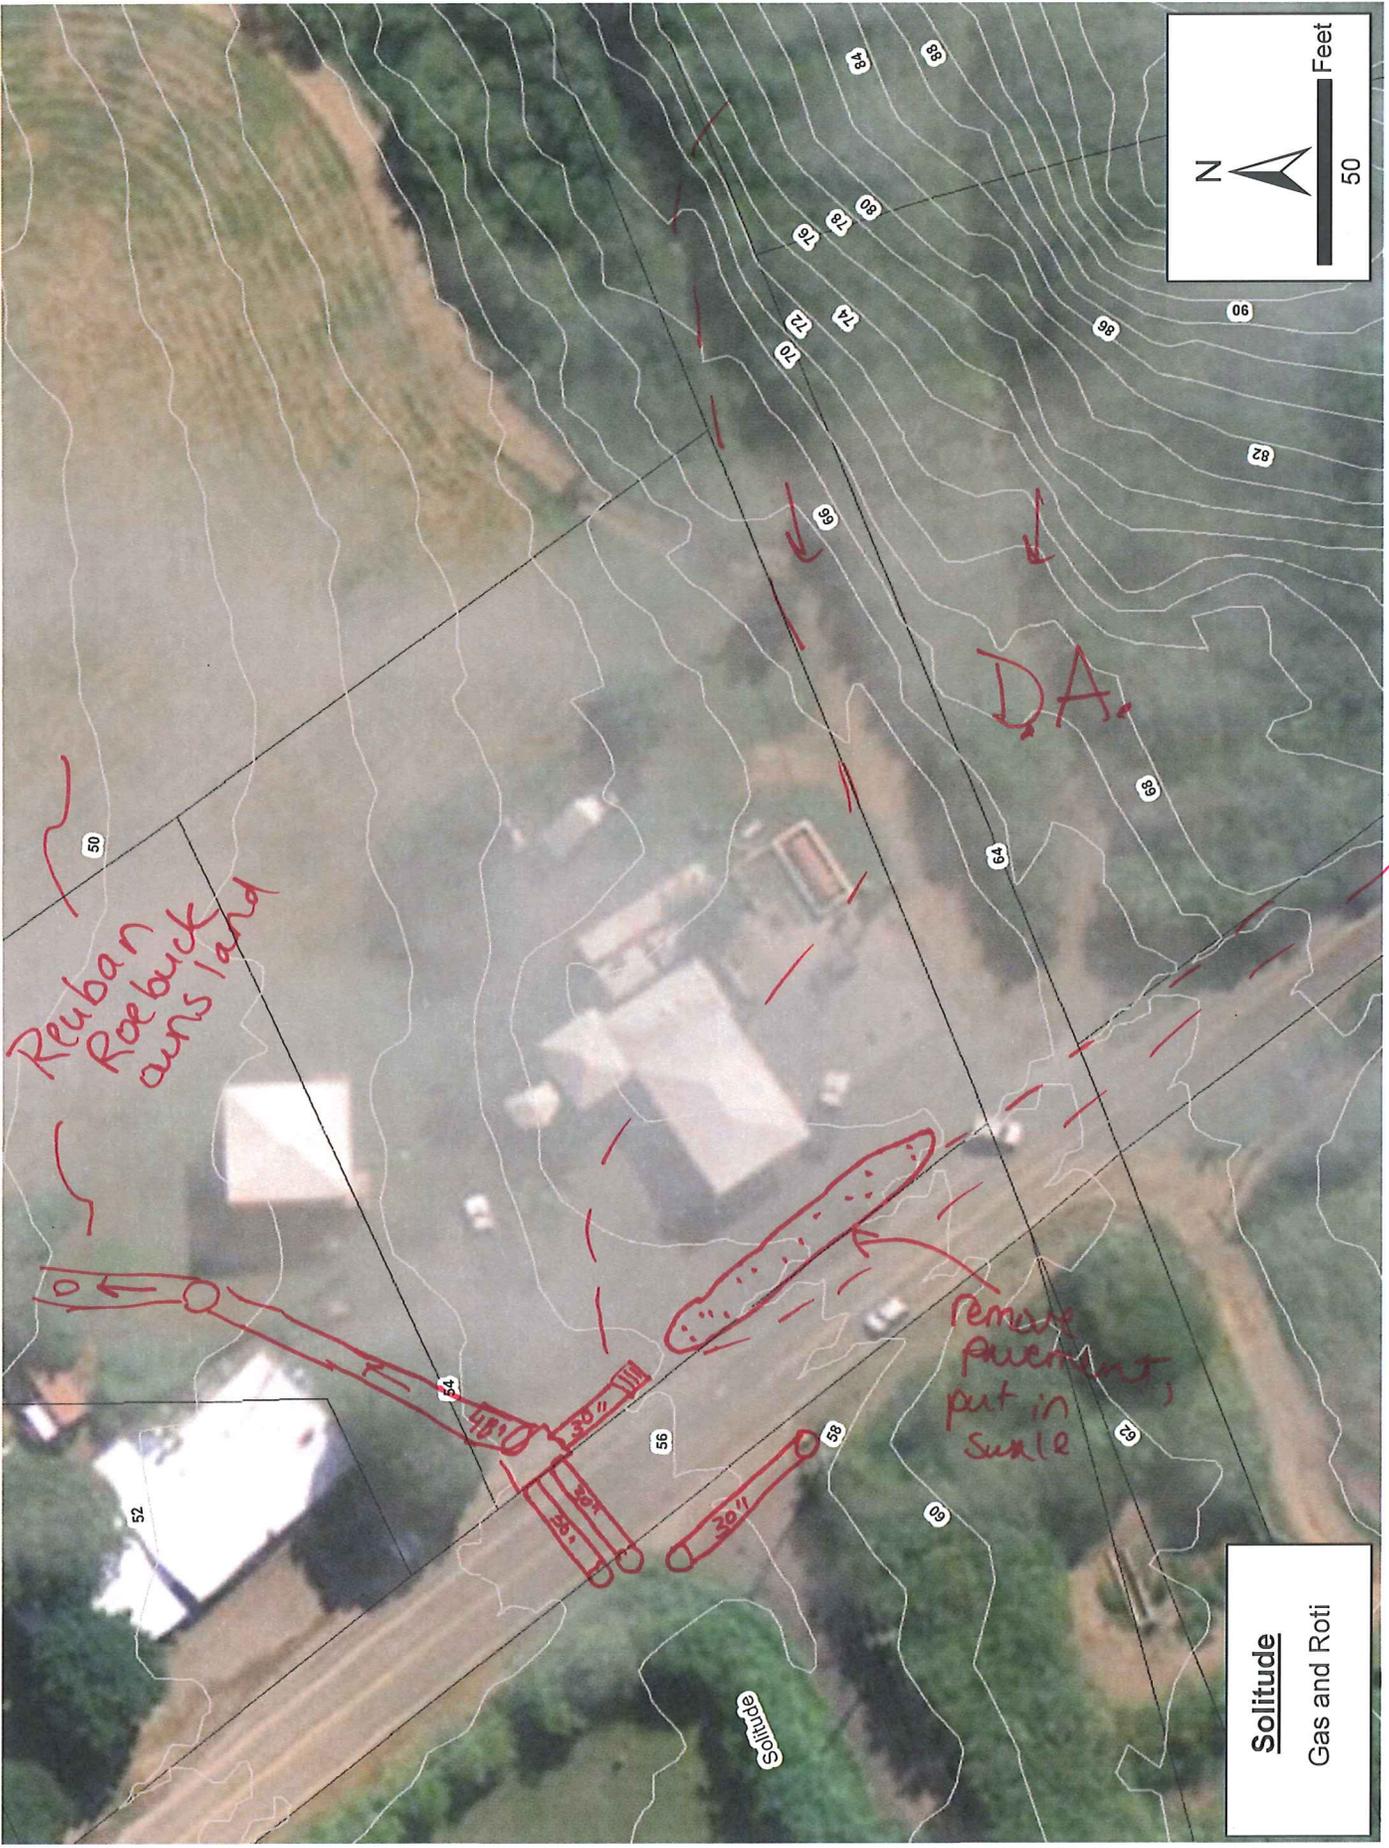
Solitude
Gas and Roti

Describe Existing Stormwater Conditions, Including Existing Site Drainage and Conveyance:
Catchbasin - 30 in pipe discharges to Coakley Bay via 48" pipe through Ruban Roebuk's property
Downstream 48" culvert - sinkholes around manholes - hazard, corroded - need to
- capacity fine - no observed flooding - DRW has been contacted - est. \$42,000 - fix whole system

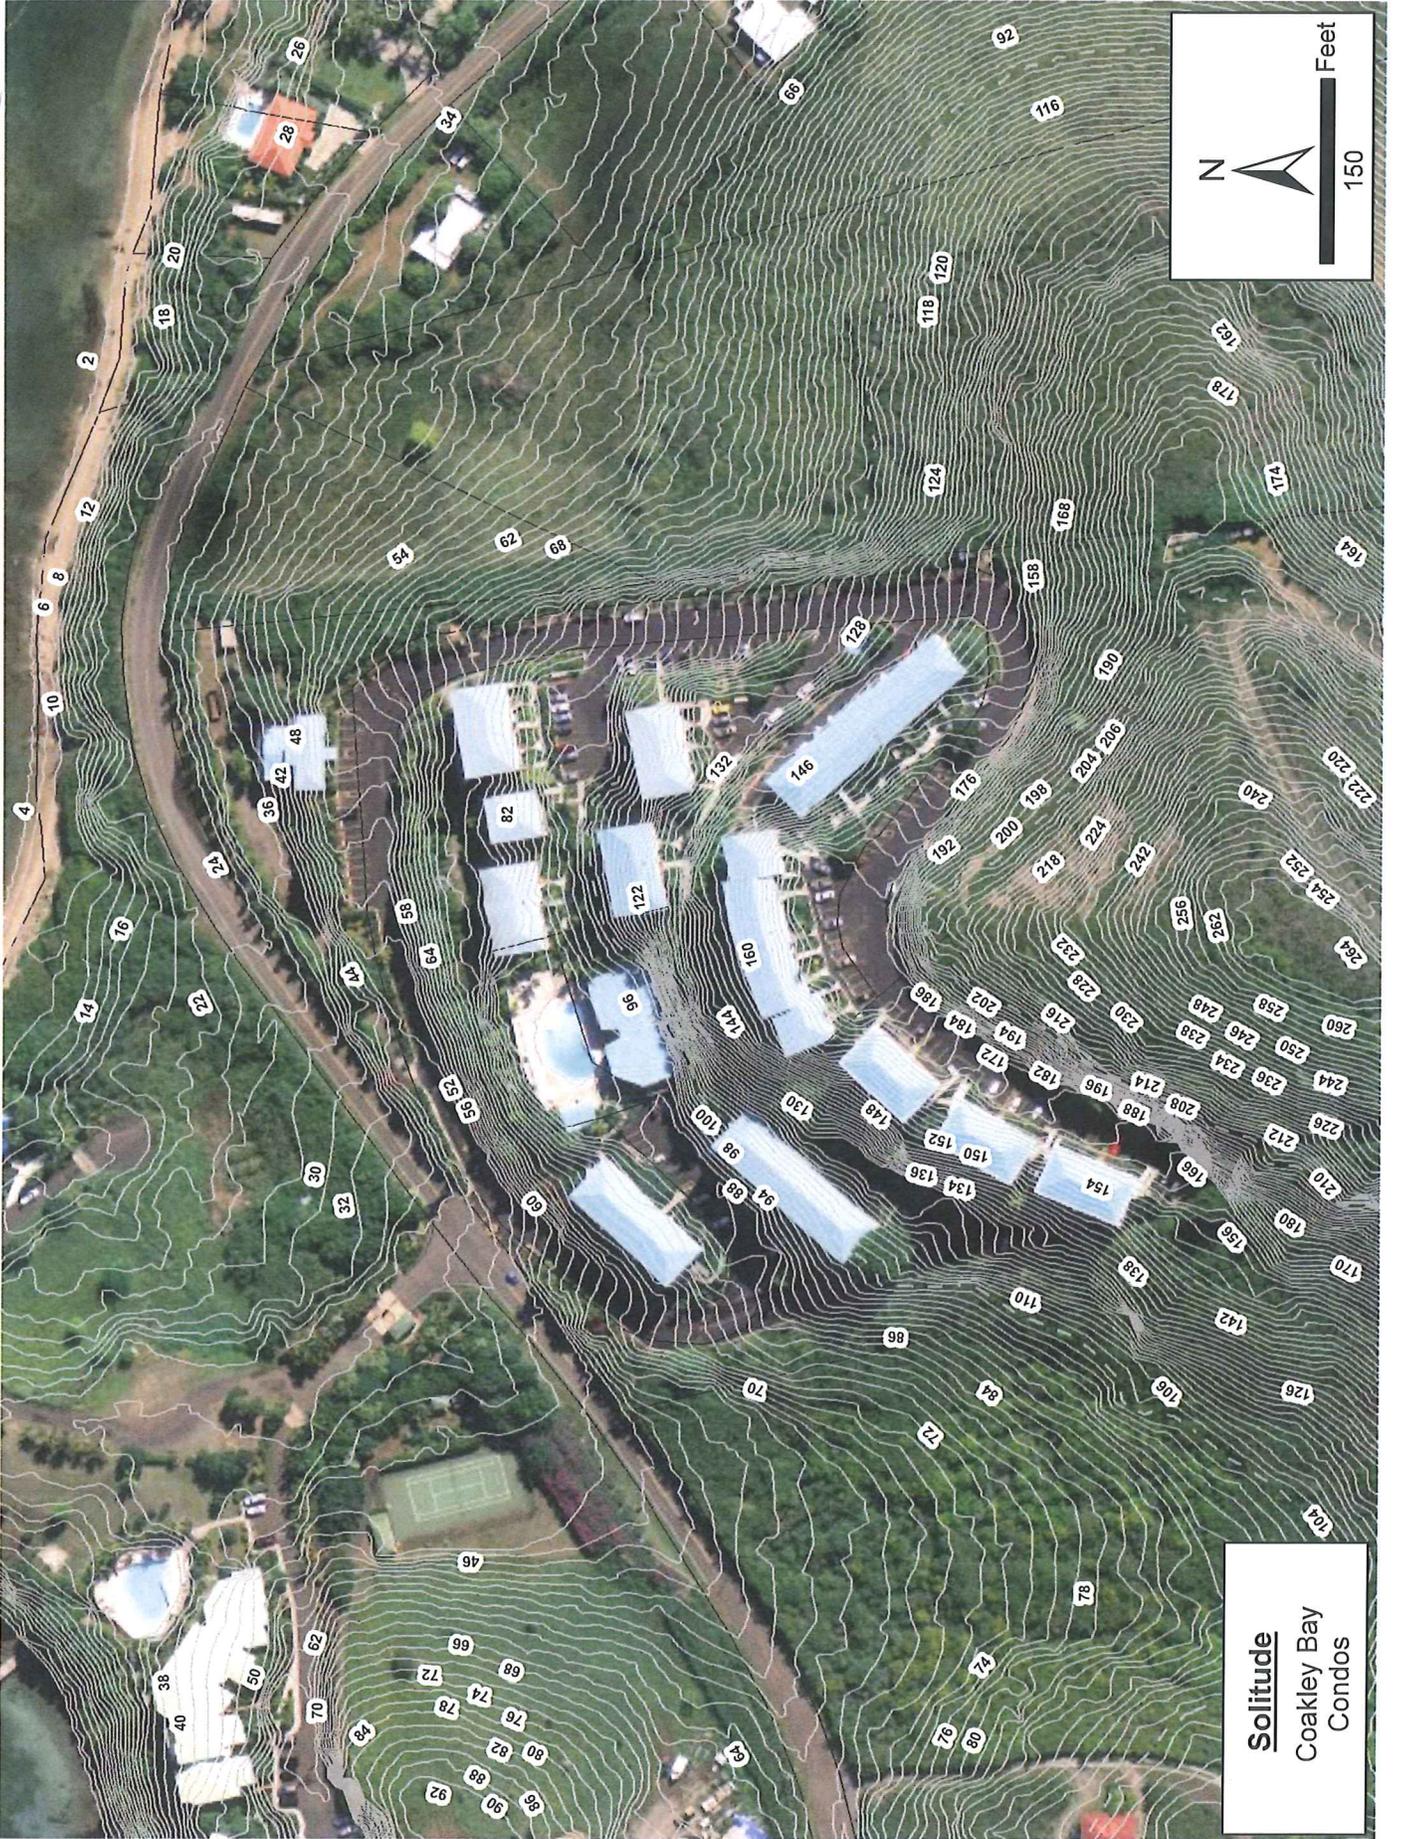
Solitude
Coakley Bay
Condos

Describe Existing Stormwater Conditions, Including Existing Site Drainage and Conveyance:
steep site with a lot of parking/driveway. Runoff directed around property in a series of concrete ditches/channels. one area where ponding has occurred and condo ass. putting in curb/pvc drains.

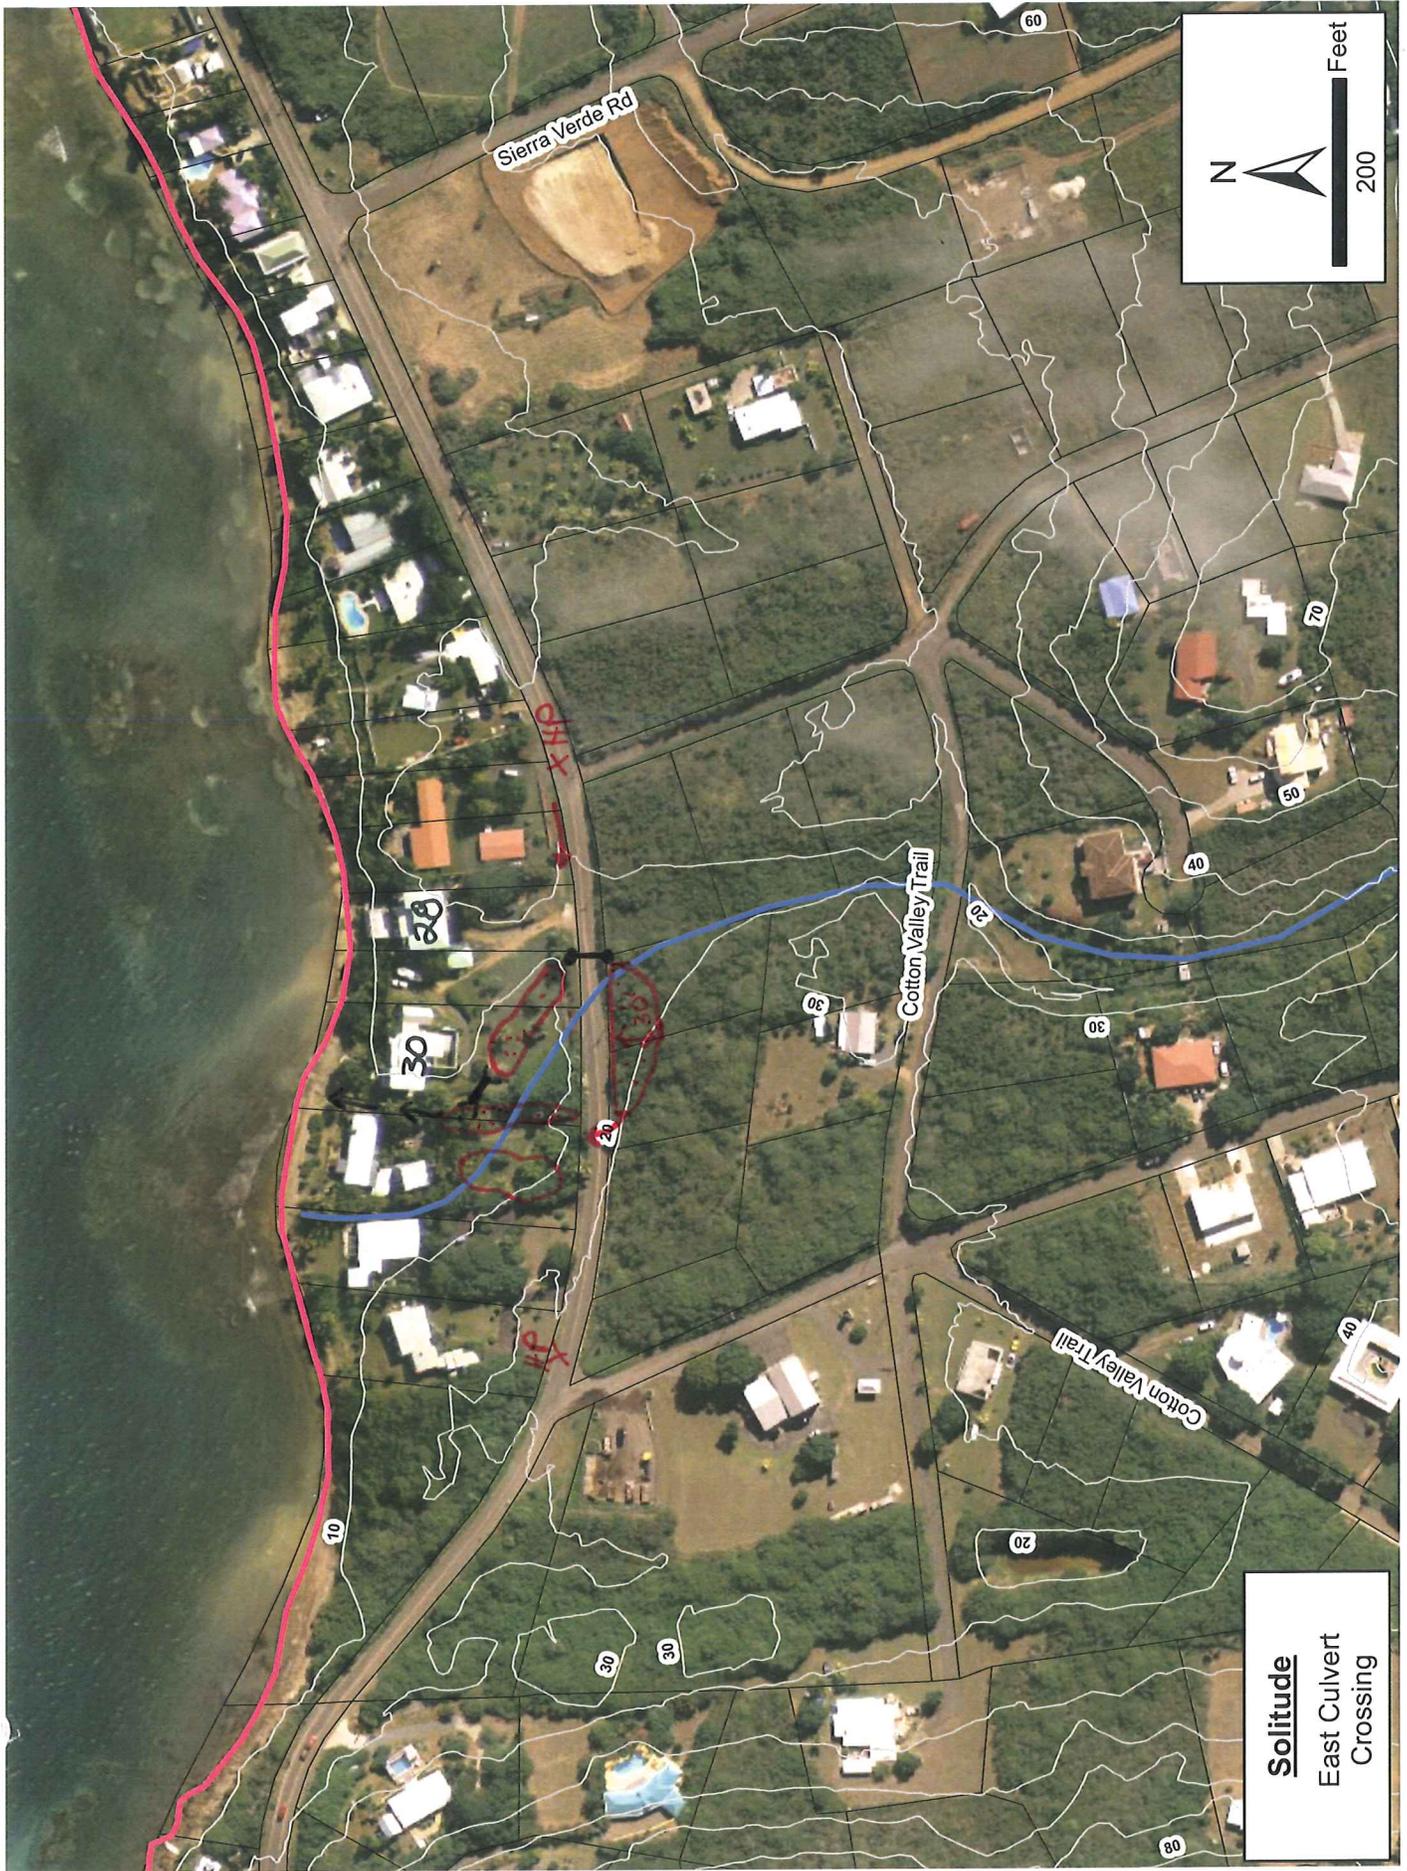
Sierra Verde Rd

*corroded CMP pipe retrofit w/ RCP end sections

DESCRIPTION OF EXISTING CONDITIONS: ① south ~~side~~ ^{North} of main road (see above) ② existing culverts: ② North side of main road - on property. - 15" single, metal circular ~10' long, somewhat subseq.

- enlarge culverts
- enlarge depression, island bio
