STX EE WATERSHEDS

RETROFITS

Site Name/ID: GP-R-1 / Great Pond Parking

Watershed: Great Pond

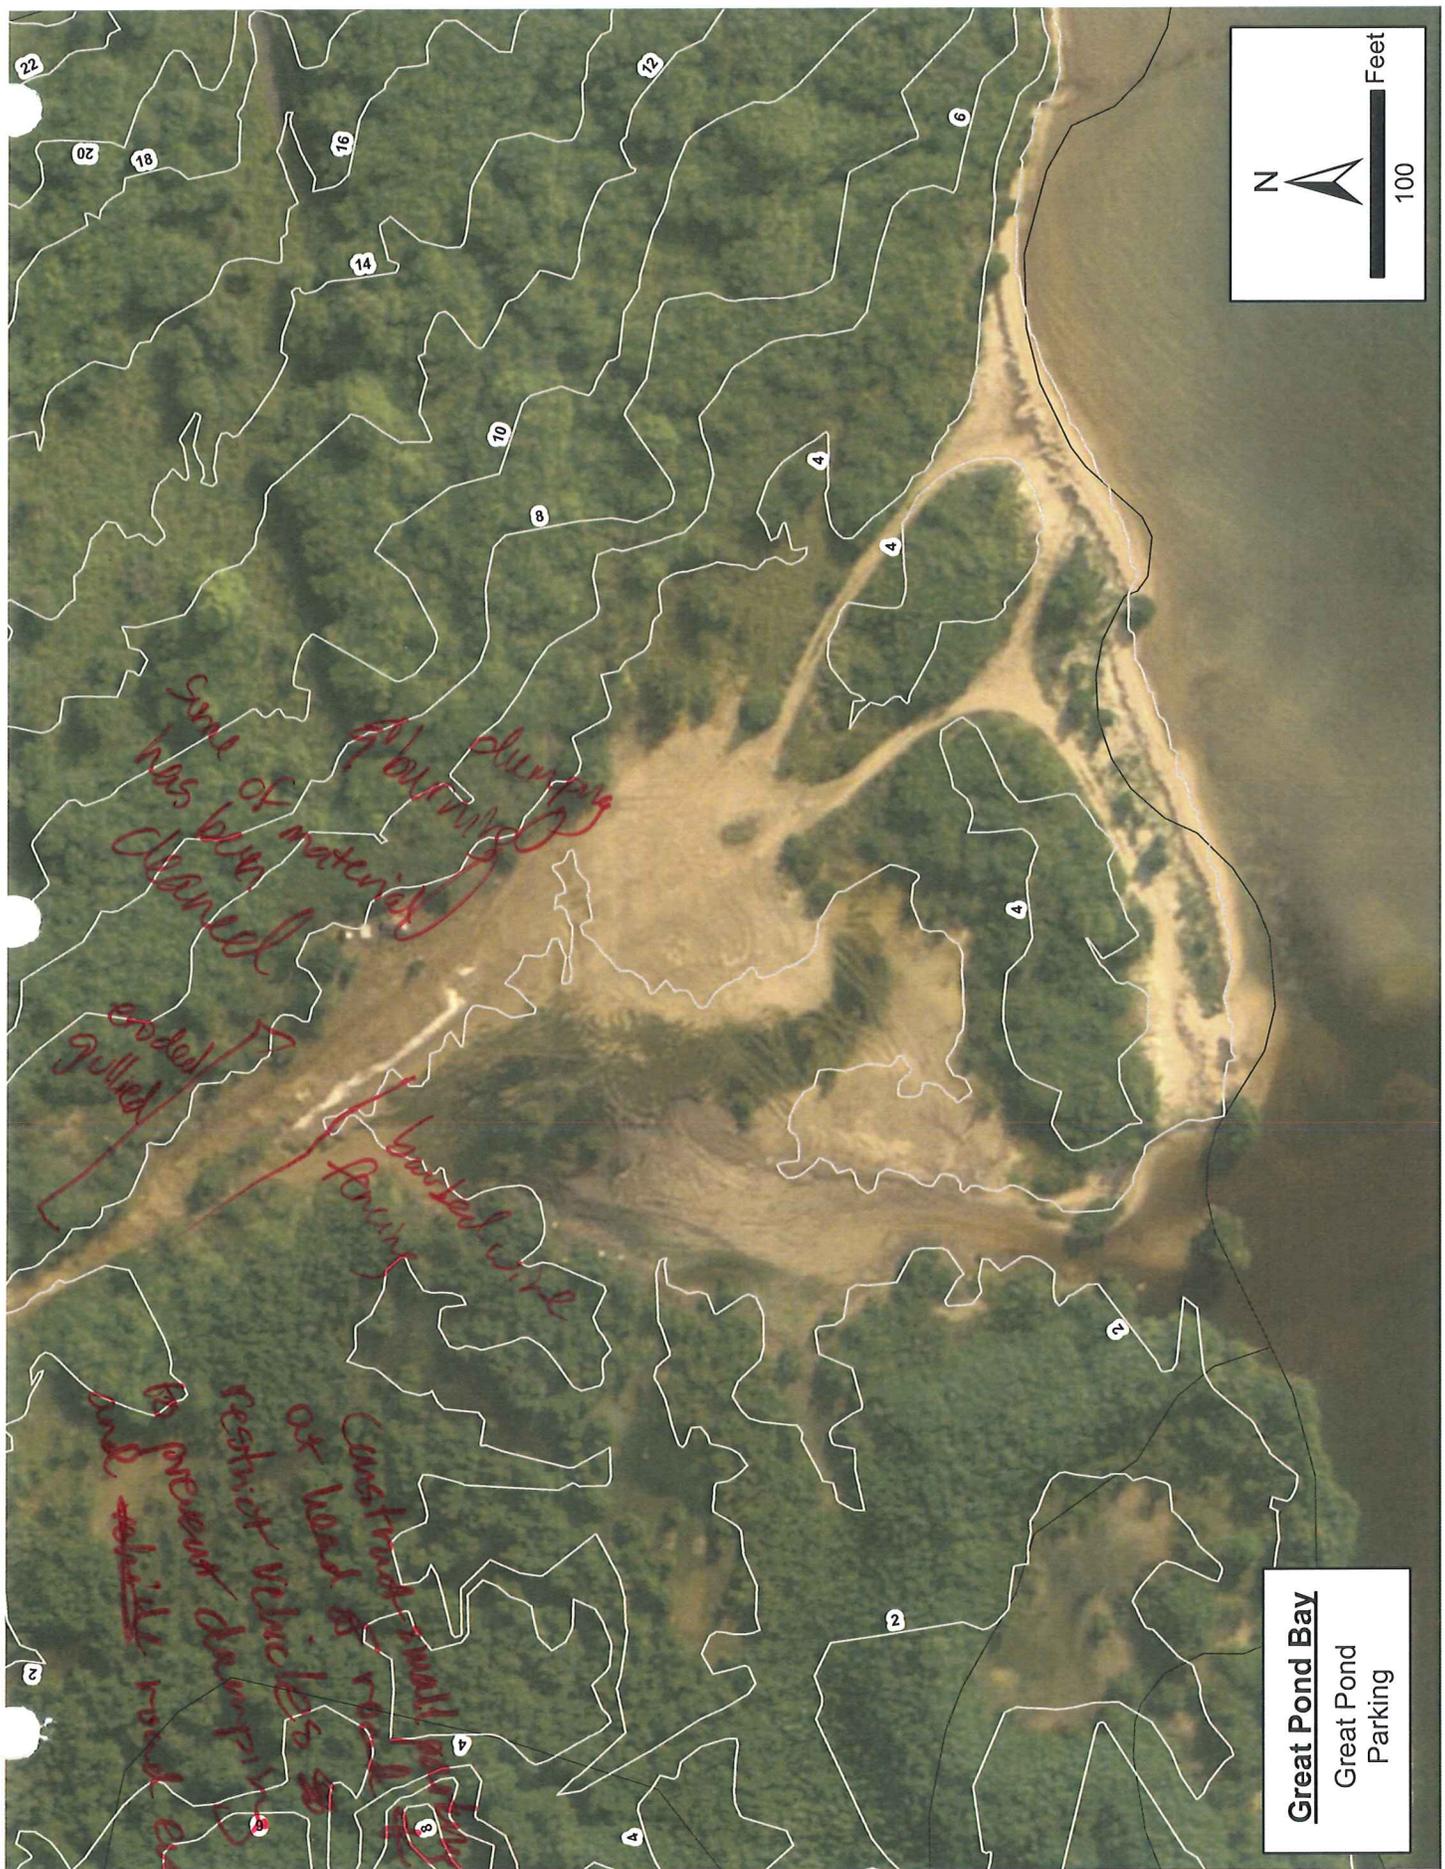
Great Pond Bay
Great Pond
Parking

Describe Existing Stormwater Conditions, Including Existing Site Drainage and Conveyance:
Stormwater sheet flow down existing dirt road/paths to pond & ocean.
Debris/staining from dump/trash piles & evidence of burn piles
along road east of pond. SW likely flows through refuse to
beach.
Significant gullying & erosion along road

Install guardrail or other suitable barrier to restrict vehicle access (and minimize potential for dumping) on road. Restore road w/ appropriate sediment and/or gravel
- Clean/remove trash/refuse/debris to suitable off site location
- 'No dumping' signage?

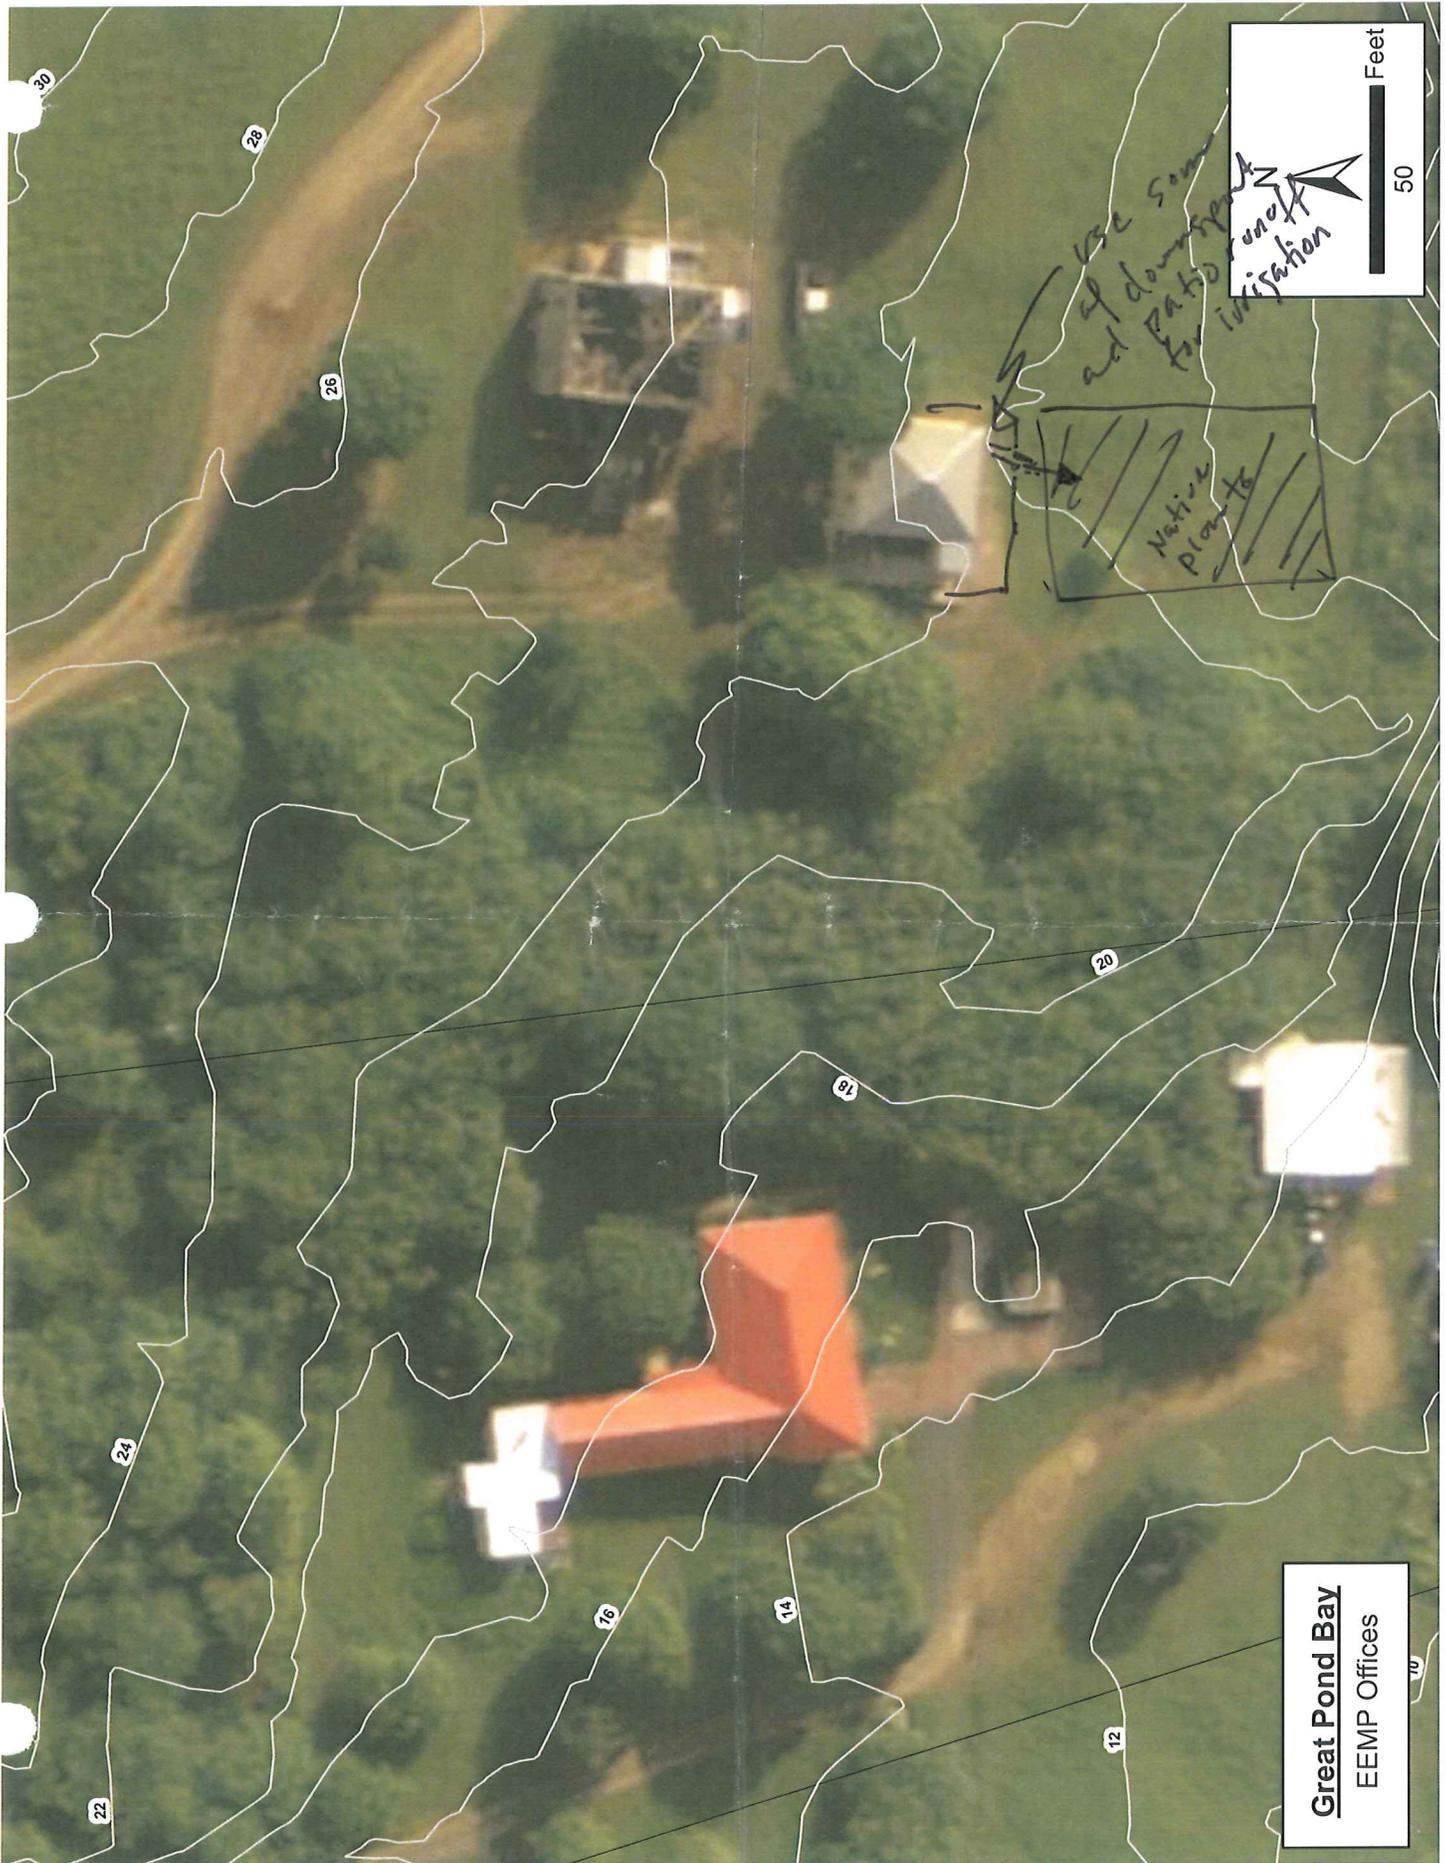
Great Pond Bay
EEMP Offices

Describe Existing Stormwater Conditions, Including Existing Site Drainage and Conveyance:
No Problems here — maybe use empty open space to grow plants for rain gardens & erosion control projects??

use some of downspout water for irrigation

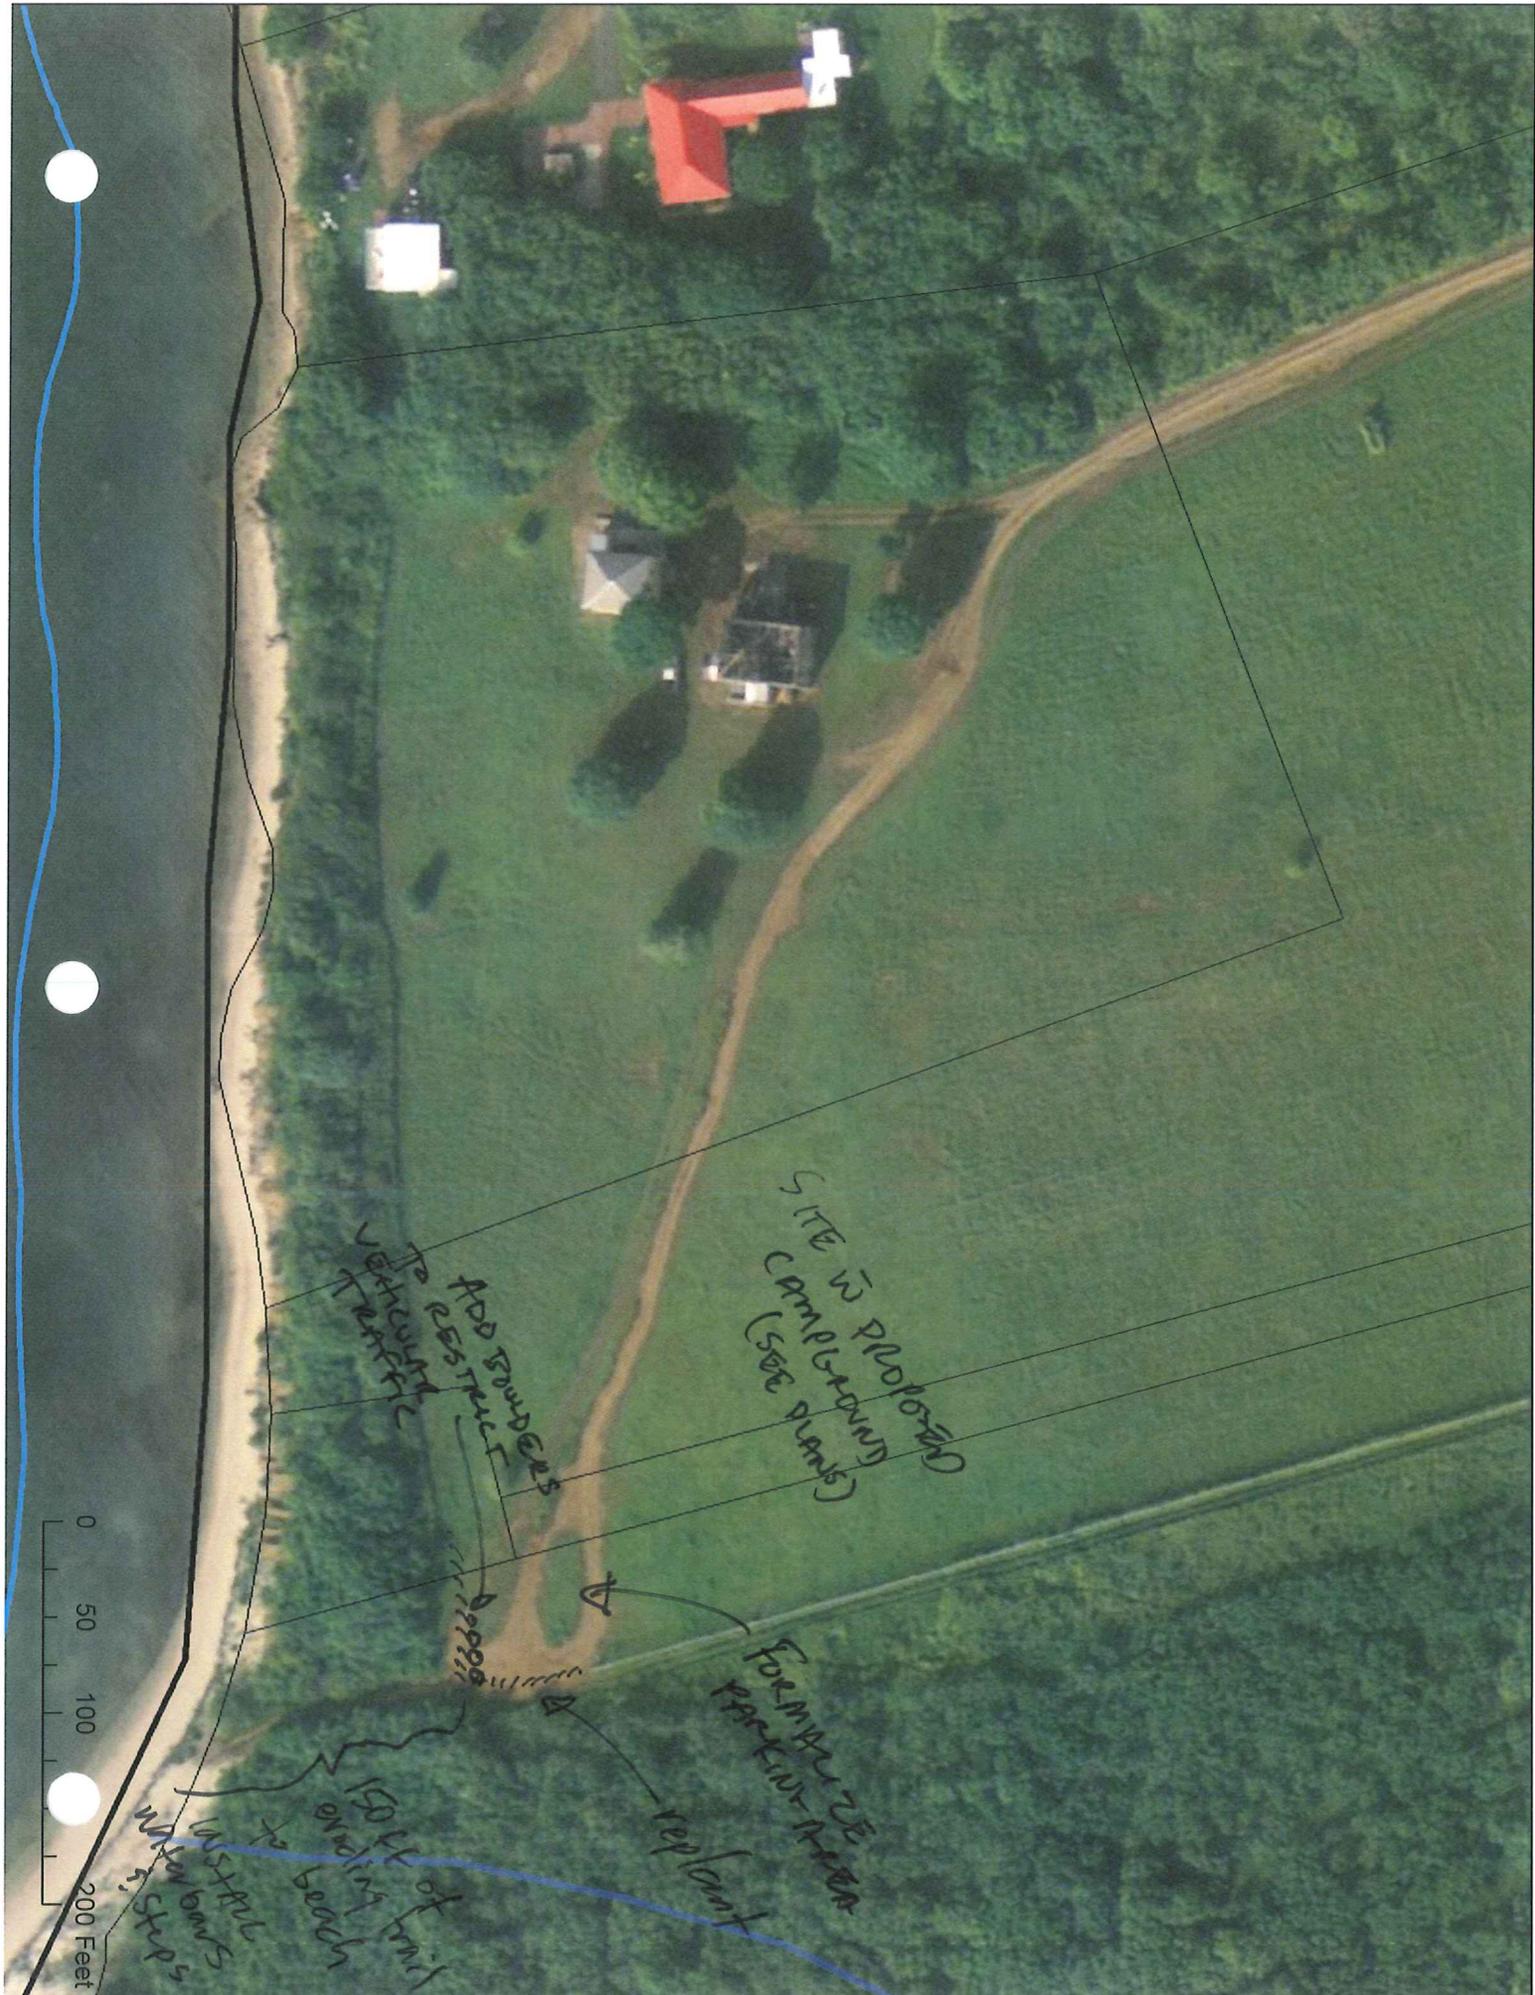
Runoff from UNPAVED AREA DRAINS DOWN THRU TRAIL/BENCH ACCESS.
2:1-3:1 slopes down trail; rills & gullies are evident.

FORMER USE
PARKING AREA

NEED TO REVISIT SITE TO IDENTIFY
POSSIBLE LOCATIONS FOR STEPS &
WATER BARS.

ADD BOUNDARIES
TO RESTRICT
VEHICULAR
TRAFFIC

REPLANT

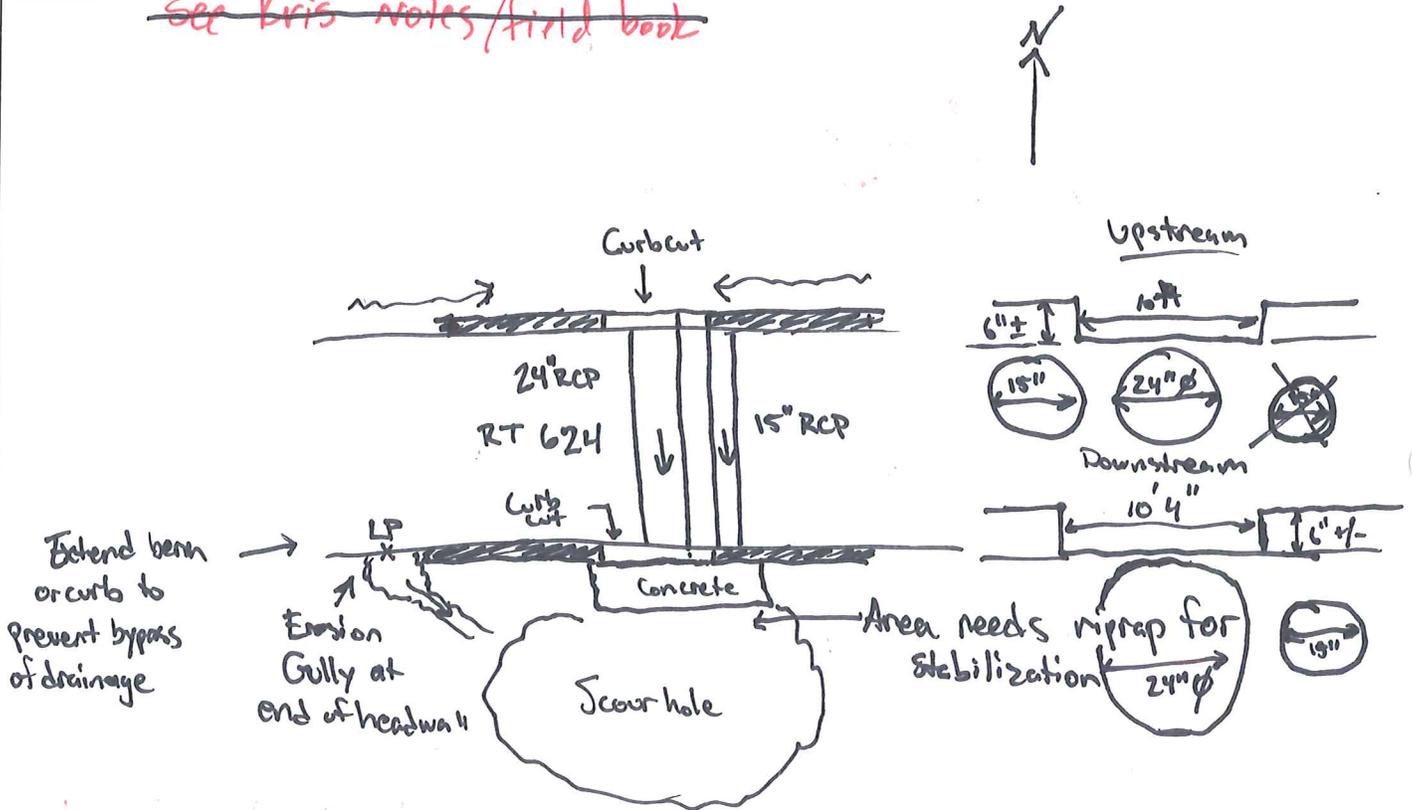
DESCRIPTION OF EXISTING CONDITIONS:
 wall has drainage ports - $\approx 15"$ DIP west of culvert abandoned
 two existing RCPs (15" & 24") cross road conc. flume @ outlet
 roadside swales drain to culverts, 'Muddy Mongoose' potential
 development on North side of road

Muddy Mongoose development could impact capacity of culverts

Proposed rip rap lining for scour hole to stabilize outlet stilling basin
perm @ overflow location west of culverts

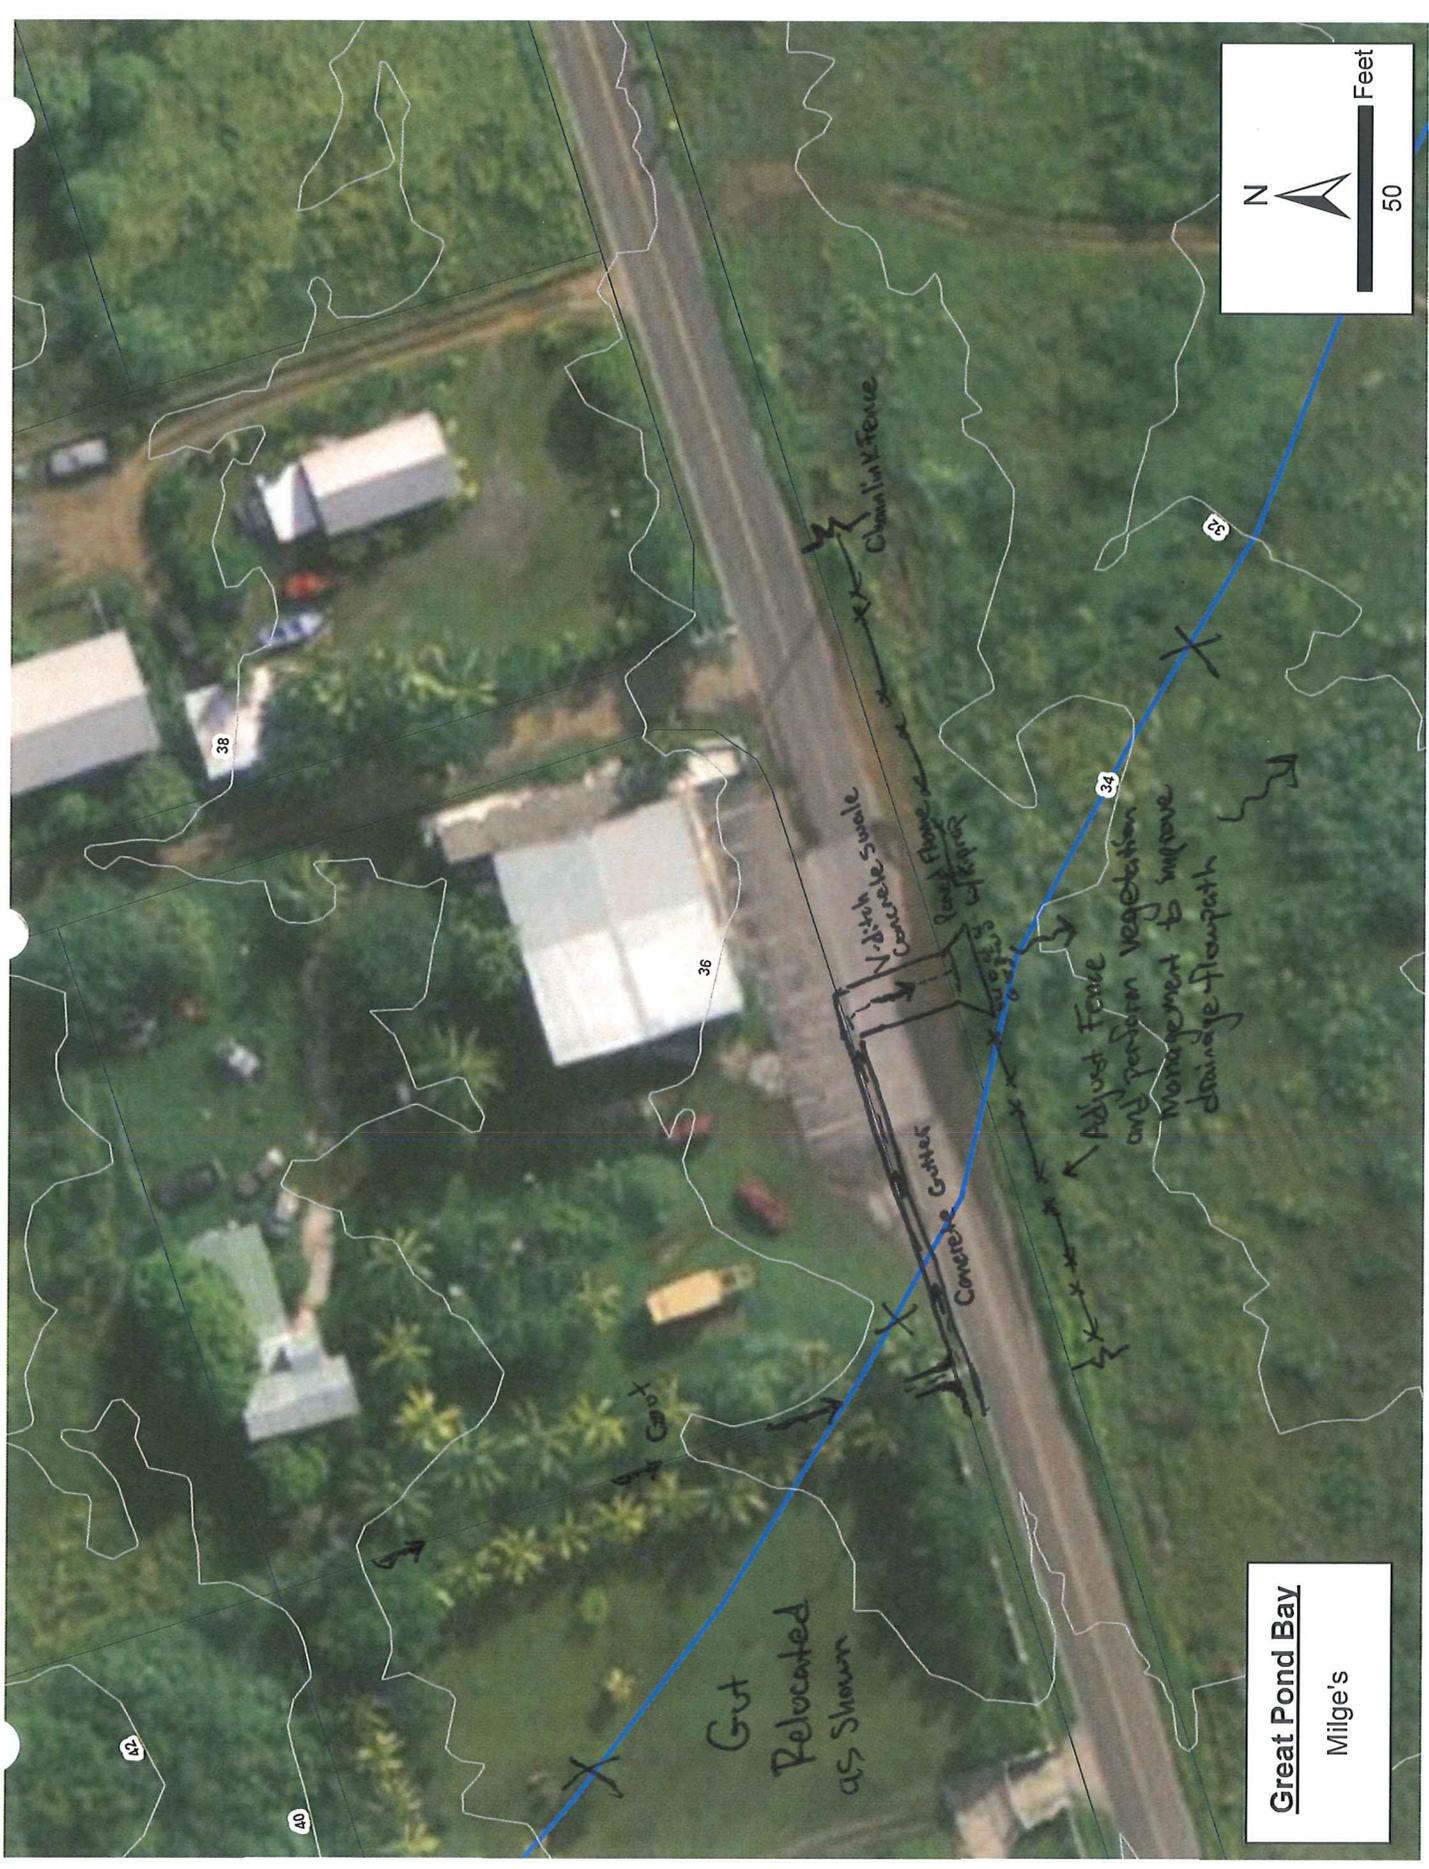
Great Pond Bay
Milge's

Describe Existing Stormwater Conditions, Including Existing Site Drainage and Conveyance: gut flows from Salys Fancy neighborhood along fencing to roadway then east parallel to Rte 6042 and flooding in Melgies parking. Water then flows across road via concrete swale south to Great Pond. Pounding/debris obstructing flow at fence.

excavate swale/ditch along road @ base of parking lot leading from gut to swale. Pave dirt parking area @ west end of Milgies to prevent rutting and ponding.

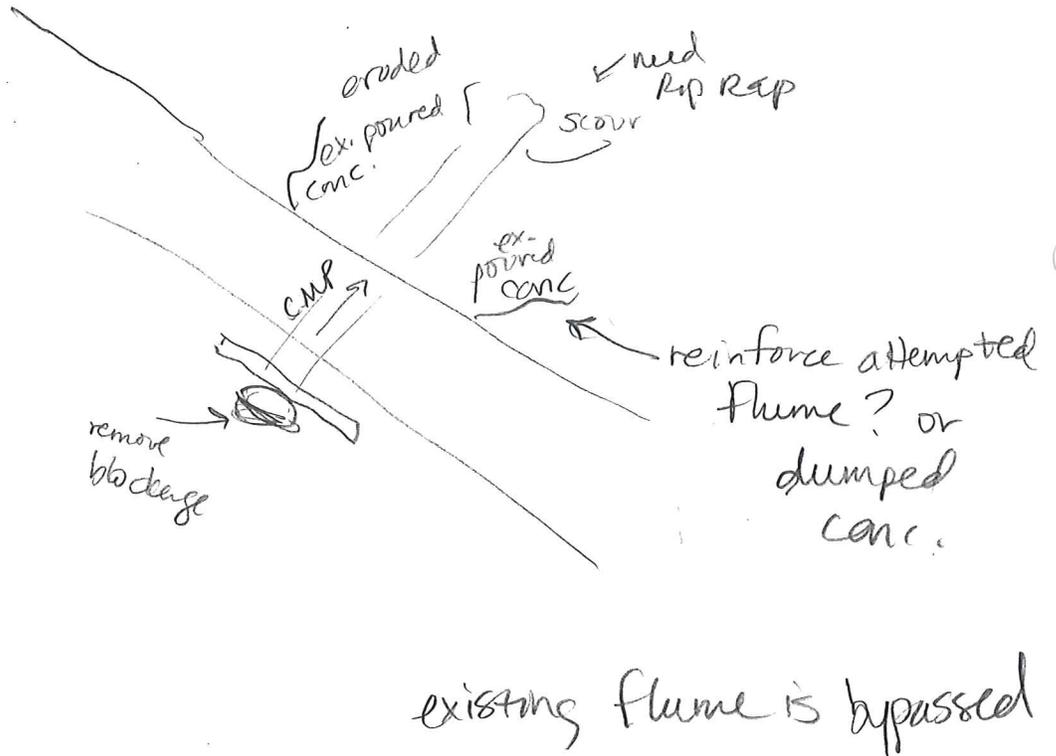
DESCRIPTION OF EXISTING CONDITIONS: attempt at conc. flume - eroding partial blockage of culvert inlet outlet hanging/suspended and 3ft scour hole down m. culvert undermined moderate bank erosion ~15ft wide

Extend paved flume stabilize below with rip rap. Fill in undermined area beneath culvert and clear blockage/debris @ inlet

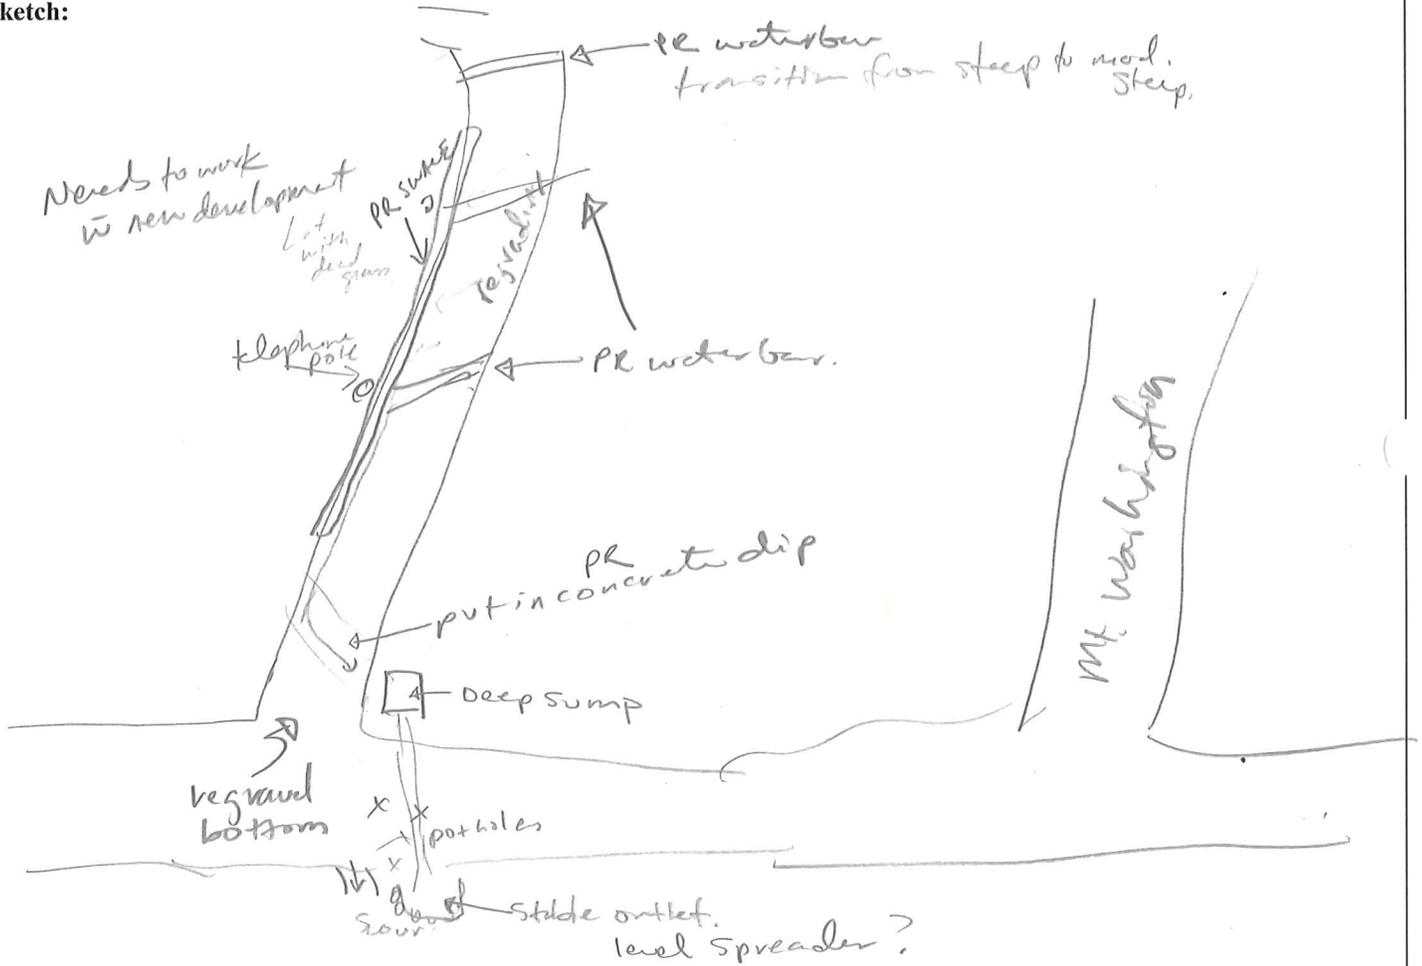
SEVERITY OF PROBLEM: <input type="checkbox"/> High <input checked="" type="checkbox"/> Med <input type="checkbox"/> Low (Explain): <i>LOTS of DIRT Getting across main road</i>			
	POTENTIAL FOR SEDIMENT LOADING TO RESOURCE AREA: <input type="checkbox"/> HIGH <input type="checkbox"/> MED <input checked="" type="checkbox"/> Low

DESCRIPTION OF EXISTING CONDITIONS:
*water pitches to left side (facing uphill) some erosion in
 could do something now to help prevent more problem*

will need to clean sed. out

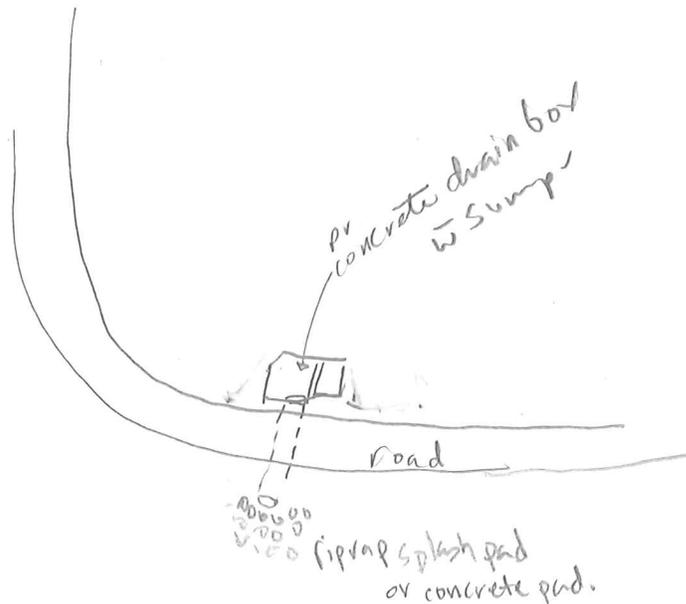
Drainbox w a sump. (see Kris' notes)

DESCRIPTION OF EXISTING CONDITIONS:
12" RCP completely blocked; maintenance scooped out sediment w backhoe scoops

put in concrete ~~to~~ (stepped)
drain box w a sump need to flush out pipe
& stabilize outfall
may have to regrade swale.

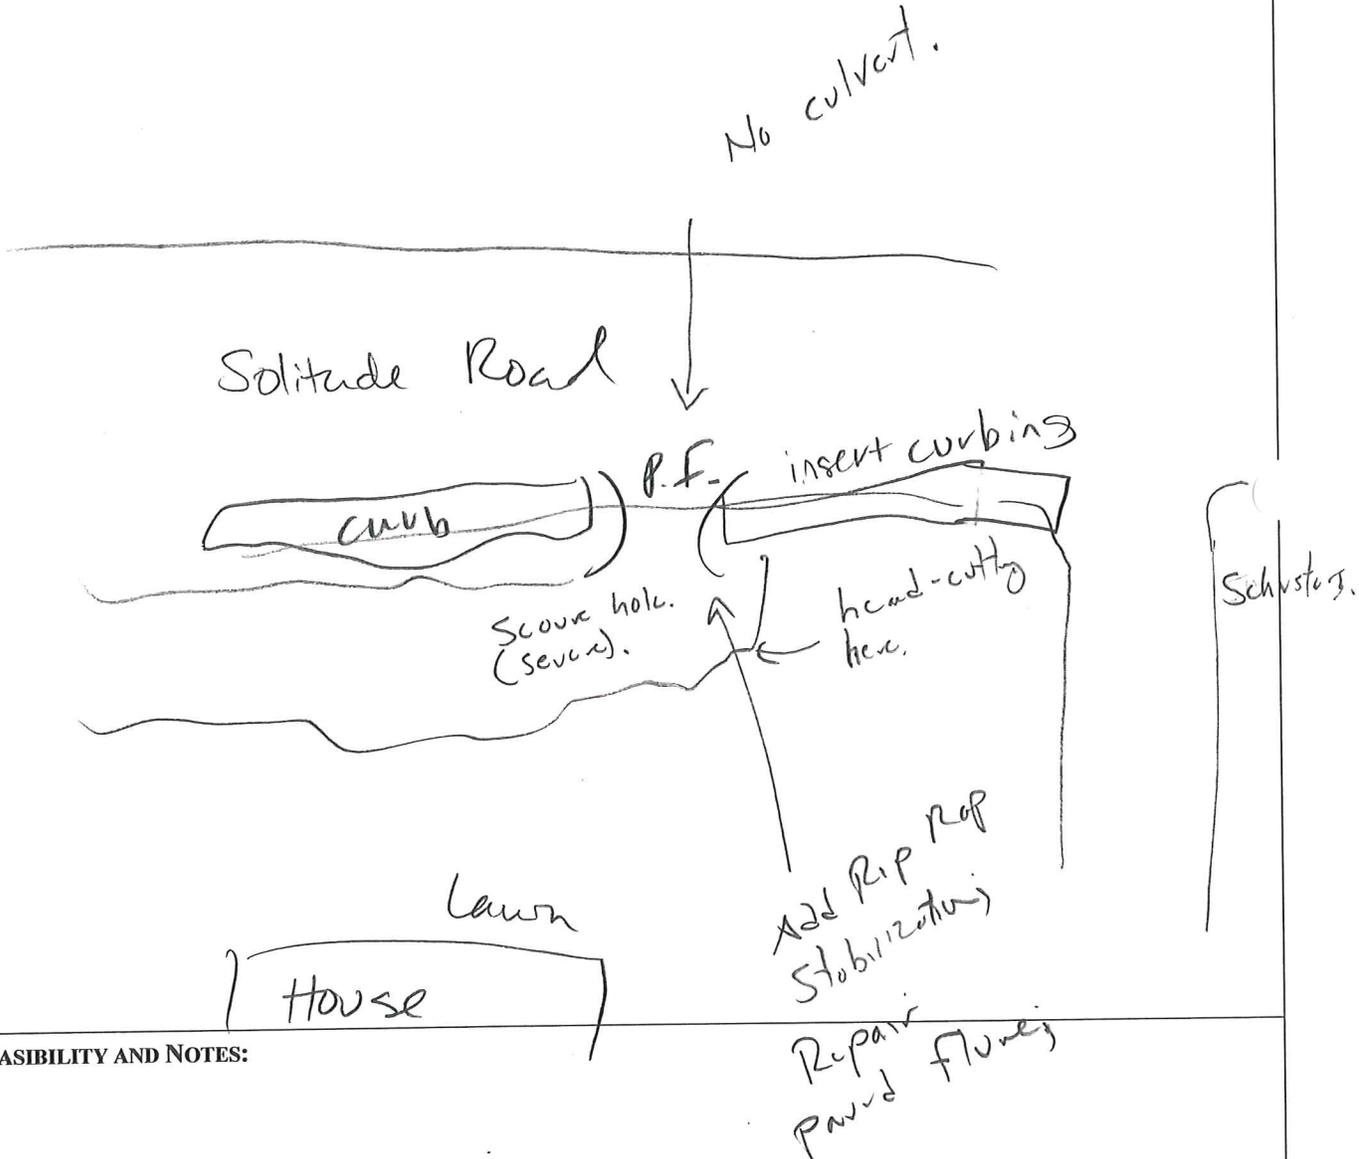
EROSION SEVERITY	Active downcutting; tall banks on both sides of the stream eroding at a fast rate; erosion contributing significant amount of sediment to stream; obvious threat to property or infrastructure.	Pat downcutting evident, active stream widening, banks actively eroding at a moderate rate; no threat to property or infrastructure	Grade and width stable; isolated areas of bank failure/erosion; likely caused by a pipe outfall, local scour, impaired riparian vegetation or adjacent use.
	5	4	1

insert conc curb & paved flume
to redirect water & stabilize banks

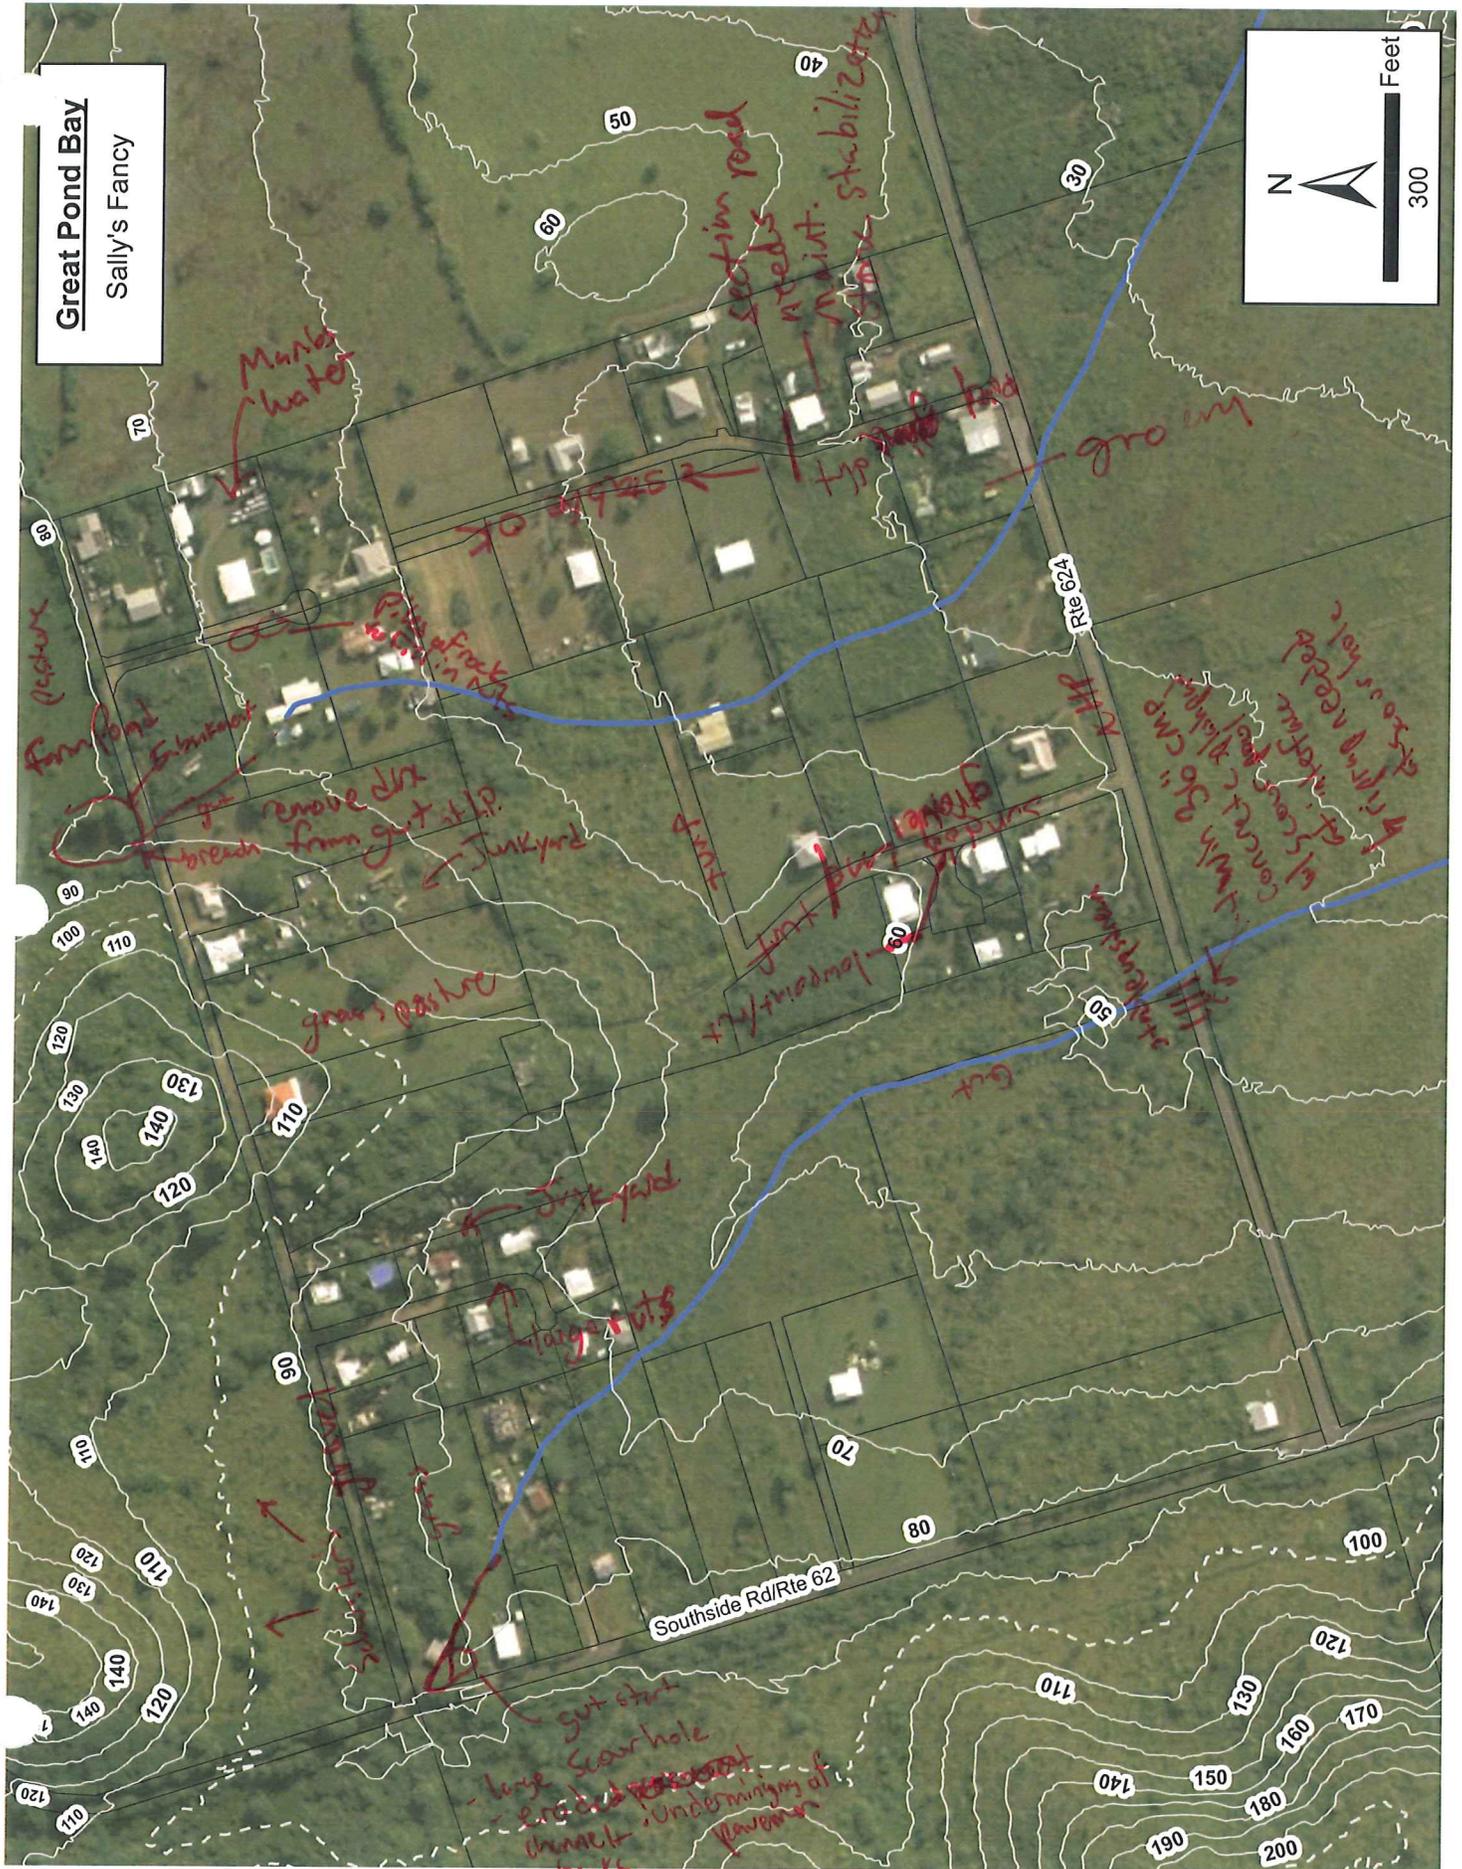
Great Pond Bay
Sally's Fancy

section road
needs maint.
storm stabilizator

sewer line
leaking

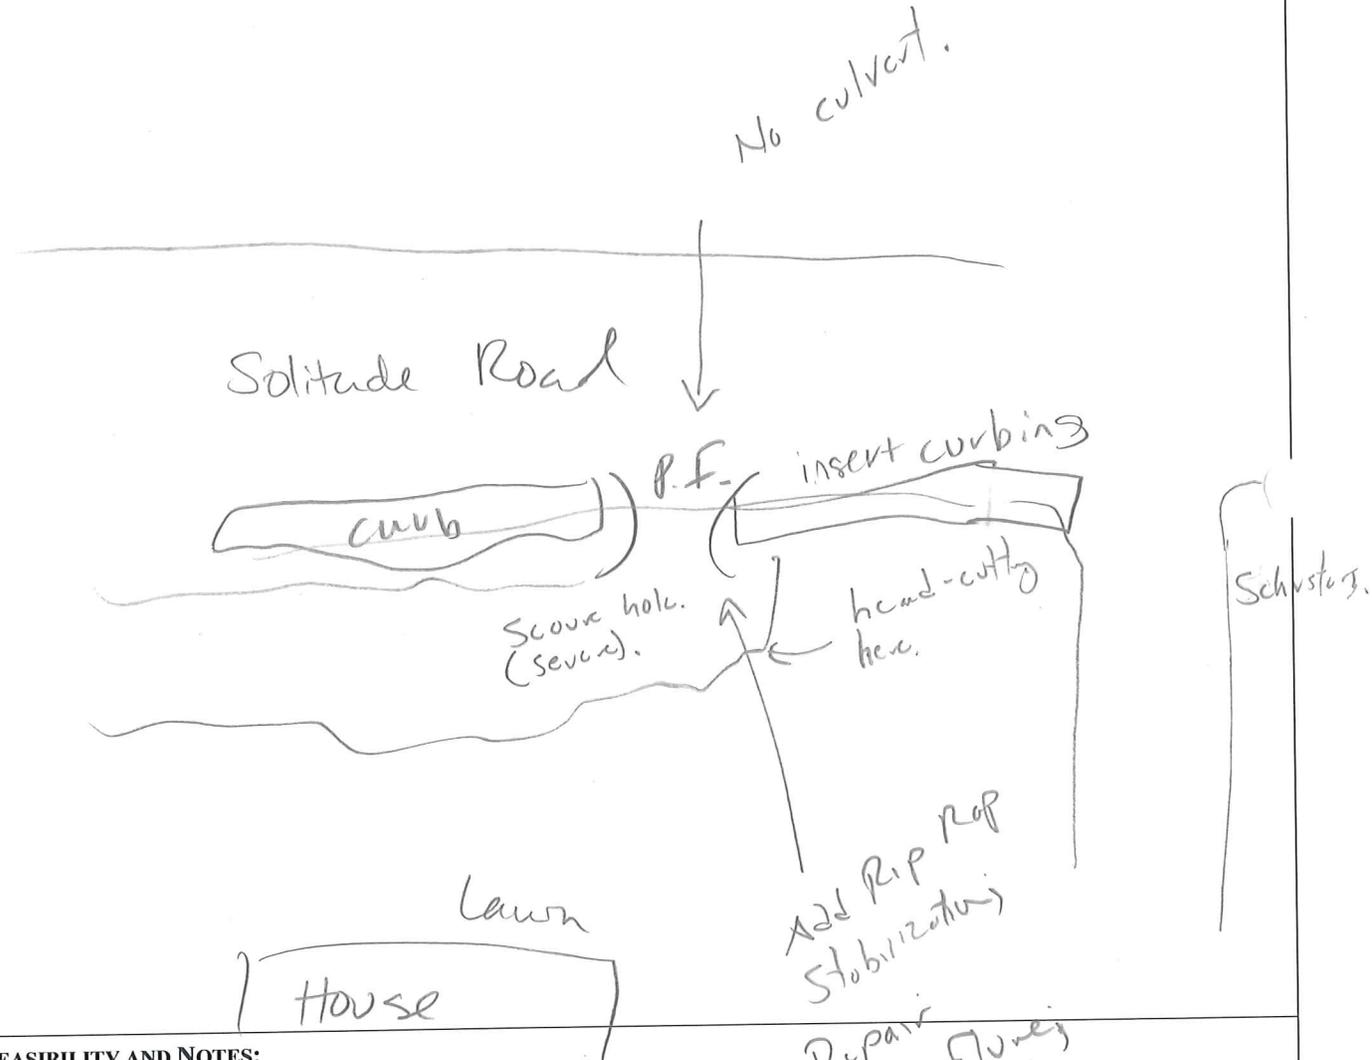
EROSION SEVERITY	Active downcutting; tall banks on both sides of the stream eroding at a fast rate; erosion contributing significant amount of sediment to stream; obvious threat to property or infrastructure.	Pat downcutting evident, active stream widening, banks actively eroding at a moderate rate; no threat to property or infrastructure	Grade and width stable; isolated areas of bank failure/erosion; likely caused by a pipe outfall, local scour, impaired riparian vegetation or adjacent use.
	5	4	1
ACCESS:	Good access: Open area in public ownership, sufficient room to stockpile materials, easy stream channel access for heavy equipment using existing roads or trails.	Fair access: Forested or developed area adjacent to stream. Access requires tree removal or impact to landscaped areas. Stockpile areas small or distant from stream.	Difficult access. Must cross wetland, steep slope or other sensitive areas to access stream. Minimal stockpile areas available and/or located a great distance from stream section. Specialized heavy equipment required.

insert conc curb + paved flume
to redirect water + stabilize banks

Repair paved flumes
