STX EE WATERSHEDS

RETROFITS

Site Name/ID: Cheesburgers SG-R-1

Watershed: Southgate

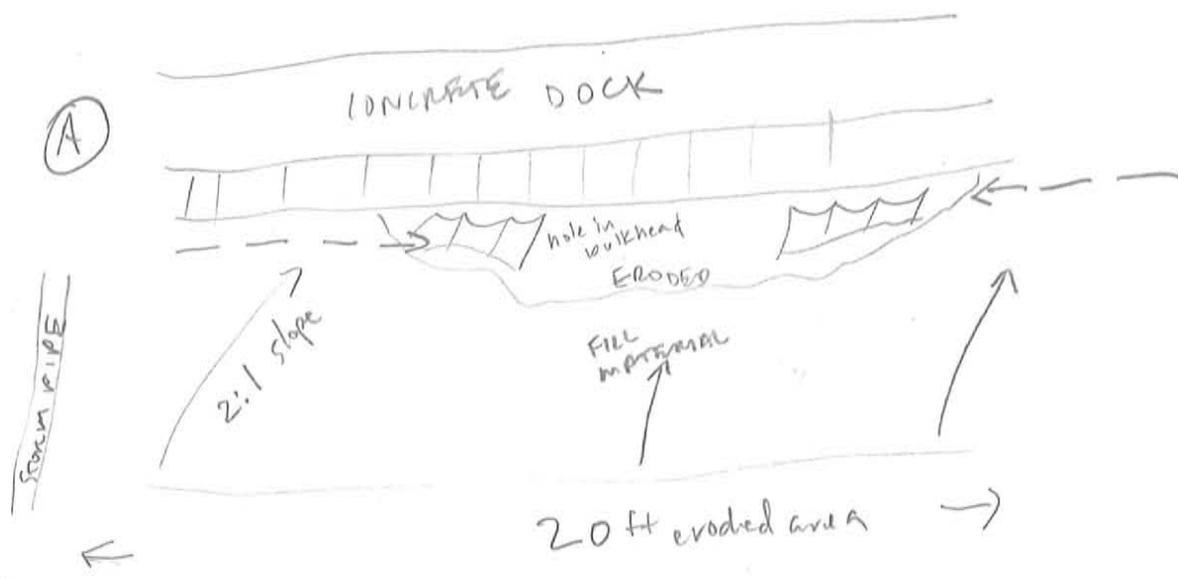
Describe Existing Stormwater Conditions, Including Existing Site Drainage and Conveyance:
parking area draining to open channel, no treatment staining on parking lot

- A → repair bulkhead. provide drain inlet, erosion control matting ~~with~~ for swale
- B → demo raingarden at existing low point in lot (lots of sediment accumulation) existing 4" PVC drain pipe at end of swale
- C → "pretreatment sptic tank" at existing inlet; at open channel. 12" outlet pipe 23 1/4" sedimentation in.

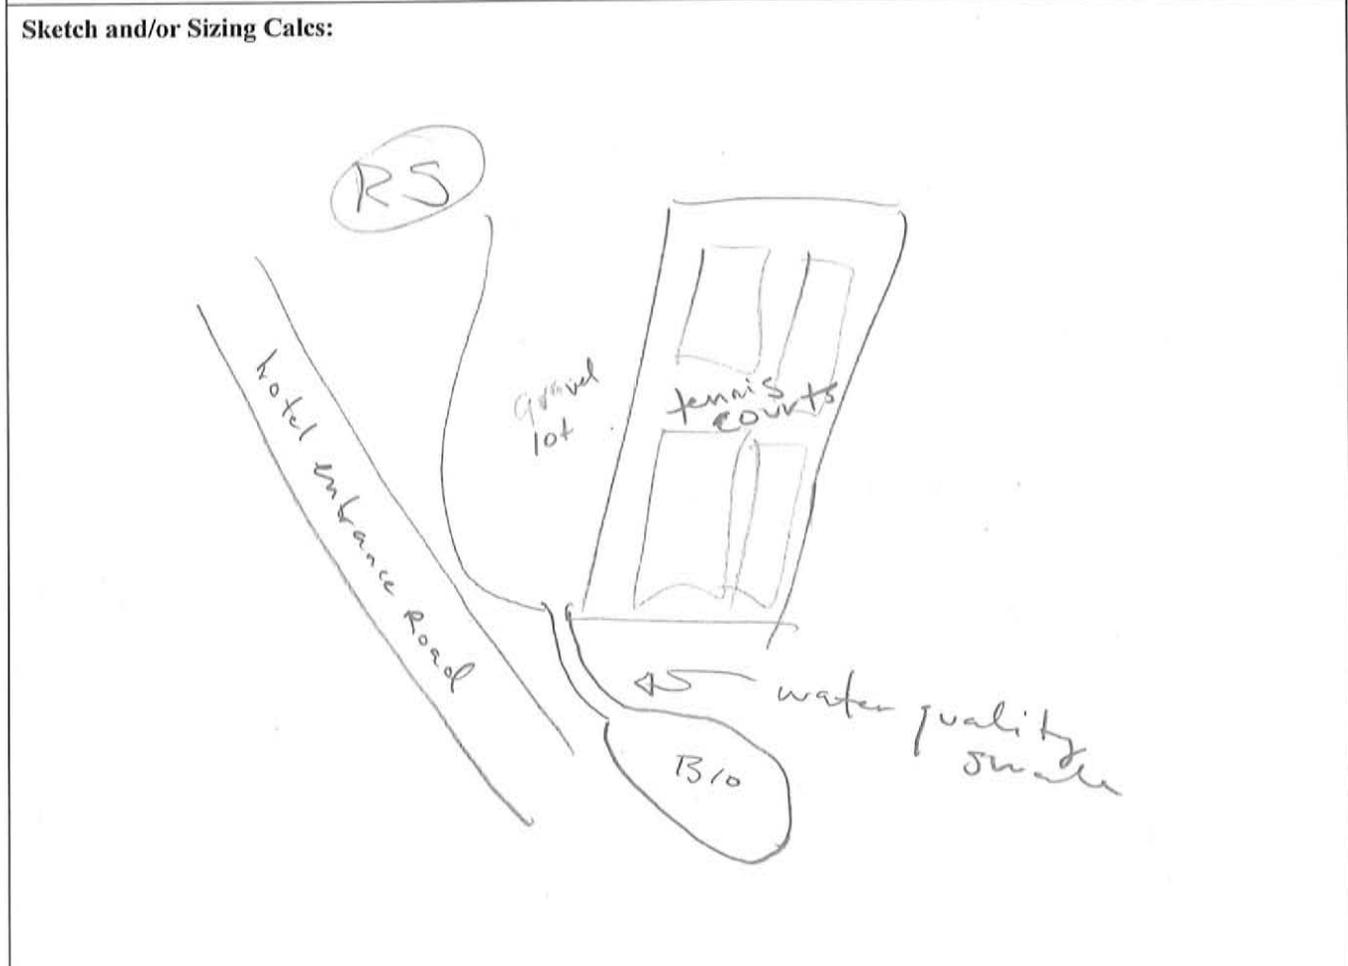
Describe Existing Stormwater Conditions, Including Existing Site Drainage and Conveyance:
turf ROW areas, water ponds for long time
Marina has dug a swale on one side to help improve drainage.

R4 - bio swales with median to capture road runoff and treat prior to discharge in wetland

R5 - small raingarden/bio at edge of tennis court to capture runoff from gravel lot. high visibility

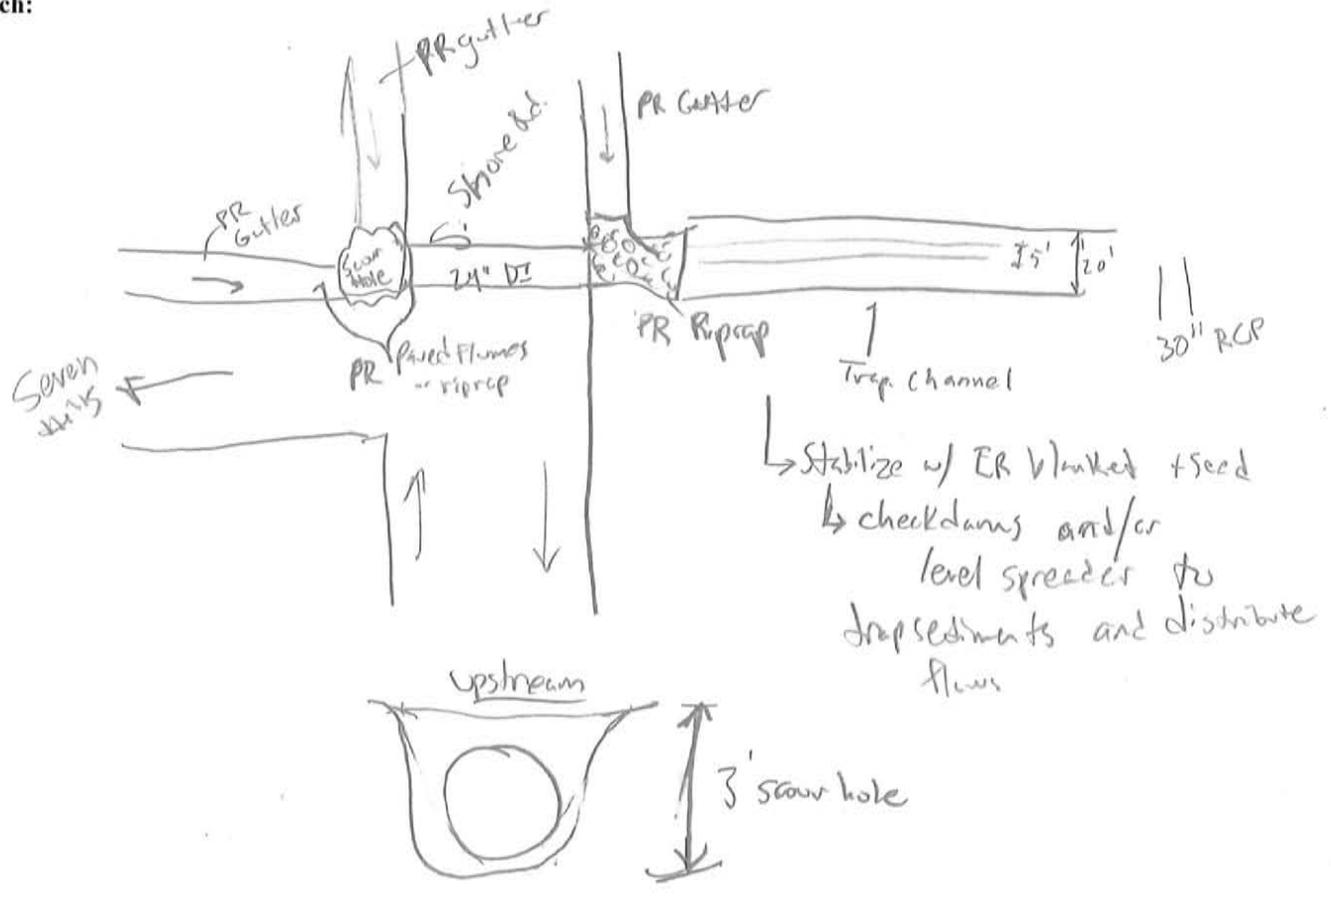
DESCRIPTION OF EXISTING CONDITIONS:
New culverts put in / or replaced in December to help alleviate neighborhood "aquifer ooze".

at outlet pipe install concrete box w weir to act as sed. forebay and level spreader. ECB
