# Initial Observations on Biological Damage Arising from the Cape Flattery Ship Grounding at Barbers Point, Oahu with Recommendations for Quantitative Surveys and Substrate Stabilization to Minimize Further Loss of Coral Reef Resources

Steven P. Kolinski

13 February 2005

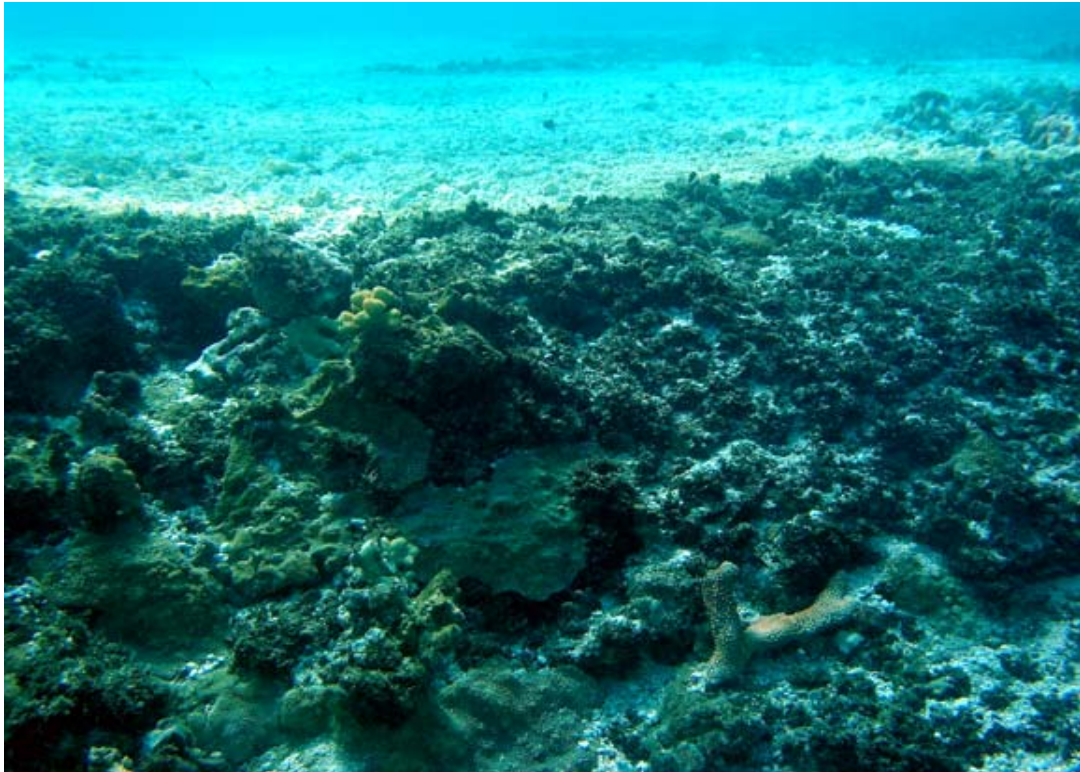
At 23 ft (7 m), corals, macro-invertebrates and even fish were pulverized by direct contact with the ship and related equipment (Figures 2 and 3). In addition, large numbers of colonies were broken/sheared, apparently from lines and anchors used in ship stabilization and towing (Figures 4 and 5). Collision and burial by loose substrate and colonies was observed (Figure 6). Reef organisms also succumbed to cement deposited during removal from the ship (Figures 7 and 8). Damage along the upper escarpment was extensive and appeared to result mainly from the use of tow lines and anchors in the area (Figures 9 - 11).

Figure 2. Perspective of the main impact scar of the Cape Flattery from a reef depression (23 ft depth).

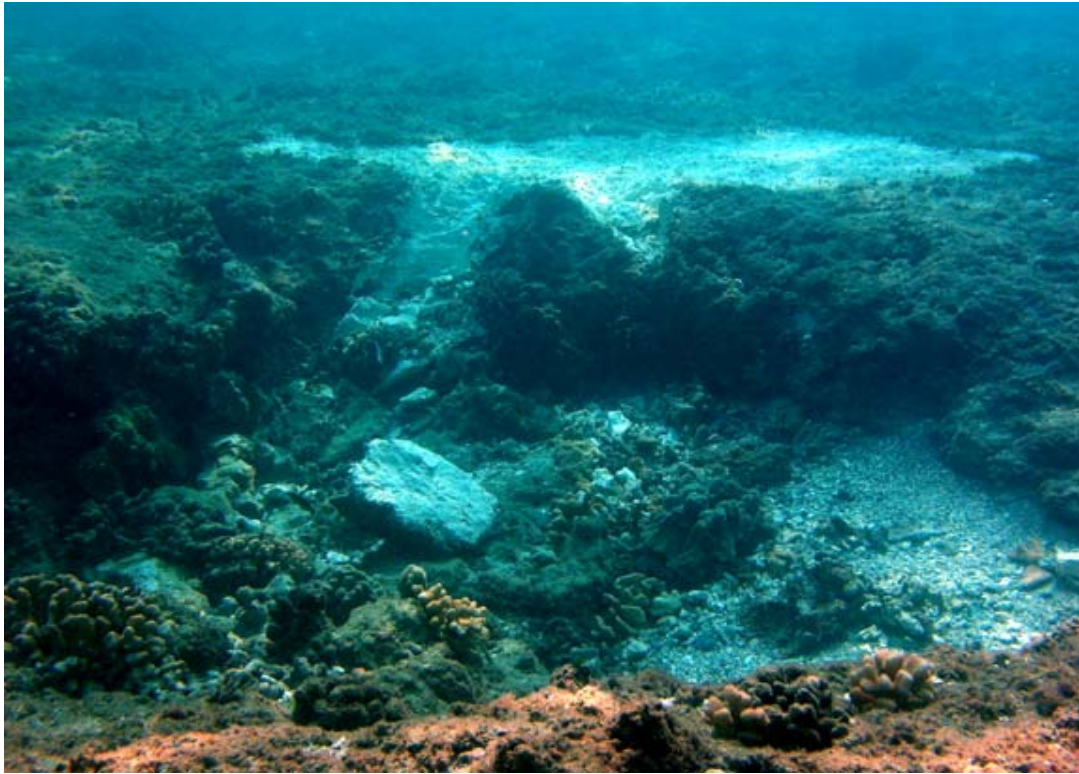
Figure 6. Deposition of loosened material on organisms which escaped initial injury.

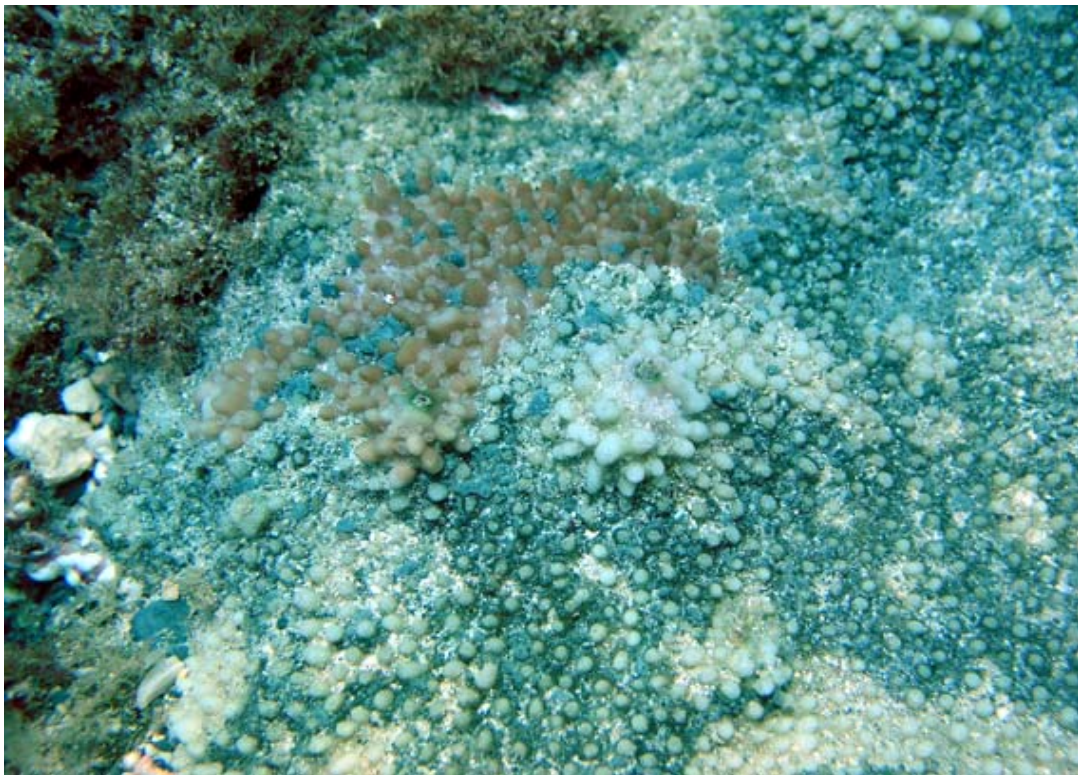
Figure 7. Cement damage to *Montipora capitata* (23 ft depth)

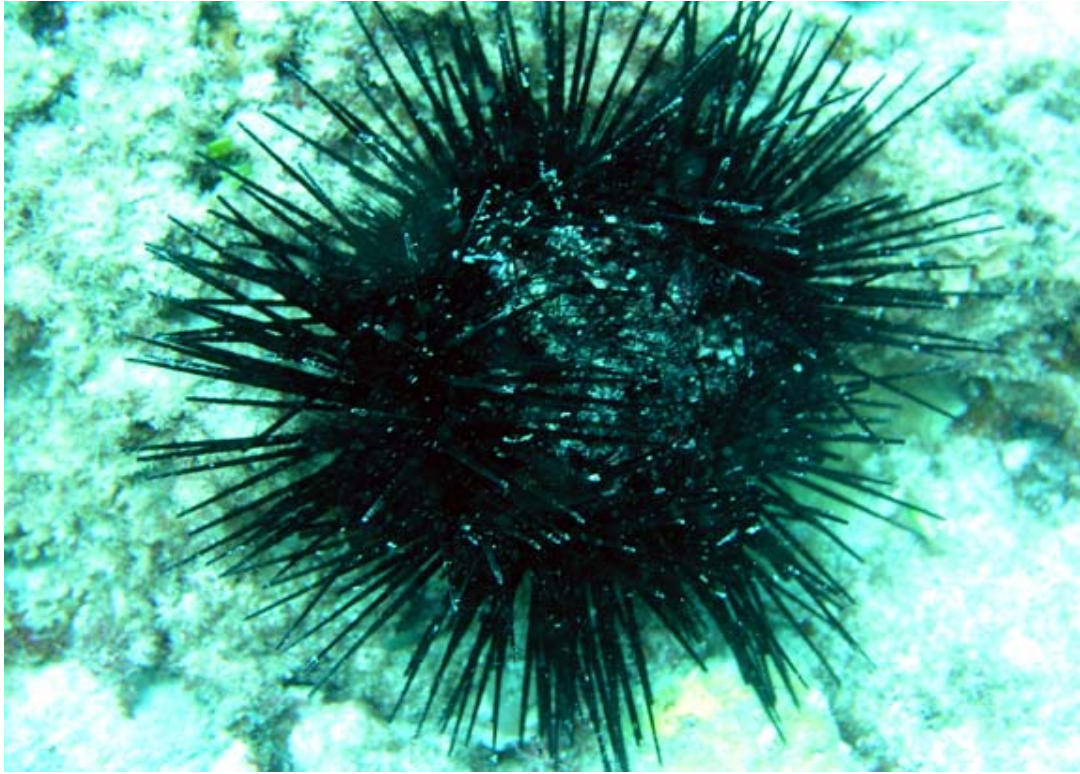
Figure 8. Ailing sea urchin, *Echinothrix calamaris* (23 ft depth).

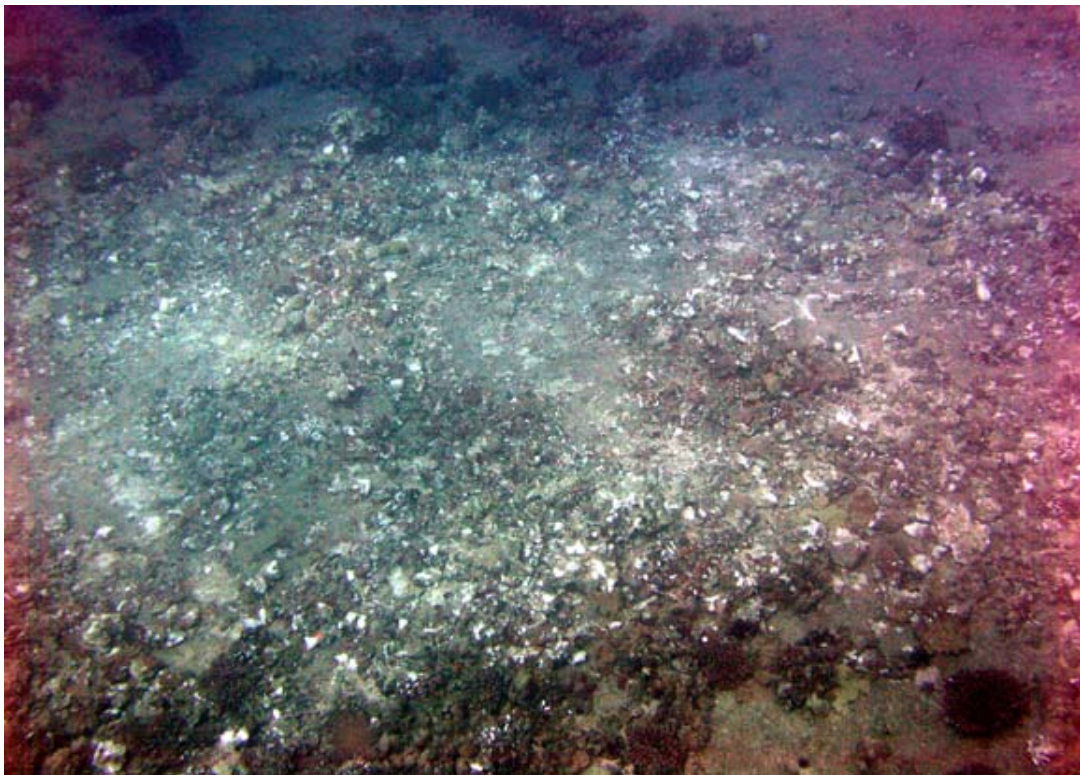
Figure 9. Tow-line damage along reef escarpment (50 ft depth).

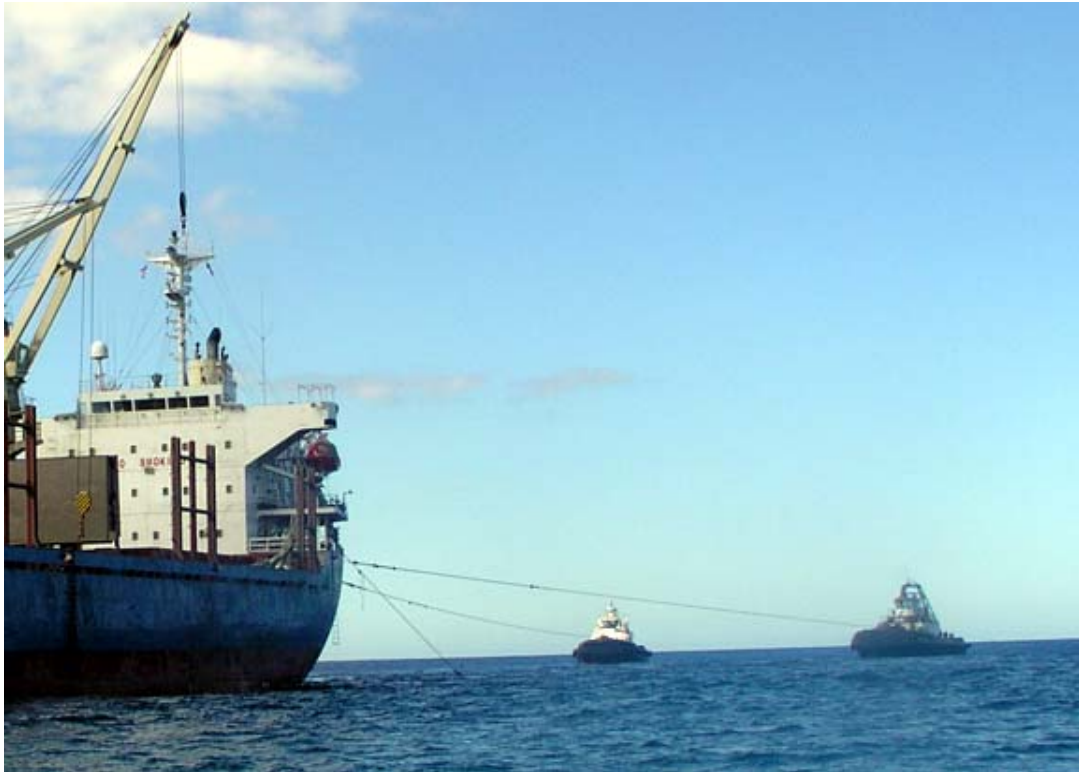
Figure 10. Tow line and chain trailing far below the waters surface.

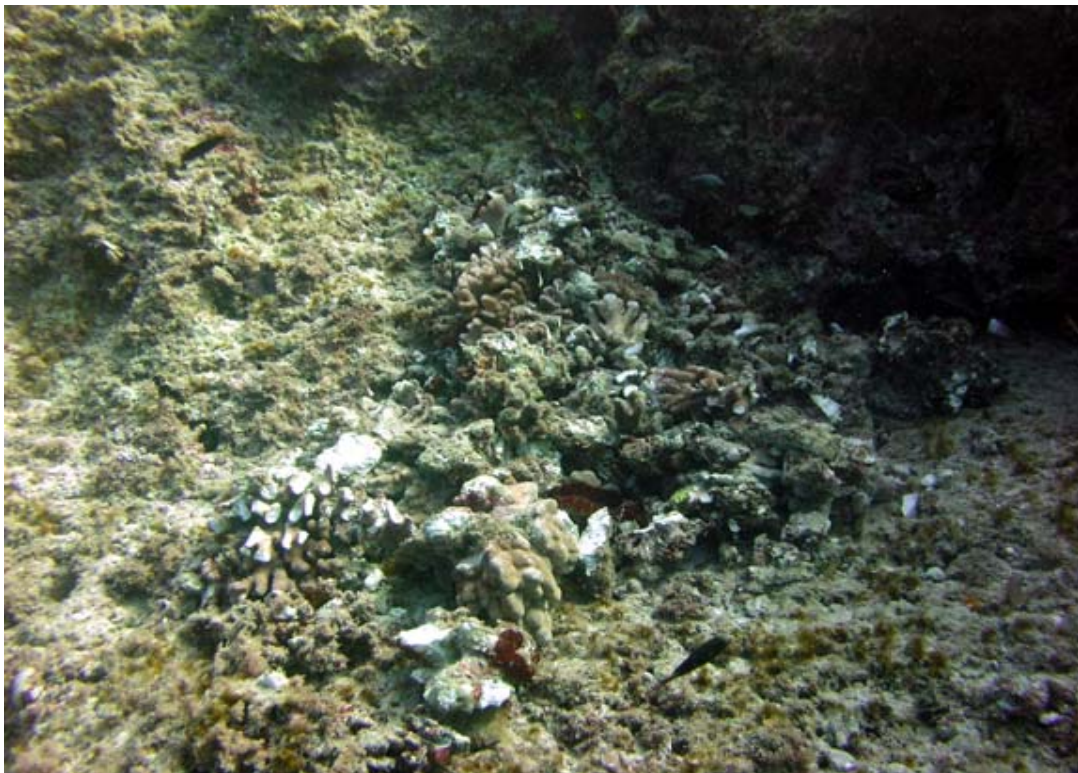
Figure 11. Detached colonies and fragments accumulating below the escarpment (74 ft depth).

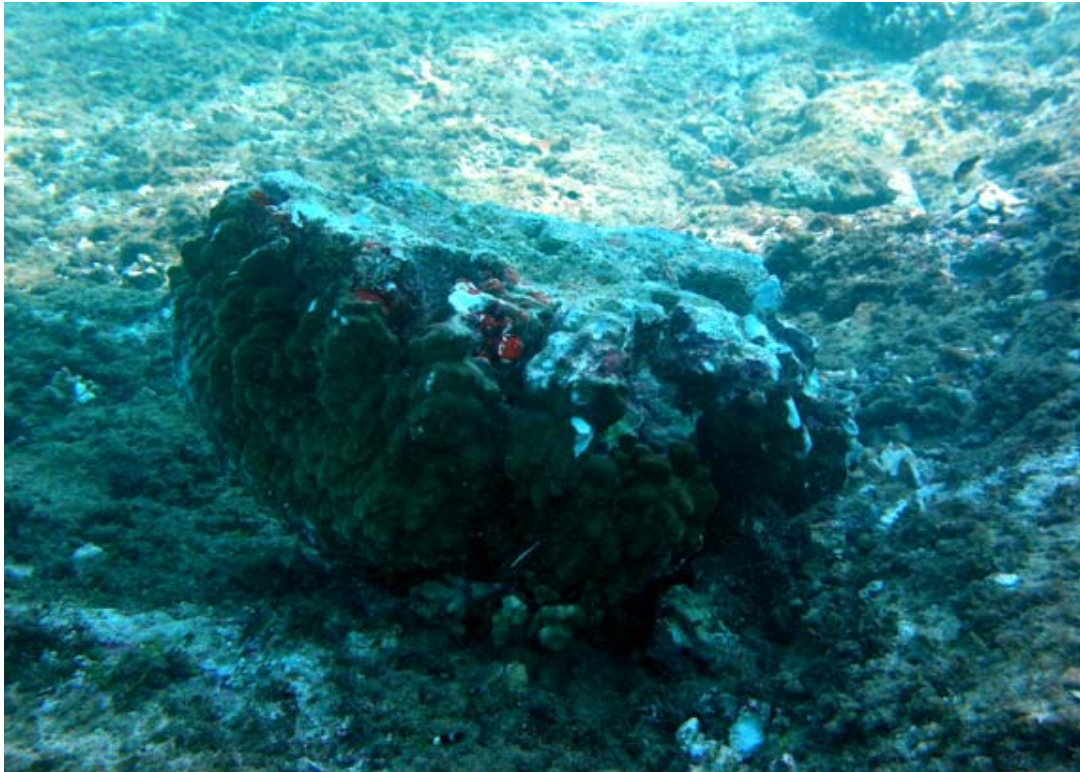
Detached colonies, fragments, cobble, rubble and sediment were generated in an area typically exposed to high wave energy. Movements of these materials have the potential to cause damage to macro-invertebrates survivors through collision and scour. Stabilization of large living corals should enhance their probability of survival (Figures 12 and 13).

Figure 12. Stabilization of this *Porites* head will enhance its potential to survive while reducing its capacity for collision with other colonies in the region.

3. **Detached Colony and Substrate Stabilization:** Large coral colonies and pieces of substrate that became detached as a result of ship grounding activities should be reattached using cement (Portland Type II and Molding Plaster mixture) and/or epoxy (Zspar) to reduce further mortality and limit collisions with previously non-impacted corals in the area. Efforts should also be made to remove excess debris from turtle resting holes.

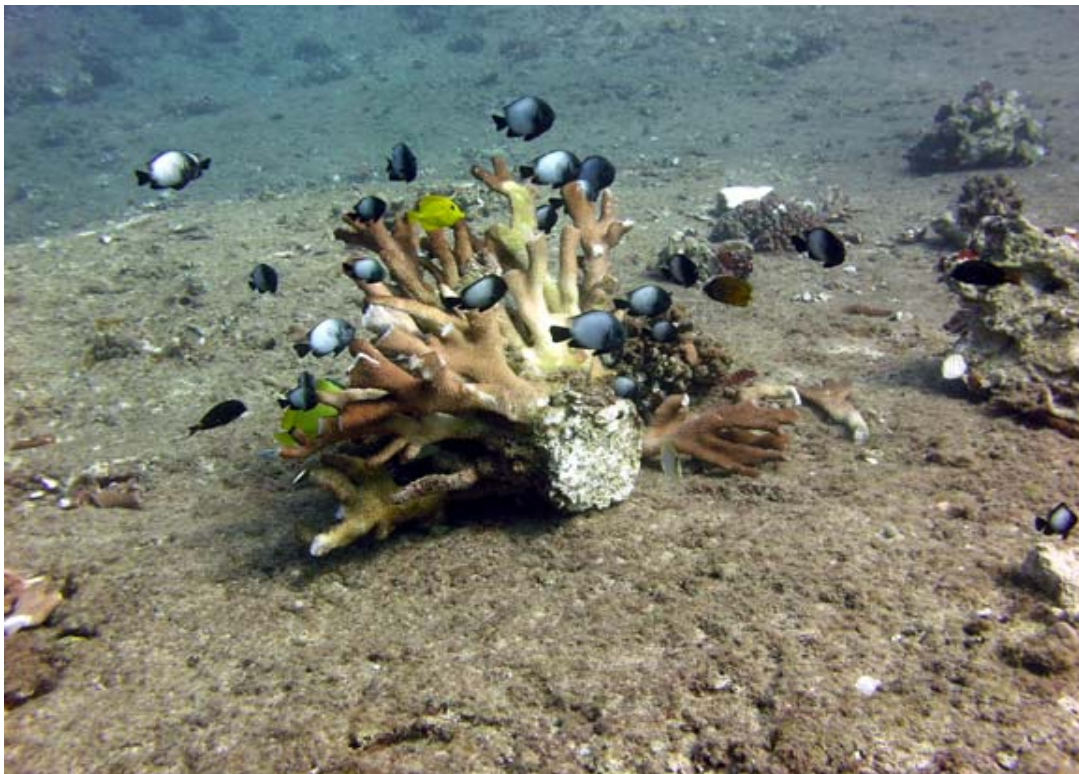
Figure 13. *Pocillopora eydouxi* colony that may survive if reattached.
