**SURVEYS OF ABANDONED VESSELS:
AMERICAN SAMOA**

Christine L. Boring
Research Planning, Inc.
Columbia, South Carolina 29202

Doug Helton and Ian Zelo
NOAA Office of Response and Restoration
Seattle, Washington 98115

January 2008

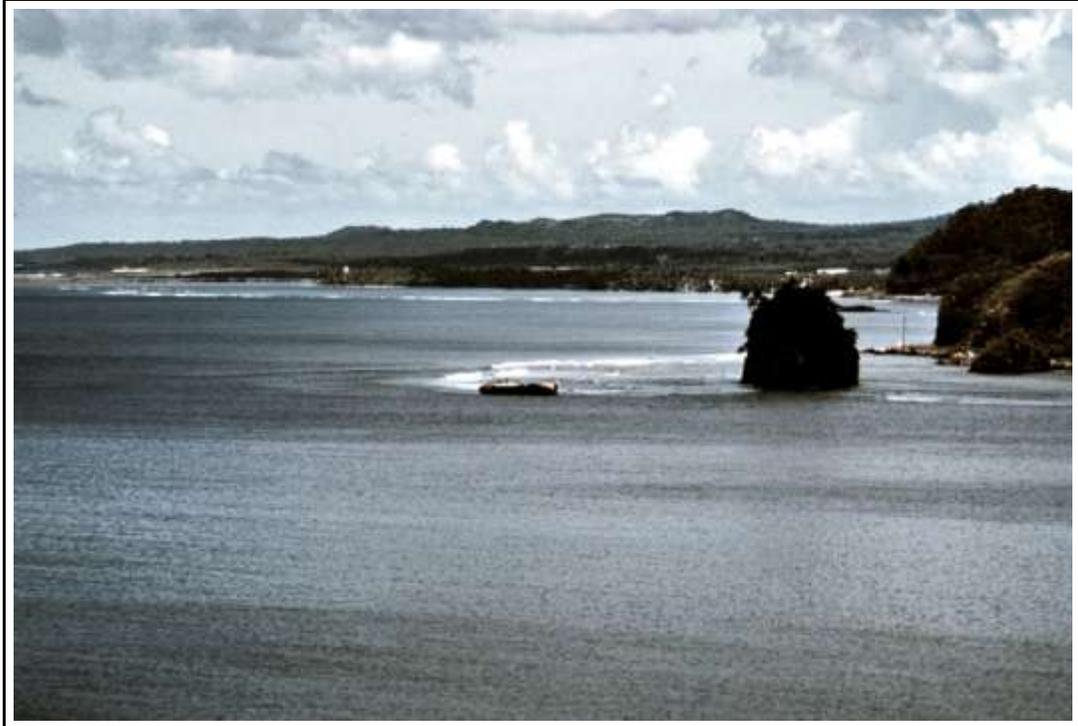
Unknown 1270, a vessel grounded in the 1960s, was located at Niuloa Point on Tutuila (Figure 2). The vessel was present at 1-10 feet of depth on a wide reef flat and debris was widely spread (Figures 3 and 4). The reef was heavily used by residents for subsistence (invertebrates were abundant) and recreation.

FIGURE 3. Historic NGS photo from 1971 showing Unknown 1270 intact.

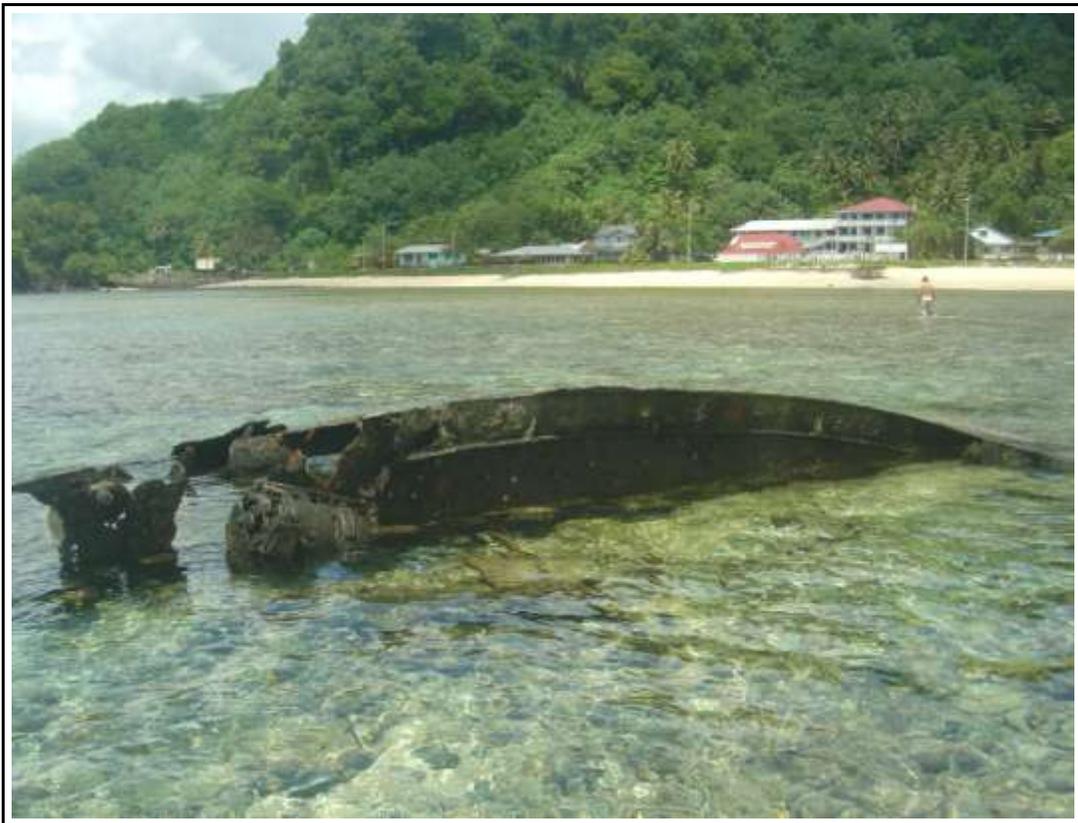
FIGURE 4. February 2008 photo of wreckage from Unknown 1270.

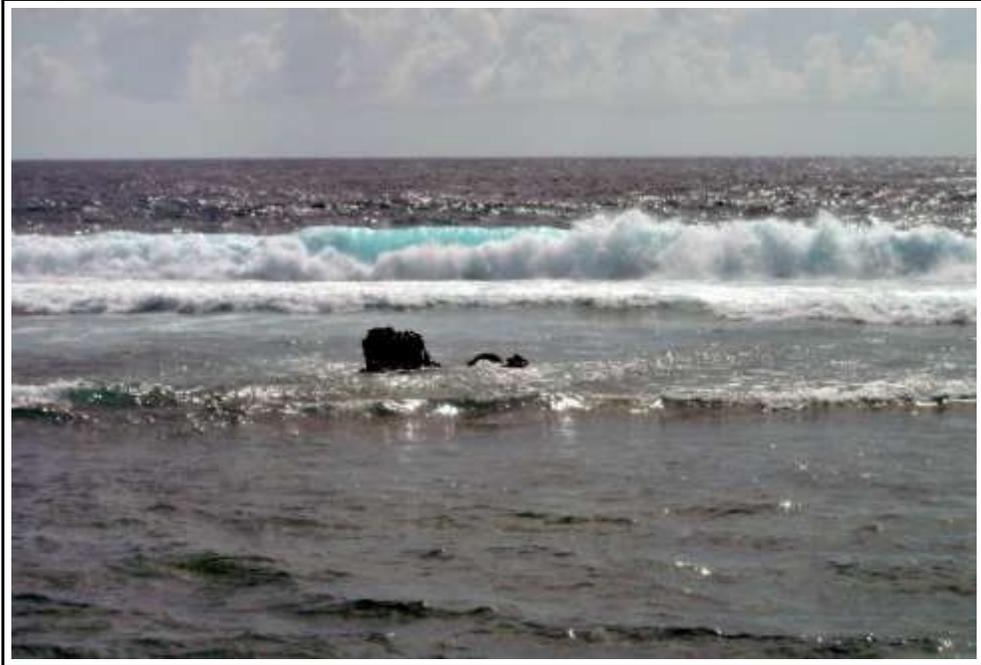
Yien Len 3 was located at Alao on Tutuila Island (Figure 5). The vessel is grounded between 1-10 feet in depth and may be a public health hazard to recreational beach users because there is a large engine block within 20 m of shore (Figures 6 and 7).

FIGURE 6. April 2005 photo of *Yien Len 3* engine block.

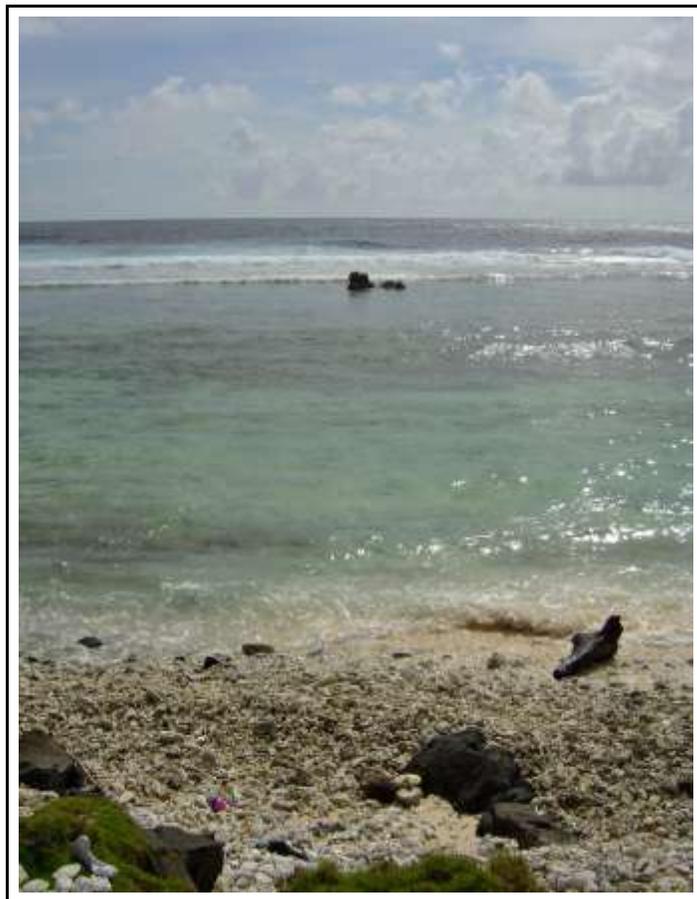
FIGURE 7. *Yien Len 3* engine block view from shore.

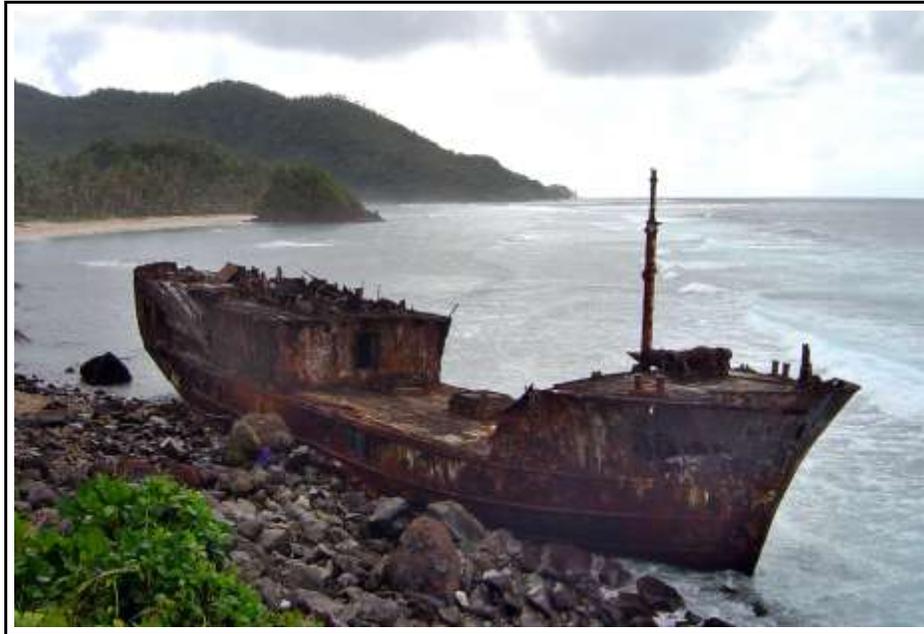
Jui Man No. 3 was located at Amouli on Tutuila Island. It was a longliner likely grounded in the 1960s and is located on narrow reef flat adjacent to an exposed rocky shore (Figure 8). The vessel is visible and accessible (Figure 9). The position and state of the vessel observed during the 2008 visit was comparable to the 2005 survey (Figures 10 and 11). Hard corals were observed on the reef flat.

FIGURE 8. April 2005 photo of *Jui Man No. 3* from shore.

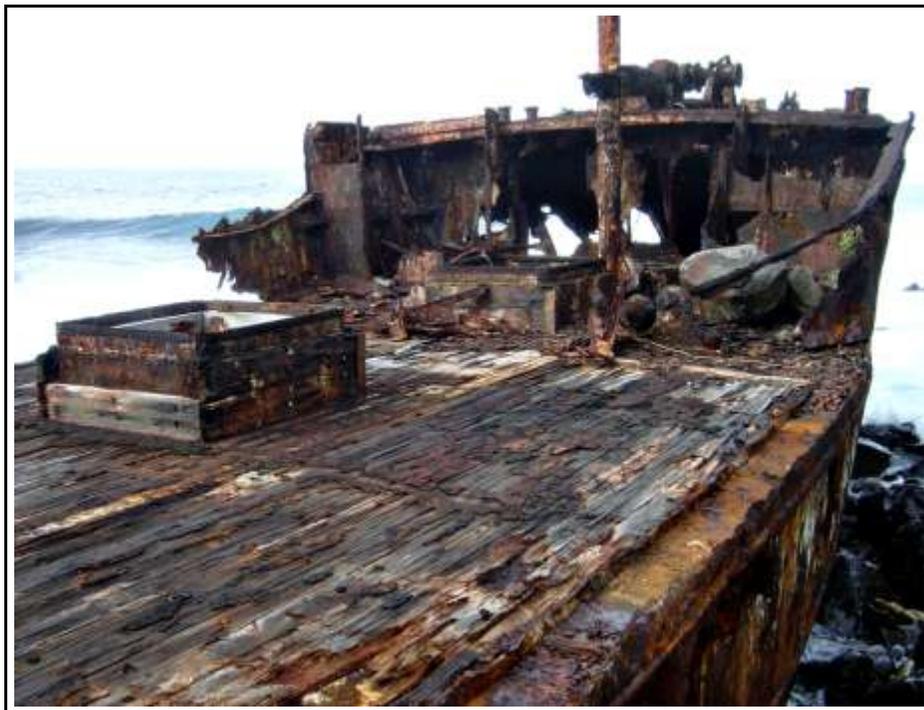
FIGURE 9. Deck of *Jui Man No. 3*.

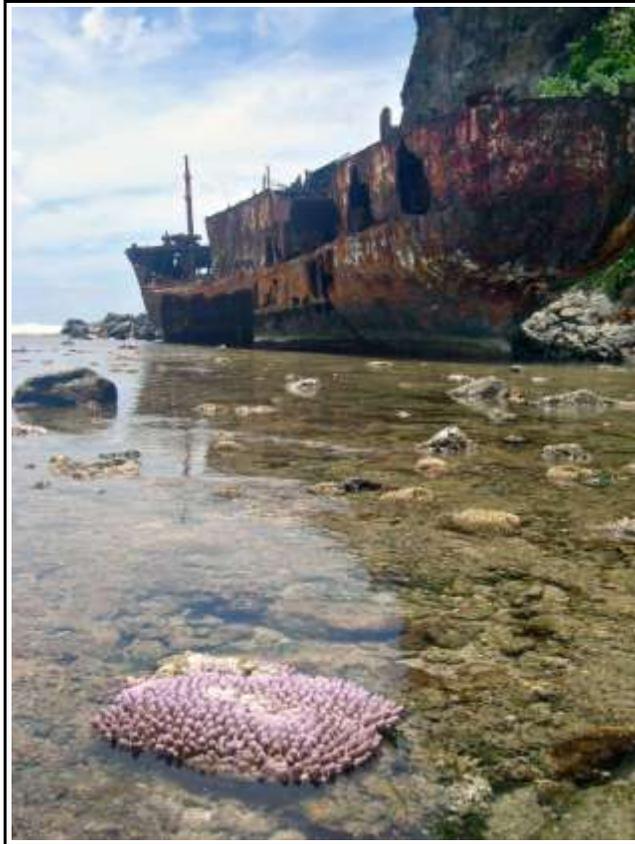
FIGURE 10. February 2008 photo of *Jui Man No. 3* and reef.

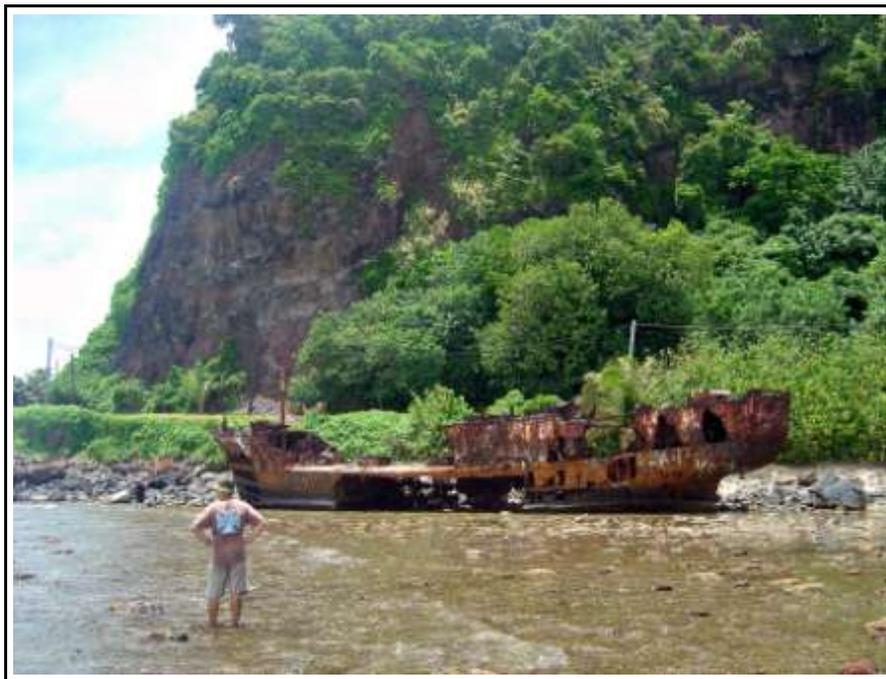
FIGURE 11. February 2008 status of *Jui Man No. 3*.

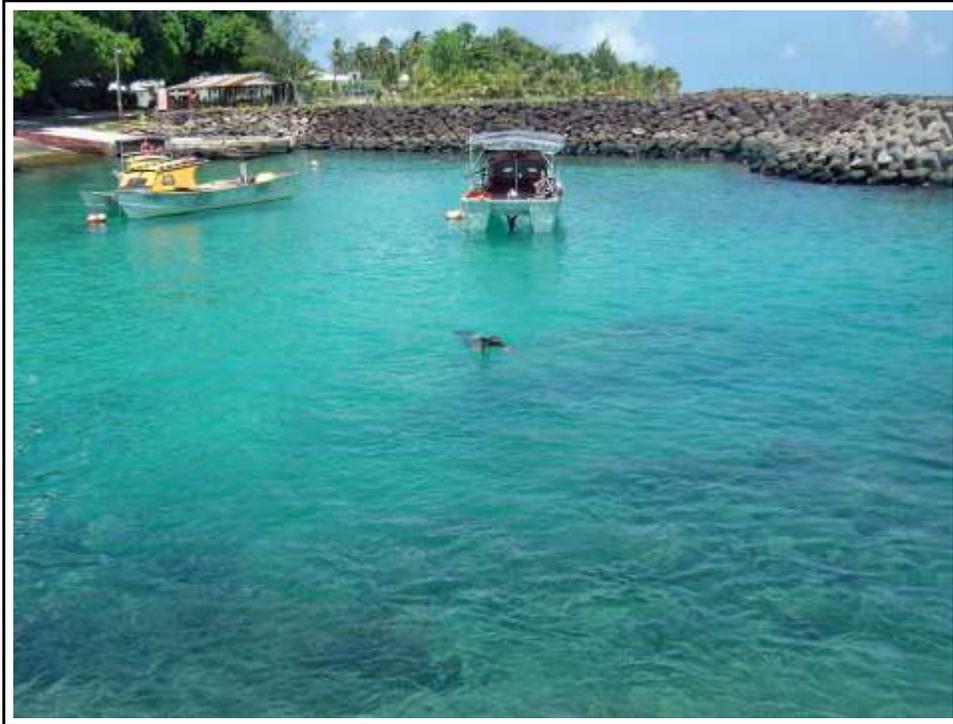
A small passenger vessel was located in 20 feet of water in the Aunu'u Harbor (Figure 12). It is a possible threat to the anchorage/small boat harbor (Figure 13).

FIGURE 12. April 2005 survey of Aunu'u harbor.

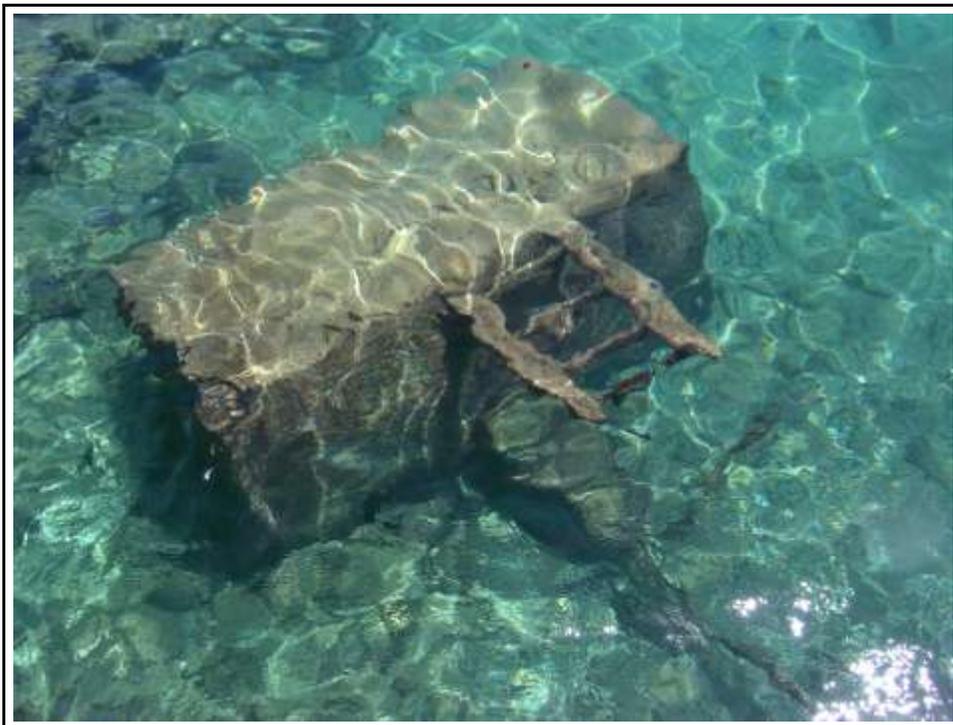
FIGURE 13. Debris in Aunu'u Harbor.

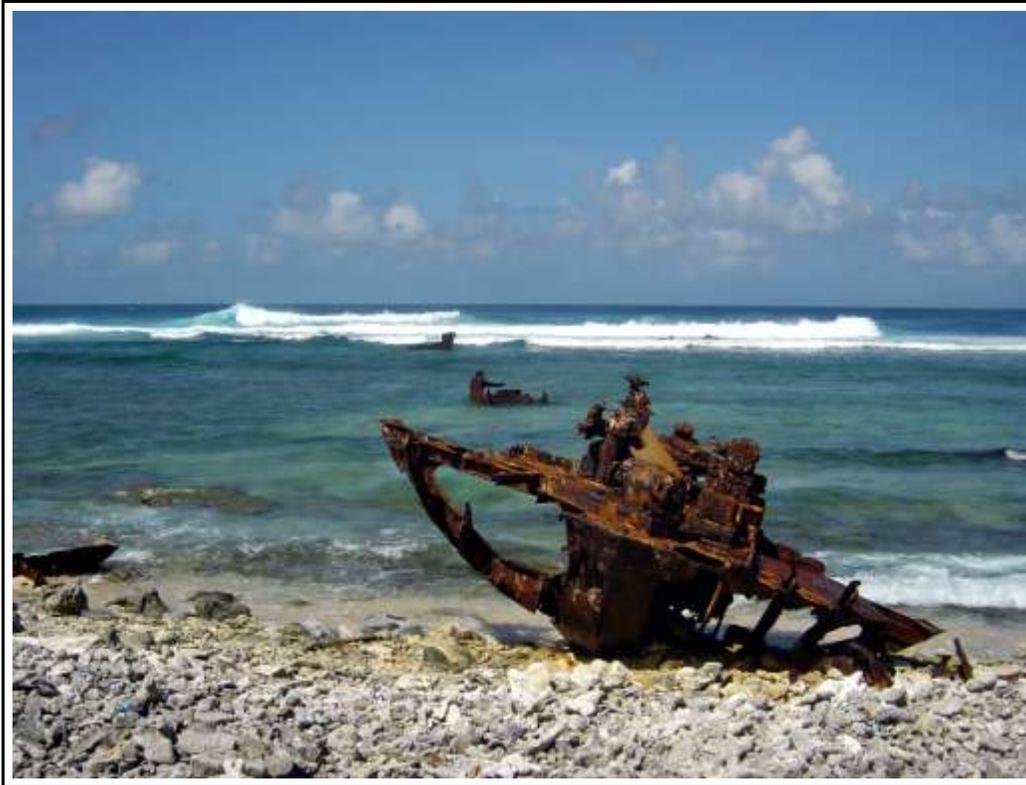
Along the west shore of Aunu'u there is a large debris field, believed to be from the wreck of the F/V *Young Kwan* that grounded in 1986 (Figure 14). Local residents recalled the vessel breaking apart during Typhoon Val in 1991. Debris stretches from the supratidal to the subtidal along over a kilometer of shoreline (Figure 15). The benthic habitat consisted of soft and coralline algae and some hard coral which may be threatened by mobile debris pieces (Figure 16). The vessel is located on a public beach and children were observed playing on the wreckage (Figure 17). February 2008 surveys showed the debris in a further deteriorated condition (Figures 18 and 19).

FIGURE 15. April 2005 photo of F/V *Young Kwan* debris field.

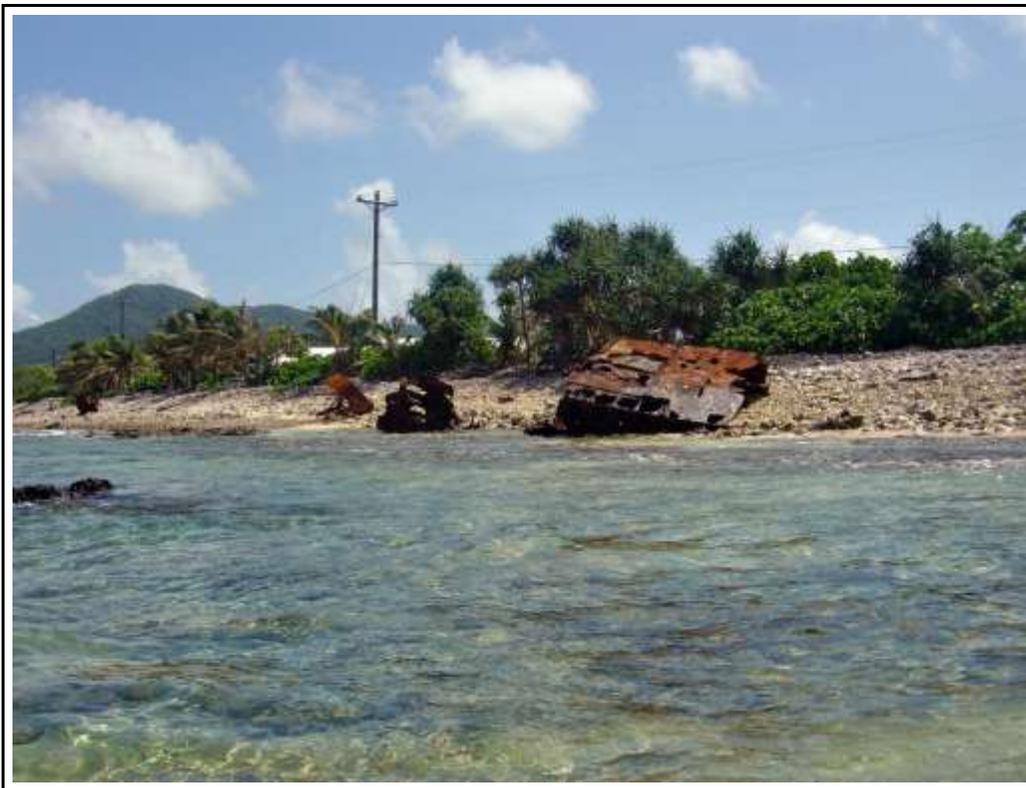
FIGURE 16. F/V *Young Kwan* debris on beach during 2005 survey.

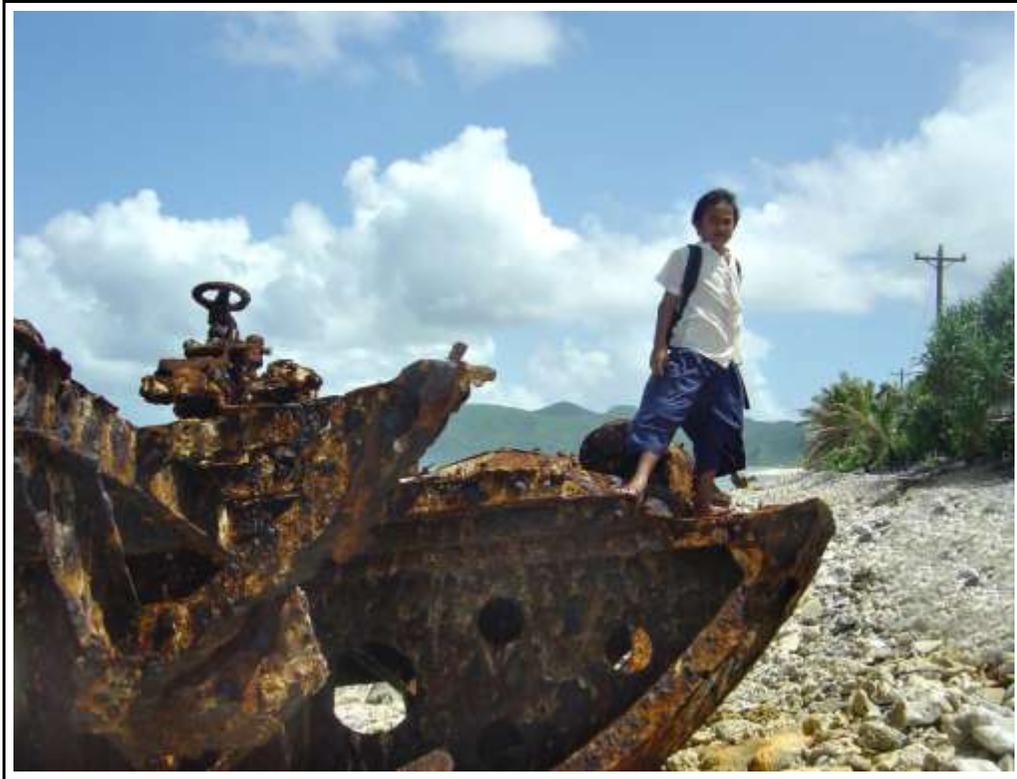
FIGURE 17. Children playing on F/V *Young Kwan* debris.

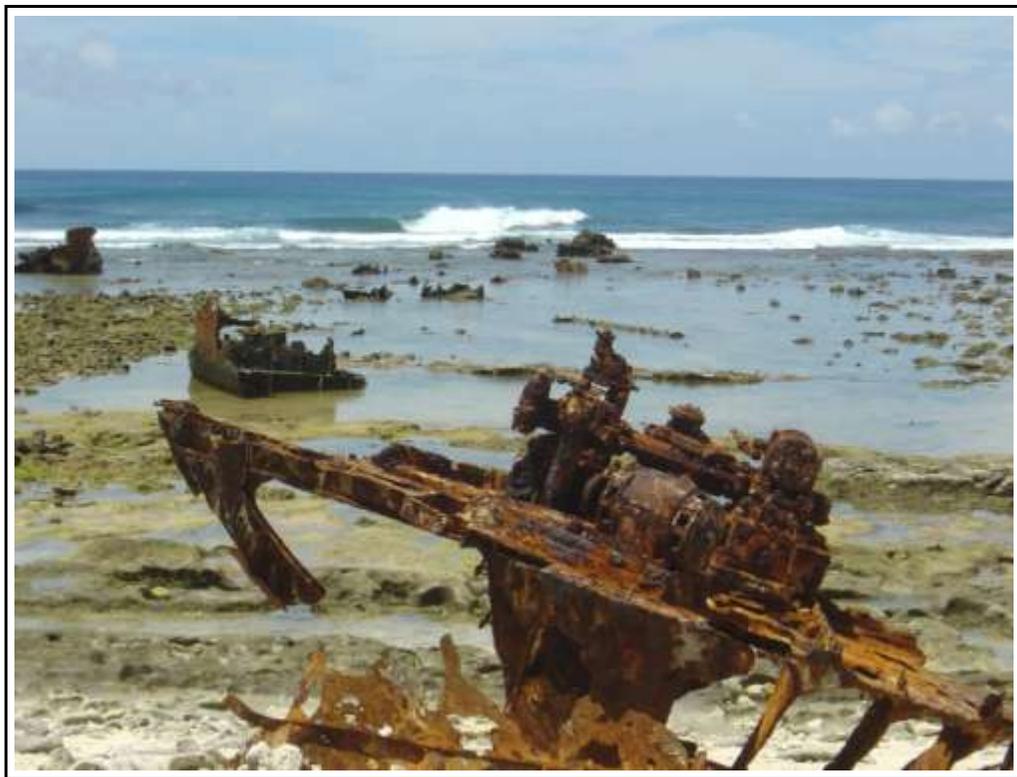
FIGURE 18. February 2008 photo of debris field; note further decay of large pieces.

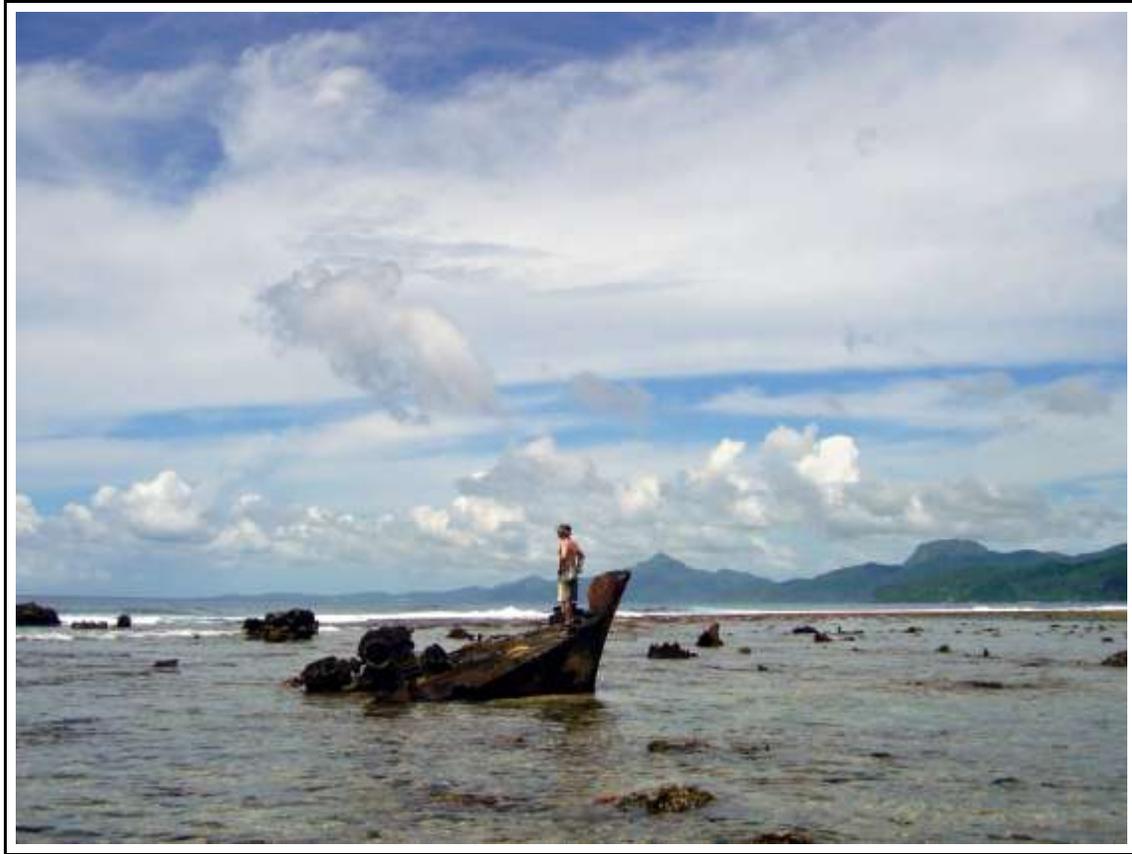
FIGURE 19. February 2008 photo of *F/V Young Kwan* debris.
