St. Croix East End Watersheds Existing Conditions Report

July 2011

Prepared by:
Horsley Witten Group, Inc
90 Route 6A, Sandwich, MA, 02563
508-833-6600

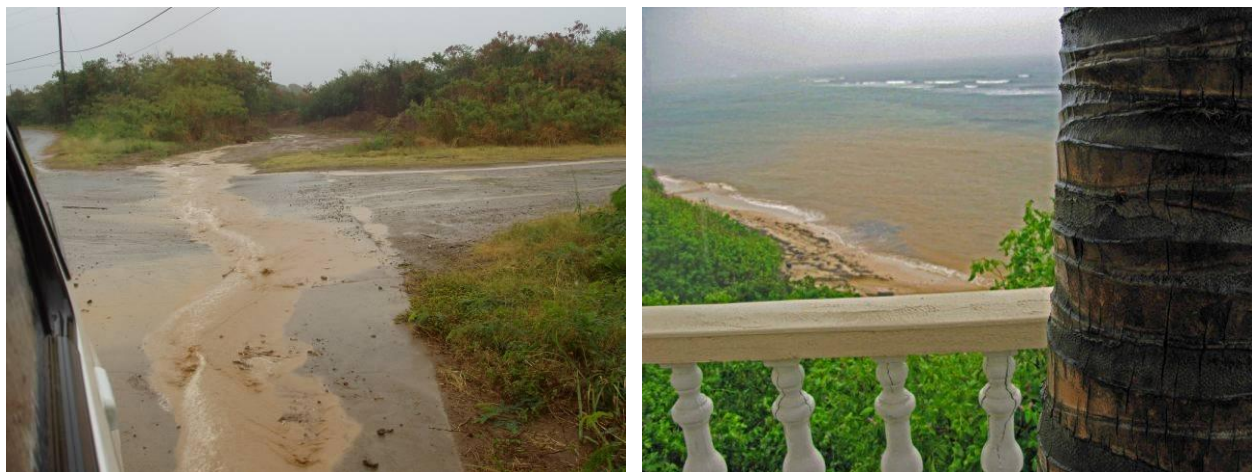
Figure 1.3. Sediment-laden runoff from unpaved roads in Cotton Valley conveyed in concrete swale (left, photo courtesy of Zandy Hillis-Starr). Uncontrolled runoff resulting in sediment plume in Grapetree Bay during heavy rains in July 2010 (right) (photo courtesy of Kathy LaGrange/Dave Rivers).

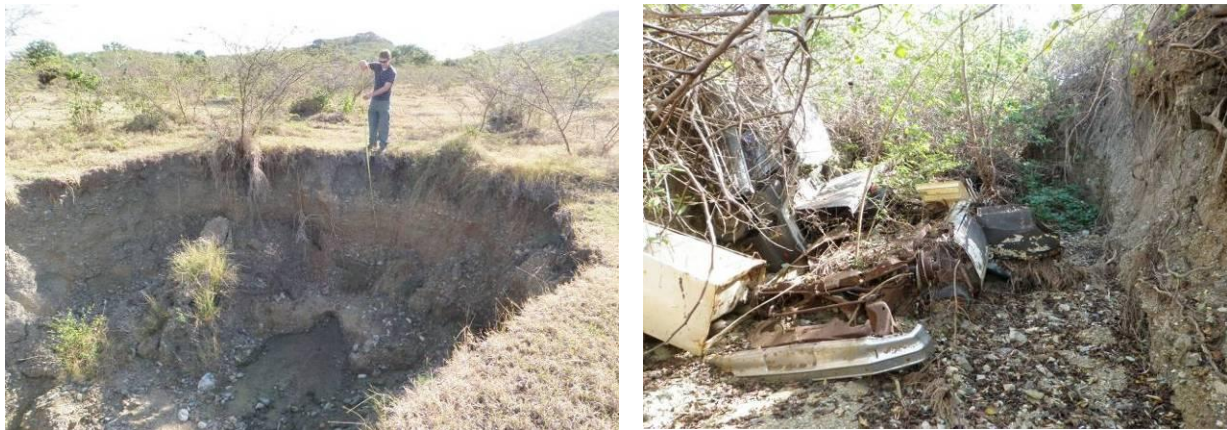
Figure 3.3. Top of East Gut headcut (left) and debris remnants in incised channel (right)

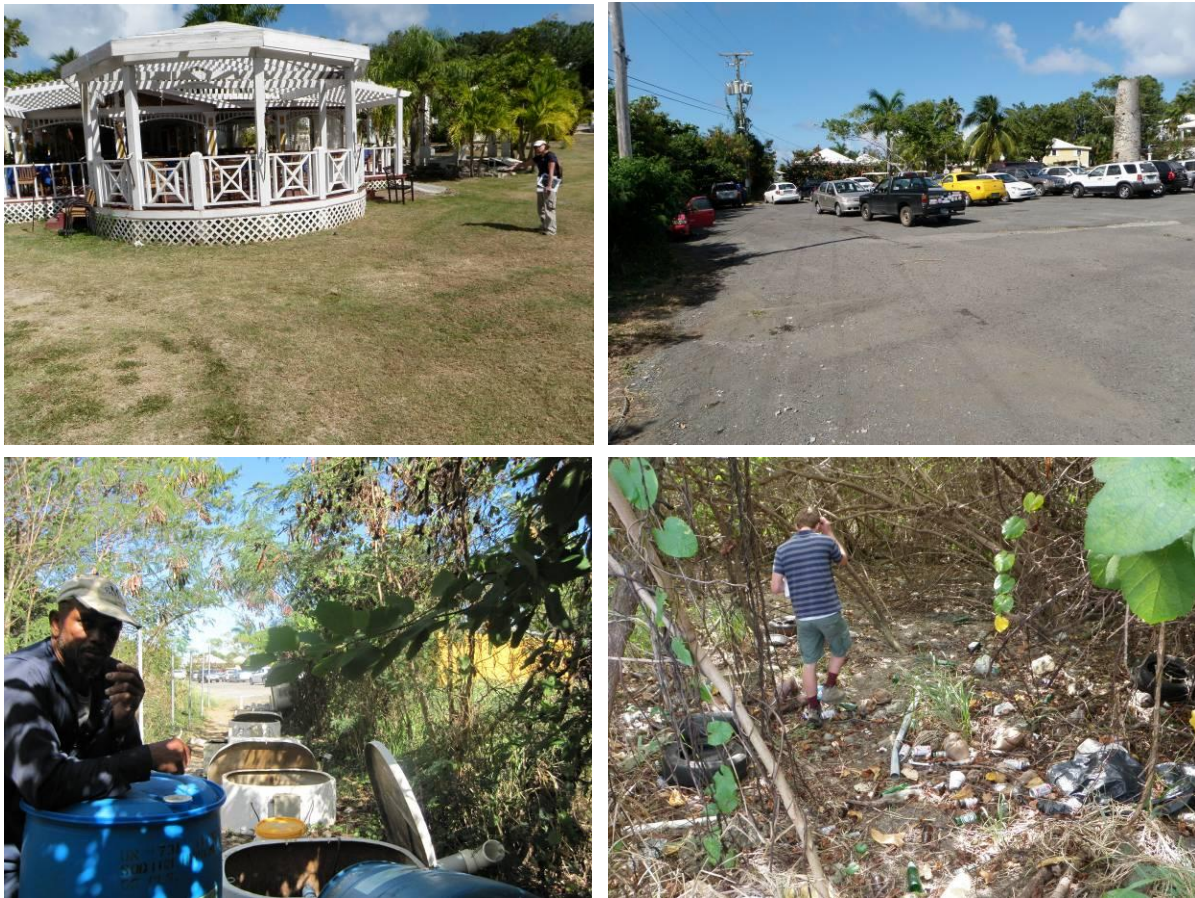
Figure 3.5. Two locations to capture and treat stormwater runoff (top); active upgrade of wastewater system (bottom, left); and trash/debris in adjacent wetland (bottom, right).

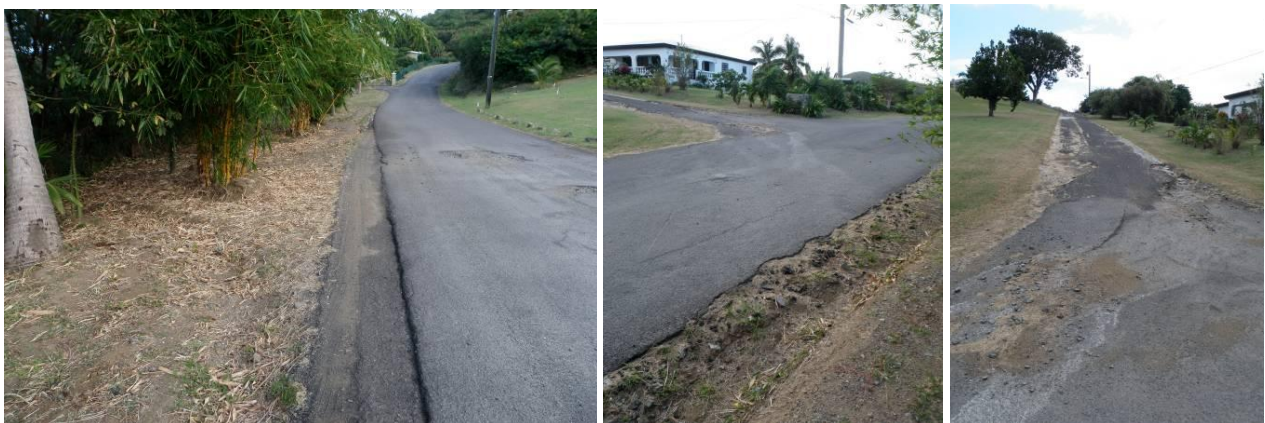
Figure 3.7. Road drainage from residential areas leading to gut erosion.

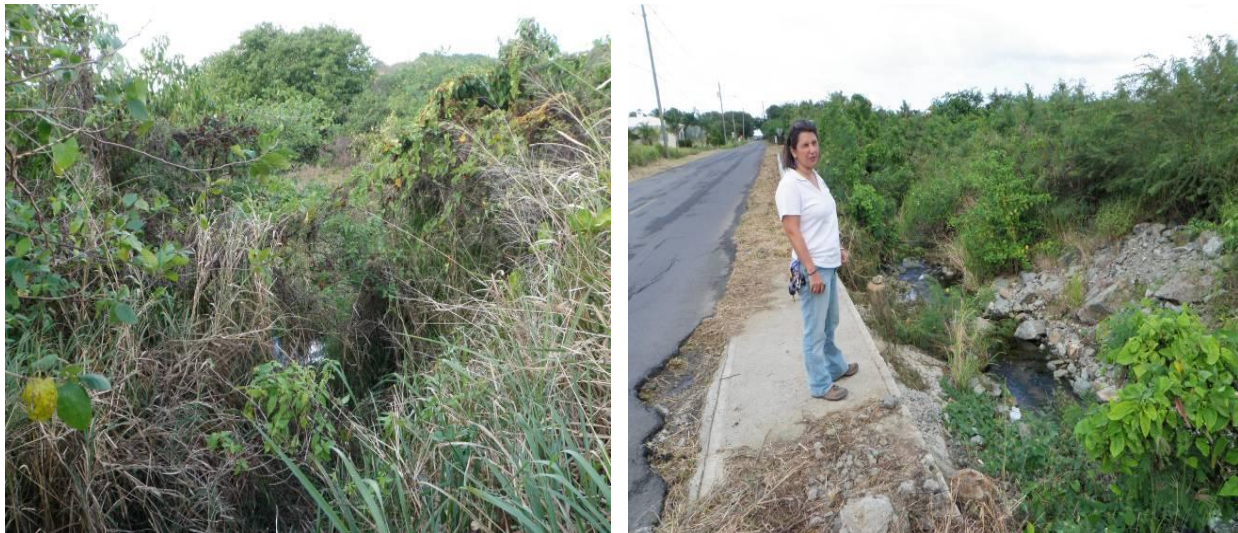
Figure 3.8. Well vegetated banks of west gut on Schuster's property (left) and example of on-going road repair and bank stabilization efforts along South Shore Rd. (right).

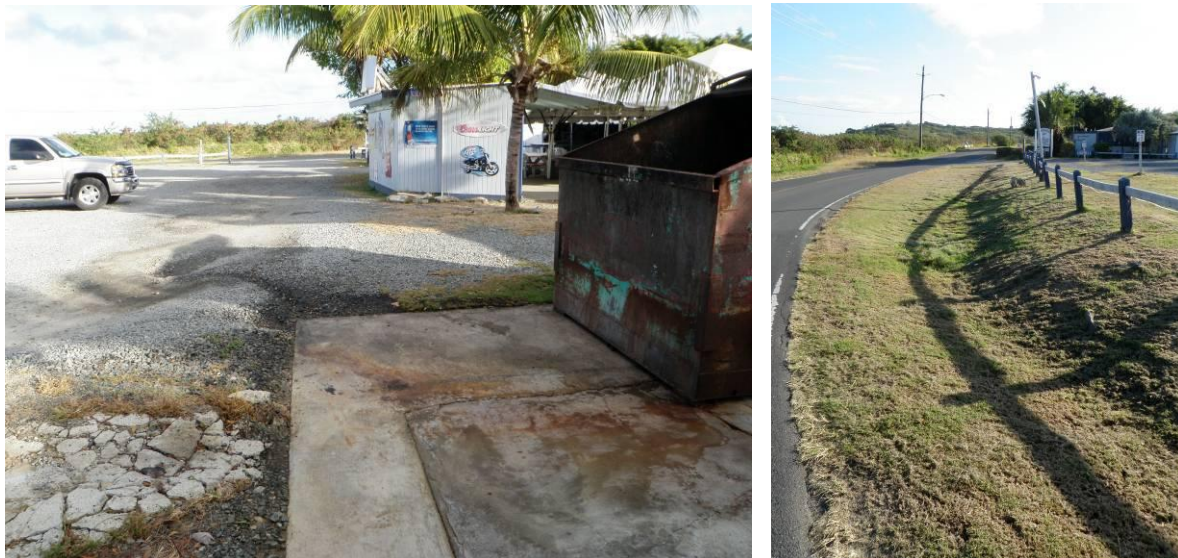
Figure 3.9. Evidence of dumpster juice in stormwater runoff (left); location for swale enhancement to increase water quality treatment.

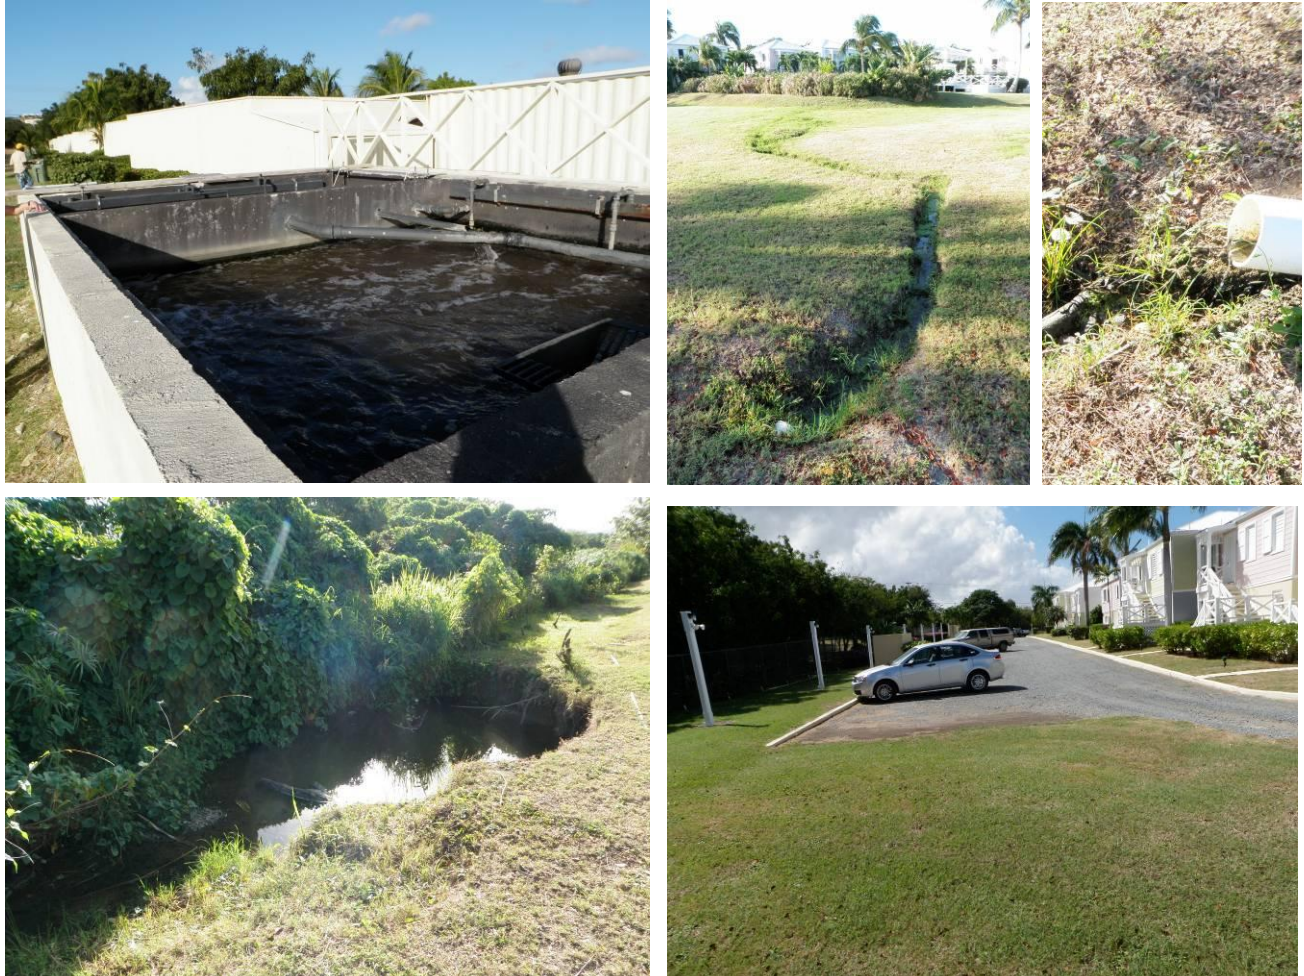
Figure 3.10. (From top left to bottom right) Wastewater system, drainage channel and pipe, gut erosion, and potential location for a rain garden at the Southgate Plantation Condos.

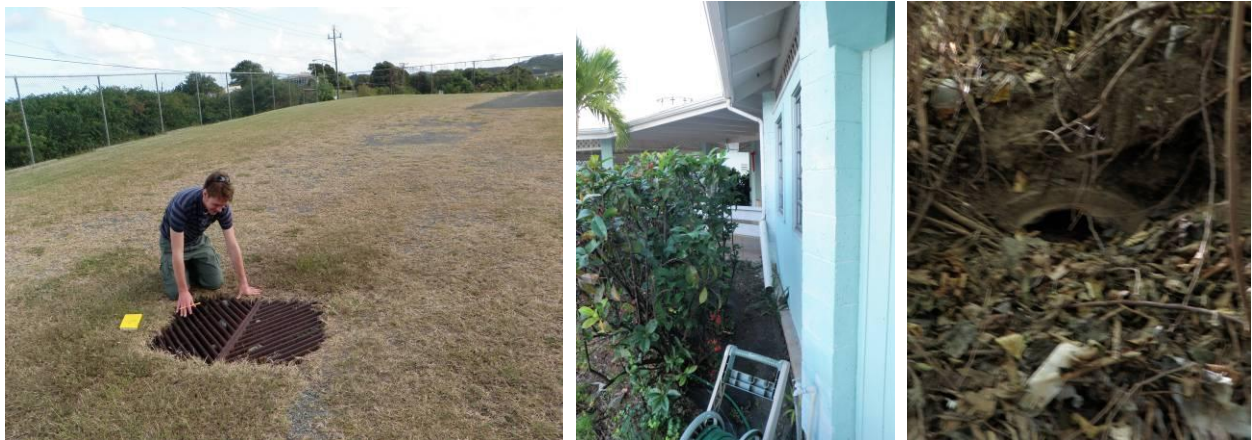
Figure 3.12. Drain inlet in lower parking lot (left); downspout to existing flowerbed that could be converted to a rain garden or collected for irrigation (middle); almost completely blocked culvert (right).

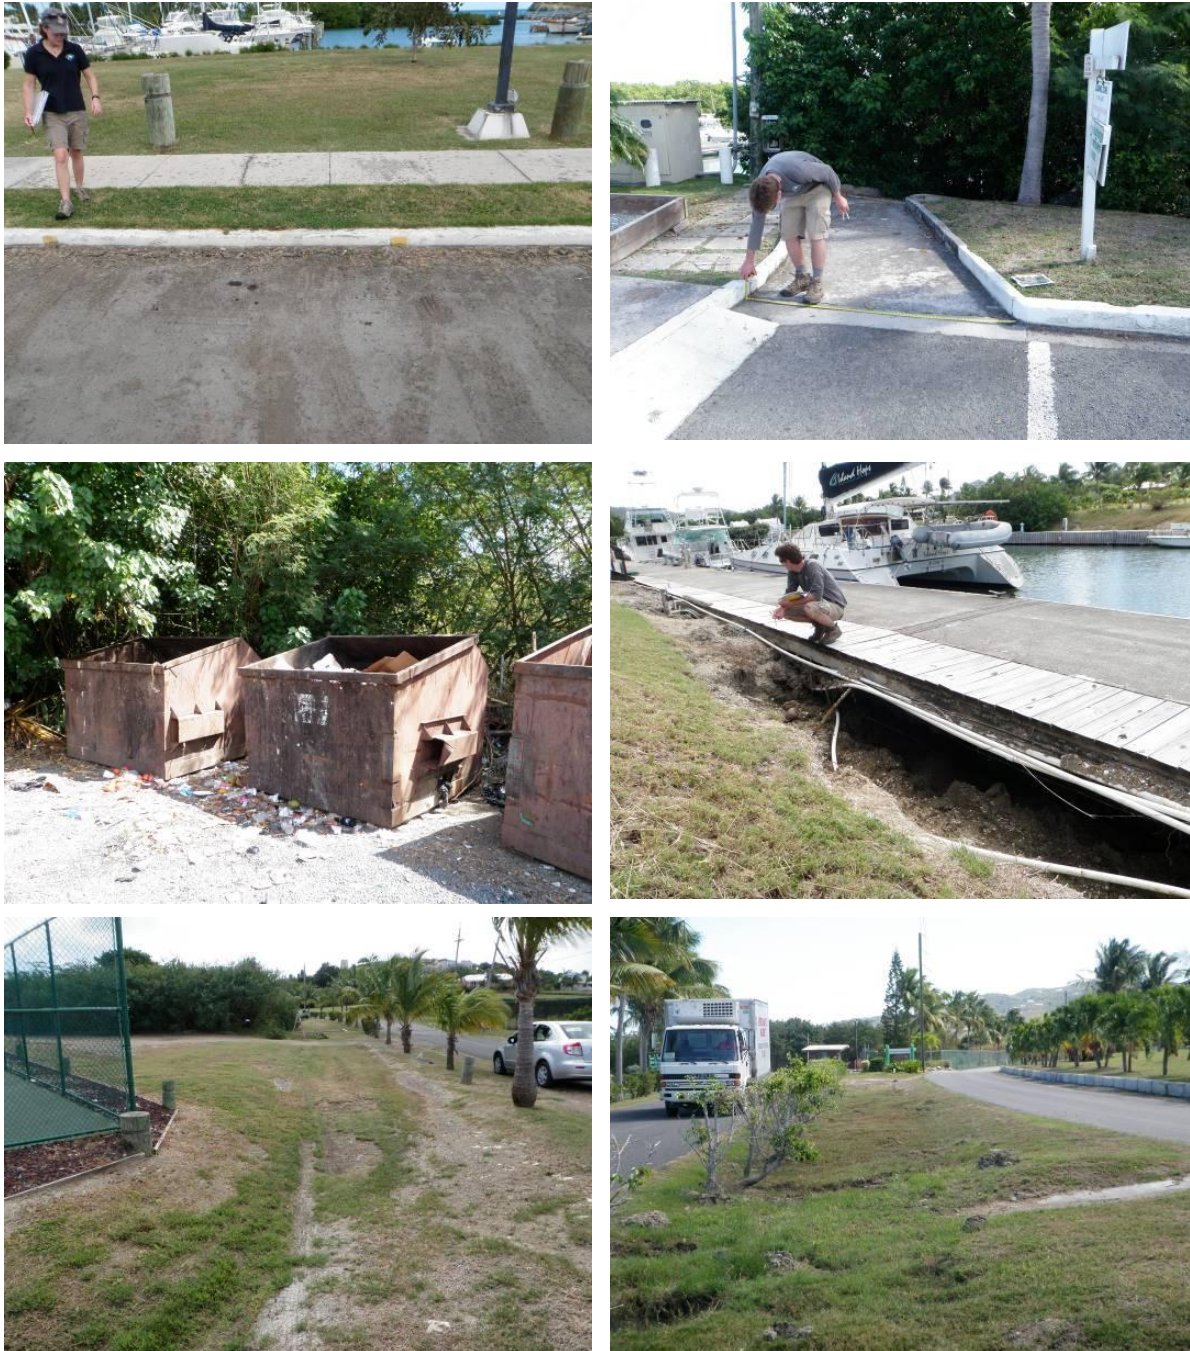
Figure 3.13. (Top left to right) Areas for bioretention and oil grit separator, (middle left to right) dumpster management and bulkhead stabilization, and (bottom left to right) areas for road drainage improvements (SG-R4-5).

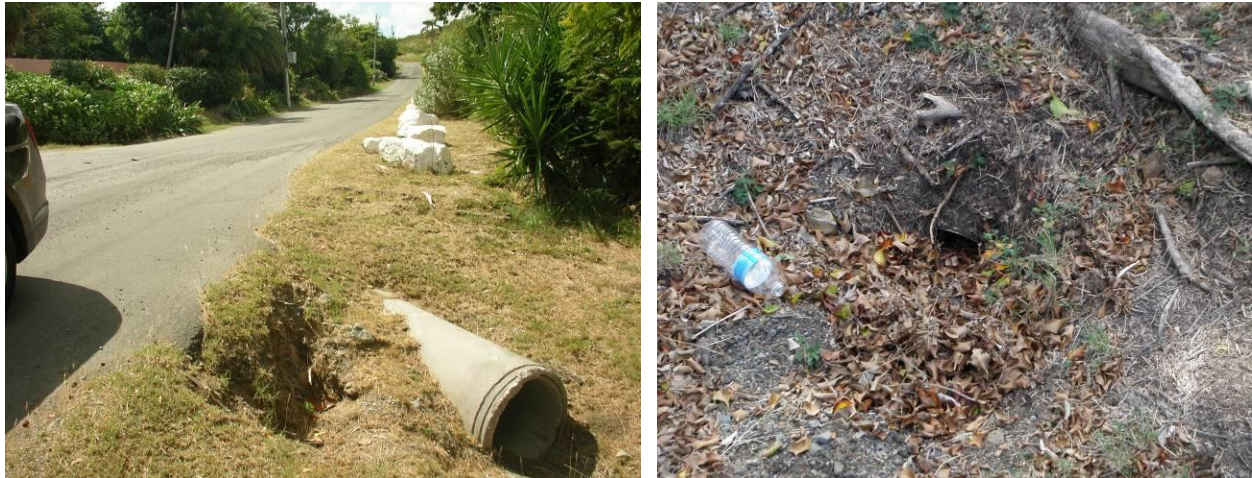
Figure 3.14. Examples of collapse at road edge in the Punnett Bay area (left), and a completely clogged culvert in Southgate Farm/Anna’s Hope (right).

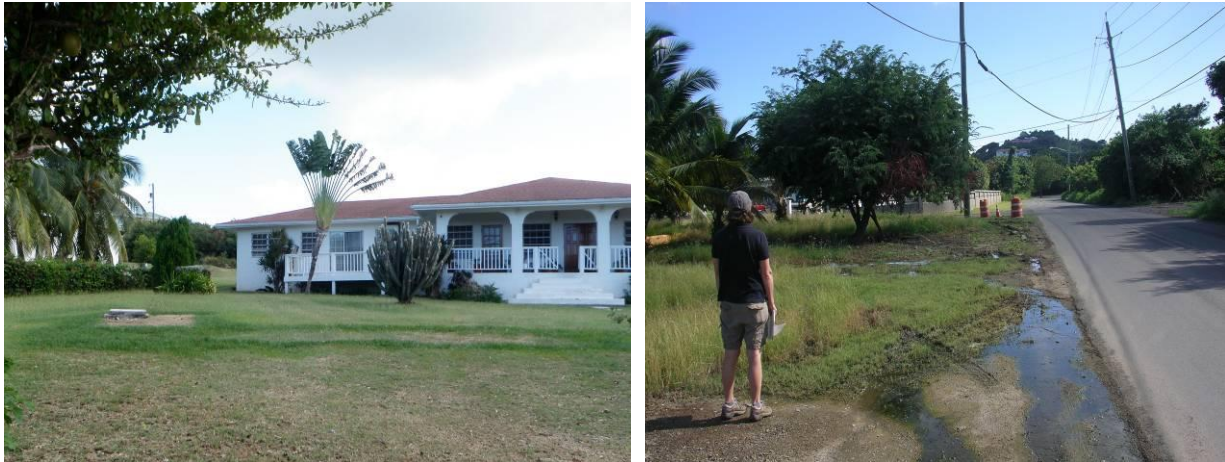
Figure 3.8. Green rectangular indicators of septic system on single family lot (left). Record high groundwater tables and resulting surface seepage in Tipperary/All for the Better residential areas may have resulted in failing septic systems (right).

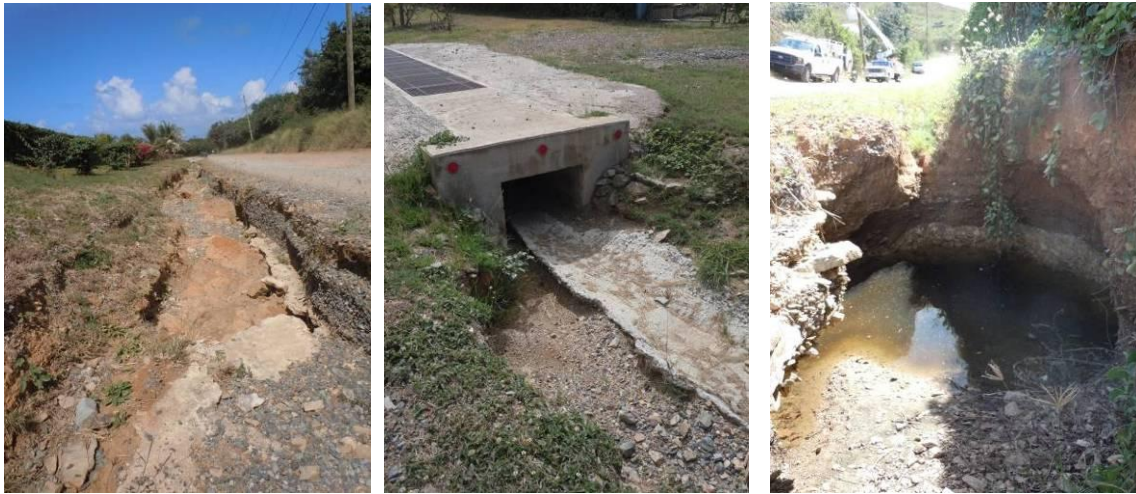
Figure 4.5. Erosion gullies are undermining the unpaved Seven Flags Rd. (left), scouring around and under existing infrastructure (middle), and creating dangerous public hazards (right).

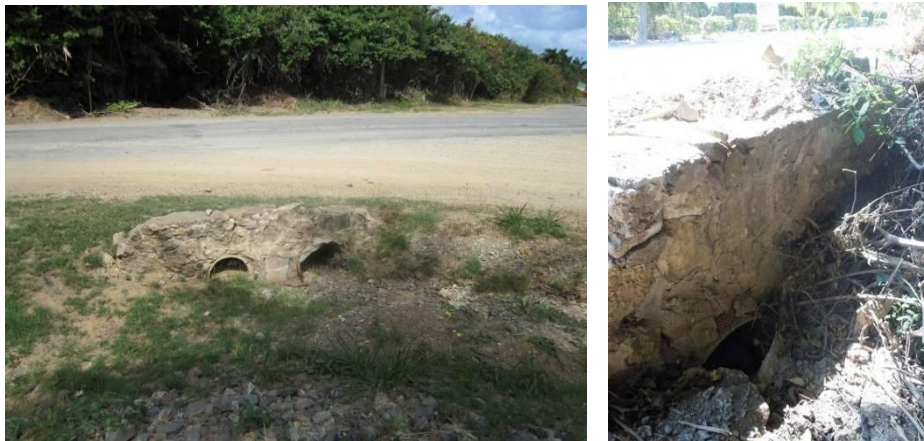
Figure 4.6. The two culverts that carry flow from Seven Flags Rd. and a portion of East End Rd. to Solitude Bay blocked with sediment on both the upstream (left) and downstream ends (right).

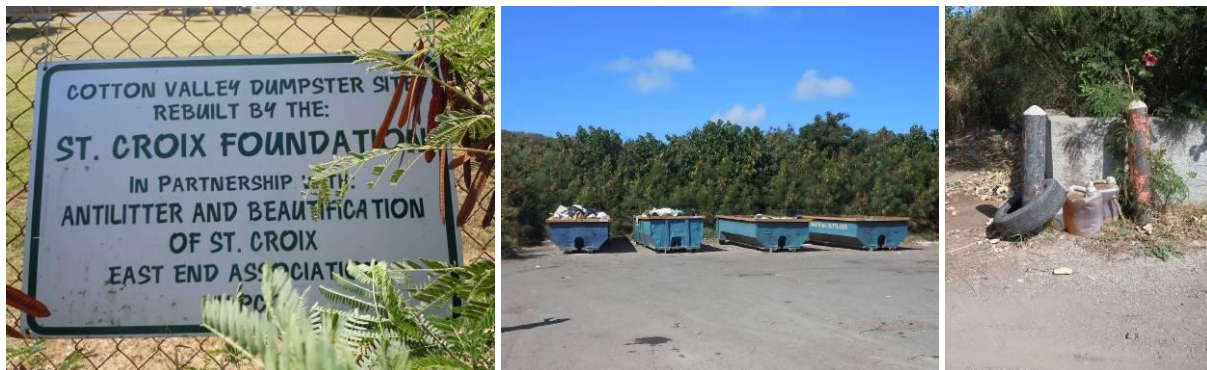
Figure 4.8. The rebuilt dumpster site is an important resource for the community (left). However, the dumpsters are uncovered, overflowing, and located directly adjacent to a gut (middle). Potentially hazardous materials are left in this area (right).

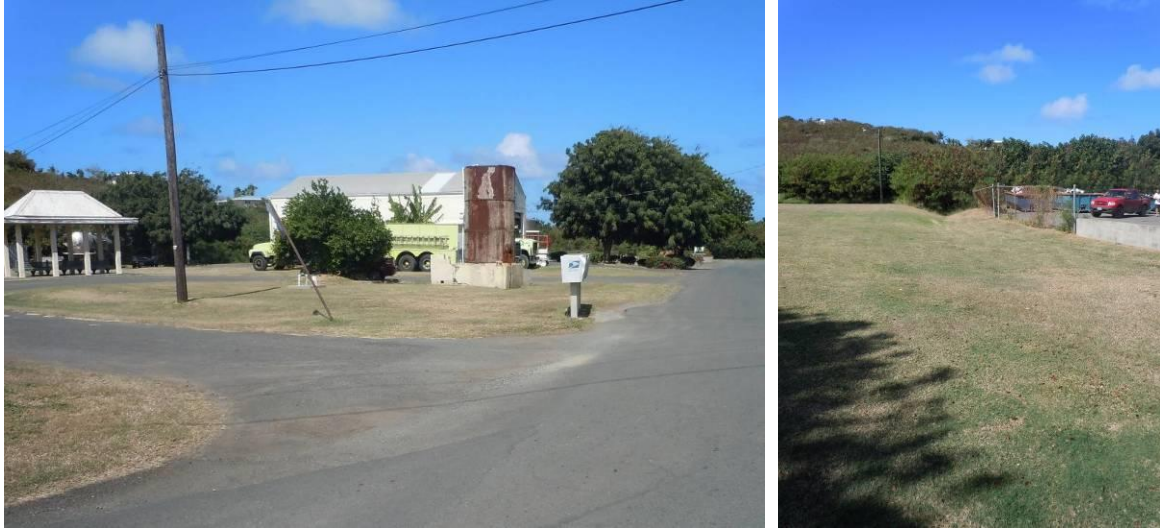
Figure 4.9. The area in front of the bus stop could be retrofitted to manage stormwater from the roadway (left). Stormwater from the fire station could be managed in a retrofitted bioretention system in the existing depression before discharging into the gut behind the property (right).

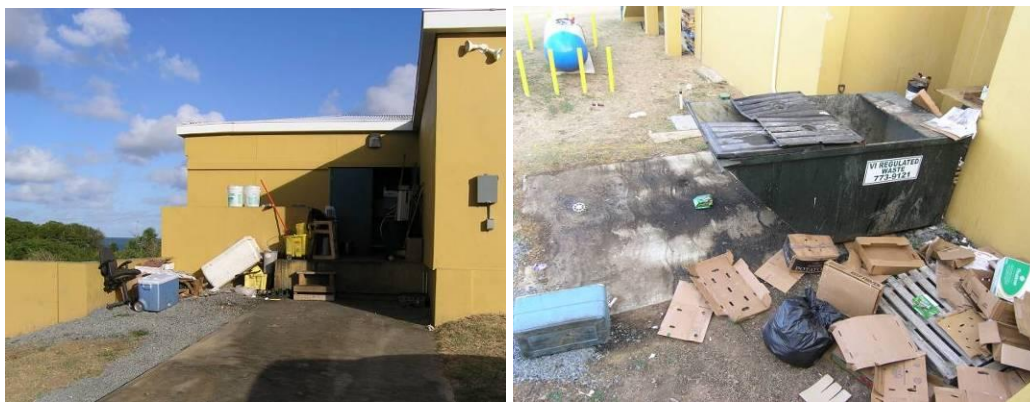
Figure 4.10. Blue Water Terrace has an uncovered area where cleaning products appear to be rinsed (left) and an uncovered dumpster/materials storage area with evident leaking and staining (right).

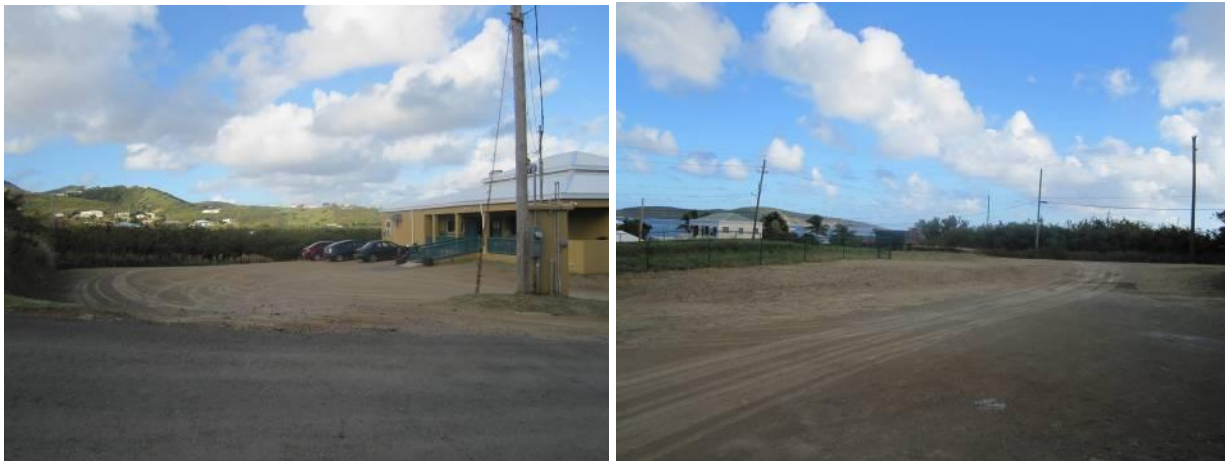
Figure 4.11. The grassy area in the far left of this photograph is a good location for a bioretention facility for runoff from the parking area (left). This depression on the north side of the building could also be converted to manage stormwater from the property (right).

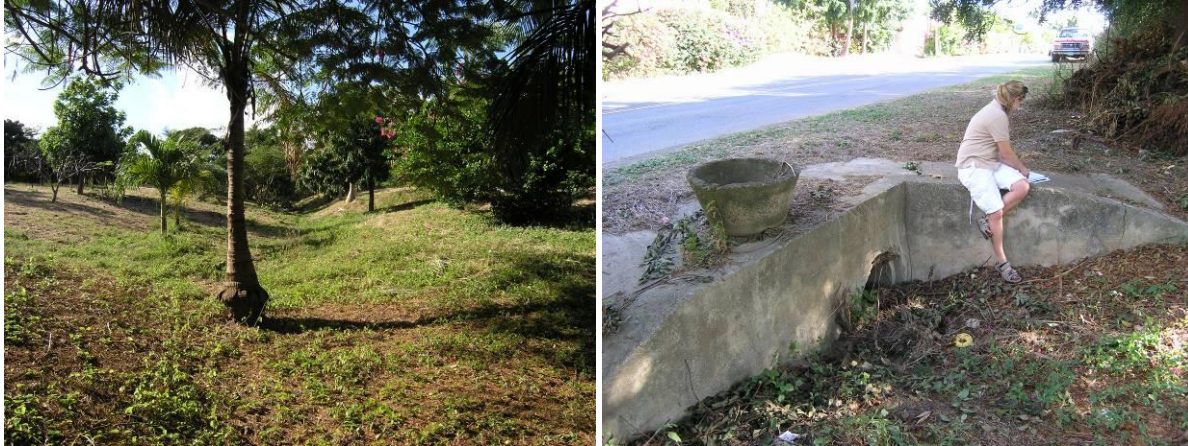
Figure 4.12. View upstream along one fork of the gut system (left). Concrete headwall for 15-inch reinforced concrete culvert (right).

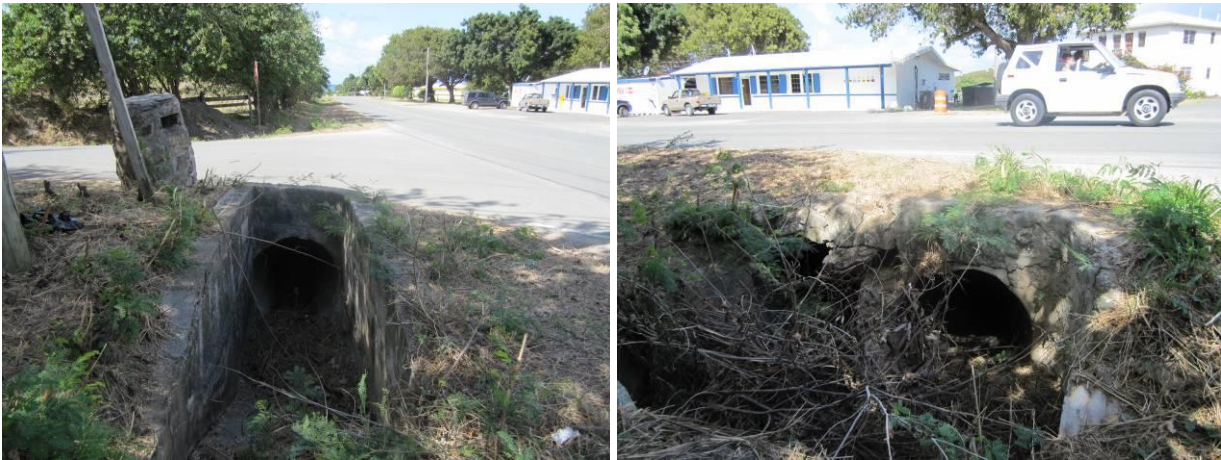
Figure 4.14. 30-inch culvert under Solitude Rd (left) and two 30-inch culverts under East End Rd., leading to a 48-inch culvert that discharges to Coakley Bay (right).

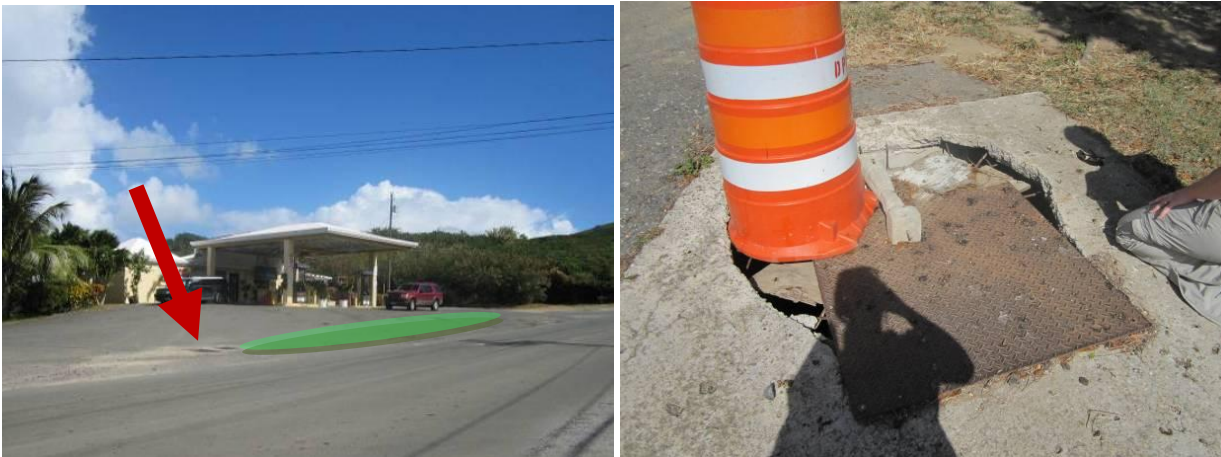
Figure 4.15. Some pavement could be removed at the gas station to create a treatment swale (shown in green) up-gradient from the existing catch basin indicated with an arrow (left). Manhole covers are missing all along the 48-inch culvert leading out to Coaklely Bay, creating a safety hazard (right).

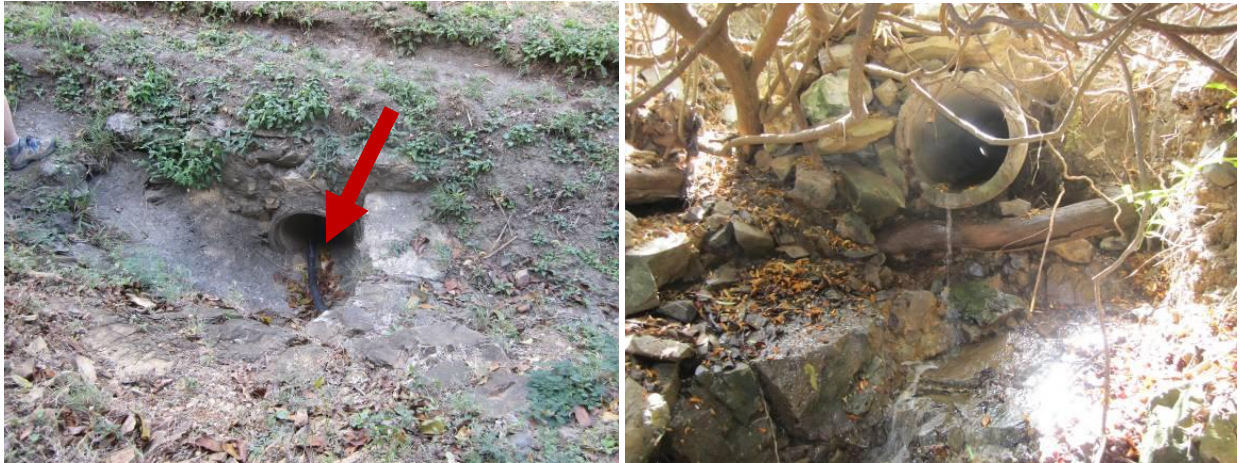
Figure 4.18. Arrow indicates PVC pipe discharging dry weather flow into culvert (left). Dry weather flow observed at downstream end (right).

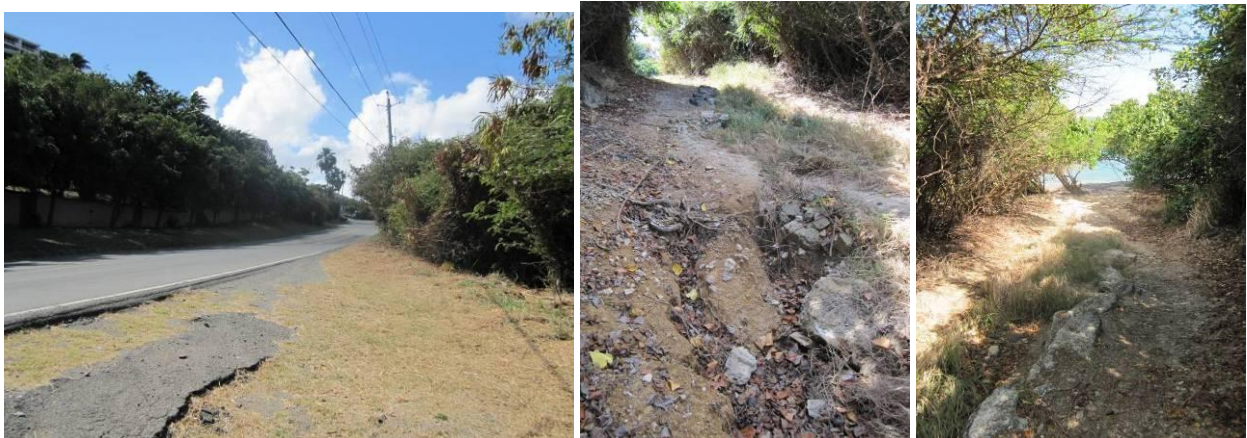
Figure 4.19. Runoff from Coakley Bay Condos flows across East End Rd. and down a beach access road (left) causing erosion gullies (middle), and this sediment-laden runoff enters Coakley Bay (right).

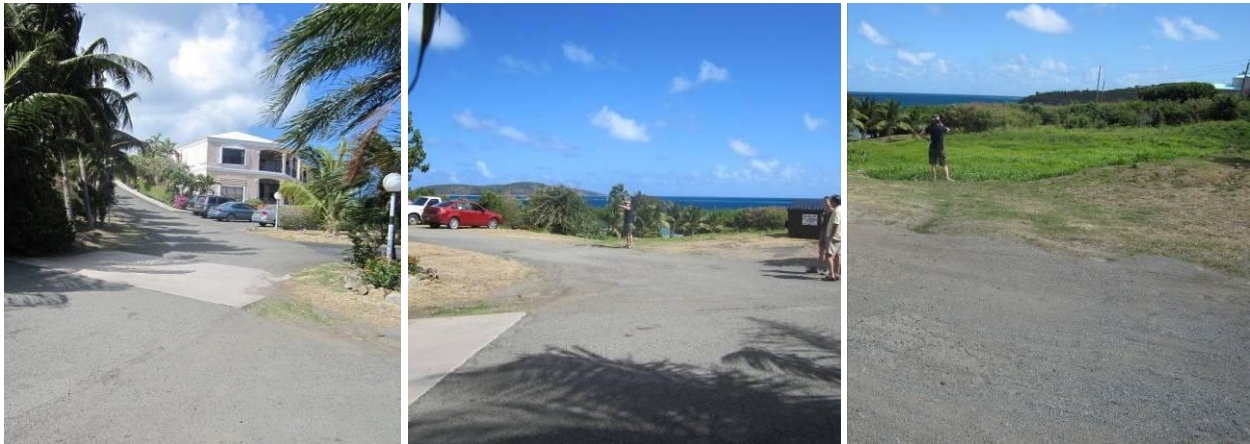
Figure 4.20. Stormwater runoff is conveyed across the entrance road with a shallow water bar (left) and continues towards the parking area near the dumpster (middle), eventually, flowing down into a grassy depression that exists in an undeveloped lot (right).

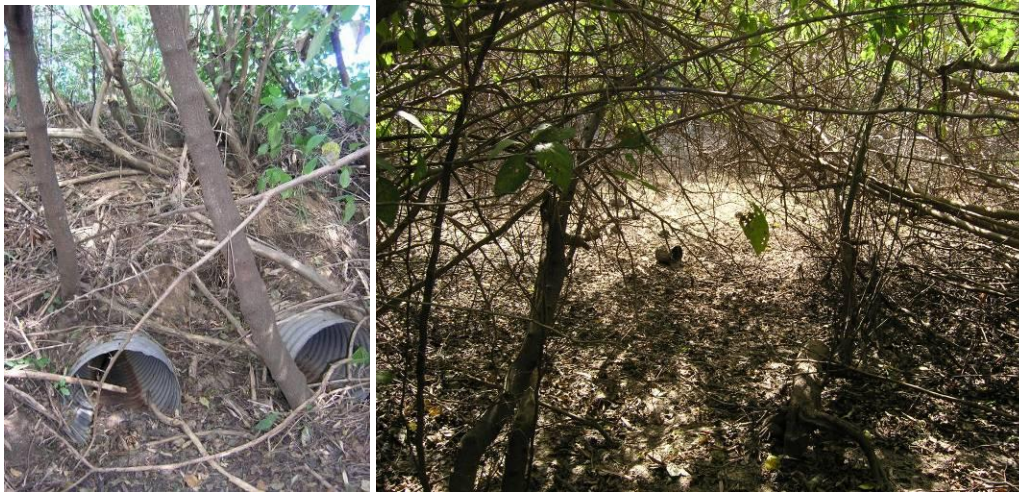
Figure 4.24. Two 24-inch CMP culverts that cross an unnamed road (left). A depression exists at the upstream end that only holds water in the wet season (right).

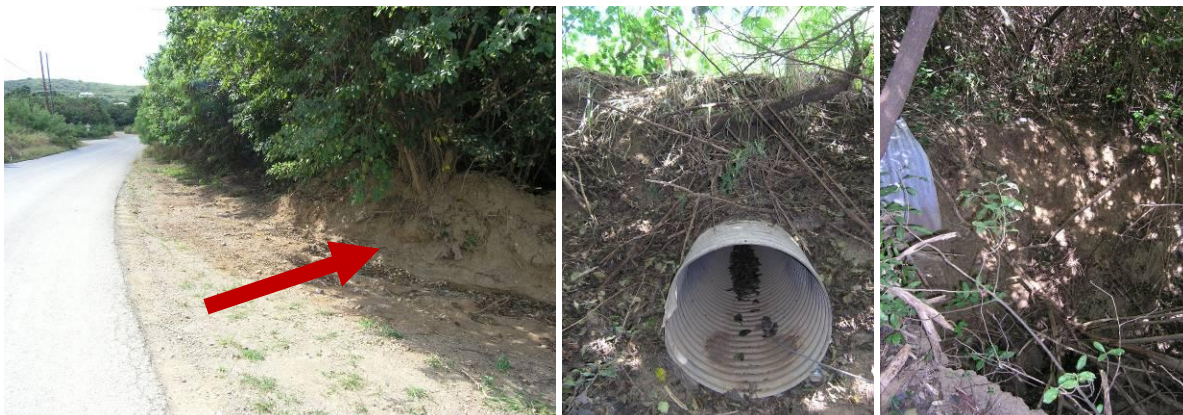
Figure 4.25. The arrow shows the sediment that gets cleared off Pony Club Trail and pushed into the gut (left). The upstream end of the culvert is clear of debris and is in generally good shape (middle); however, a large scour hole has formed at the downstream end (right).

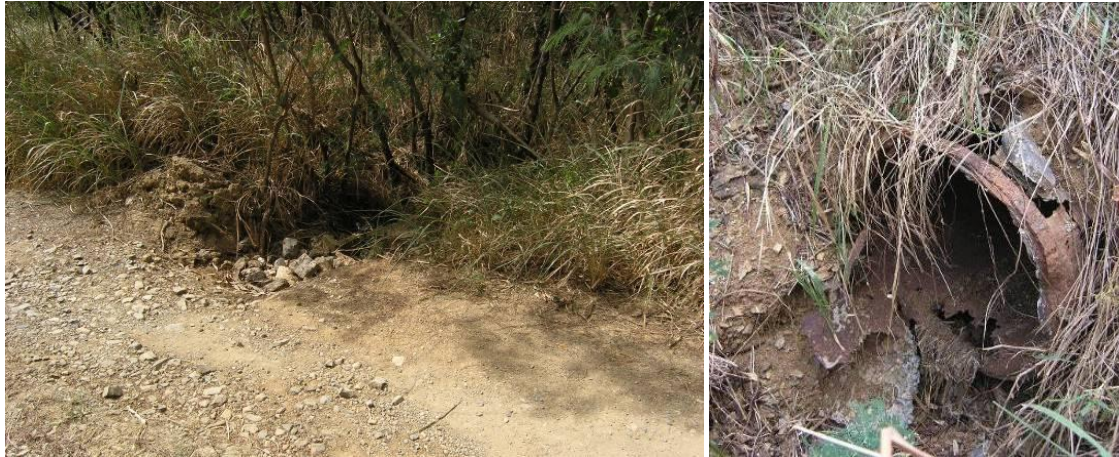
Figure 4.26. The upstream end of this ductile iron culvert is completely blocked (left). The downstream end is corroded and disintegrating (right).

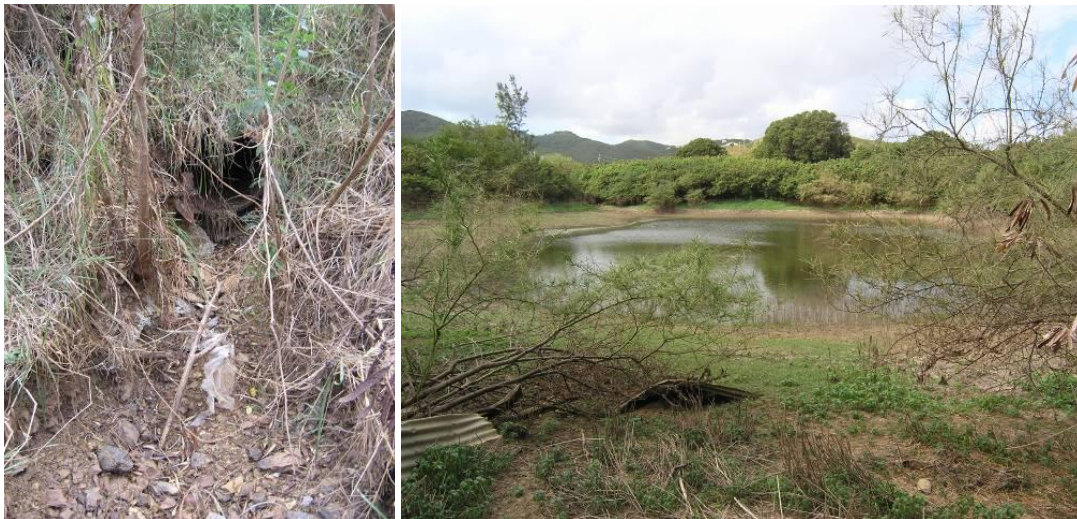
Figure 4.27. Scouring was observed downstream of this culvert (left), which leads to sedimentation of the large pond downstream (right).

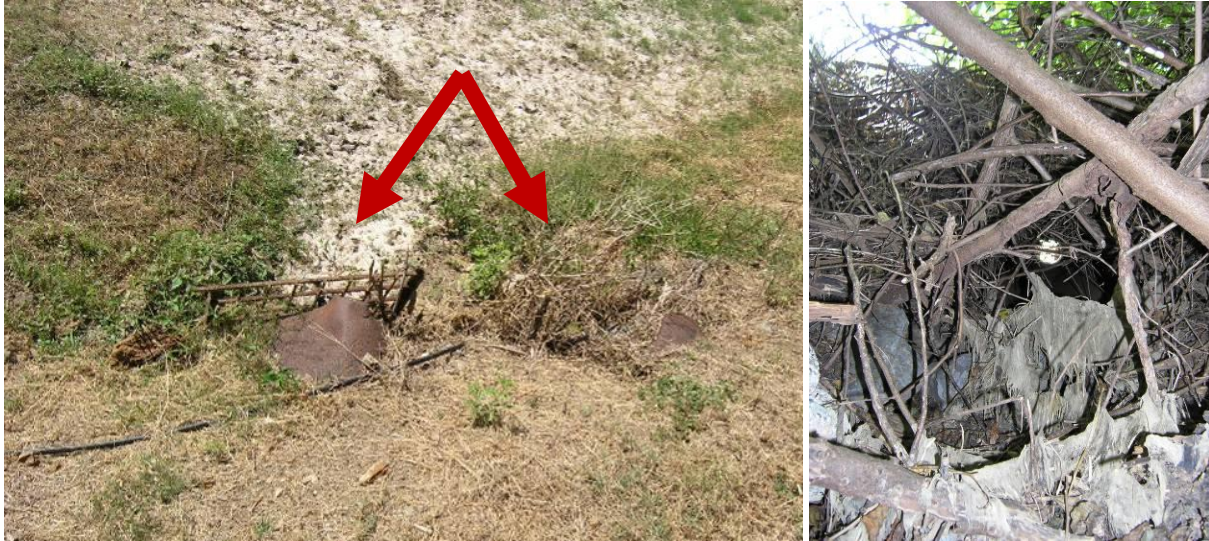
Figure 4.28. The two 24-inch ductile iron culverts have damaged trash racks – one made of rebar grate and one made of wire fencing and sticks (left). The downstream end is clogged with vegetation (right).

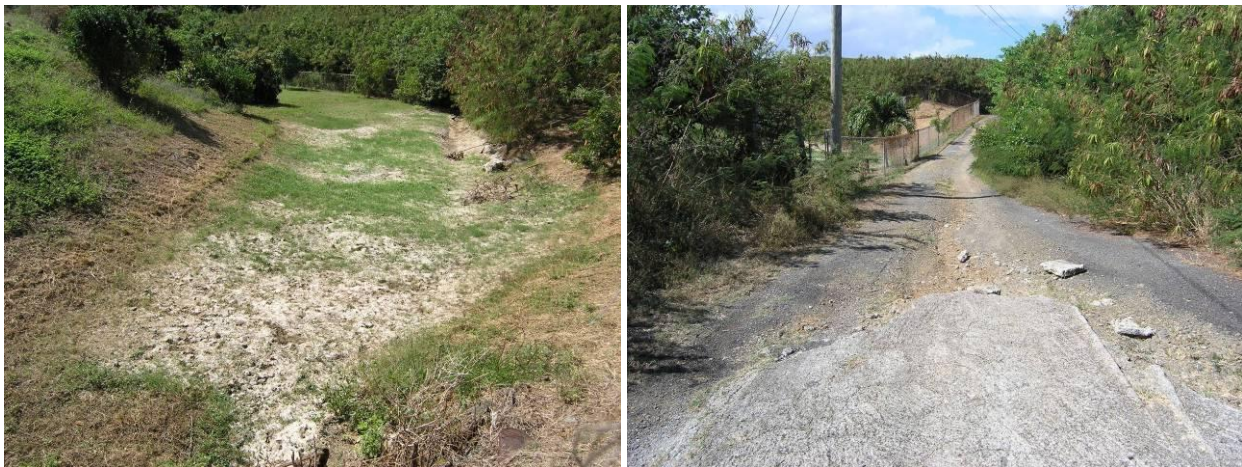
Figure 4.29. A pond is located upstream from the culverts – dry at the time of observation (left). The road itself is deteriorating and providing a sediment load to the gut (right).

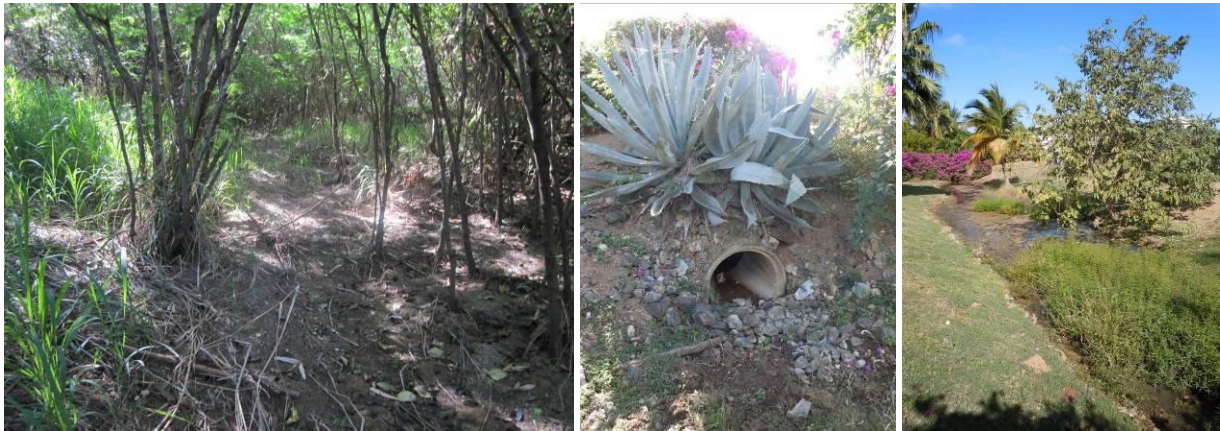
Figure 4.30. The gut upstream from the culvert (left). The downstream end of the culvert (middle). Ponded water in the front of a private residence (right).

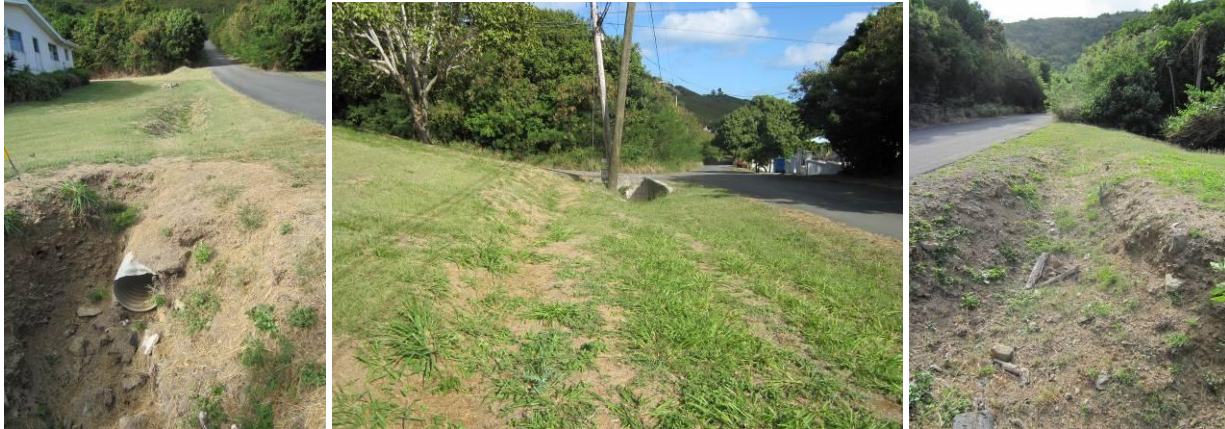
Figure 4.32. Erosion caused by deteriorating culverts in the southern portion of Pleasant Valley.

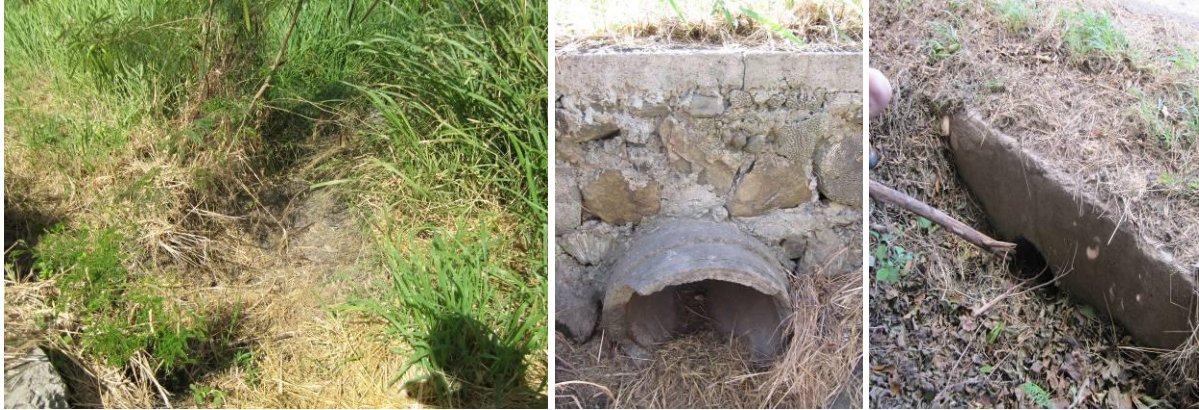
Figure 4.33. Erosion downstream from the first culvert (left); the second, chipped culvert (middle); and the partially blocked third culvert (right).

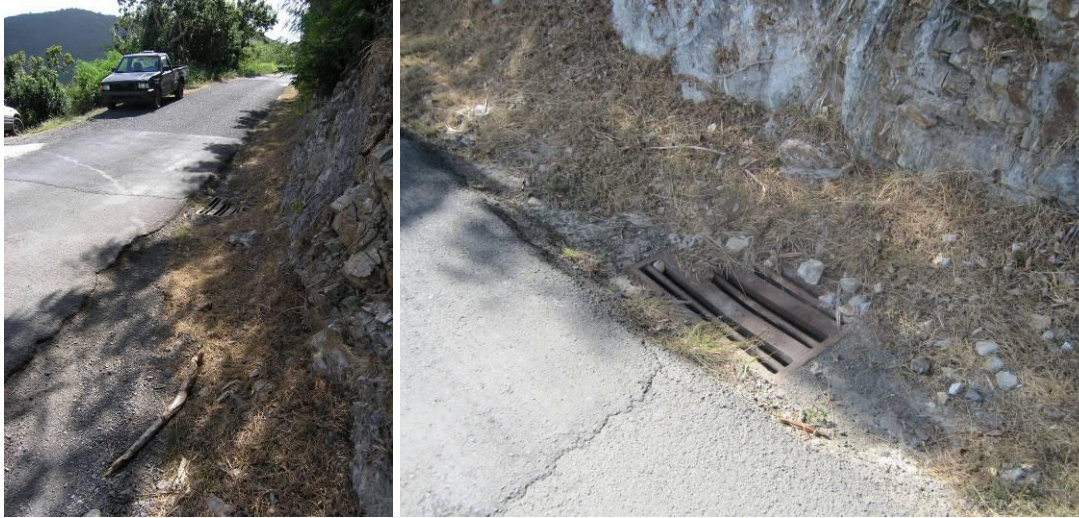
Figure 4.35. Blocked inlet to this culvert on Seven Flags Rd.

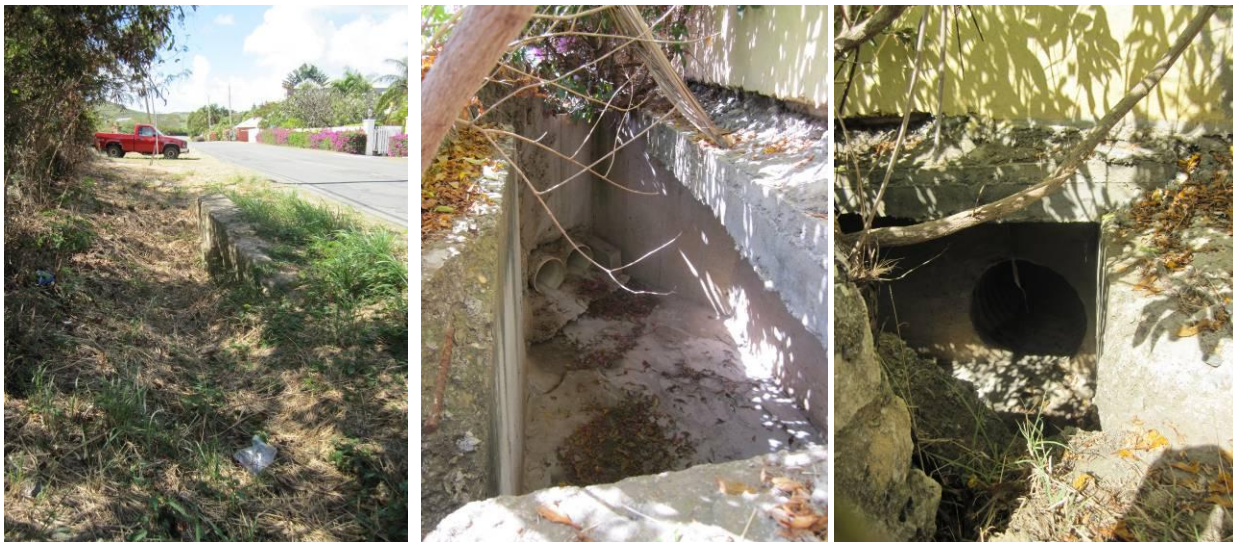
Figure 4.36. Upstream end of 24-inch culvert and headwall; Sierra Verde Rd. in the background (left); the two PVC pipes in the drainage structure at the downstream end of the culvert (middle); and the ultimate discharge pipe to the bay where runoff leaves the drainage structure (right).
