St. Croix East End Watersheds Existing Conditions Report

July 2011

Prepared by:
Horsley Witten Group, Inc
90 Route 6A, Sandwich, MA, 02563
508-833-6600

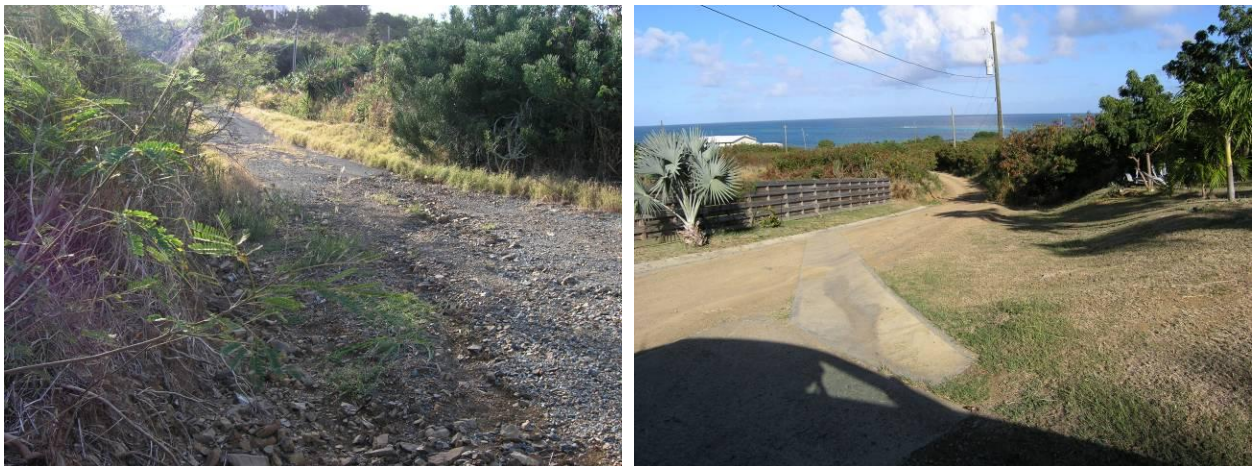
Figure 4.37. Erosion along private road within Sierra Verde neighborhood at meeting point between paved and gravel roadways (left) and water bar installed along main dirt road in Sierra Verde neighborhood.

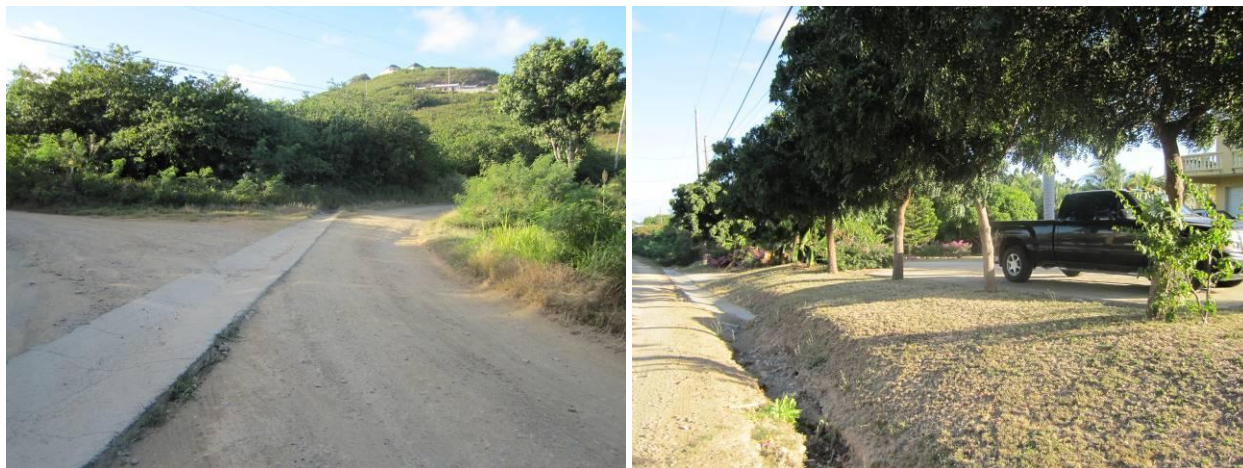
Figure 4.38. Concrete swale installed along dirt road in Hope and Carton Hill neighborhood (left) and erosion along dirt road where a paved swale ends (right).

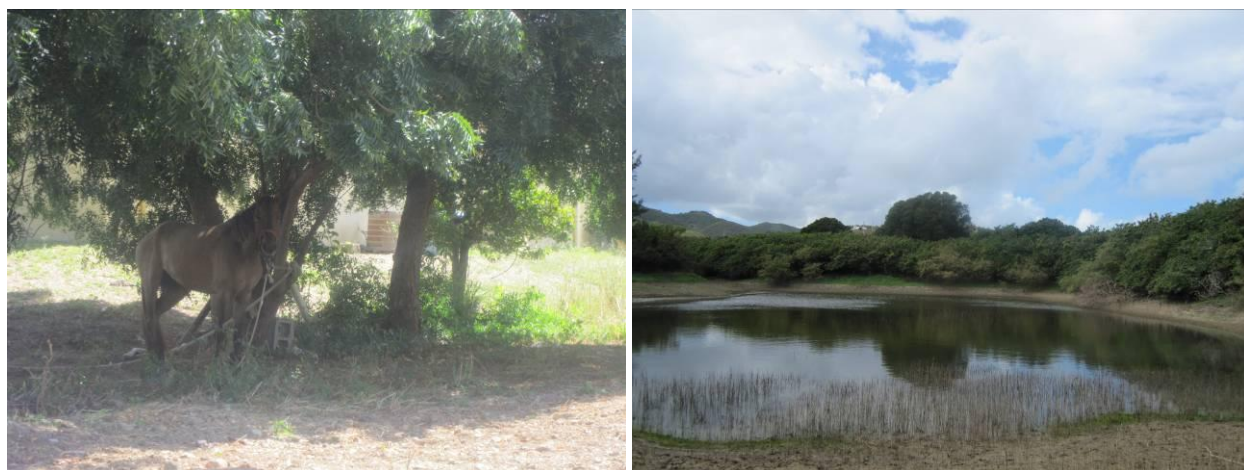
Figure 4.39. Horse kept on private lot (left) and pond with standing water (right) within Cotton Valley neighborhood.

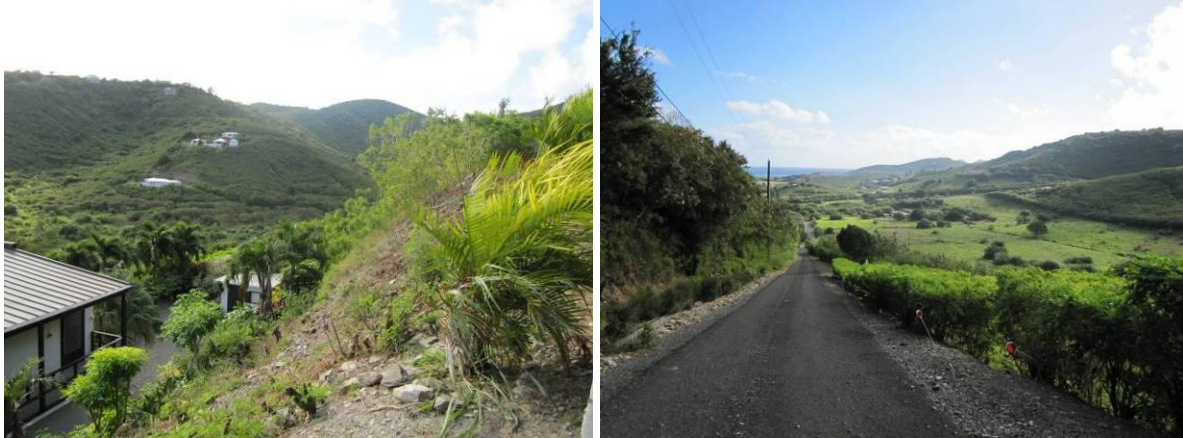
Figure 4.42. Single-family home built on steep slope within Pleasant Valley neighborhood (left) and paved Solitude Rd. adjacent to Roebuck Goat Farm in Pleasant Valley neighborhood (right).

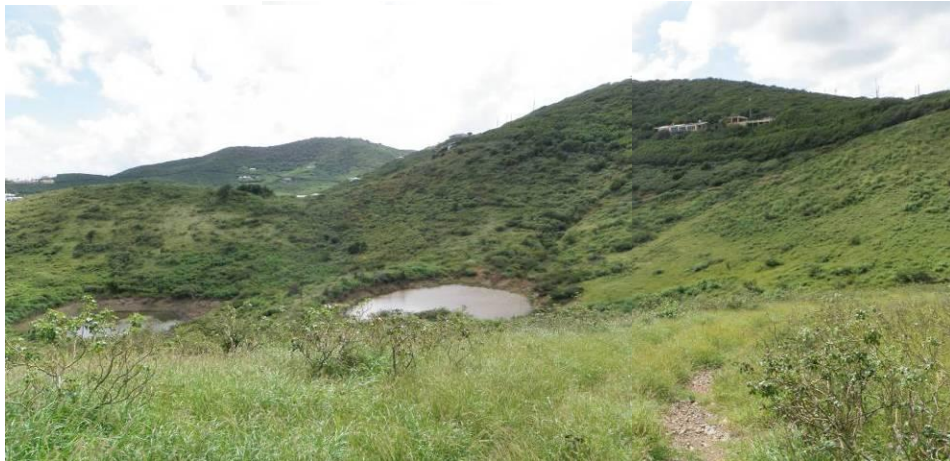
Figure 5.2. Skov farm ponds. The pond on the left is leaking, the one on the right is receiving sediment from hillside erosion.

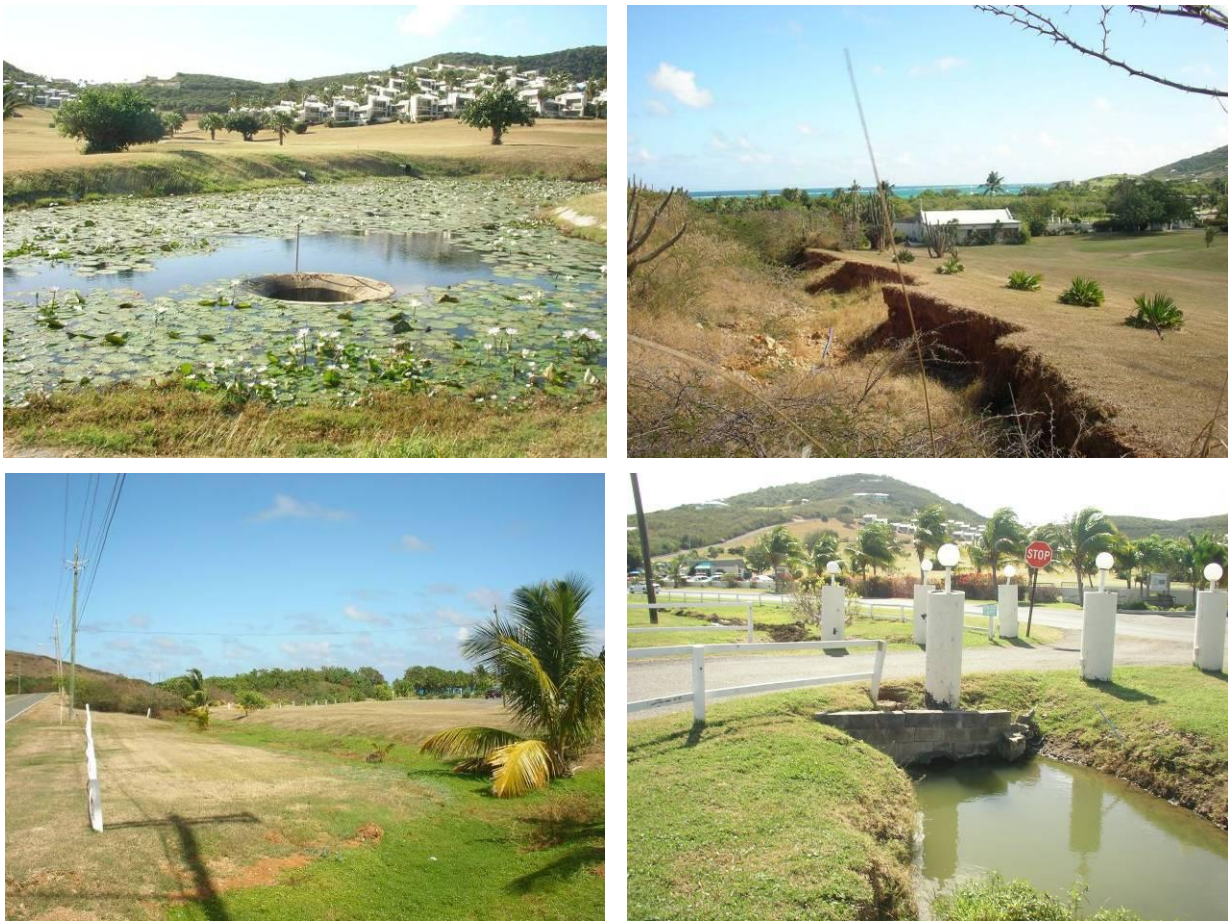
Figure 5.3. One of three golf course ponds (top left) covered in highly invasive water hyacinth; eroded gut along western edge of Reef property (top right); potential location for constructed wetland retrofit (bottom left); and parking lot retrofit location at Duggan’s (bottom right).

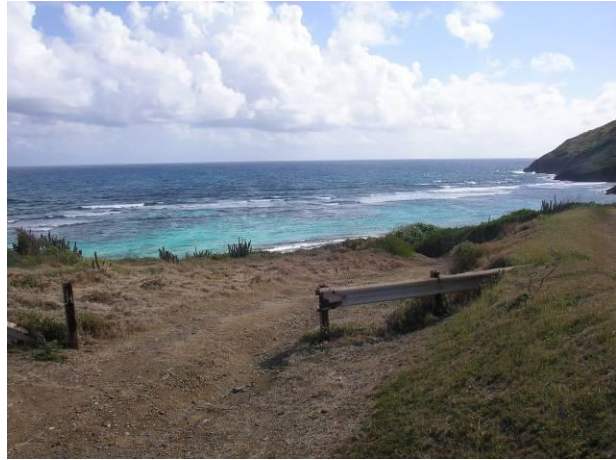
Figure 5.5. Open guardrail off East End Rd.

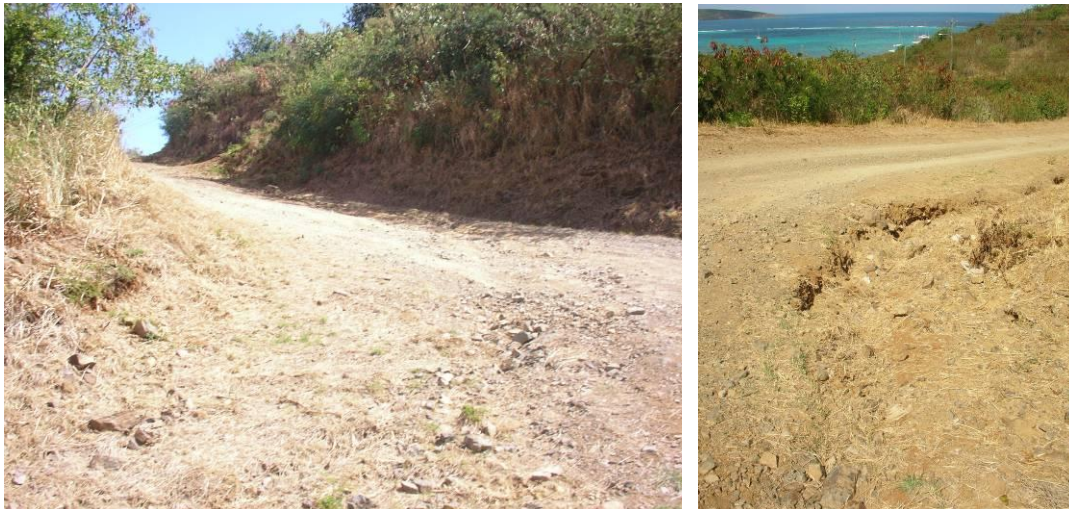
Figure 5.7. Gullying and erosion observed along Ridge Rd.

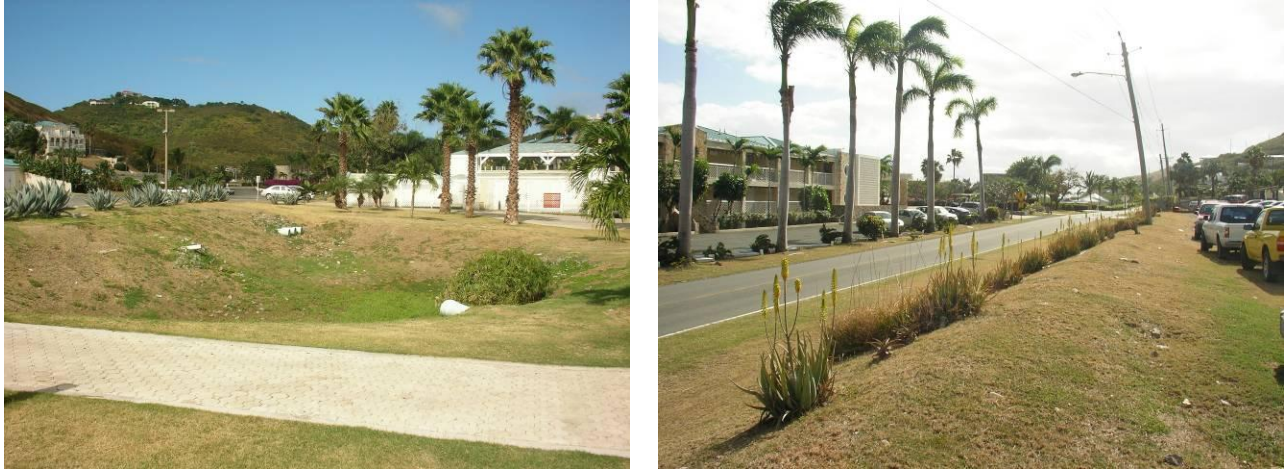
Figure 6.4. Detention basin at Divi Carina Bay Hotel & Resort (left). View of Divi Hotel parking areas along South Shore Rd and potential area for a rain garden/swale (right).

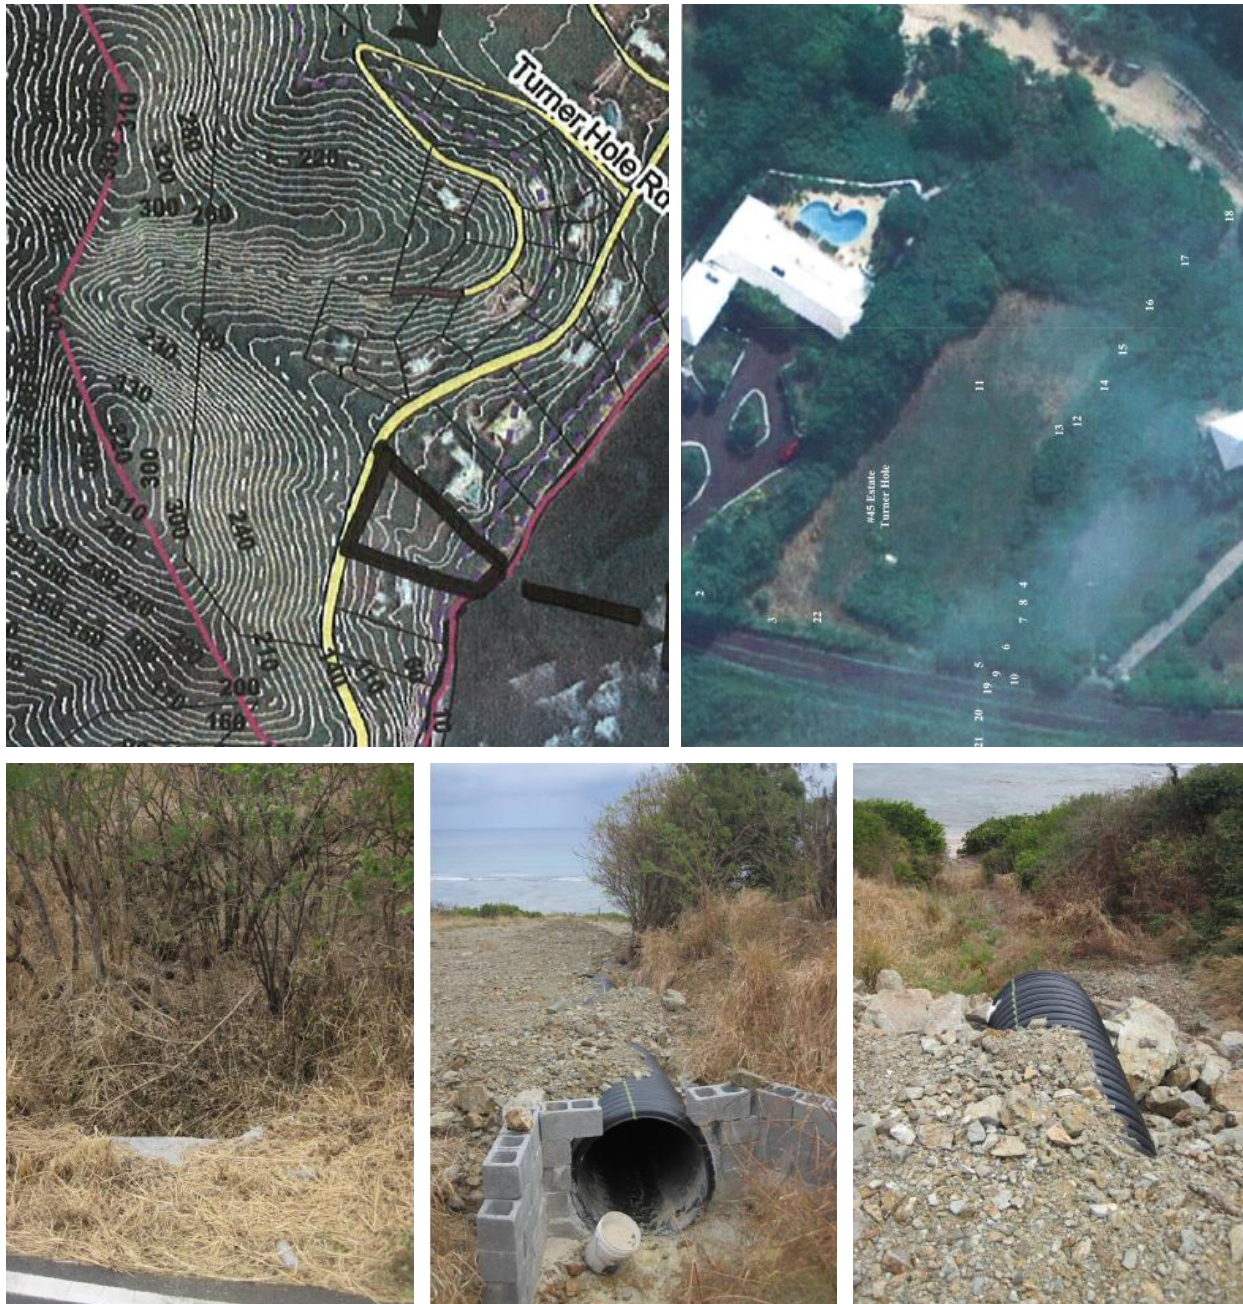
Figure 6.9. (From top left to bottom right) Parcel location; aerial photo of site with location along channel/culvert where photos were taken by EEMP staff; looking at gut above road crossing; new culvert inlet on property, and culvert discharge to bay (photos from EEMP staff on March 14, 2011).

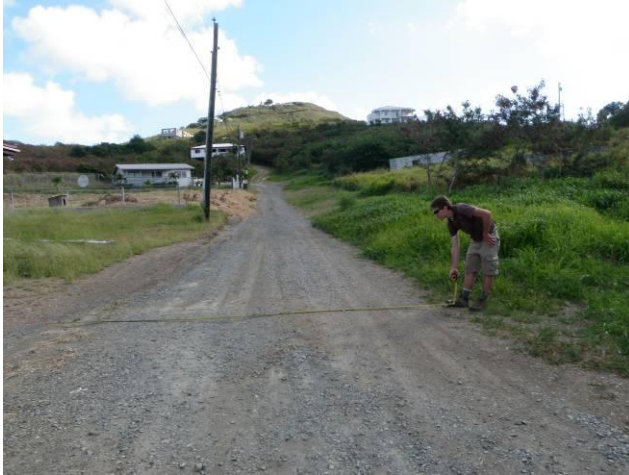
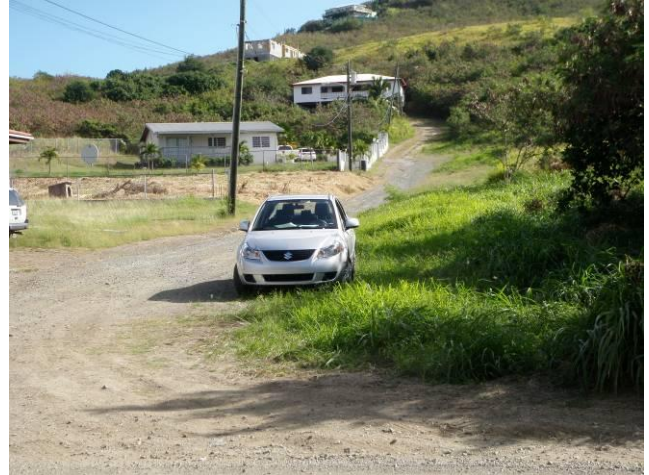
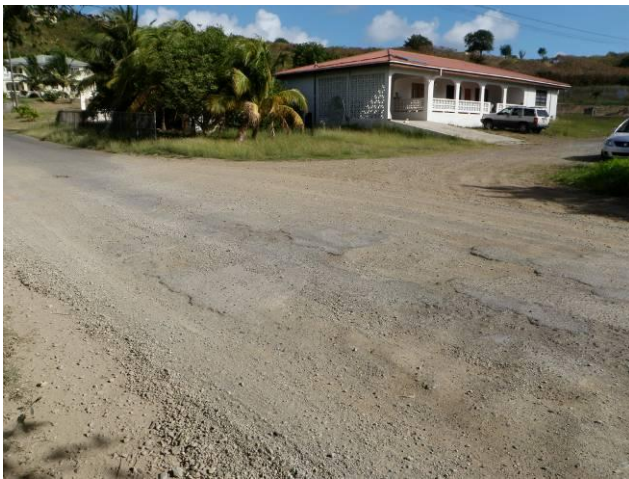
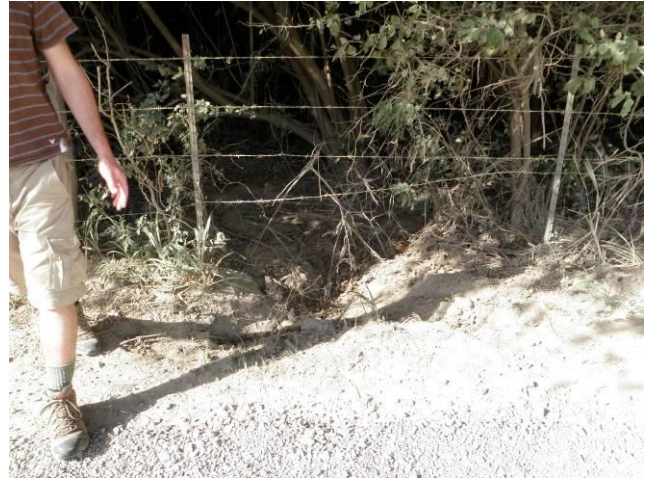
Figure 8.2. Unnamed, unpaved road (top photos) draining to South Shore Rd. deposits sediment across South Shore Rd. into vegetated area and is contributing to road surface degradation (bottom photos).

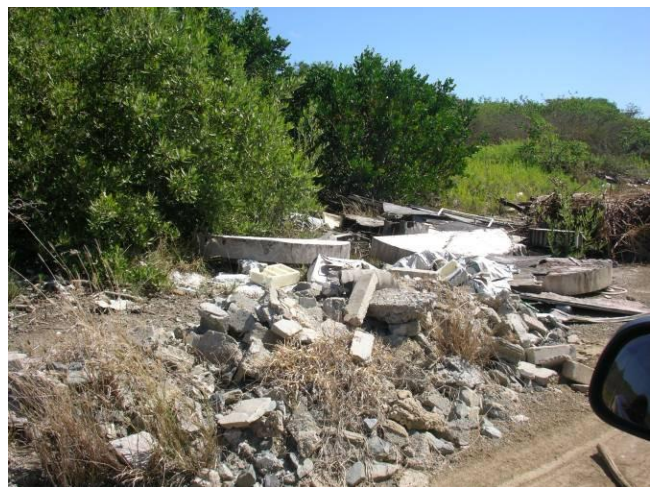
Figure 8.4. Dumping and debris at the Great Pond parking area

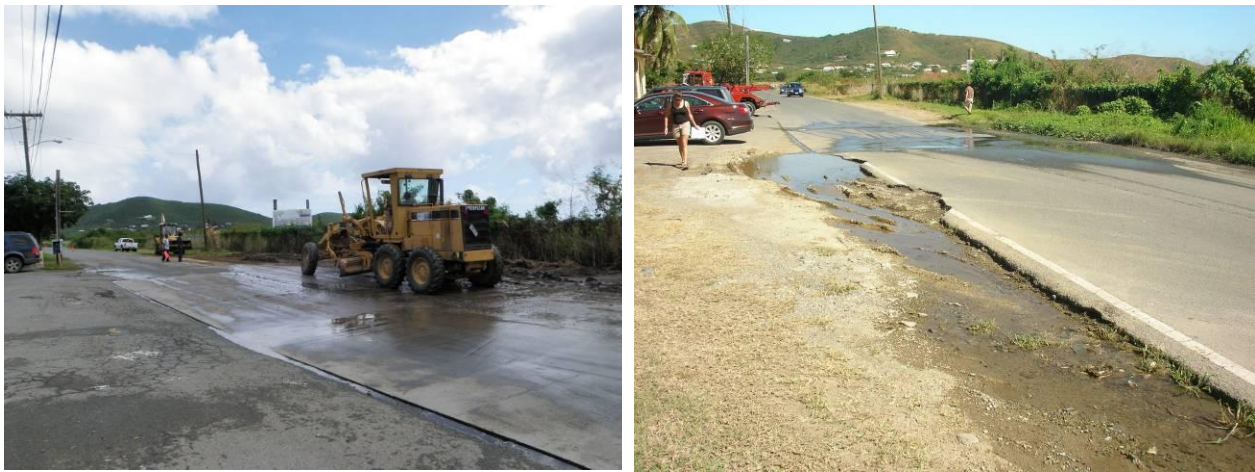
Figure 8.5. Road drainage issue in front of Milgie's Grocery.

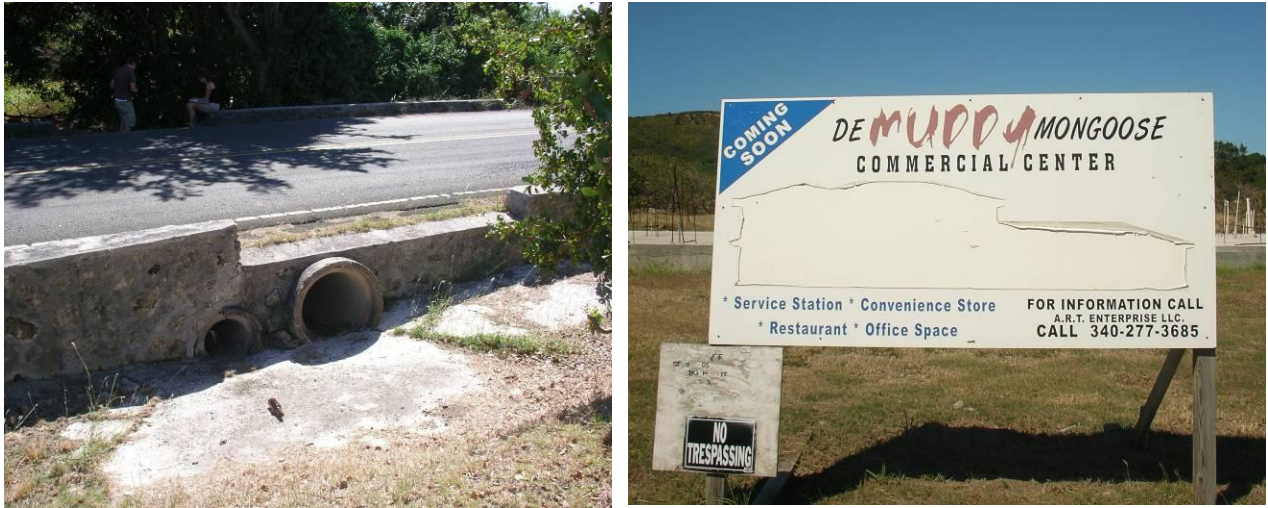
Figure 8.6. Culvert near Muddy Mongoose proposed development.

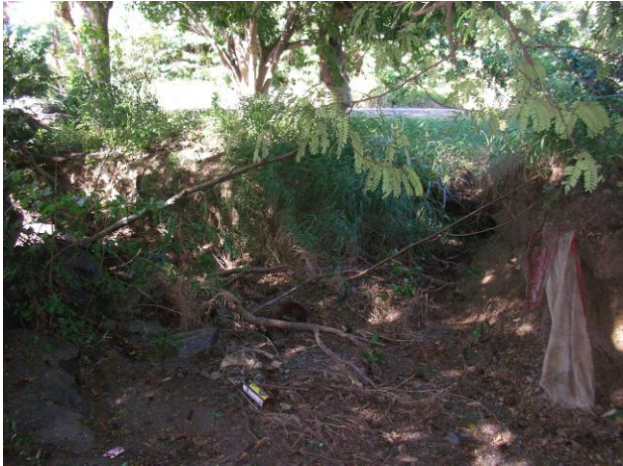
Figure 8.7. West gut erosion and trash.

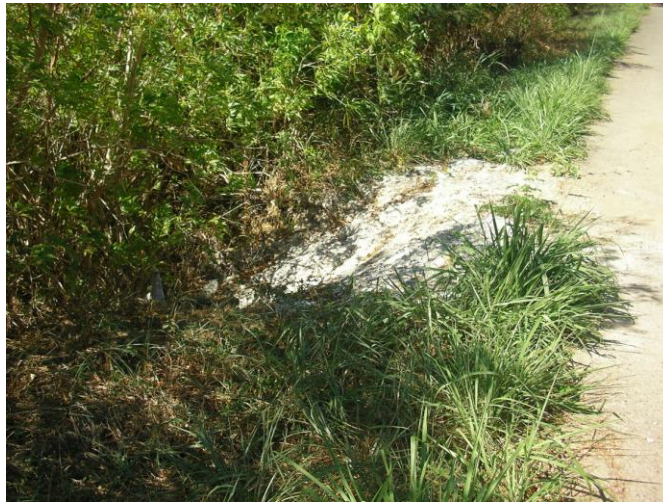
Figure 8.8. Attempt at concrete flume to manage runoff on East Maria Lane above culvert (GP-RC-4).

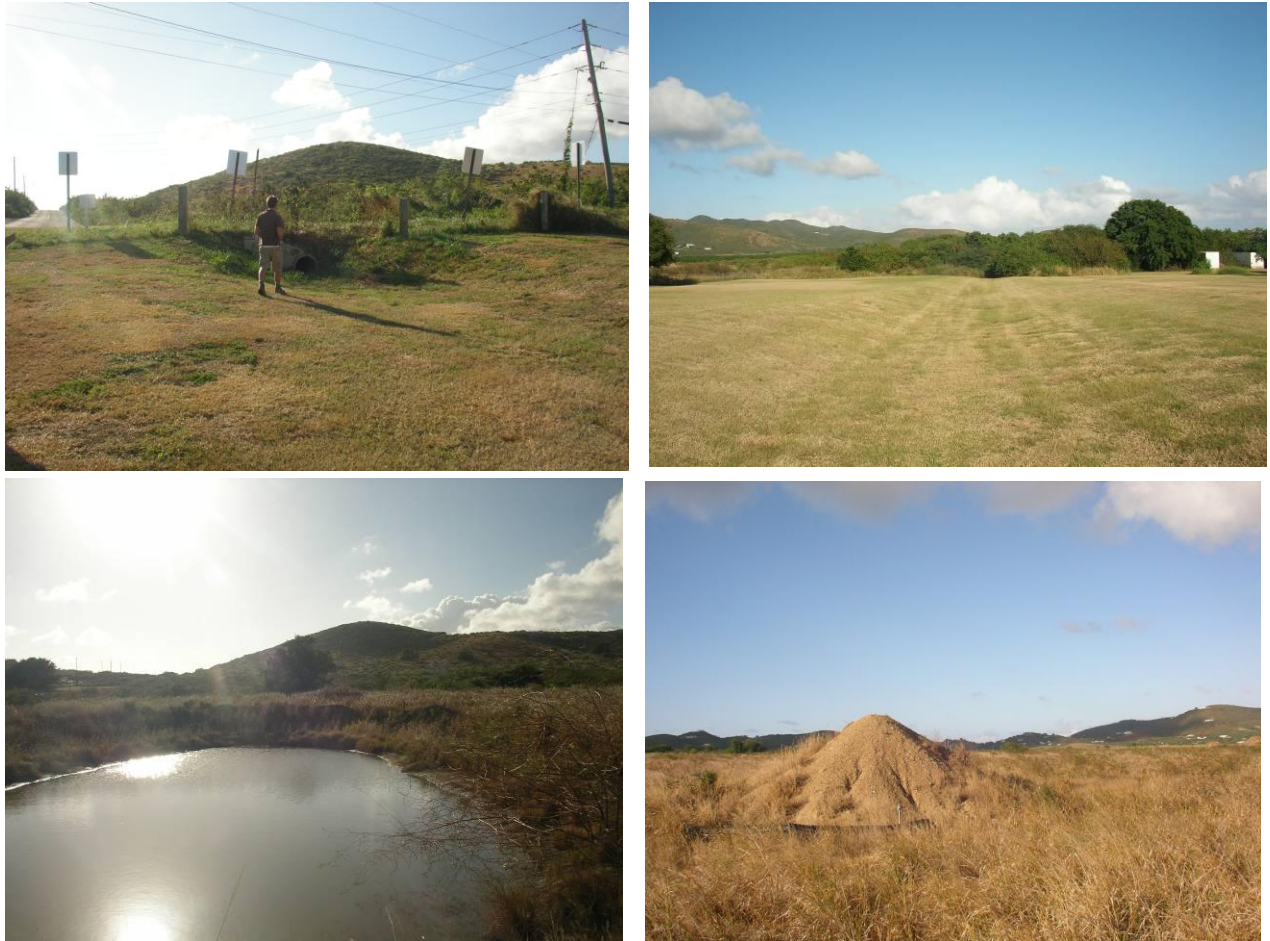
Figure 8.9. Clockwise from top left: Culvert leading from Southside Rd. to grass swale at Boy Scouts site; Grass swale leading from culvert outfall to Great Pond on Boy Scouts property; Detention pond adjacent to Great Pond near Boy Scouts property; Soil mounds from Wyndham excavation.

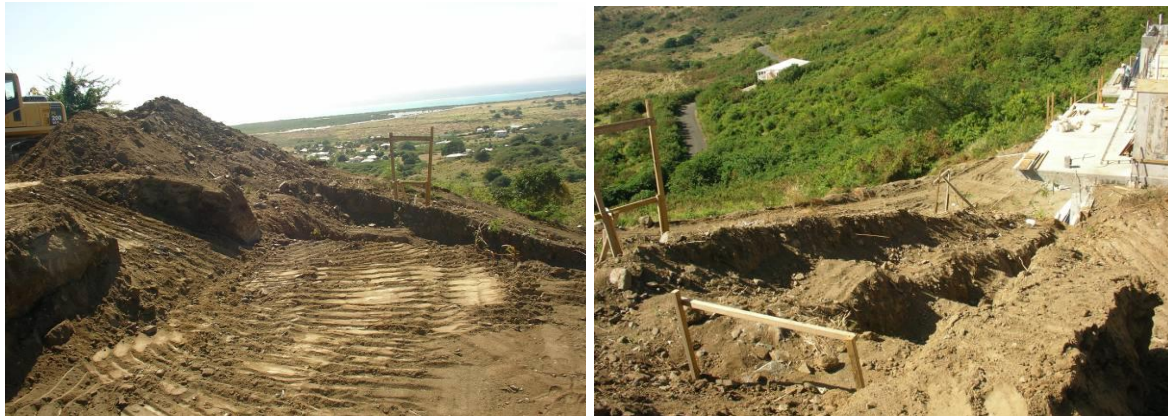
Figure 8.13. Slope clearing at residential construction site in Marienhoj.
