**PUERTO RICO ARTIFICIAL REEFS EVALUATION ON THE EAST COAST**

**SEPTEMBER 23, 2013**

**RE: PROGRESS REPORT #1 - PUERTO RICO ARTIFICIAL REEFS EVALUATION ON  
THE EAST COAST. CONTRACT # 2013-000096**

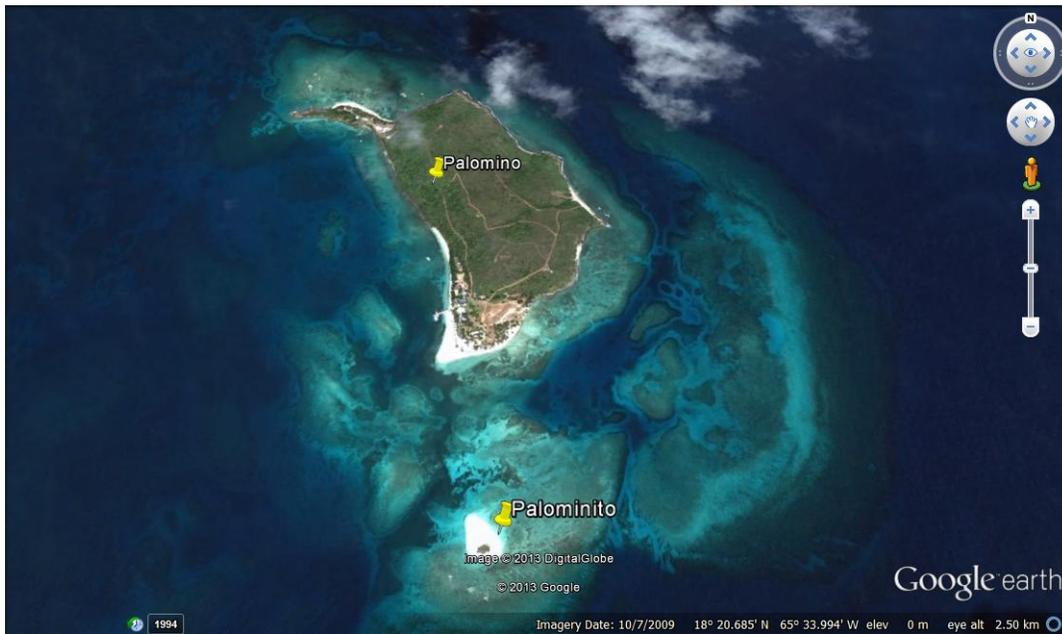
Aerial Photo #1  
Palomino & Palominito

Located 3.5 nautical miles east from the Fajardo marinas. Palomino is the tallest of the islands in the Fajardo nature reserve. Very easy to see from 20 miles away because of her size, height and greenness. West side offers lee protected bay, with ample space for swing while at anchor or mooring ball. The bay is semicircular with a length of 0.5 nautical miles, from Punta Aguila demarcating its north end, and small patches of coral on its south boundary. Consists mainly of uniform seabed of mostly sea grass with a depth ranging from 12 to 30 feet. Palomino's bay has approximately 25 mooring balls.

Small island approximately 400 X 250 feet, 0.25 nautical miles from Palomino with abundant white sand beaches. The small island's northwest shore is the most used because of its calm and crystal clear waters. A coral reef surrounds the southern half of this island. Very few trees remain standing, all located in a small area in the center of the isle.

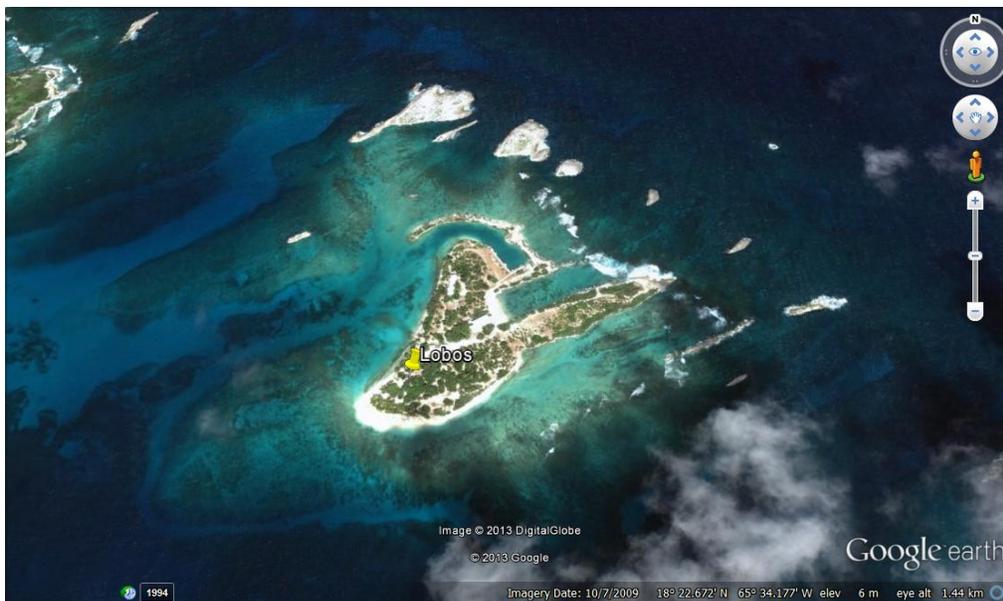
Aerial Photo #2  
Cayo Lobos

Located directly 1.5 nautical miles north from Palomino. This privately owned island offers protected waters on its western side. Because of private ownership, beach use is restricted. A manmade canal and small marina is found on the island's, north shore. A total of only 4 mooring balls were found, all being used by tourism vessels. The island's main attraction is the coral reef that borders the west shore and its schools of yellow tail snappers and blue tangs.

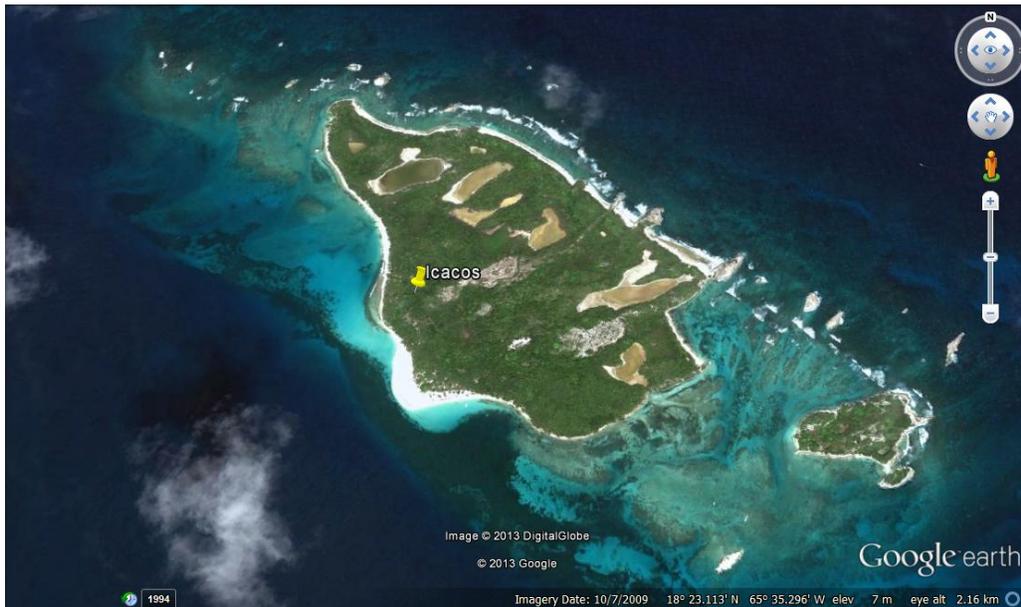
Aerial Photo #3

The largest in area of the four, 0.7 nm x 0.5nm. With approximately 0.7 nautical miles of sandy beach, has been the favorite for many families for a beach day. Boats concentrate in the south shore beaches. The island offers excellent anchor holding sandy bottom. Coral reefs are found in both ends of the island ( north & south ).

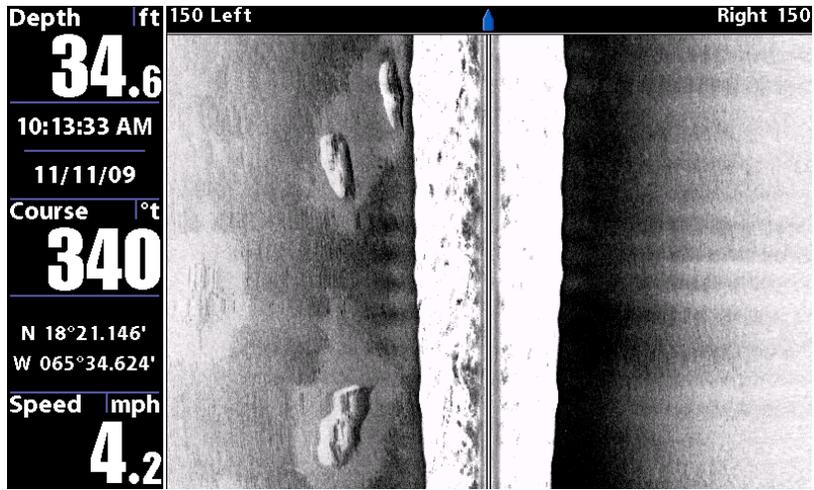
Among the found targets, three objects similar to boats ranging from 25 to 40 feet in length resting on a sea grass bed in a depth of 34 feet near Punta Aguila in Palomino Island. These targets are within 200 feet of each other. During the next phase a ROV will be used to investigate and video the associated marine life on these structures.

SD Card Image #2  
Sunken Sailboats
