Project Period	07/01/2012 - 07/30/2013
Award Amount	\$60,000.00
Matching Contributions	\$68,000.00
Project Location Description (from Proposal)	Makeahua Stream on the Pelekane Bay watershed. South Kohala district, Hawaii Island, State of Hawaii.

Project Summary (from Proposal) Reduce sediment inputs into Pelekane Bay coral reef system by reducing land-based run-off. Project will engage volunteers to capture overland flow of sediment with erosion-control structures, and will restore stream banks in key drainages.

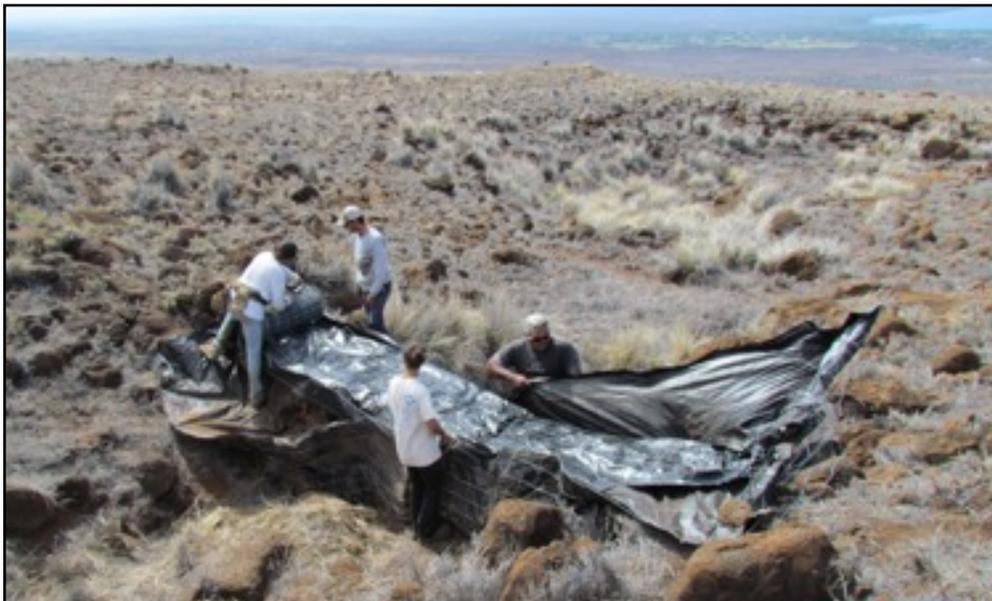
Sediment Dams - To address the amount of sediment that moves off the watershed during flash floods, we constructed or rebuilt 10 sediment check dams. The photo to the left shows the last step in the process. The crew is wrapping the rock wall with woven wire and ground cloth, which will act like a sieve when surface flow washes into this gully. Depending on the slope and area of the drainage basin, we construct one or more dams like this, adjusting the size of the dam to fit the amount of sediment it will need to hold.

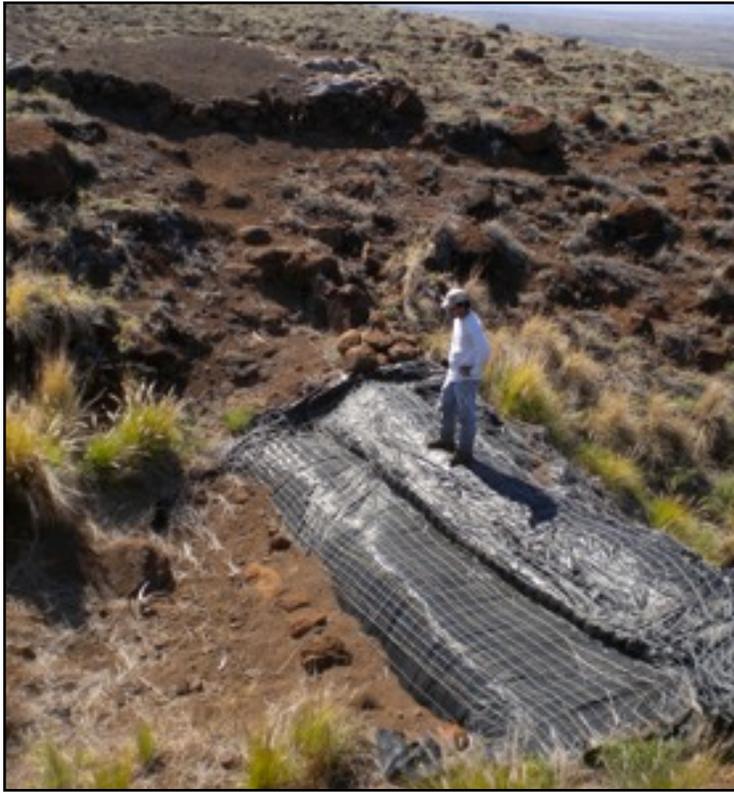
Because these dams fill with sediment after a rain storm, we need to either empty the dam of sediment and/or build the dam higher to collect more sediment. The photo to the left shows a dam location that has had both treatments over the past two years. At the top of the photo is the berm that was created to hold the “unloaded” sediment. The dam that the crew member is standing on has two layers visible. The top layer is made of rocks and sediment that are held in place by wire and cloth. The lower layer is an extension of the first dam built here. This “rebuild” has allowed the original dam to stay in place, keeps most of the collected sediment in place as well, and doubles the original volume of sediment that the dam can hold. Not only does this allow the physical capacity of the dam to increase, but keeping the sediment on site means that the top soil, leaf litter, and seeds that come with the sediment are also held in place, creating a biological barrier in addition to the physical barrier (see outcomes, below).

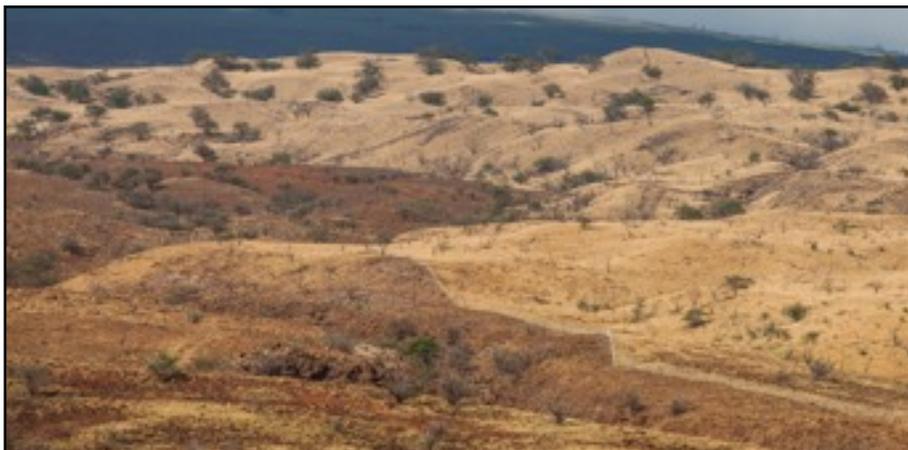
Increased Vegetation Cover - The impact of so greatly reducing the goat population can be seen in the photo to the left, which shows the lack of vegetation cover where there are still uncontrolled goat populations (left side of photo) and the fenced, managed Pelekane Bay watershed where goat populations have been severely reduced (right side of photo). Even in these extremely dry periods, the amount of vegetation is noticeably different. (Photo from July 2013).

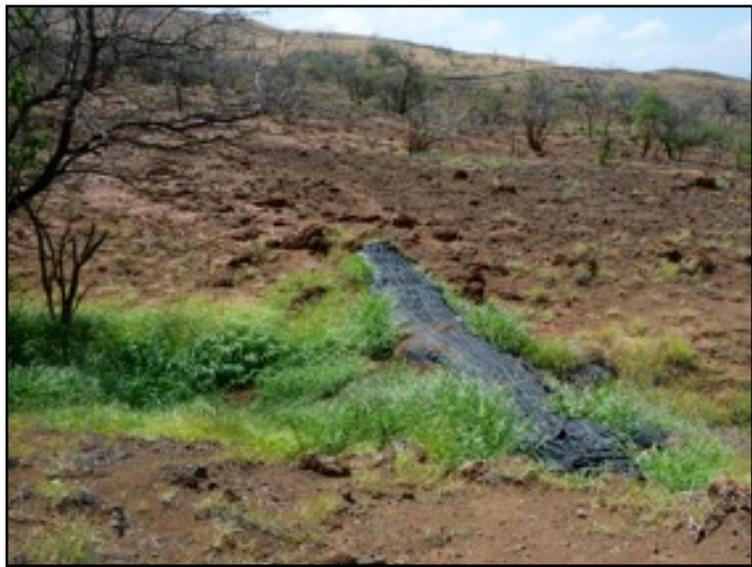
The dams themselves not only trapped sediment during the few small rain storms, but also topsoil, leaf litter, seeds, and composted cattle manure. This resulted in a vegetated gully behind every sediment dam that saw precipitation, as shown in the photo to the left. These green spots on the landscape showed the ability of the dams to trap and hold moisture along with sediment. The vegetation in the gully slows the flow of water, and helps it to soak into the soil, rather than run down the gully as a raging torrent. Although the surrounding land is still bare here, the sediment dam is reducing erosion.

The most important lesson learned is just HOW effective the sediment dams are! We knew that they could hold back tons of sediment from the watershed, but didn't expect that their effective could increase over time as they became vegetated. The bright green spots on the landscape are symbols to us of the ability of the land to heal itself, given the right conditions.

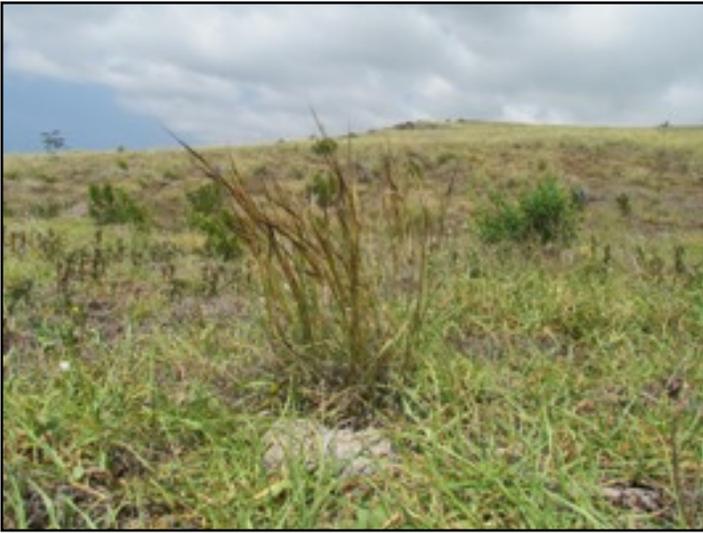
Native plantings - The 25,000 native plants that have survived through the first years of outplanting in the riparian restoration corridor are continuing to grow. In the picture to the left, the foreground has a native bunch grass called pili that is outcompeting the non-native grasses that surround it. In the background are native shrubs and trees. These planted and irrigated areas continue to amaze us, in the resilience of native Hawaiian plants, and their ability to use small amounts of rainfall. Many of the grasses and shrubs are blooming and seeding!
