# NOAA ARRA USVI Watershed Stabilization Project

## East End Bay, St. Croix Erosion Repairs, Trail Construction, and Drainage Improvements

March 31, 2012

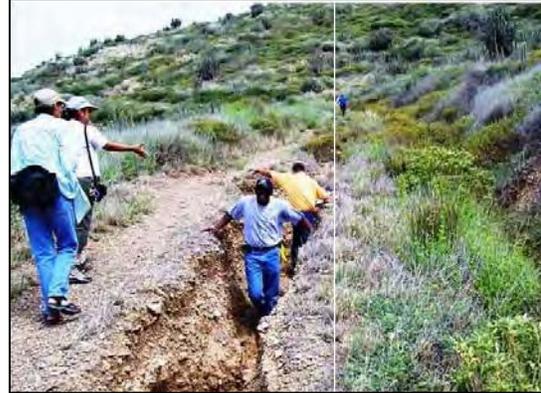
Photo 1: Severe gully erosion on the East Trail.

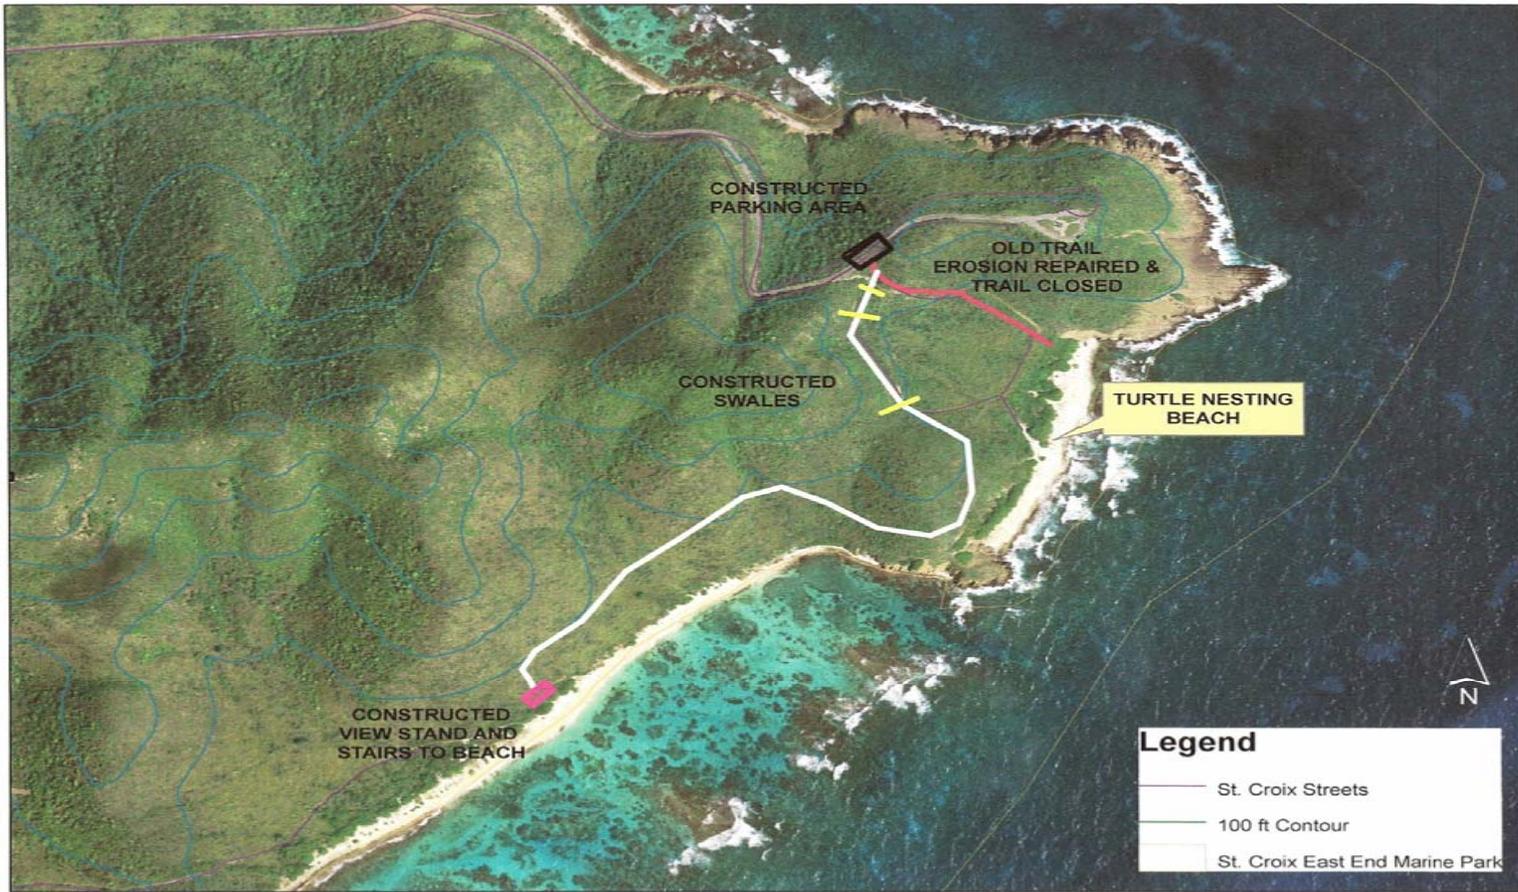
Figure 1 shows the implemented actions. The net effects are:

Figure 1: East End Bay Erosion Repairs and Trail Construction Actions

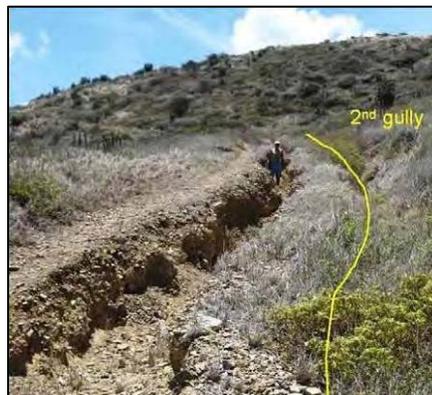
East End Bay beach was accessible by four-wheel drive vehicles in the past, but is now accessible only on foot because of the severe erosion along the access path (Photo 2). The beach itself is not a popular recreational area due to stoniness and heavy surf, but pedestrians frequently cross it to access the popular Isaac Bay beach.

Photo 2: Severe gully erosion on the East Trail.

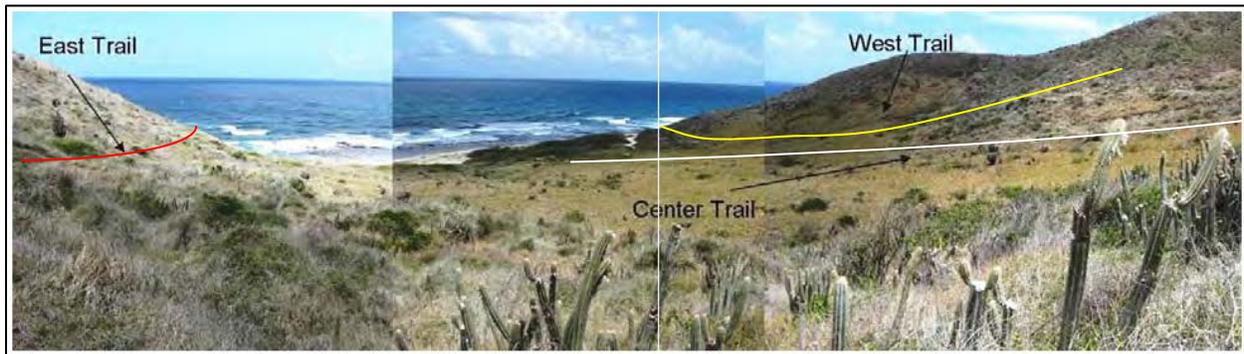
Photo 3: Composite photo of East End Bay Watershed trails.

A severe gully in the East Trail begins where the trail crosses North Ghut. The trail effectively intercepts North Ghut at this point, channeling ghut flow down the trail bed instead of allowing the ghut to cross the trail and dissipate in the flat area at the base of the watershed. The combination of intercepted ghut flow and accelerated stormwater flowing down the steep, upper portion of the trail has severely eroded the deeper soils in this area. This gully is over 100 feet long and has widened to approximately 3 feet in one location and deepened to almost five feet deep at its deepest point (Photo 1). Additionally, a newer gully has formed to the east of the original gully, in some areas threatening wholesale destruction of the entire trail section (Photo 2). These gullies have effectively rendered the trail impassable to all vehicles and will soon expand to cut off the trail. Eroded soil from these gullies and trails has been deposited several feet deep behind the beach at the base of each trail, partially burying vegetation. In addition, the sediment is being discharged into nearshore coastal habitats and threatening coral reef ecosystems.

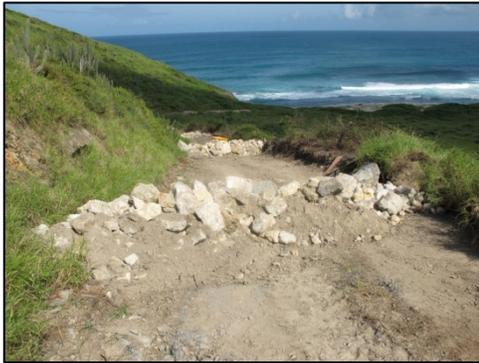
Photo 4: Construction of drainage structures along the East Trail.

A bleeder trench or drainage dip is a broad, gradual excavated trail feature designed to redirect water off the trail and prevent erosion. For EEB, the contractor constructed bleeder trenches, approximately two feet in width, along the East Trail at 100-foot intervals to route runoff intercepted by the trail back downslope. Bleeders were excavated by hand to the maximum

extent practicable, supplemented by use of the smallest backhoe-equipped or skid-steer loader possible. Bleeder depth was only a few inches at the inside edge of the trail and proceeded diagonally across the trail with a base slope of 5 to 10%. The bleeder extended out through the existing earth berm, emerging through the outside of the downhill edge berm (Photos 4-5).

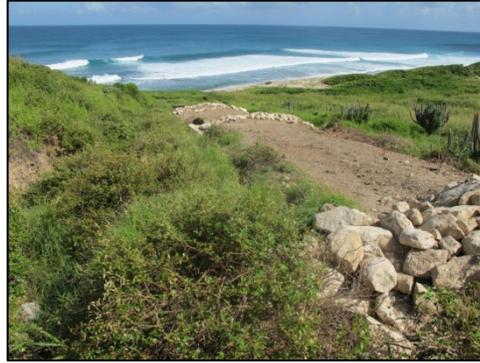
Photo 5: Completed drainage structures along the East Trail.

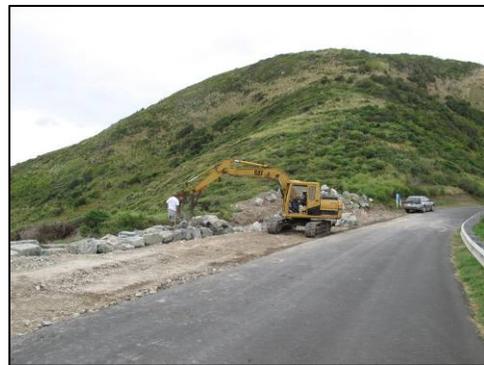
Photo 6: Overall layout of the Parking Area.

An approximately 30 foot deep by 70 foot long parking area for a total of 2100 ft<sup>2</sup> was constructed adjacent to the East End Road (Photo 6) in the same roadside area which was used for unauthorized and haphazard “pull-off” parking. The parking area was cleared and grubbed, excavated with minimum cut and fill, graded, and compacted, and covered with 6” gravel (Photos 7-8).

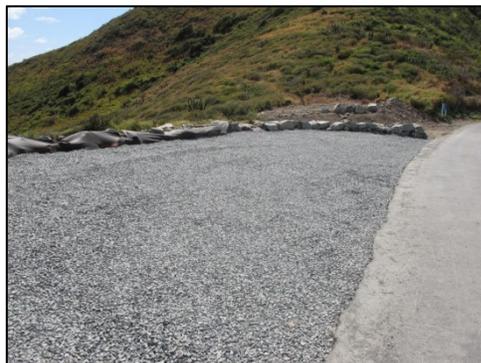
Photo 7: Completed Parking Area.

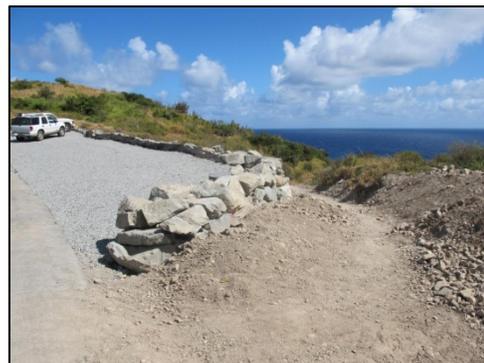
Photo 8: Completed Parking Area with trail entrance.

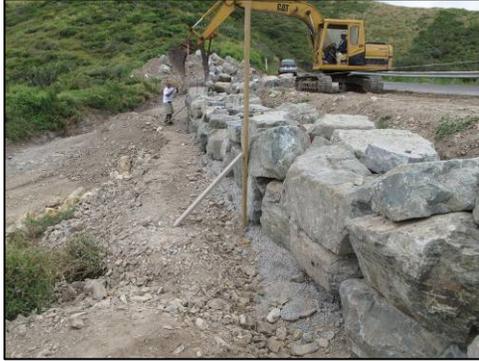
Photo 9: Construction of the Parking Area retaining wall.

The downslope perimeter of the parking area was stabilized, defined, and built up with an approximately 175-foot long by 5-foot high boulder retaining wall (Photos 9-10).

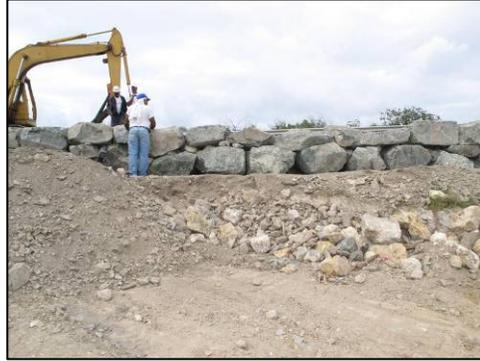
Photo 10: Construction of the Parking Area retaining wall.

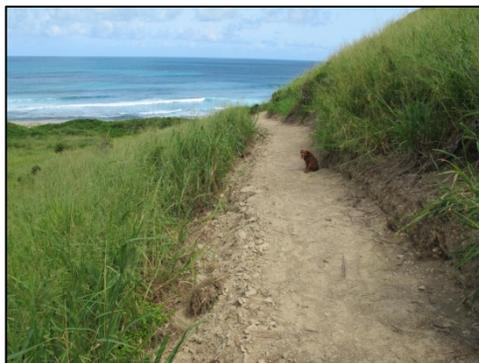
Photo 11: Newly constructed trail.

The opening and stabilization of the West Trail and construction of the Isaac Bay Spur Trail followed U.S. Department of Agriculture Forest Service Trail Management Handbook (2008) guidelines. The West Trail was cleared and grubbed by hand (Photo 11) along the contour, removing primarily the invasive exotic guinea grass and acacia that have colonized the trail cut. The reopened section of the West Trail was stabilized using bleeders/drainage dips, waterbars, cross-ditches, and other trail stabilization measures (Photo 12). Where necessary, the trail path was routed around any endangered plant species to avoid damage.

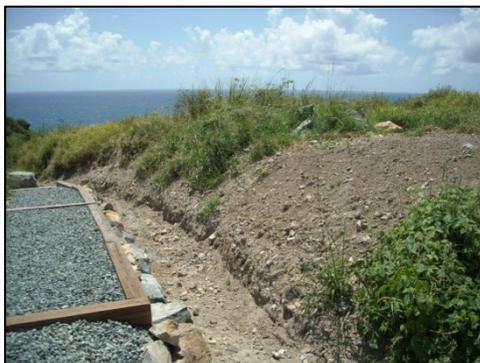
Photo 12: New trail stabilization measures.

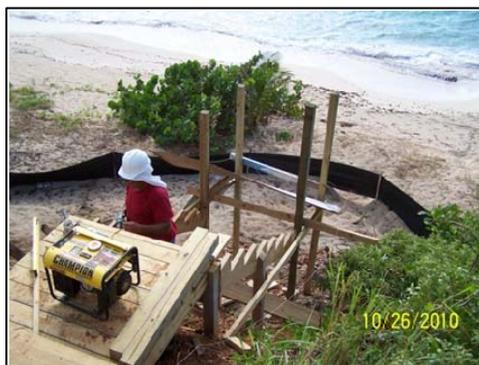
Photo 13: Construction of the lower stair stringers and landing to Isaac Bay beach.

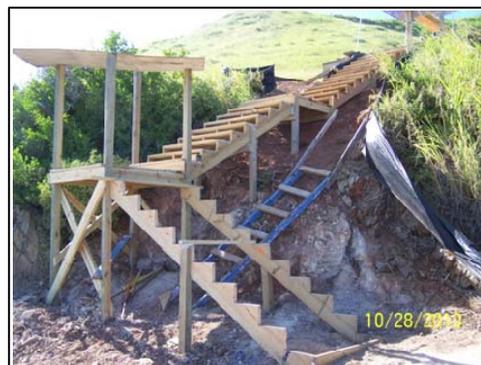
Photo 14: Construction of the stair stringers, landings, and treads to Isaac Bay beach.

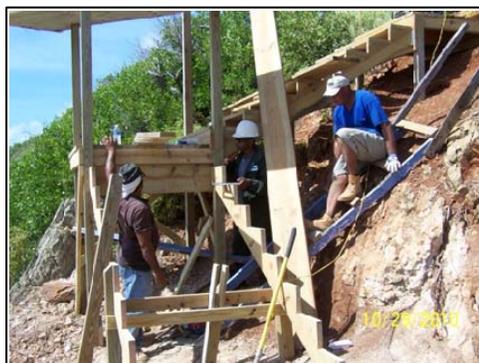
Photo 15: Construction of the stair stringers and landings to Isaac Bay beach.

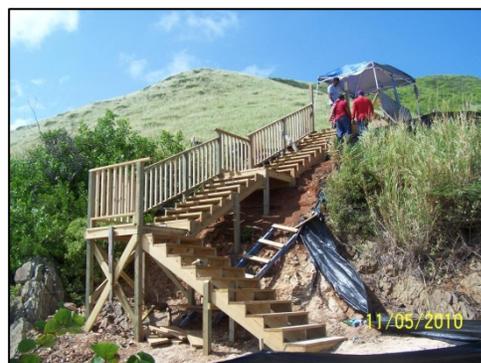
Photo 16: Construction of the stairs, including handrails, to Isaac Bay beach.

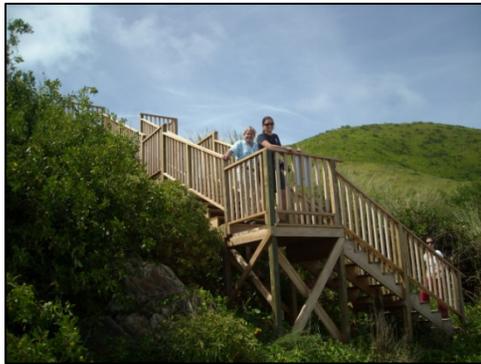
Photo 17: Completed stairs to Isaac Bay beach.

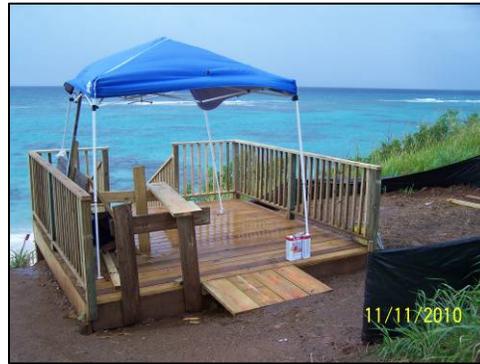
Photo 18: Construction of the Isaac Bay viewing platform (shelter is temporary).

A 12-foot-by-12-foot wooden viewing platform was constructed at approximately the top of the stairs (Photo 18).

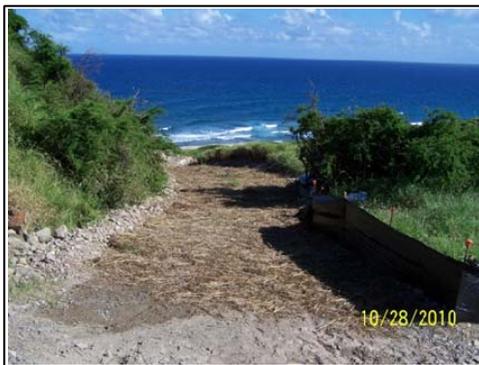
Photo 19: Mulch and seeding of the East Trail.

Stabilization and closure of the East Trail reduced traffic through this area allowing the trail to re-vegetate and lessen the sediment off loading from this trail (Photos 19-21). Construction of the parking lot, clearing trails, and installing drainage structures for the West Trail and Isaac Spur Trail, and constructing steps and a viewing platform ensures that recreationists can enjoy the East End without damaging the environment and contributing more sediment to marine waters. For a total project cost of \$224,076 V.I. RC&D was able to reduce trail erosion; thus reducing sediment eventually discharged into East End and Isaac Bays.

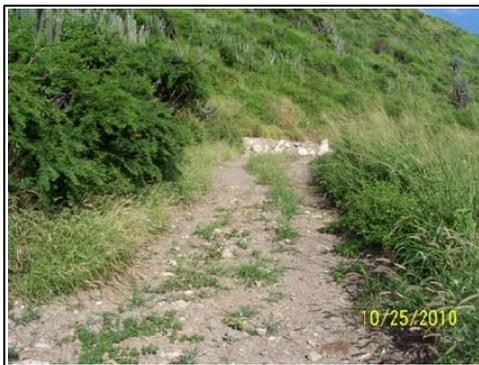
Photo 20: Natural revegetation of the East Trail.

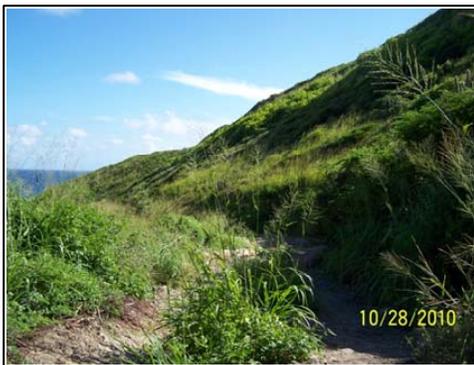
Photo 21: Natural revegetation of the East Trail.

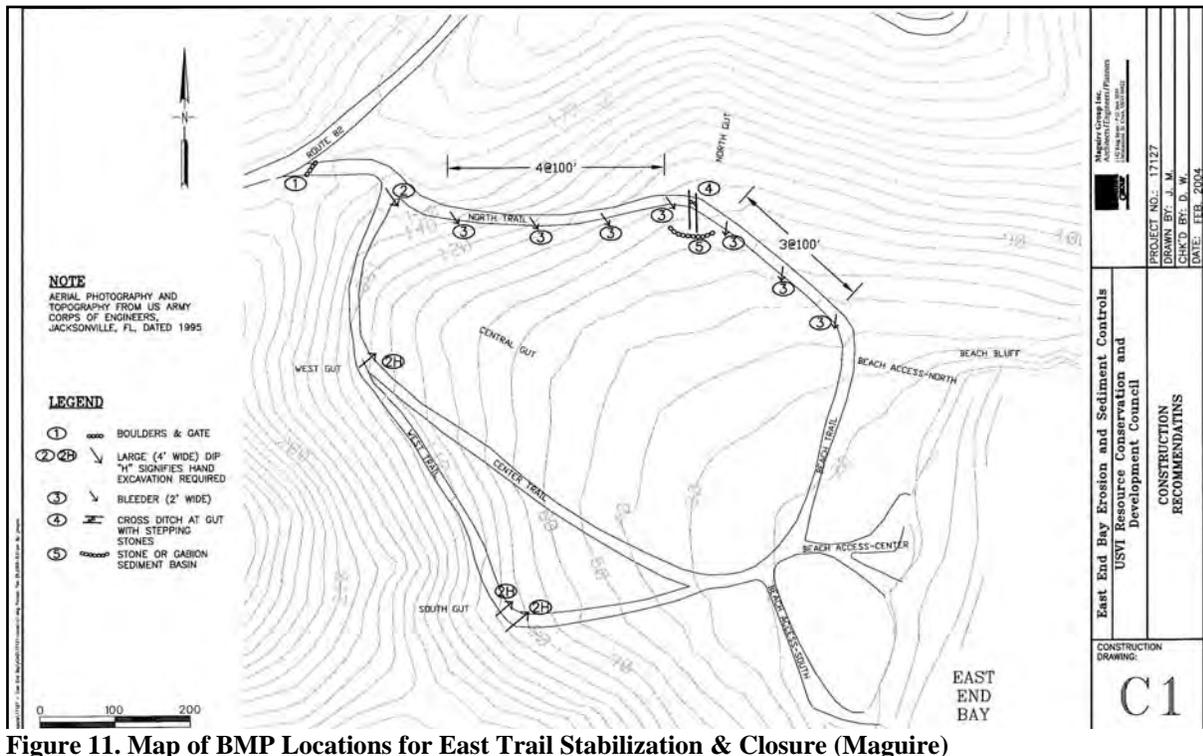
Figure 11. Map of BMP Locations for East Trail Stabilization & Closure (Maguire)

The following specific BMP implementation regime (BMP locations are indicated on Figure 11) was recommended by Maguire (2005) to stabilize and close the East Trail:

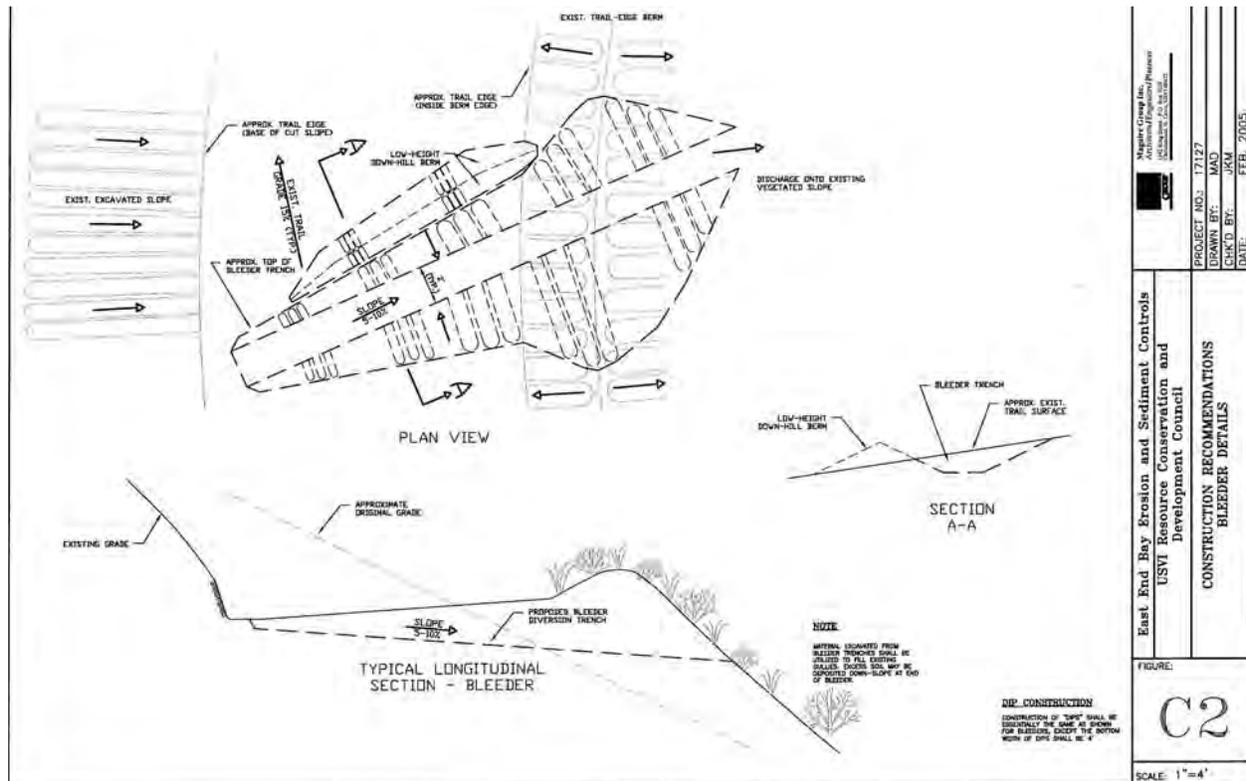
Figure 12. Design Detail for Bleeder BMP (Maguire)

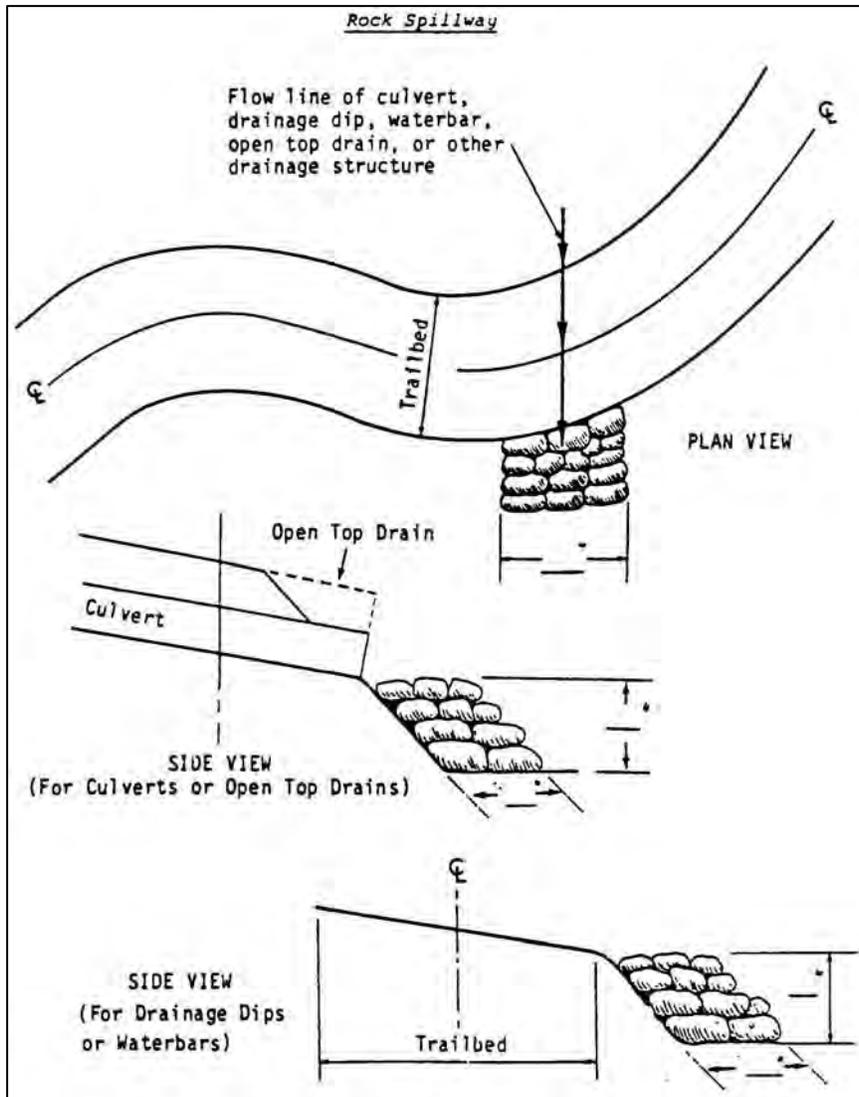
Figure 13. Rock spillway design & installation details (USDA-FS, 2008).

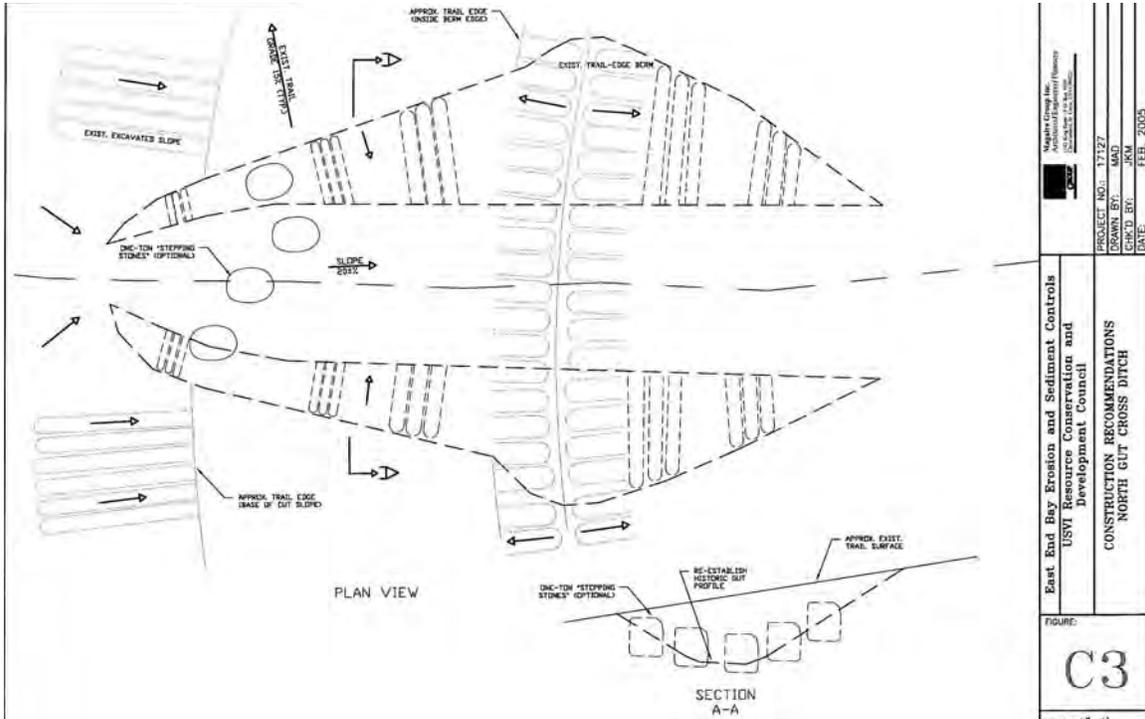
Figure 14. Design Detail for Cross Ditch BMP (Maguire).

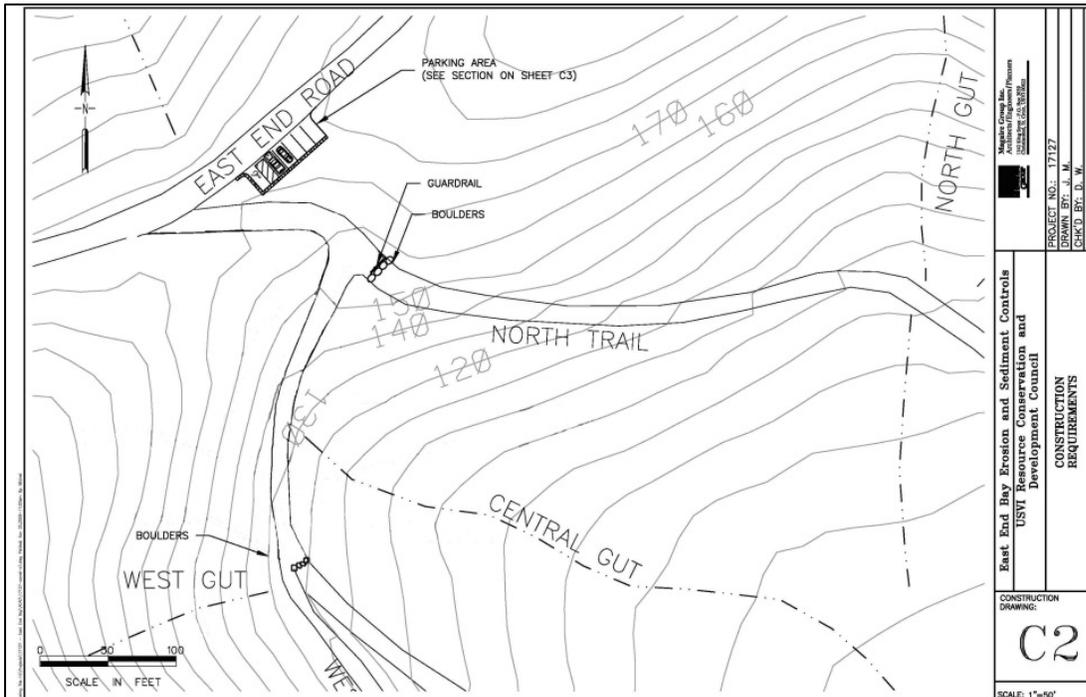
Figure 15. Map showing location of new stabilized & confined parking area for East End Bay Trail users (Maguire).

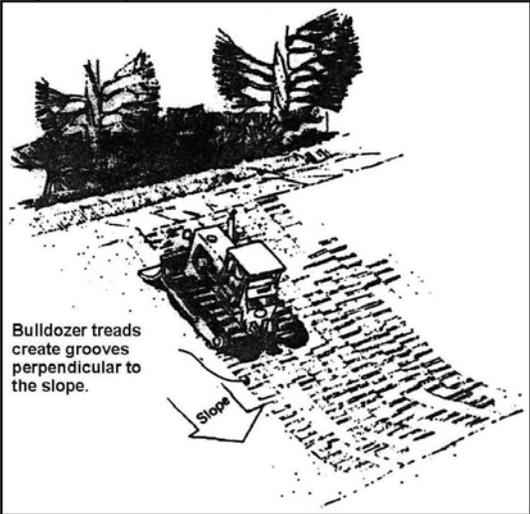
<p>Bulldozer treads create grooves perpendicular to the slope.</p> <p>Figure B.8. Bulldozer treads create grooves perpendicular to the slope.</p>

**Figure 16. Clearing, grubbing and grading construction specifications (V.I. Environmental Protection Handbook, 2002).**

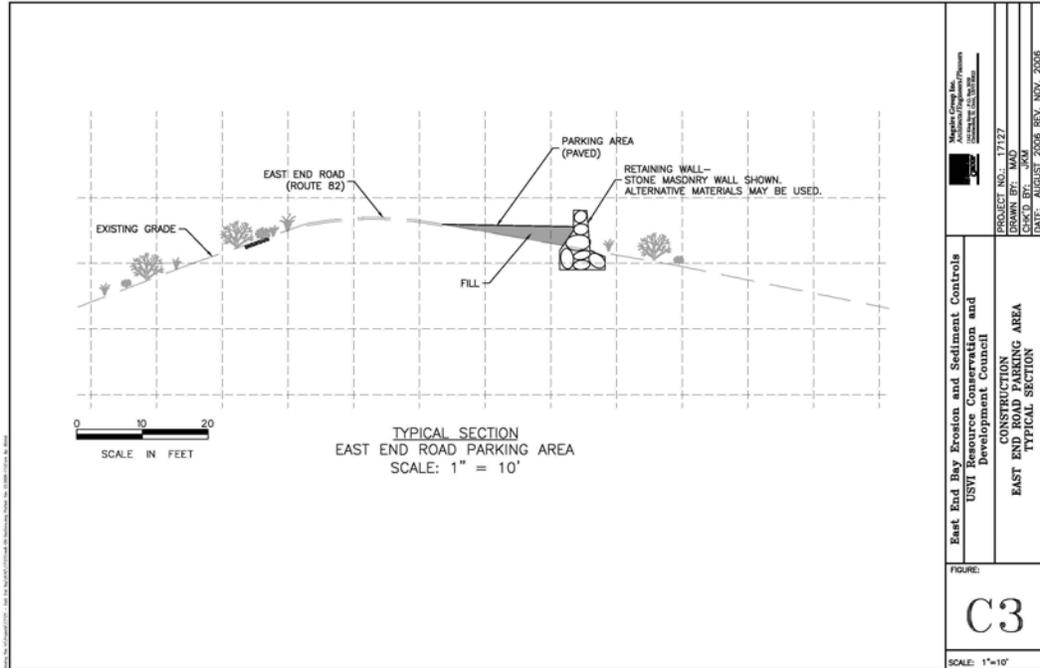
Figure 17. Design detail for parking area retaining wall BMP (Maguire).

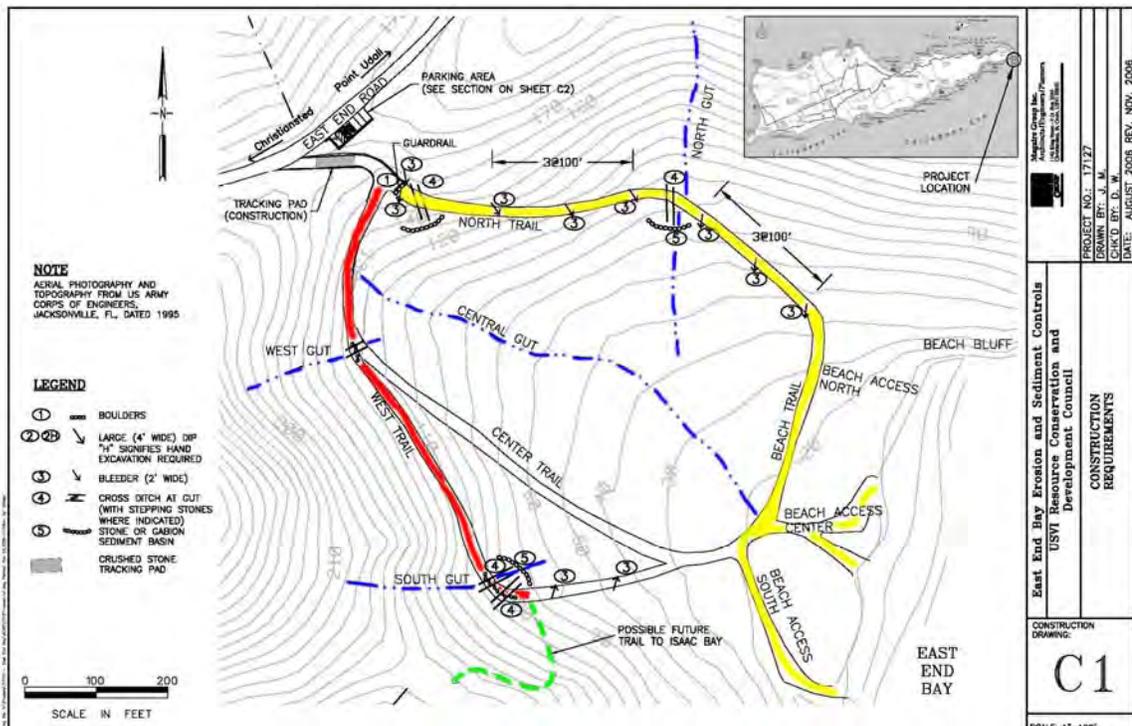
Figure 18. Topographic map of existing trails (East – Yellow, West – Red), guts, proposed Isaac's Bay Spur (Green dashed), and BMP locations.

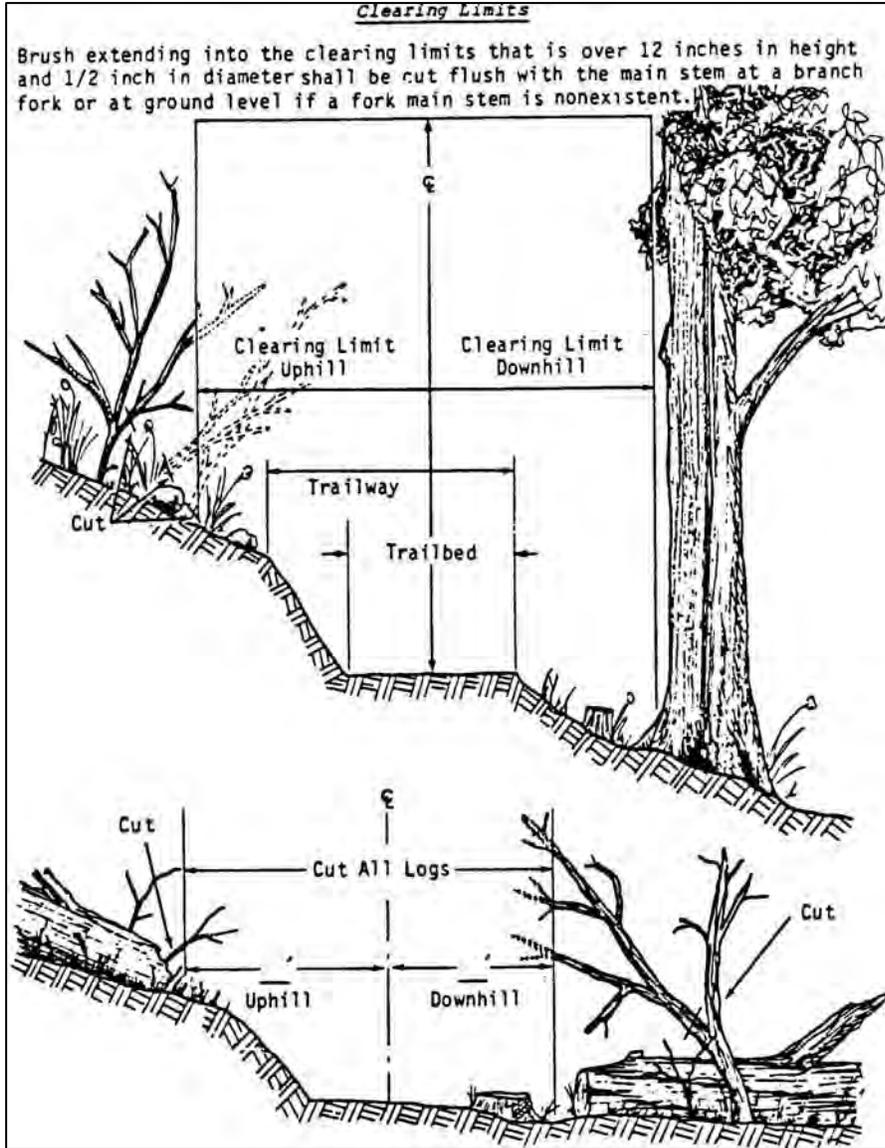
Figure 19. Trail clearing & grubbing BMP details (USDA-FS, 2008).

FS, 2008). The West Trail will be cleared and grubbed by hand along the contour, removing primarily the invasive exotic species guinea grass and acacia that have colonized the trail cut (see Trail Clearing & Grubbing Detail, Figure 19, and Trailway Cross Section / Trailbed Slope Finish Details, Figure 20). The re-opened section of the West Trail will be stabilized using bleeders (Figure 13), drainage dips (Figure 21), water bars (Figure 22), and cross ditches (Figure 14). Where necessary, the trail path will be routed around any endangered plant species to avoid damage.

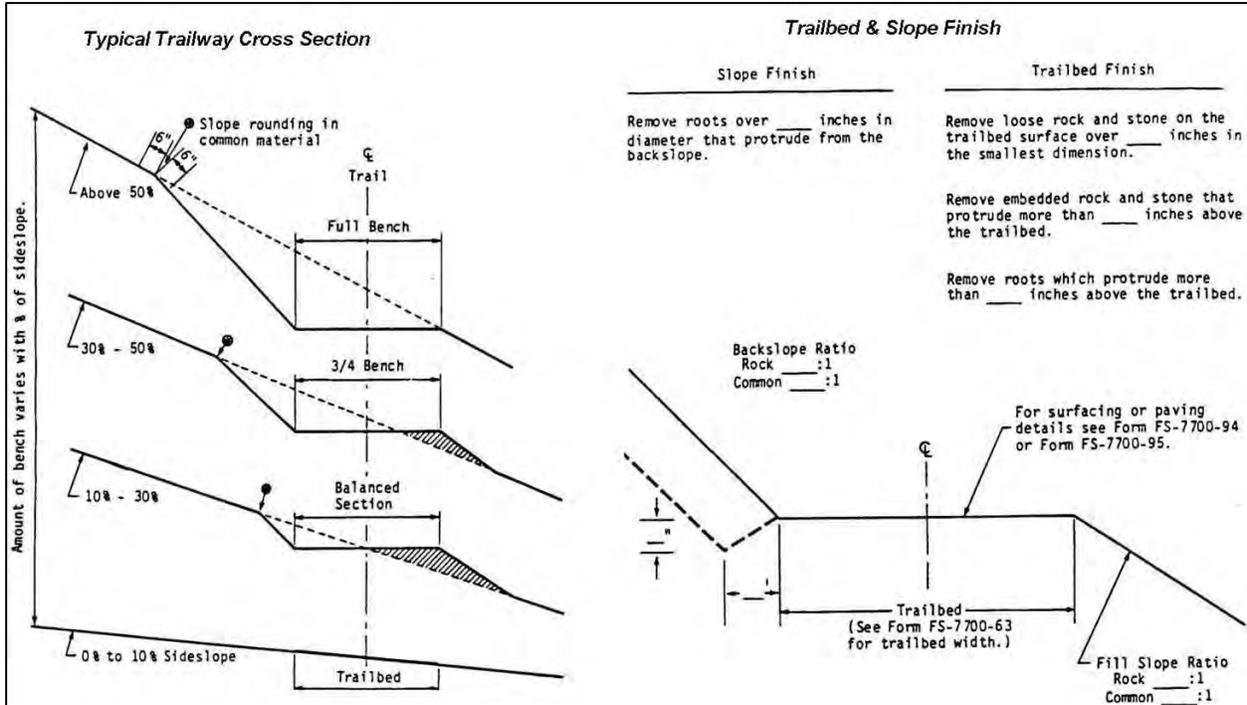
Figure 20. Trailway cross section and trailbed & slope finish design & installation details (USDA-FS, 2008).

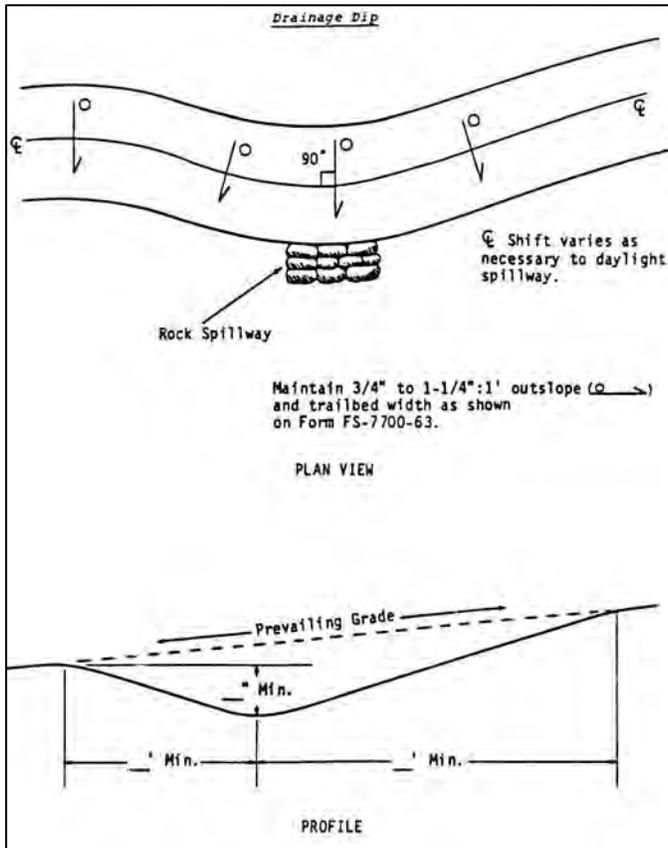
Figure 21. Drainage dip design & installation details (USDA-FS, 2008).

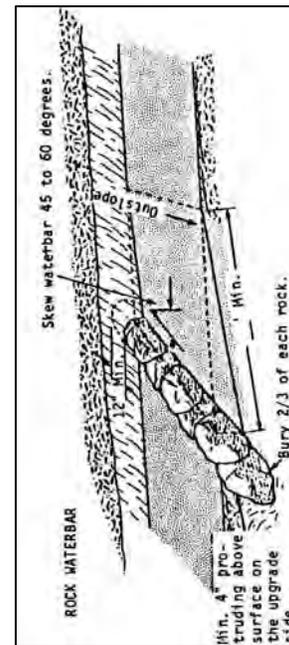
Figure 22. Water bar design & installation details (USDA-FS, 2008).

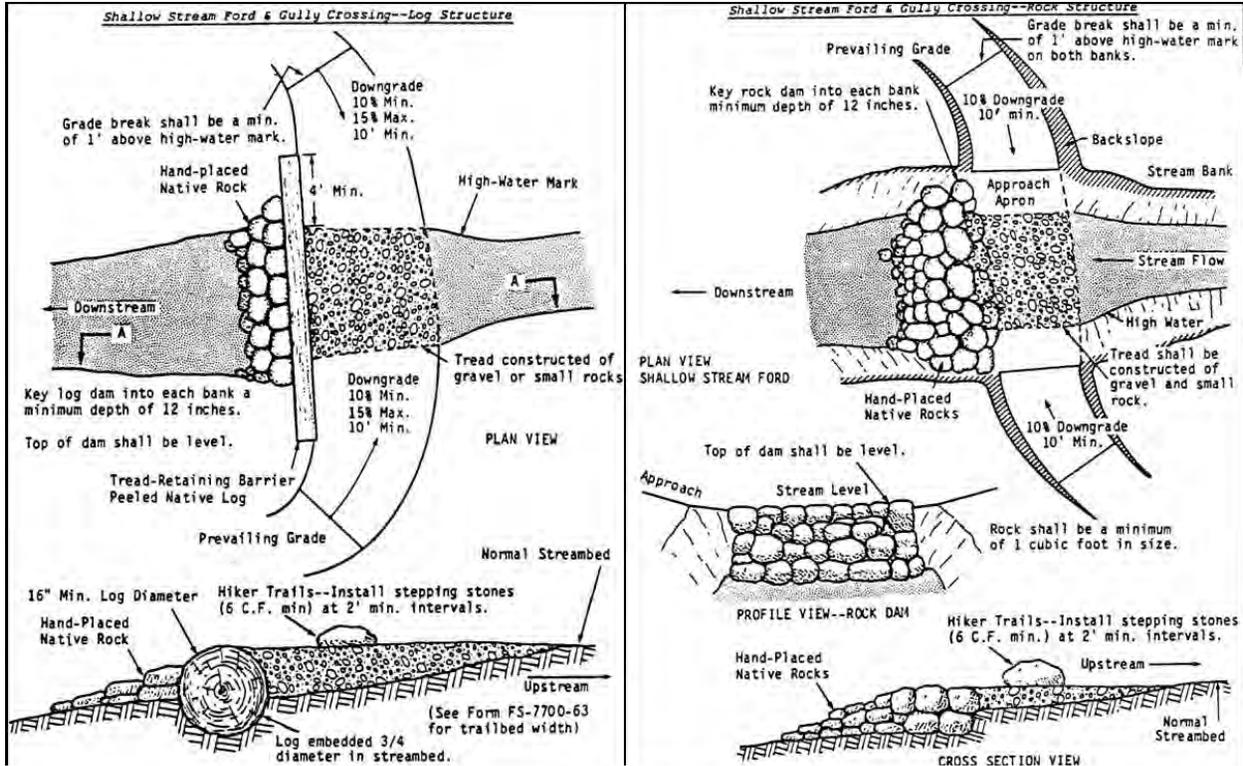
Figure 23. Stream Ford / Gully Crossing design & installation details – log & rock (USDA-FS, 2008).

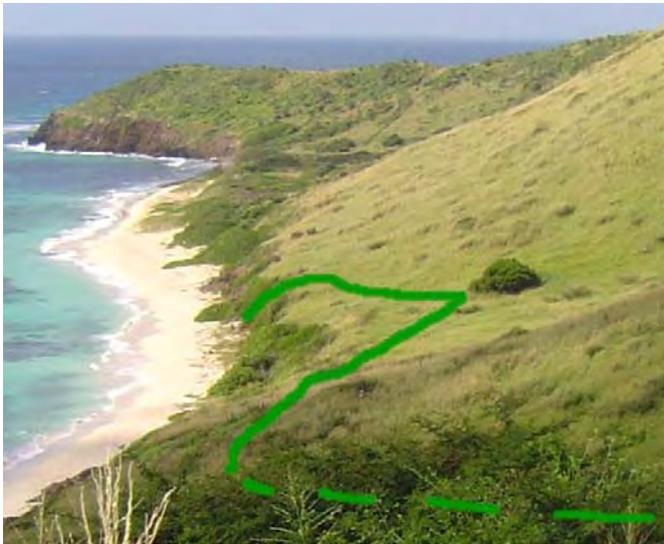
Figure 24. Isaacs Bay beach and end of spur trail (green line) in steps to the beach.
