Guánica Bay Watershed Management Plan

A Pilot Project for Watershed Planning in Puerto Rico

10/12/08

Center for Watershed Protection
8390 Main St, 2nd Floor
Ellicott City, MD 21043 USA

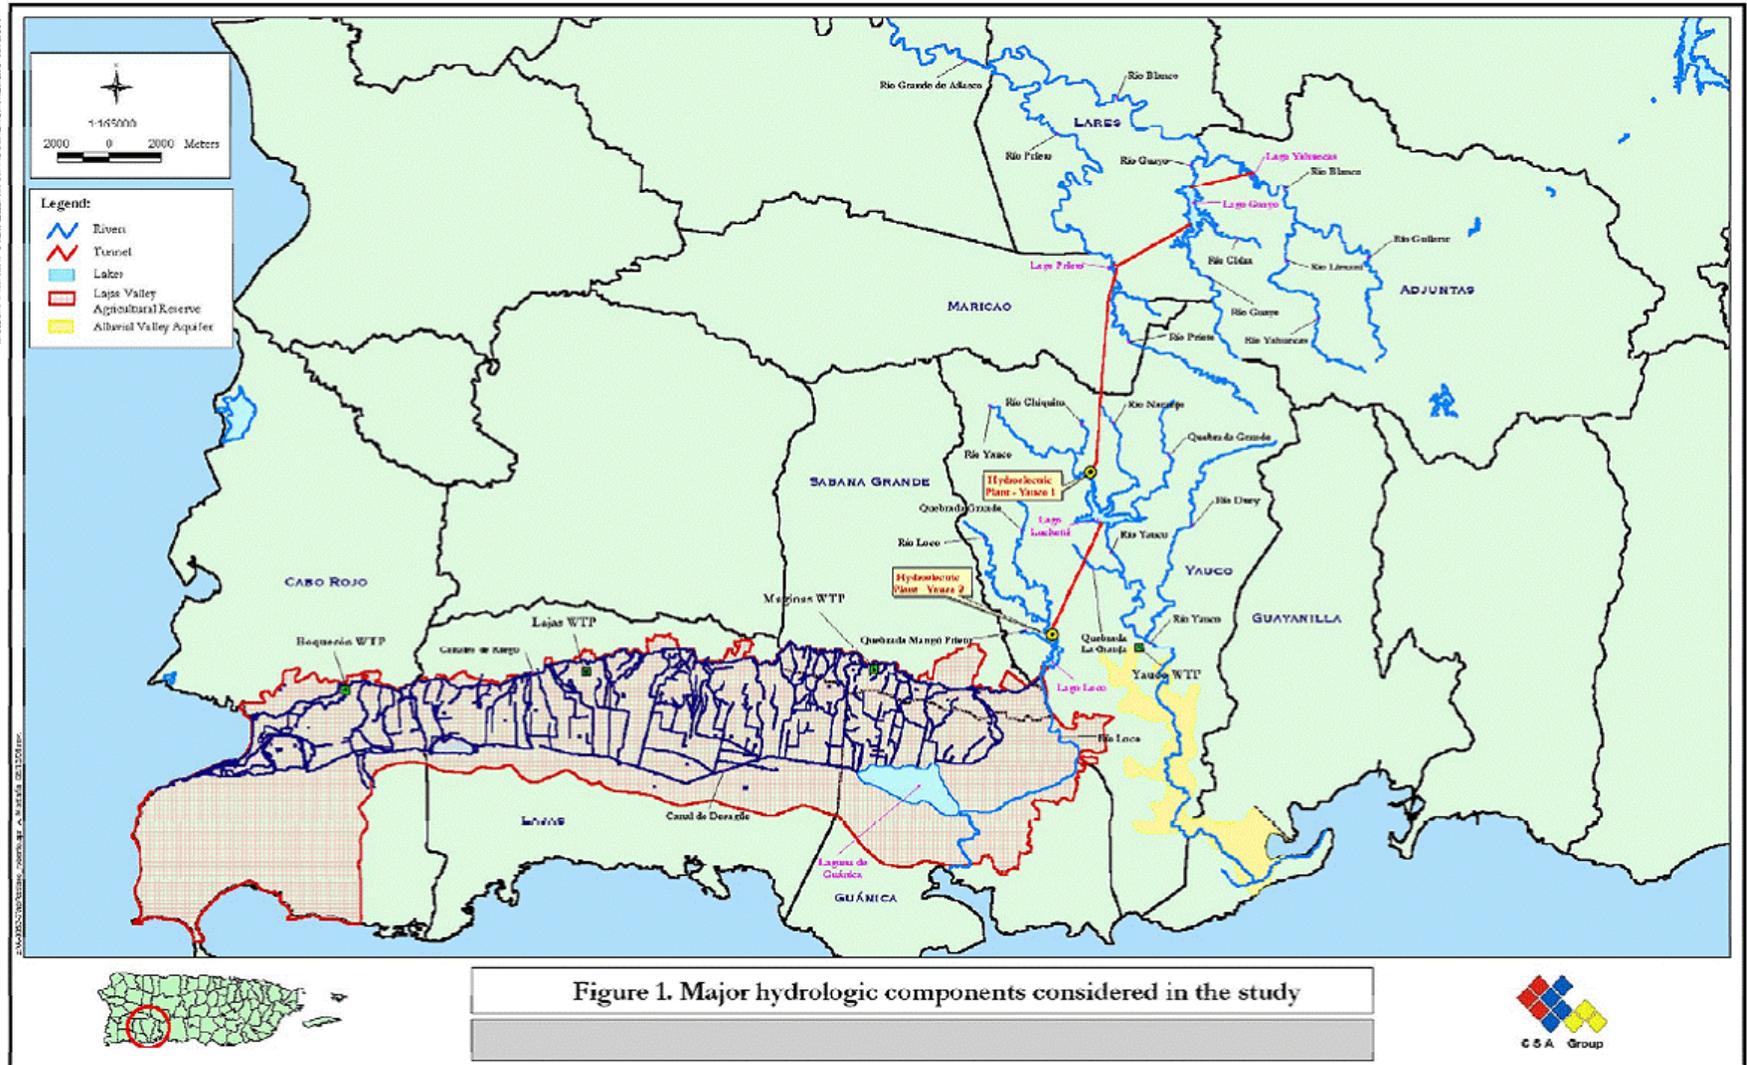
Figure 1. Major hydrologic components considered in the study

Figure 1: Shows the Guánica Bay watershed, which is drained to the north by the drainage basins of Lakes Yabuecas, Guayo, Prieto, Lucchetti, and Loco as a result of the Southwest Puerto Rico Project. To the south, the study area includes the drainage areas of Río Loco. Finally, the study area includes roughly half of the Lajas Valley, including historic Laguna de Guánica (Guánica Lagoon) and the Lajas Irrigation Canal within the Valle de Lajas (Lajas Valley) Agricultural Reserve. (Map from Ortiz-Zayas & Terrasa-Soler. 2001)

The Guánica Bay watershed is a highly manipulated watershed. It has been artificially increased in drainage area by a series of interbasin or inter-watershed water transfers, five reservoirs and two hydroelectric plants (Yauco 1 and 2) known as the Southwest Water Project (Figure 1). This project, operated by Puerto Rico Electric Power Authority (PREPA), was completed in order to increase and regulate potable water from the high elevation watersheds of the central cordillera (mountain region) for use by the local populations in Yauco, Guánica and the Lajas Valley for irrigation of crops and flood control. So while Guánica Bay receives water directly only by the Rio Loco ("Crazy River"), the actual total drainage area encompasses much more than just the Loco watershed. This includes the five smaller basins and associated reservoirs: Lago Yahuecas, Lago Guayo, Lago Prieto, Lago Lucchetti, and Lago Loco. Guánica Bay is essentially drained by both the Rio Loco which receives flow from the four reservoirs north and upstream of it as well as by historic Guánica lagoon, all of which we refer to here as the Guánica Bay/ Rio Loco (GB/RL) watershed. (Ortiz-Zayas & Terrasa-Soler, 2001).

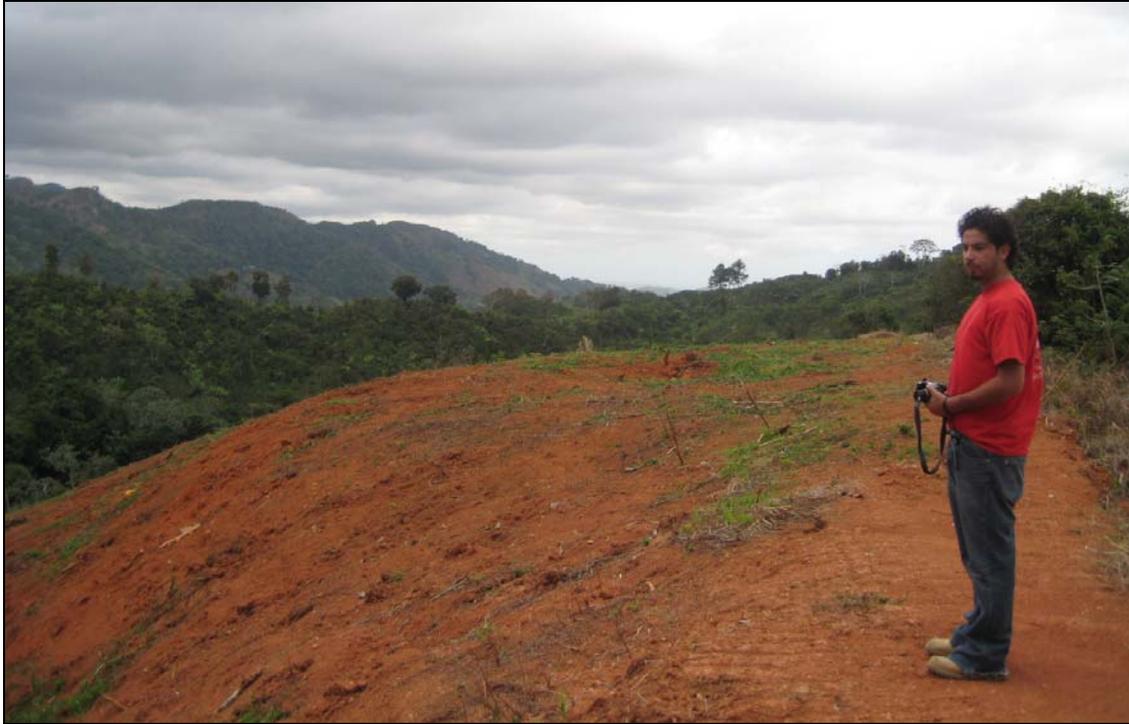
Figure 2. Typical clearing associated with sun grown coffee plantations

Field investigations in the high elevation agricultural areas near reservoir (“Lago”) Lucchetti and the Rio Loco watersheds revealed clearing for coffee and other agricultural crops, including bananas, with very little evidence of conservation practices. Mass clearing, poor soils (Humatas Clay) and runoff associated with roads has resulted in numerous areas with completely exposed soils with very limited natural re-vegetation due to the high clay content and low fertility of the soils. Promotion of sun grown coffee over historically grown shade grown coffee at the very least accelerates sediment transport during the crop establishment phase. There is an estimated 3.5 times more erosion associated with sun grown coffee than shade grown coffee over the first several years after establishment (Hartemink, 2006).

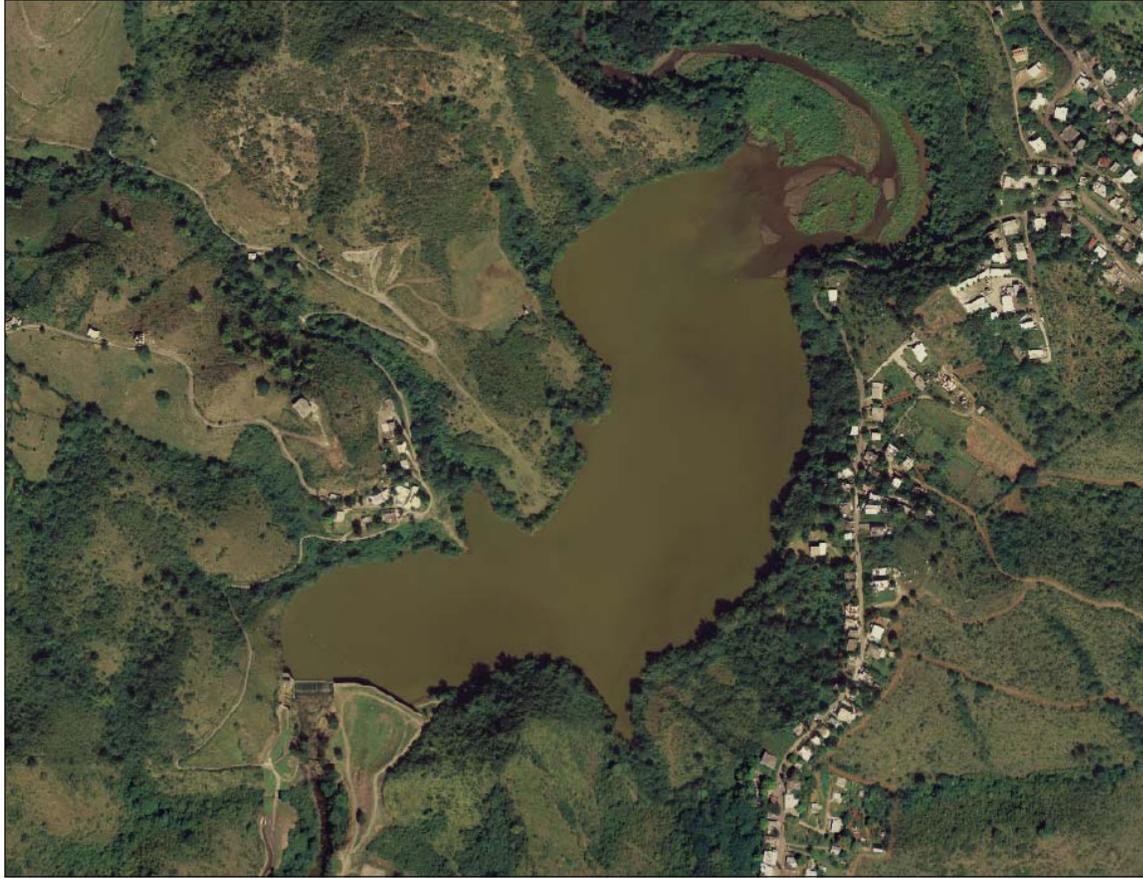
Figure 3. Snapshot of sediment accumulation and flow through Loco Reservoir.

A review of orthophotography with DRNA biologists at Guanica forest reserve clearly showed that sediment was passing through the Rio Loco Reservoir (Figure 3) through the watershed and into Guánica Bay. Even closer inspection revealed at least some of the sediment laden water was being discharged from the pump/flow house draining from Lucchetti Reservoir into Loco (Figure 4). The reddish clay colored water was clearly visible in the Rio Loco below the dam and extending down to the Guánica Bay and out to the near shore coral reefs.

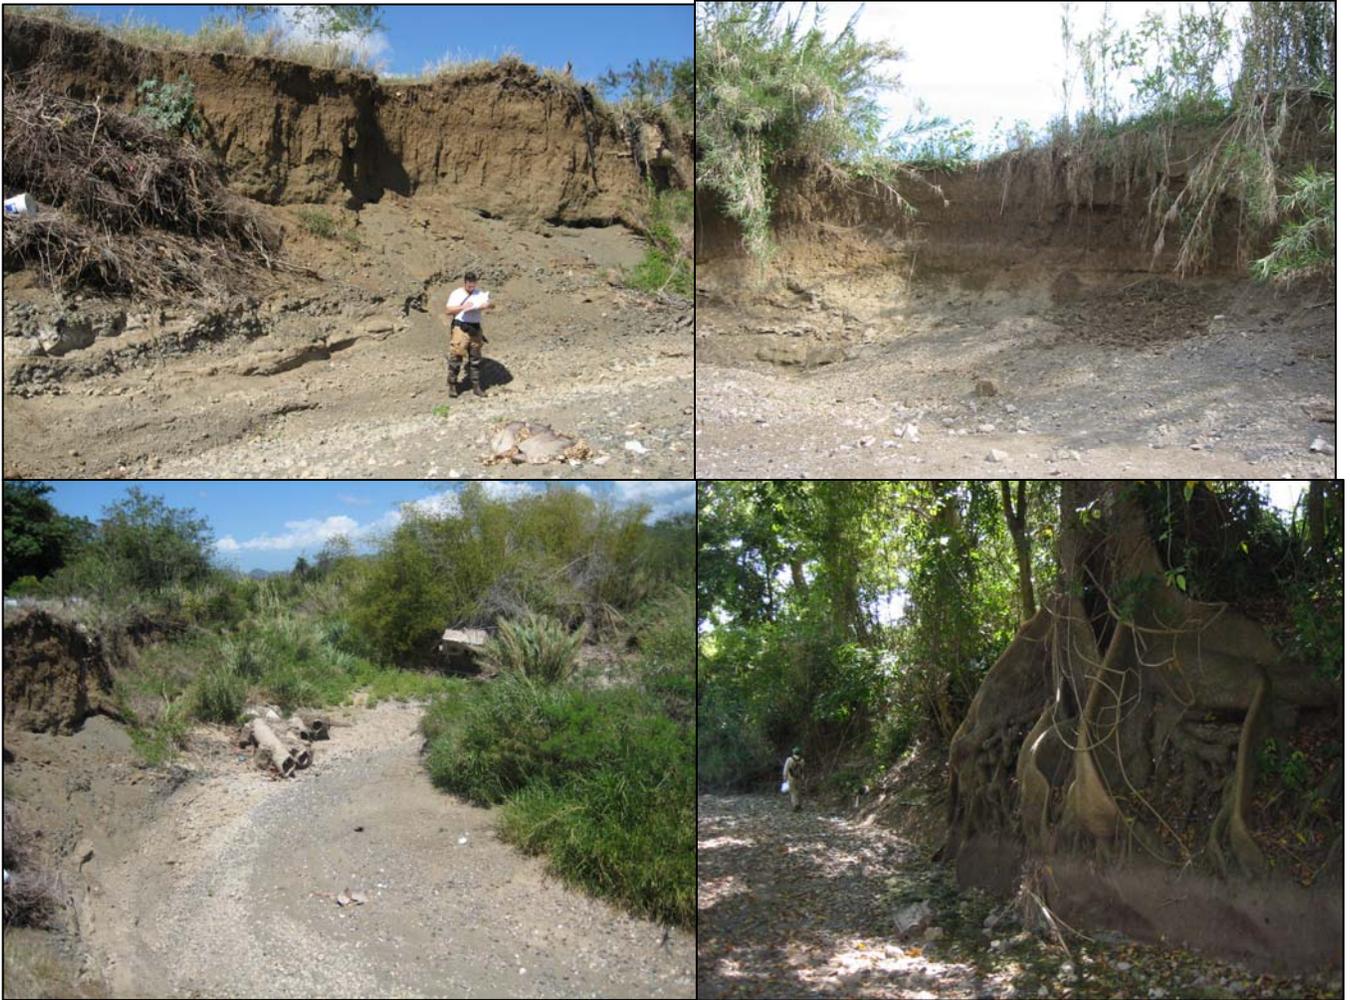
Figure 5. Channel erosion in the Rio Loco due in part to old irrigation infrastructure, invasive species and the loss of Guánica Lagoon. The picture on the lower right shows the potential role of trees in this ecosystem to help to fortify streambanks and reduce erosion

Channel erosion on the mainstem of Rio Loco was clearly another major issue in the watershed as documented in the stream channel assessments. Severe erosion was associated with areas that lacked mature riparian trees, particularly those areas that contained non-native species that seemed to exacerbate erosion as well as areas with historic irrigation infrastructure which created downstream scour (Figure 5). These low head dams, concrete footers, and other structures continue to act as strainers and constrictions in the channel causing debris to become lodged and changes in erosive forces to destabilize banks, increasing channel erosion, bed scour and sediment transport. Both Warne et. al. (2004) and Clark and Wilcox (2000) noted the continued importance of transport of historically deposited valley sediments and its likely impact on coral reef systems.

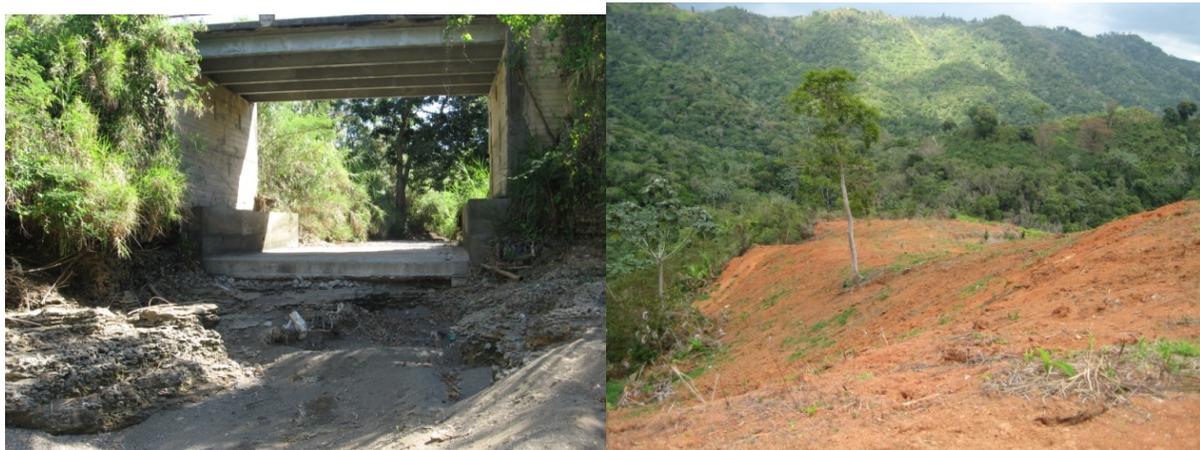
Figure 6. Left: Rio Loco river culvert, completely dry in April 2008; Right: Example of typical land clearing in upper watershed for coffee cultivation, without soil stabilization.

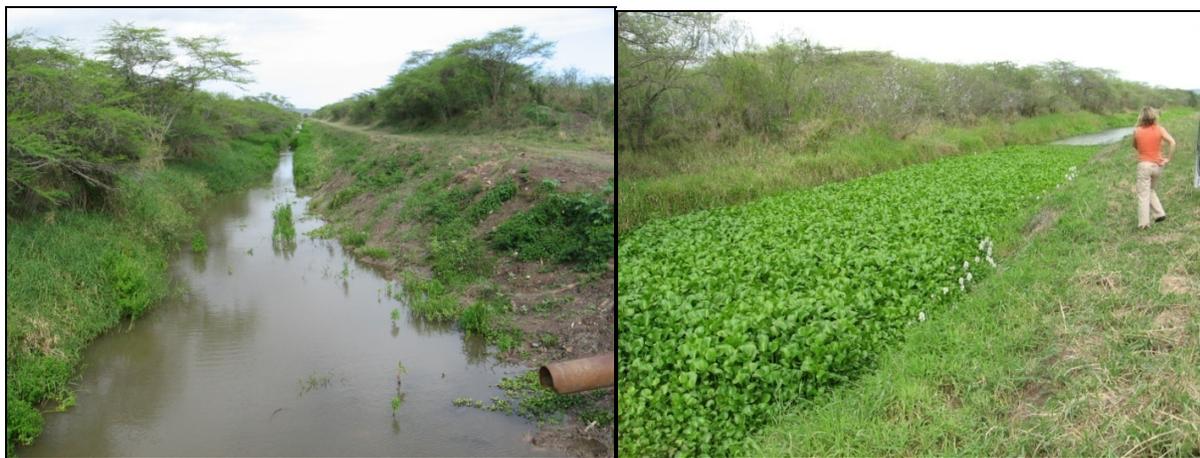
Figure 7. Lajas Valley Canal irrigation channel. Note: canal surface water immediately around outfall draining agricultural and pasture fields is replete with aquatic vegetation.

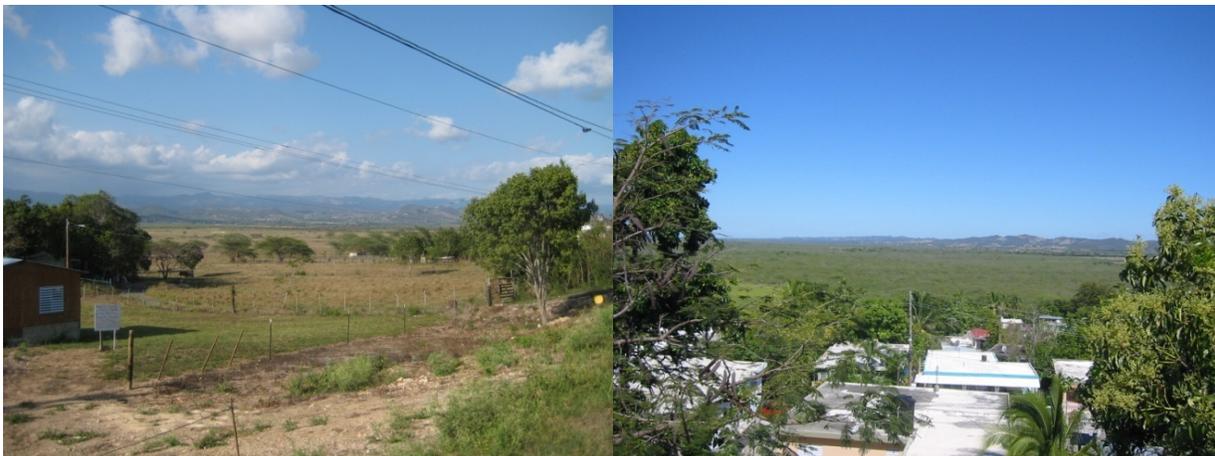
Figure 8. Section of the Lajas valley (left); Historic Guánica lagoon in the distance (right).

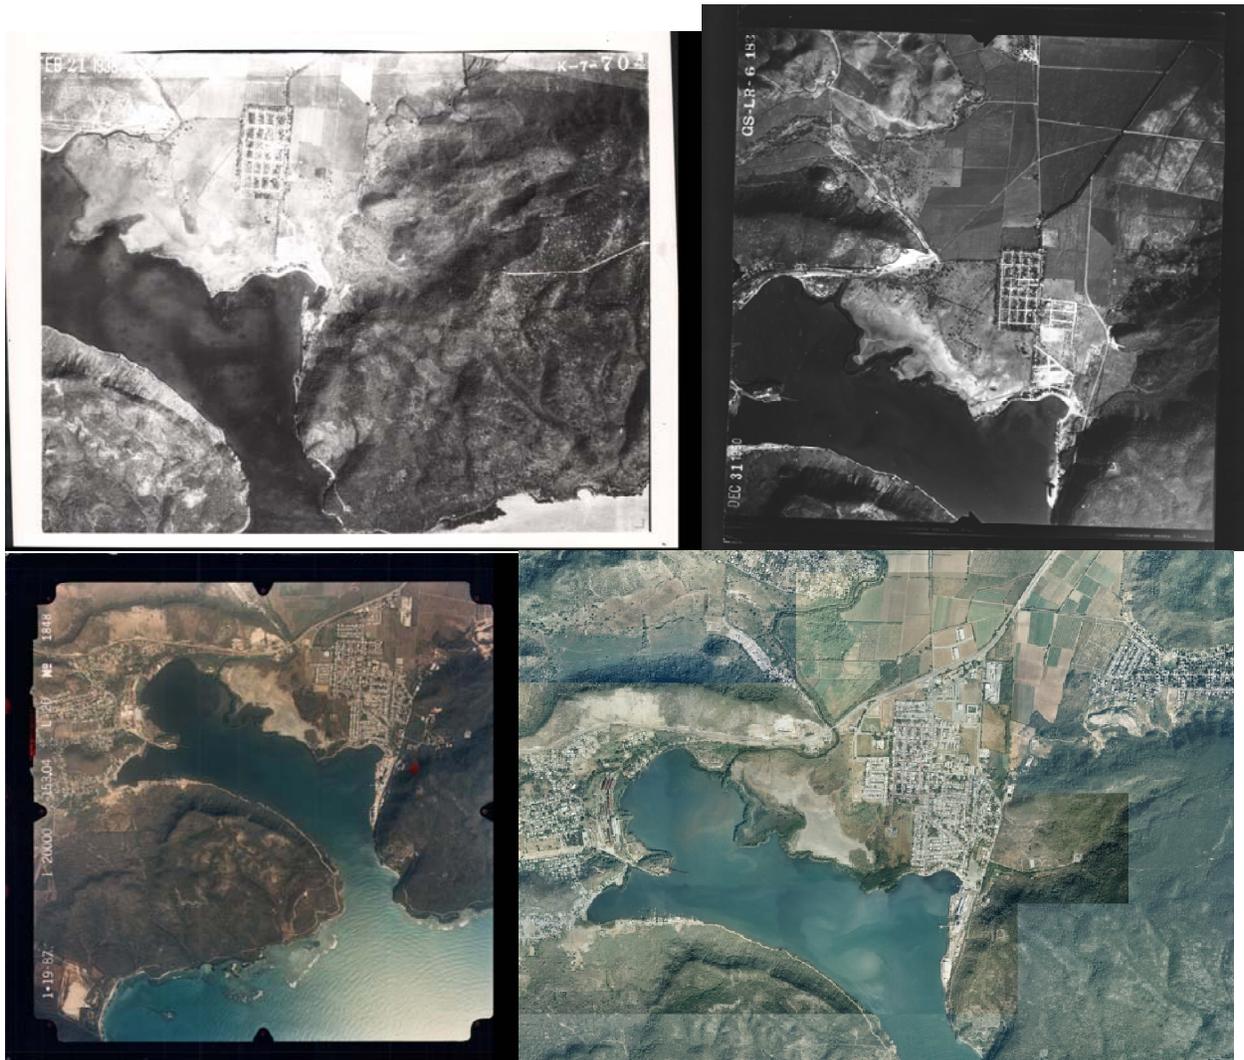
Figure 9: Aerial photographs of Guánica Bay and the near shore area taken in 1936 (top left), in 1950 (top right) in 1987 (bottom left) and again in 1996 (bottom right). Notice the significant increase in urbanization along northeastern shore nearer to mouth of the Bay sometime after 1950.

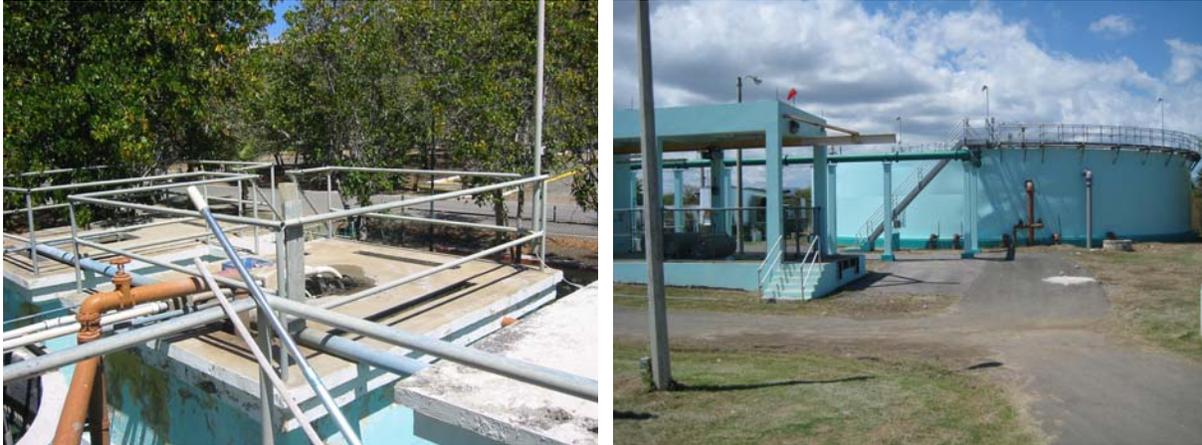
Figure 10. Small 3000 gpd sewage treatment plant at Cana Gorda Beach (left), one 750,000 gallon treatment tank within Guánica waste water treatment plant.

Two treatment plants (shown in Figure 10) are located in tidal areas in the watershed. A summary of their capacity and return flow are located in Table 4. Guánica Sewage Treatment Plant (STP) which currently receives 460,000 gallons per day from Guánica proper and but is capable of accepting 750,000 gallons per day for secondary treatment (Guanica STP operators personal communication, 2007). This same treatment plant has been recently upgraded with three additional treatment tanks with a total additional capacity of 2 million gallon per day of secondary-advanced treatment as part of additional proposed development in Guánica. The second much smaller treatment plant is located at Cana Gorda Beach and handles about 3000 gallons per day but has a treatment regime dictated by use of the public beach and associated facilities which is of course seasonal.
