# **Reduction and control of sediment-laden runoff near critical coral reef and other coastal ecosystems through the implementation of BMPs in Culebra, Puerto Rico FY-2015**

**FINAL REPORT**

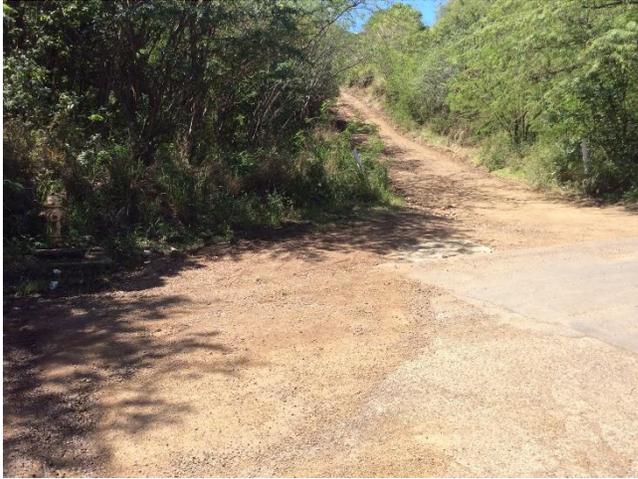
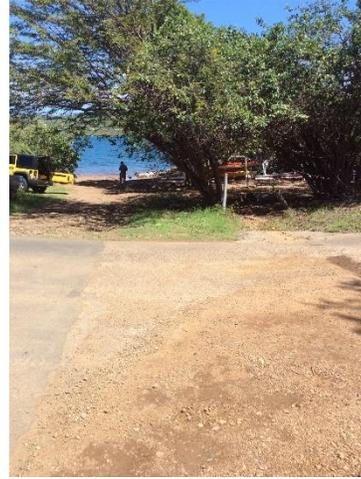
Figure 2. Sediment accumulation along dirt road at Punta Aloe prior to stabilization.

As part of this project, the sediment piles were removed along with other sediments that had built up upstream over the years, and the natural channel was restored pack to natural conditions. A series of check dams were built inside the channel to reduce runoff energy and trap some of the sediments. Downstream of the channel, where a boat launching area exists, a significant amount of sediment had also piled over the years. This sediment was removed and the bare soil was stabilized by paving it with gravel, hydroseeding and other vegetative buffers (See Figures 2 to 7). Removed sediments were appropriately disposed in a local landfill.

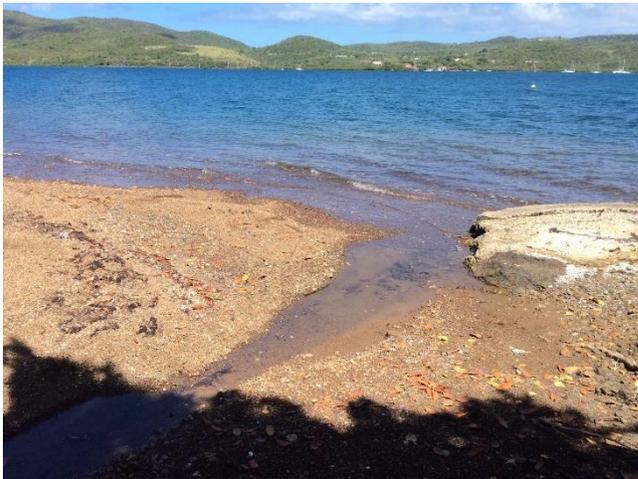
Figure 3. Sediment accumulation along boat launching area at Punta Aloe before the area was stabilized.

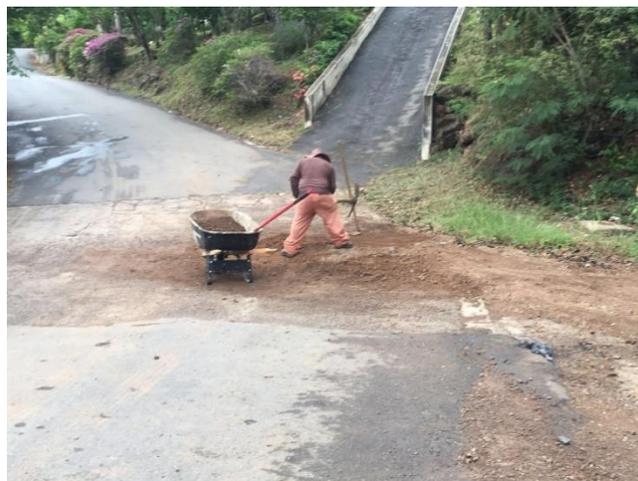
Figure 4. Sediment accumulation removal at Punta Aloe.

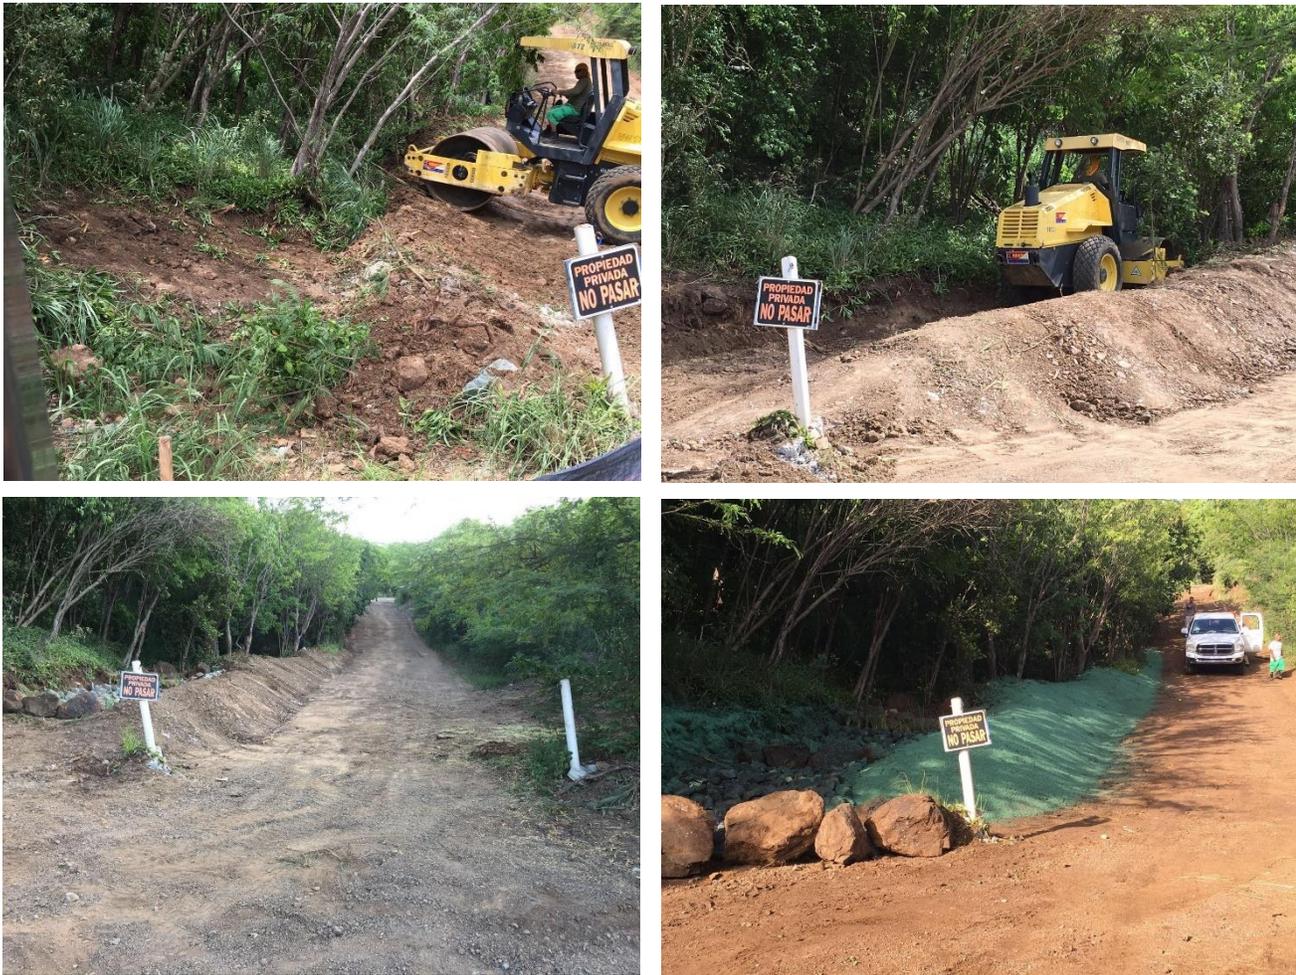
Figures 5. Dirt road stabilization at Punta Aloe including the removal of piled sediments and restoration of the natural waterway.

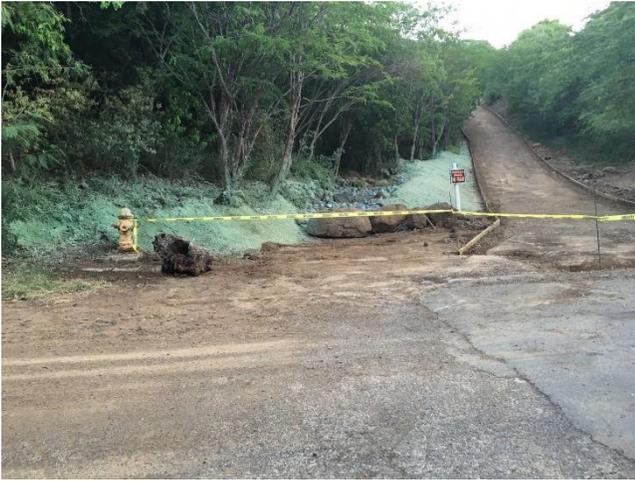
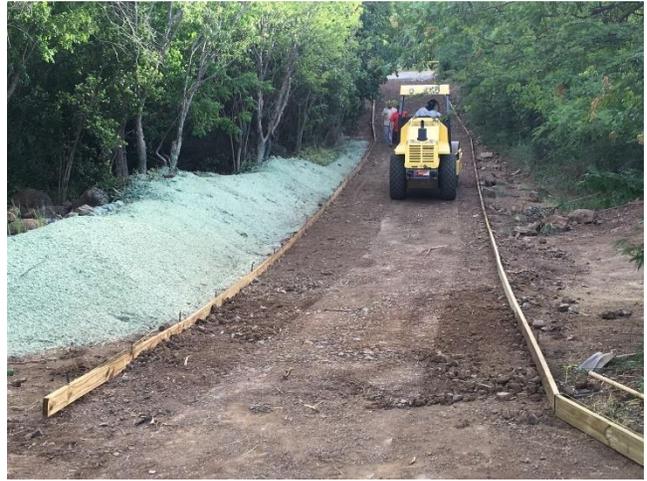
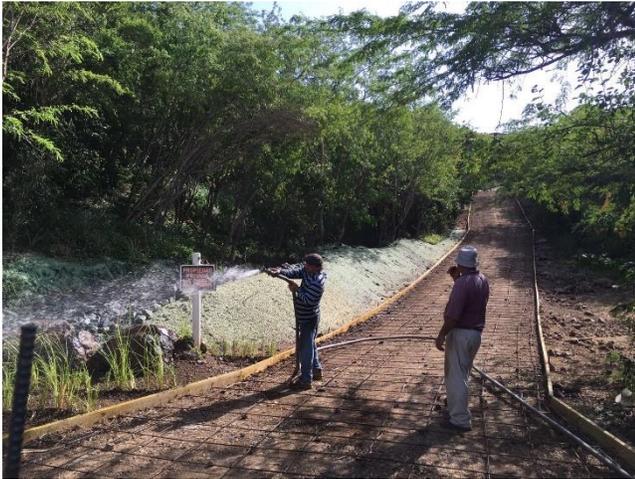
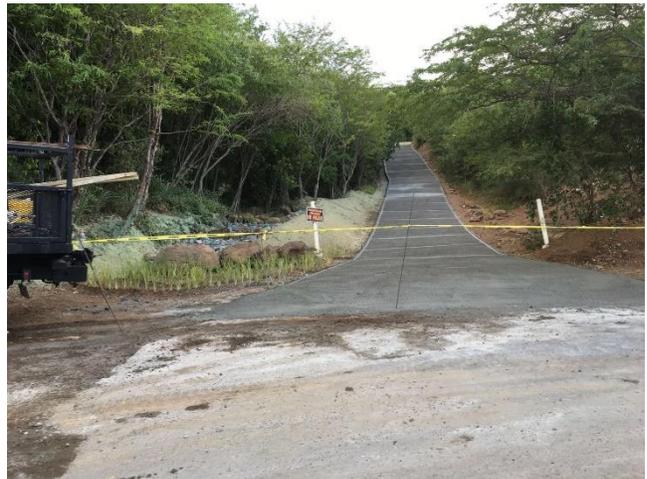
Figures 6. Dirt road stabilization, concrete paving and hydroseeding application along road at Punta Aloe.

The steepest segment of this dirt road network was stabilized by paving it with concrete. A stone swale was built on the side of the concrete to reduce the energy of the runoff prior to discharging into a raingarden, and hydroseeding was used to stabilize the remaining bare soil areas. Up gradient of the concrete stretch, the road segment was regraded towards the outside of the road and compacted. A rain garden system was constructed at the end of the dry channel before it discharges to the marine environment. Part of the channel was clogged with big piles of sediment; this was a product of the construction of the road and previous maintenance procedures. This problem was causing the natural flow to cut through these piles of sediment and through the main road, transporting them to the sea.

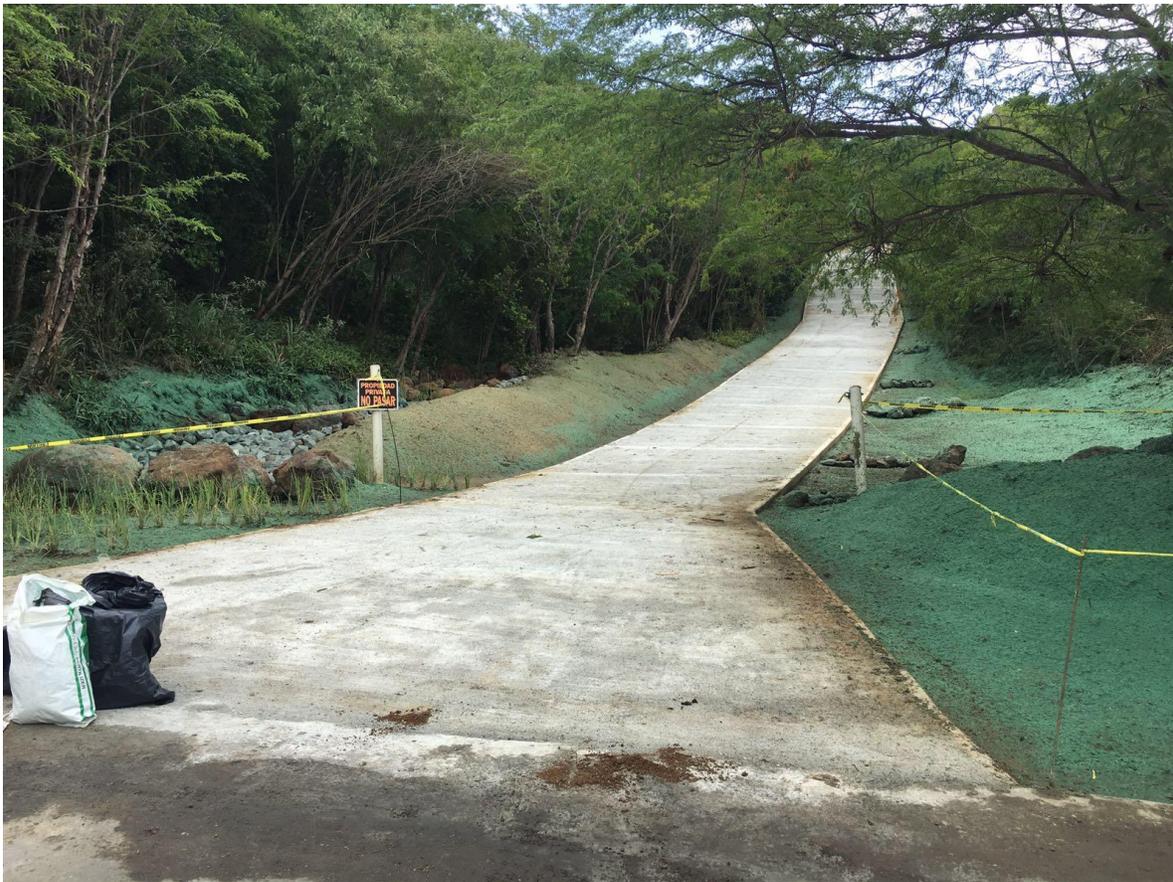
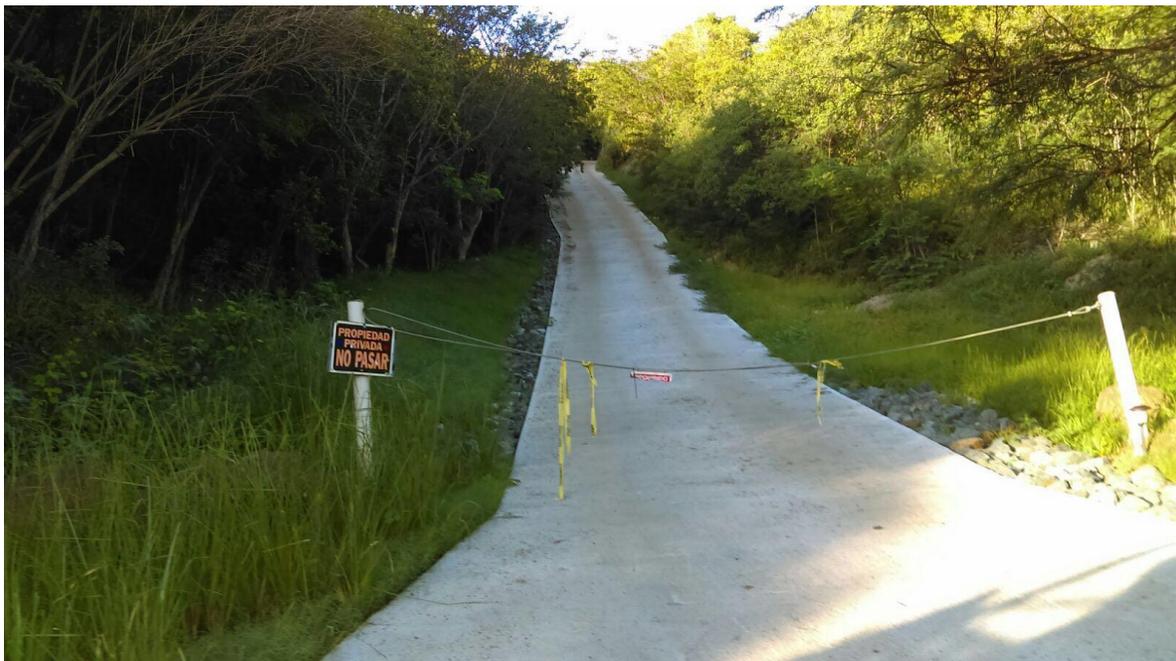
Figures 7. Completed project implementation along road at Punta Aloe.

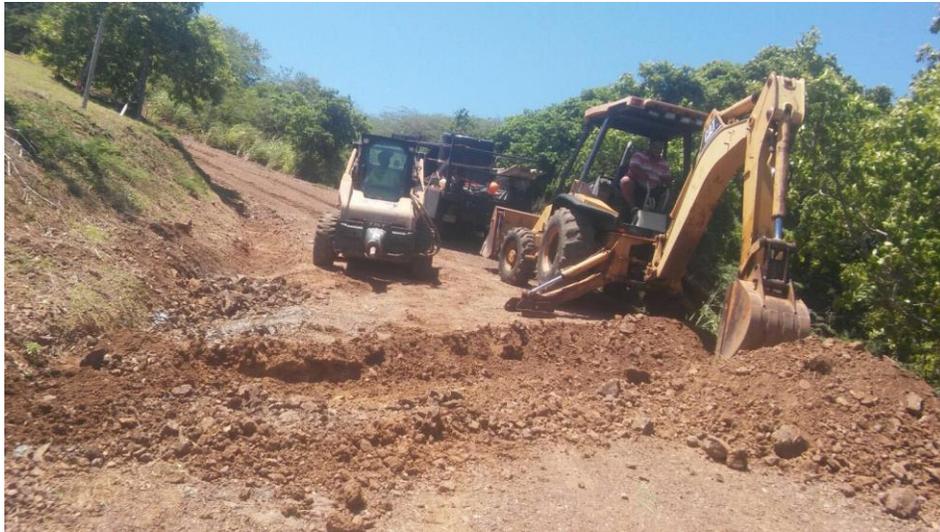
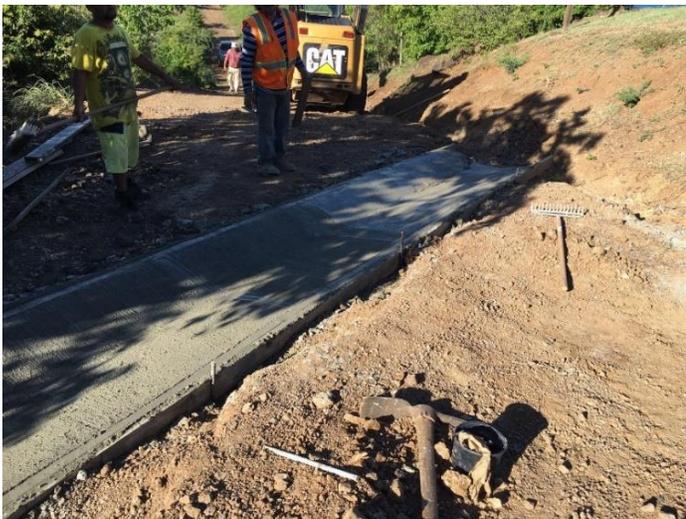
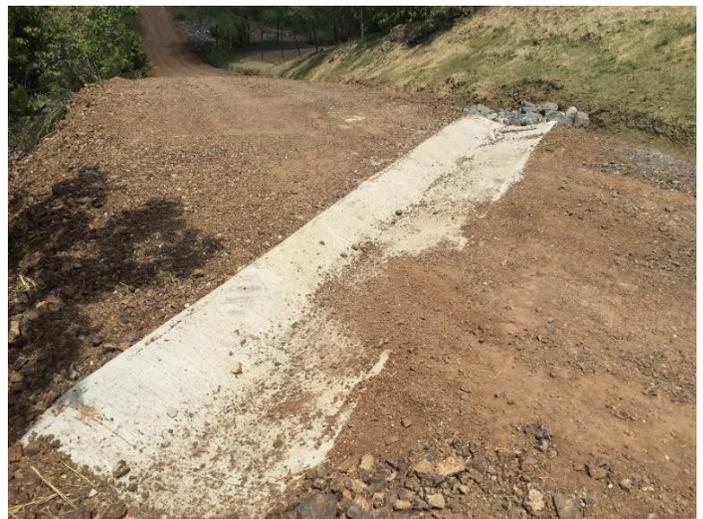
Figures 8. Construction process of concrete crossing swales along dirt road at Punta Aloe improvements of work completed with FY-2014 funds.

On the upper part of the road that was stabilized with FY-2014 funds, we added a series of concrete swales where runoff needed to cross the road (Figure 8). Concrete swales have been demonstrated to be a very reliable and effective practice on these roads.

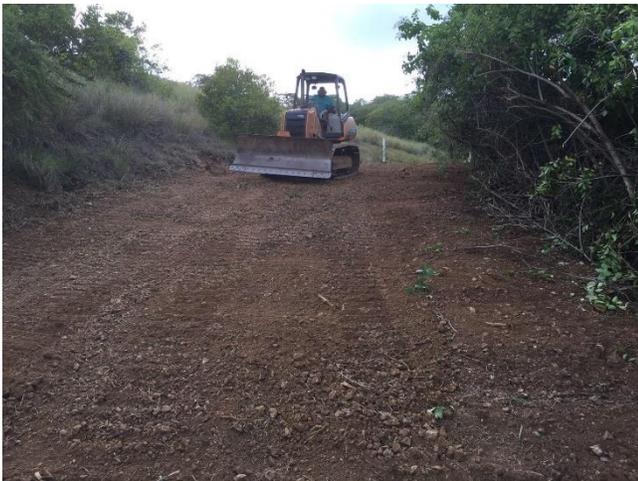
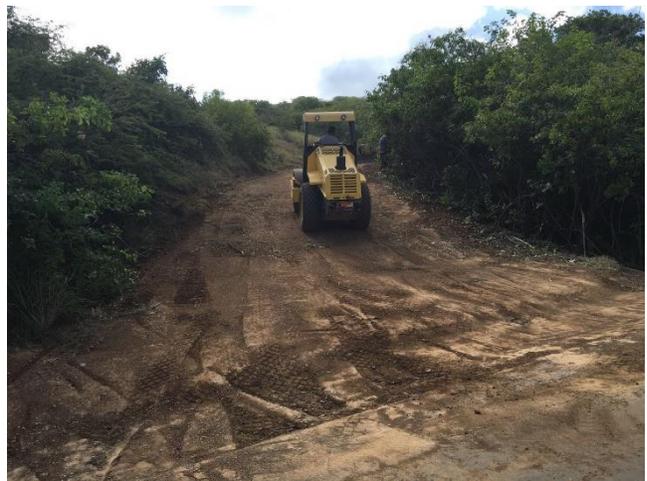
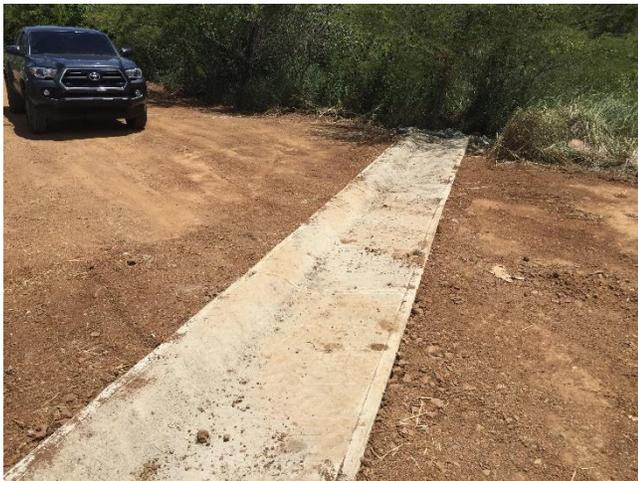
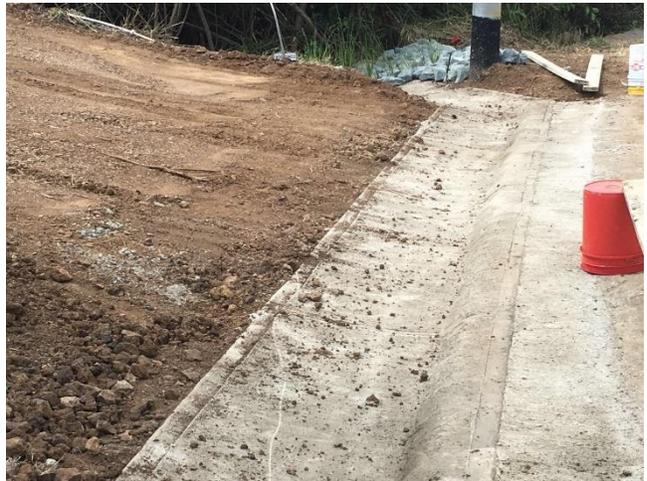
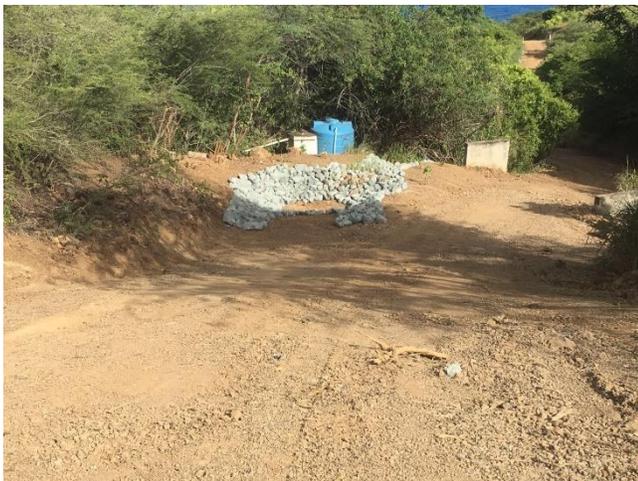
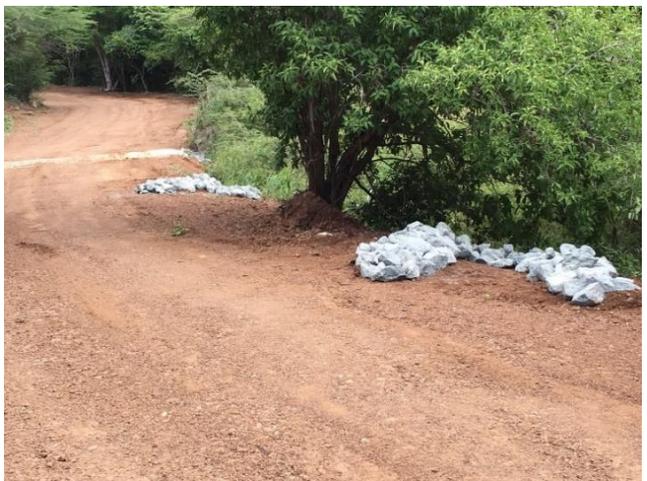
Figures 9. Regrading and compaction activities, construction process of concrete crossing swales, check dams and sediment trap along dirt road at Punta Aloe Phase II.

sediment transport to the marine environment. All the dirt road stabilized was regraded to the desired hydrological patterns, and runoff was conveyed into a continuous swale with check dams at intervals of approximately 25-30 ft., depending on the slope. The regrading process was conducted using a bulldozer, and soil was compacted with a 15-ton compacting roll. A series of concrete crossing swales was constructed to cross runoff from one side of the road to another into forested areas. Sediment traps were constructed to help filter stormwater that was causing erosion problems and discharging sediments. The traps were formed by excavating an area across a low portion of drainage swale, and berms were constructed and compacted with the small compacting roll. After compacting, the sediment traps were covered with 2-8 inch stones as rip-rap to prevent erosion from the berms, the bottom was punched through with the backhoe to promote infiltration, and Vetiver grass half-moons were planted to help trap sediment and promote infiltration and evapotranspiration. A rip-rap overflow was constructed with bigger 1-2 ft. stones to reduce energy of the water. The final segment of the road was paved with compacted gravel to reduce the sediments entering the raingarden that eventually drains to the Bay (See Figures 9 and 10).

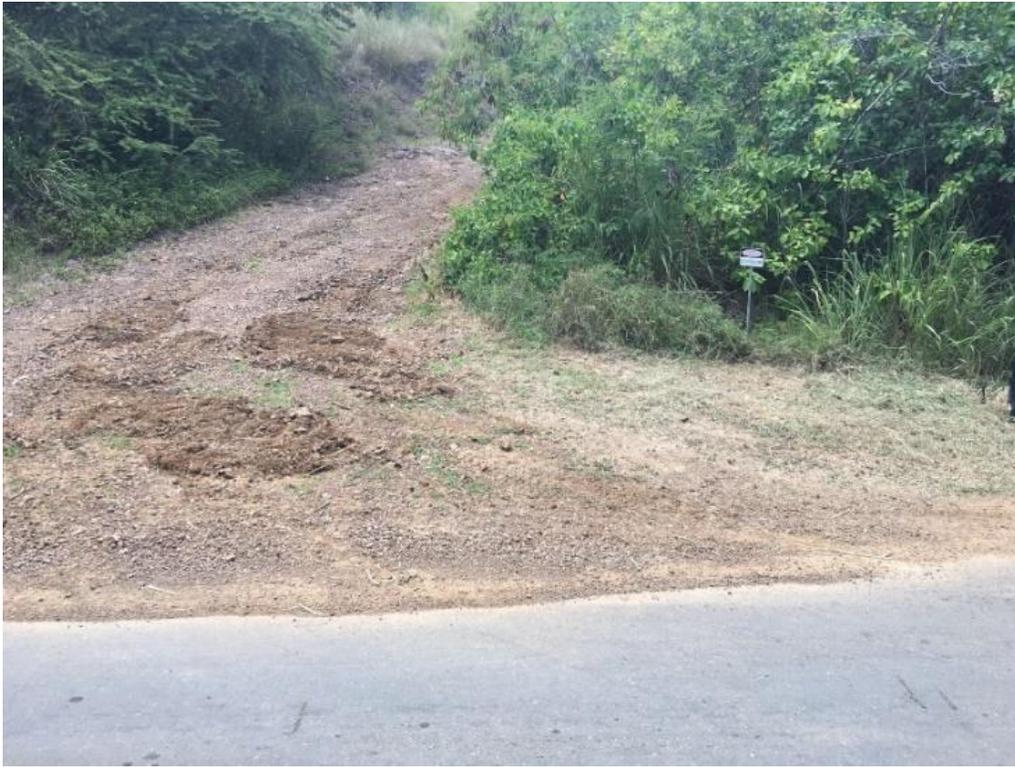
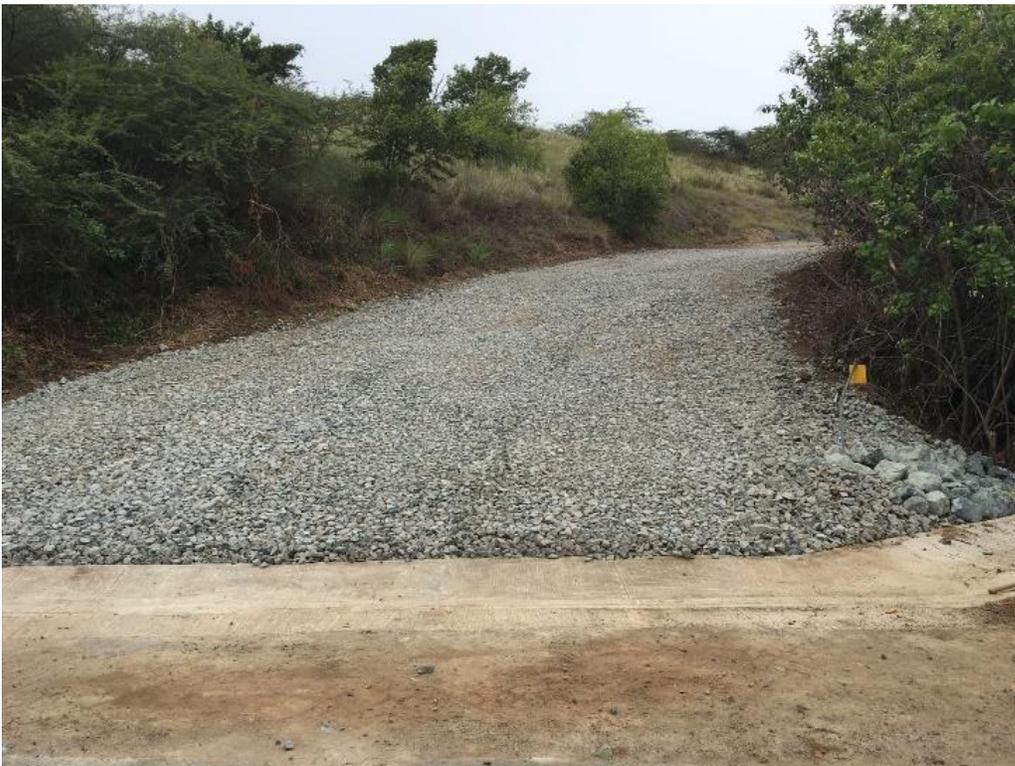
Figures 10. Before and after of completed work at second portion of Punta Aloe.

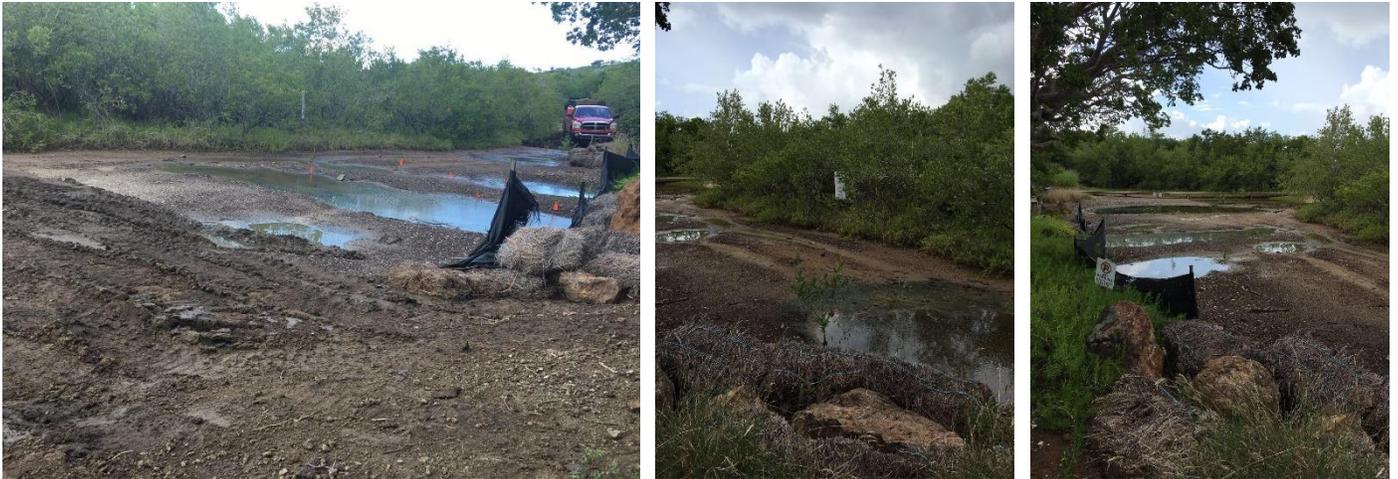
Figures 11. Wetland existing conditions before project started at Puerto del Manglar.

The salt flat wetland area was restored by removing the piles of sediment that had accumulated from the adjacent road and parking areas. This sediment accumulation was preventing natural hydrological flow patterns of tidal process. After the sediment was removed and natural hydrologic conditions were reestablished, we reforested the area with mangroves and other coastal forest. A wooden boardwalk was constructed to provide pedestrian access while protecting the surrounding restored area. Hydroseeding was used to stabilize remaining bare soil areas of the restored site (See Figures 15 to 16).

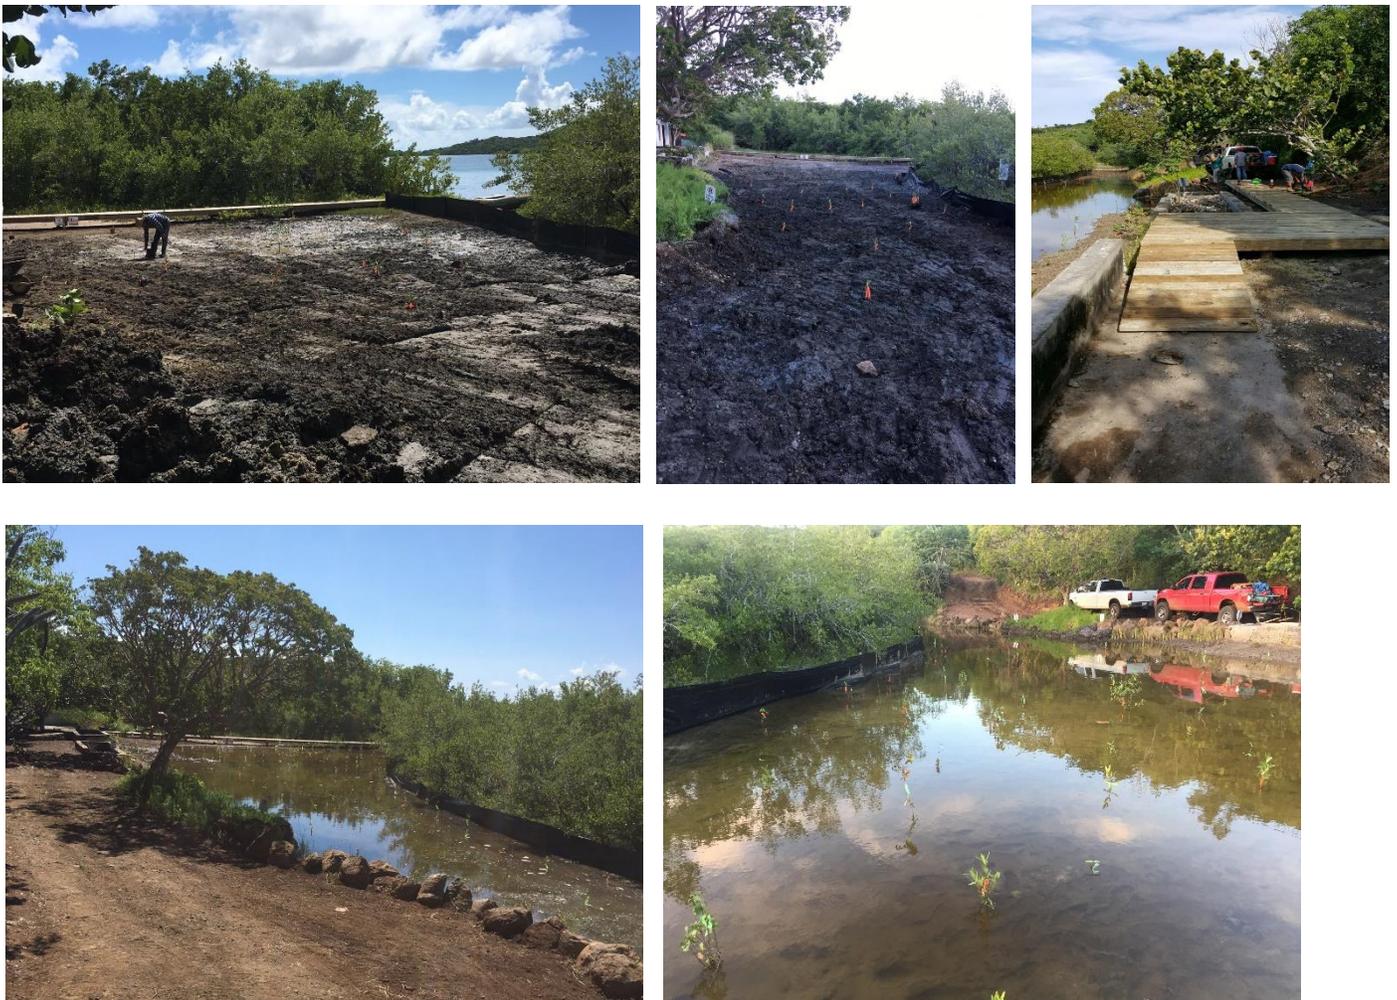
Figures 12. Wetland restoration process and boardwalk at Puerto del Manglar.

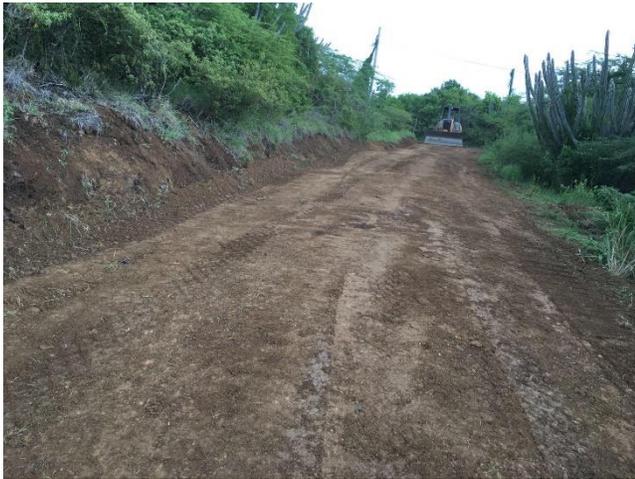
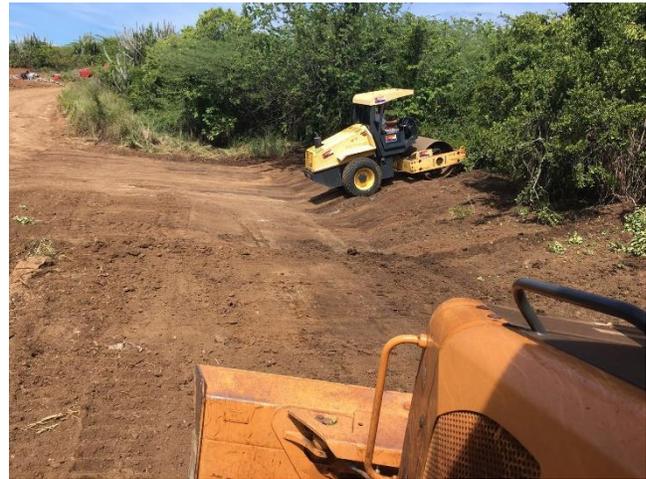
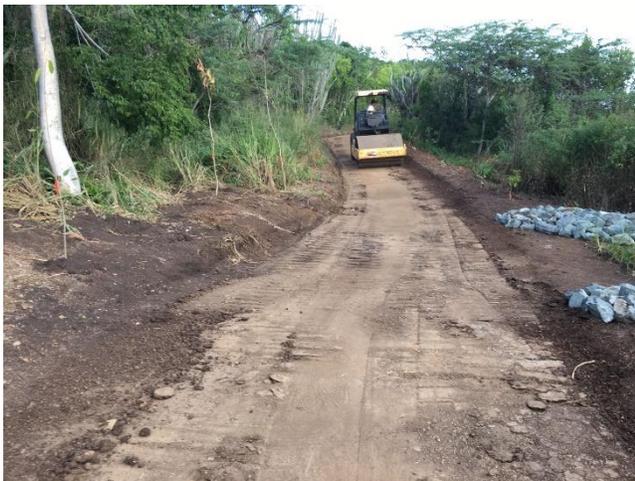
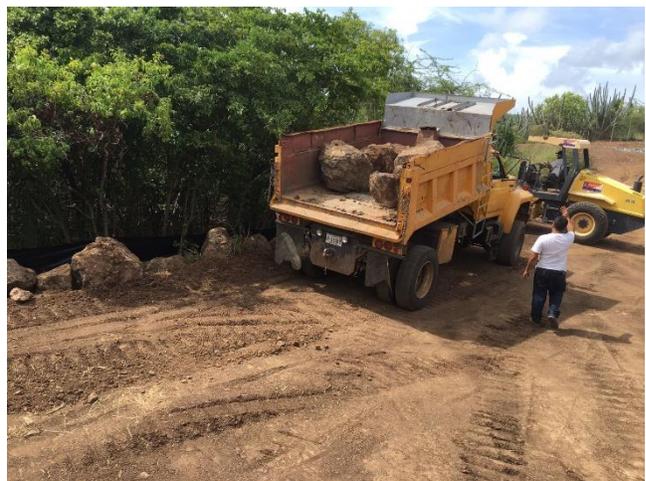
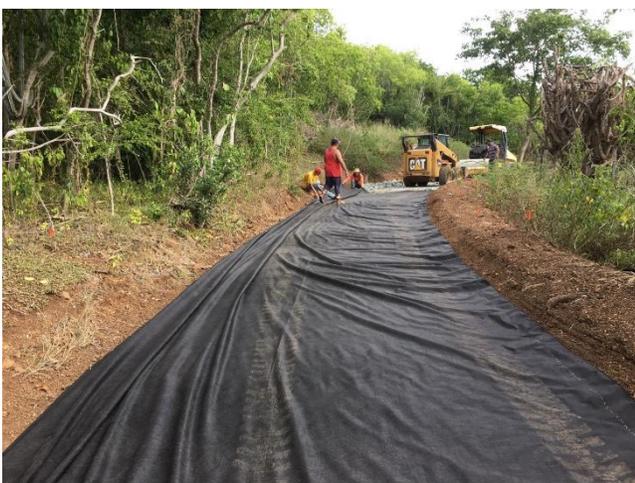
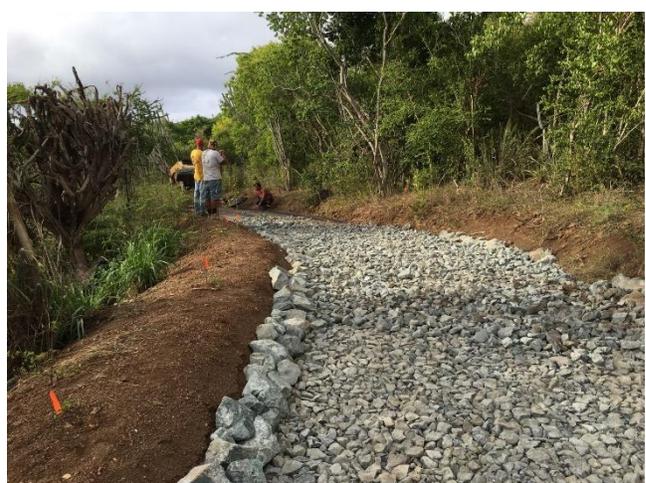
Figures 13. Dirt road stabilization by regrading and compaction at Puerto del Manglar.

Work completed consisted of stabilizing the access road and parking area by regrading and compaction (See Figures 13 and 14). Before starting any restoration work in the area, we installed a series of temporary sediment and erosion control practices at the current road and near the coastal zone and where work was going to take place. Sediment control practices included installing silt fences and planting Vetiver grass to redirect runoff to

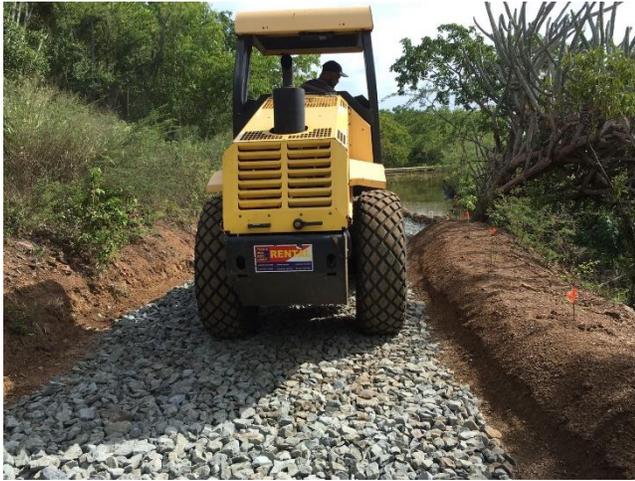
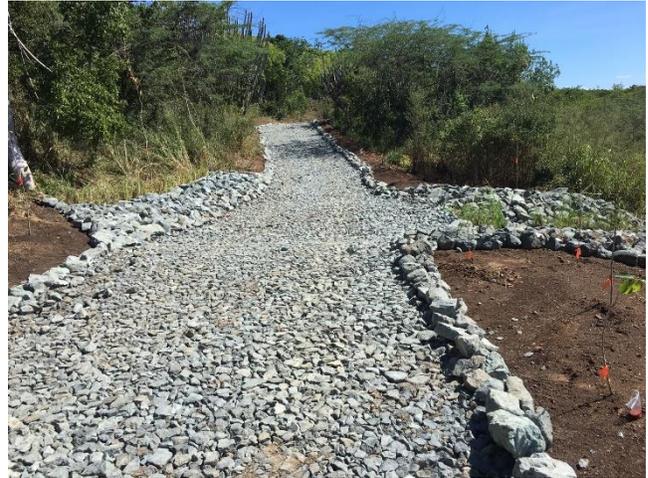
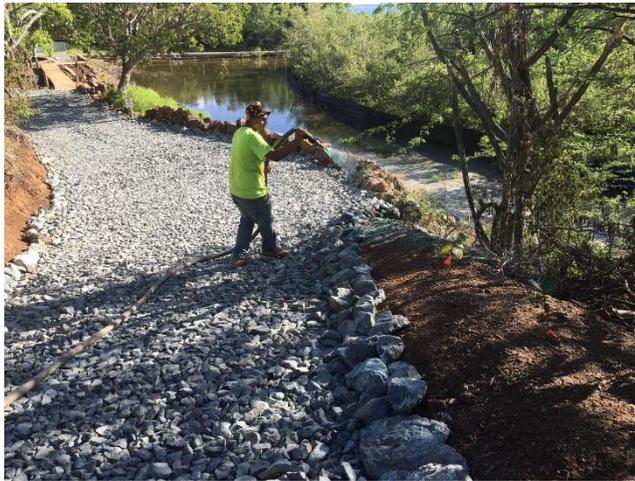
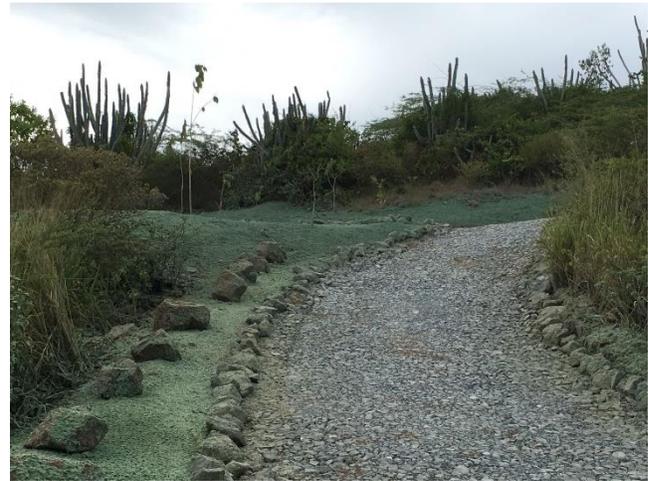
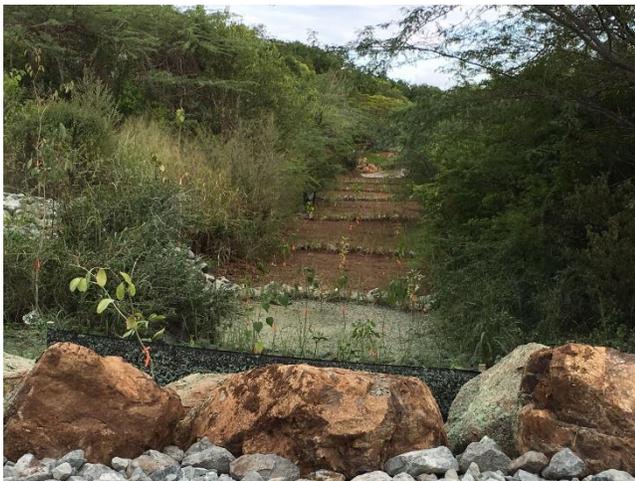
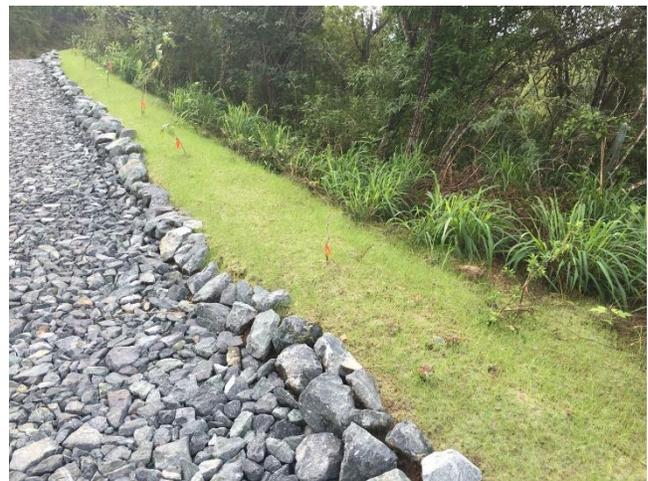
Figures 14. Completed dirt road stabilization project at Puerto del Manglar.

forested areas. A series of swales and check dams were installed to direct part of the runoff from the main access roads to a sediment trap. The parking area and all the road segments that run parallel to the wetland system were then paved with gravel after the installation of geotextile to serve as a filtration system. The gravel infill will allow vehicle support and drainage of all storm water.

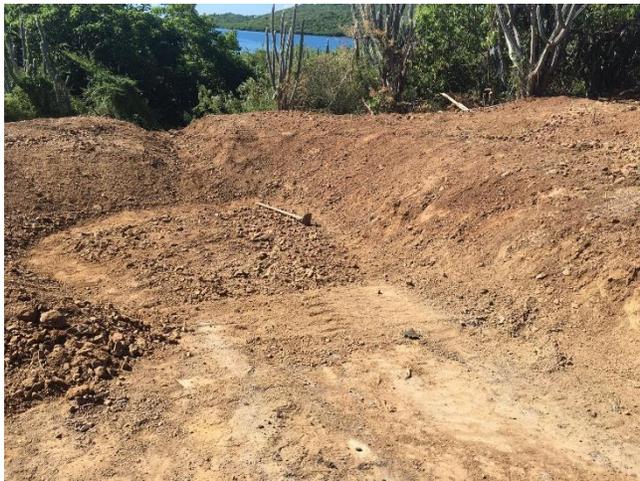
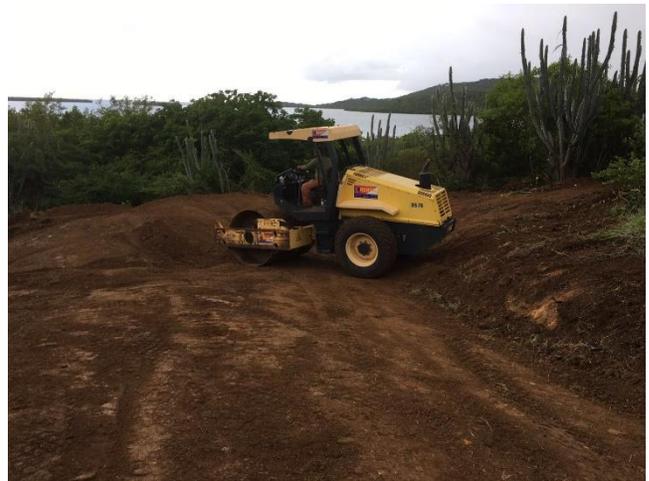
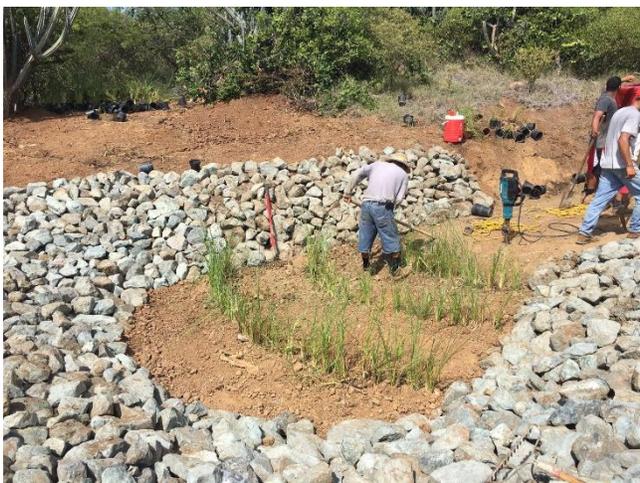
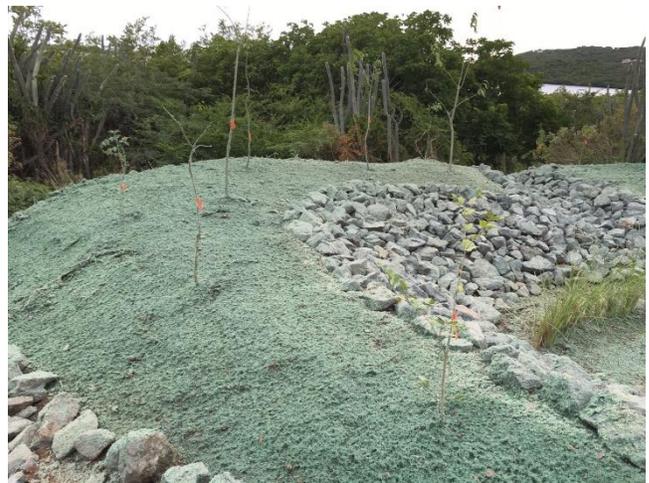
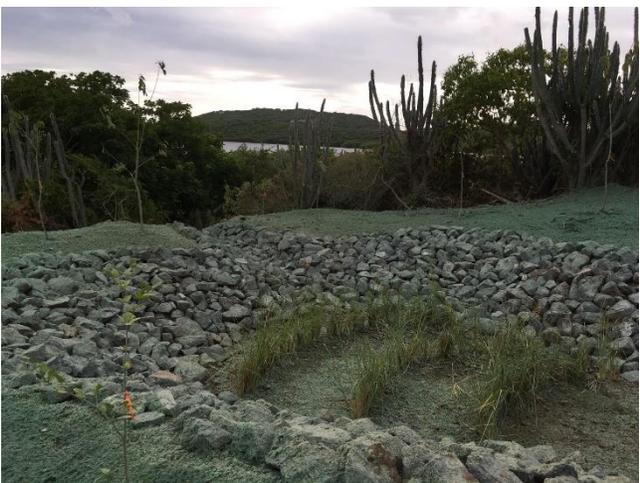
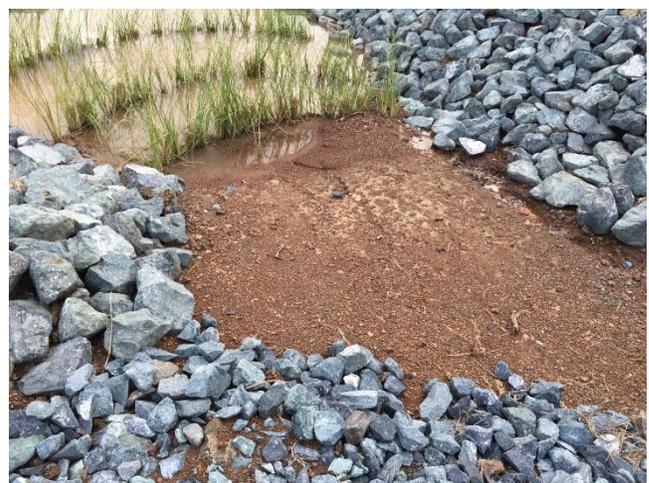
Figures 15. Construction of sediment trap at Puerto del Manglar.

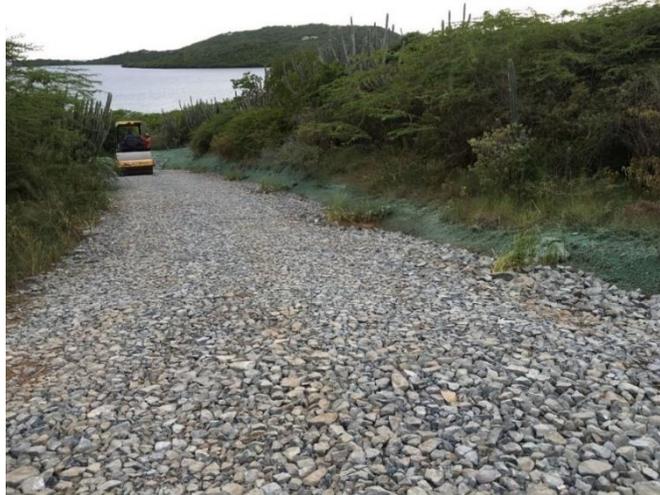
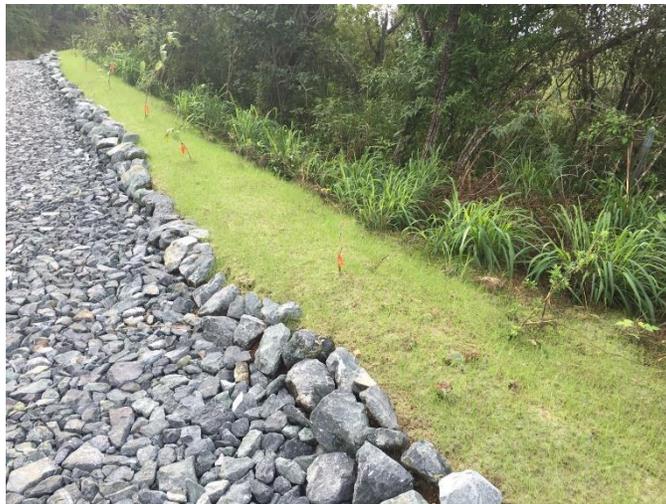
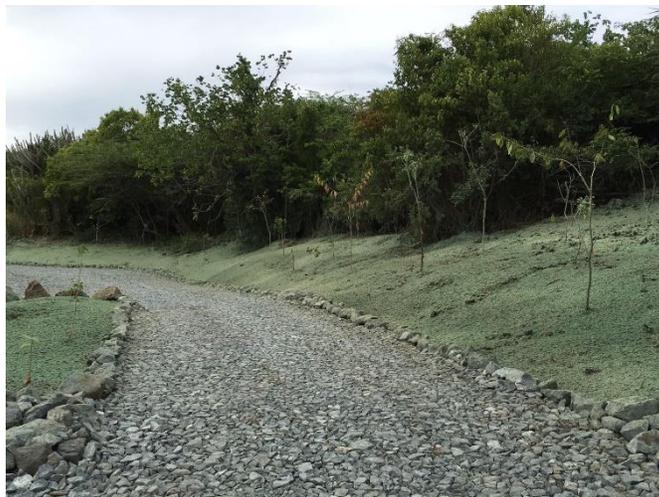
Figures 16. Completed dirt road stabilization project at Puerto del Manglar.
