# **Innovative Erosion Control Technology In Florida**

**Paden E. Woodruff**

**Bureau of Beaches and Coastal Systems  
Florida Department of Environmental  
Protection**

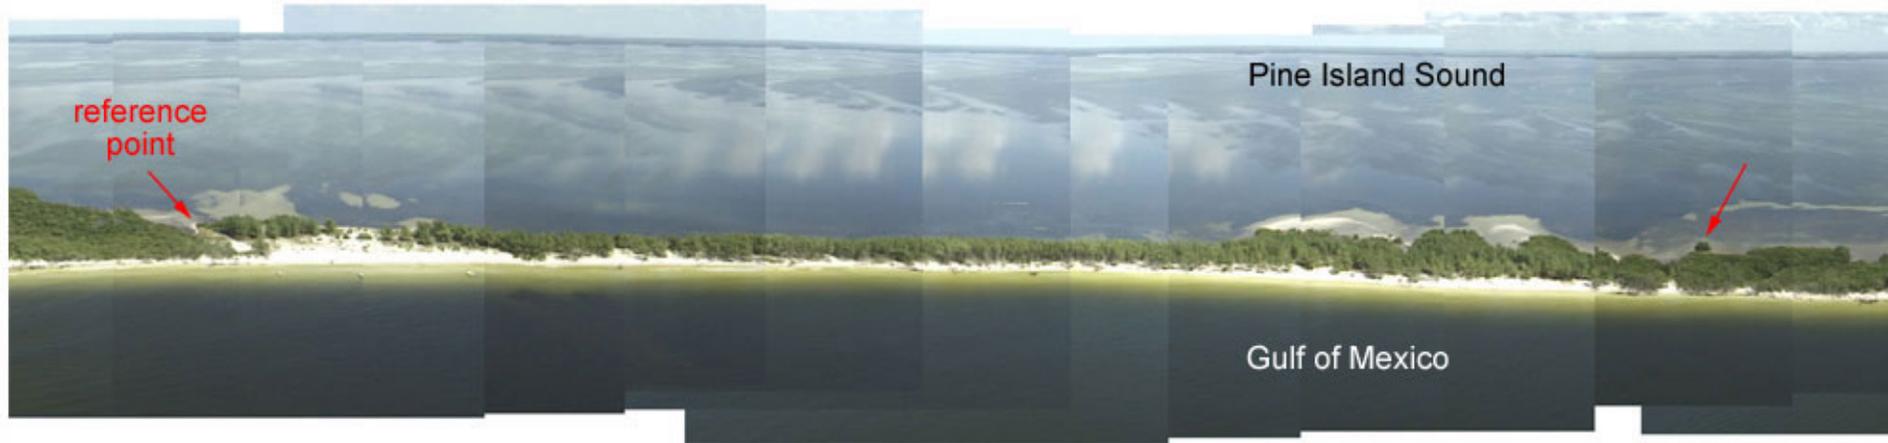
North Captiva Island, FL  
September 29, 1999

# Second cause is storm damage

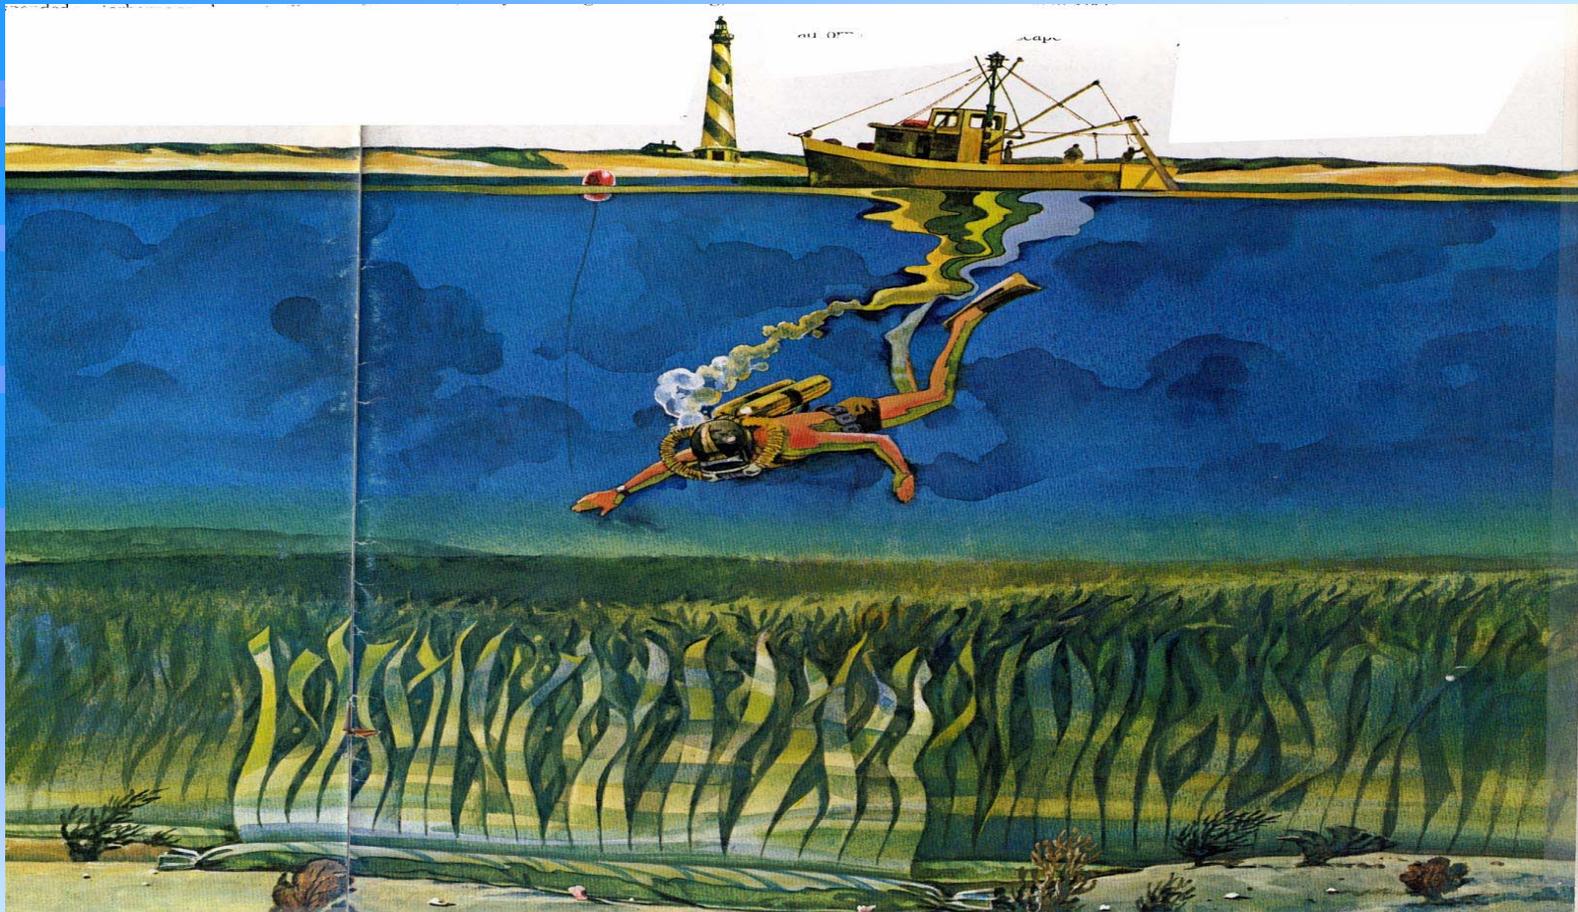
# Artificial Seaweed Theory

1983	100' to 300' south of R-90, Collier Co.	Synthetic strips 2" wide X 5' long anchored w/ a sand filled tube. 8 rows, 500' long each.	Analysis of comparative profiles indicated the project was ineffective. Department recommended removal. Diver inspection revealed the fronds were either buried, washed away or removed.
1984	100' to 300' south of T-15, Manatee Co.	A grid was located 210' seaward of the mean high-water line. Grid consisted of 4 interlocking sandbag tubes with 4 rows of seaweed fronds.	Monitoring required as a permit condition was not conducted, a removal order was issued by the Department, and the project removed. Department conclusion was the project was ineffective.
1984	500' N of T-203 to 300' N of T-204, Highland Beach, Palm Beach Co.	5 rows of seaweed, 10' apart approx. 1200' long were located approx. 300' seaward of mean high-water	The 6 mo. report indicated 65% of the project ineffective, and no further monitoring was completed. A 1992 inspection showed no trace of project.

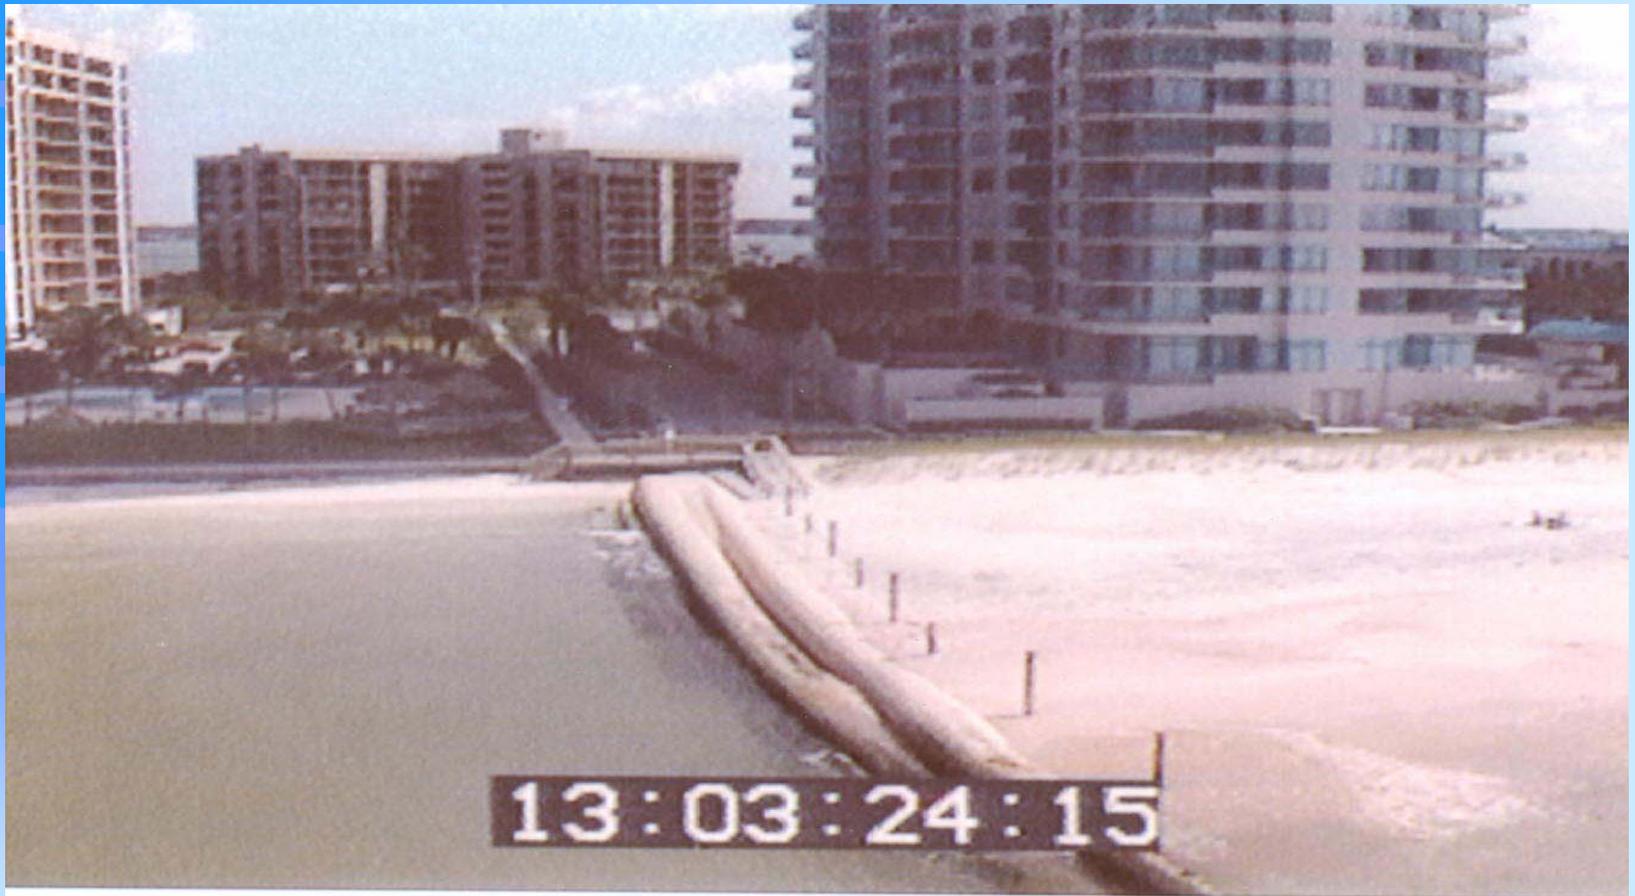
# Longard Tube Installation

Protect Tube II	1989	190' to 920' S of T-15, Longboat Key, Sarasota Co.	3-celled, sand-filled geotextile tube structure w/ crest elevation +6.5 ft. NGVD. 15 ft. wide, 600' were placed as emergency work in 1988, and a 125' added and monitored.	Beach remained stable during 2 yr. monitoring period, and no downdrift problems noted. Unusually calm period. Inhibition of turtle nesting remains a concern.
Longard Tubes	1992	350' N of R-59 to R-60, Sand Key, Sarasota Co.	70" and 40" diameter sand-filled tubes arranged as groins connecting to an offshore sill. Groin compartments filled w/ 99,000 cyd of sand.	Project performed well. Tubes were damaged and settlement occurred. Area now has a restoration project.
Undercurrent Stabilizers	1984	92' to 742' S of R-96, Captiva Island, Lee Co.	Groins constructed using 2, side by side, sand-filled bags, 13' X 5', and underlaid by anchored filter fabric.	Consultants and department concluded no beneficial effect and no improved sediment accretion rates.

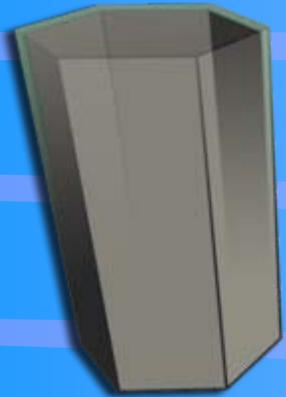
# SEAMOD Variable Sizes

- **Built on ideas from NavSea for the modular building of ships**
- **Same idea – precast concrete modules**
- **More cost effective than steel**
- **Easier to construct than steel**
- **Greater durability than steel**
- **Less maintenance**
