NOAA ARRA USVI Watershed Stabilization Project

Coral Bay Watershed Management Project – Calabash Boom Drainage Improvements

March 31, 2012

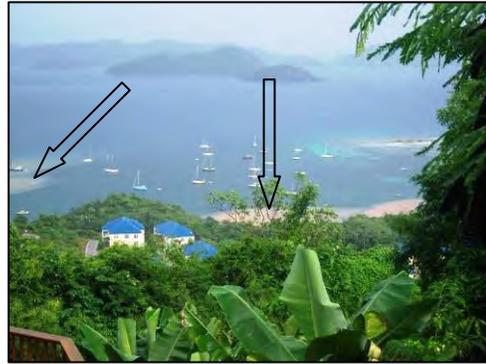
Photo 1: Plume into Johnson Bay prior to drainage improvements (Shipwreck Ghut plume on the left; Calabash Boom Ghut plume on the right).

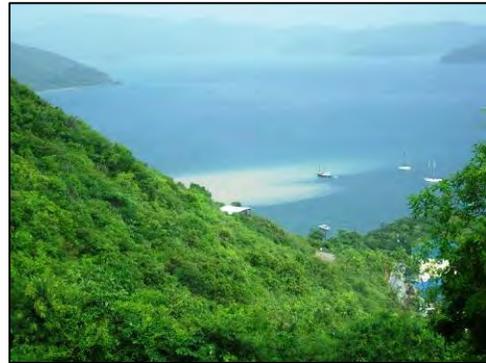
Photo 2: Shipwreck Ghut Plume into Johnson Bay prior to drainage improvements.

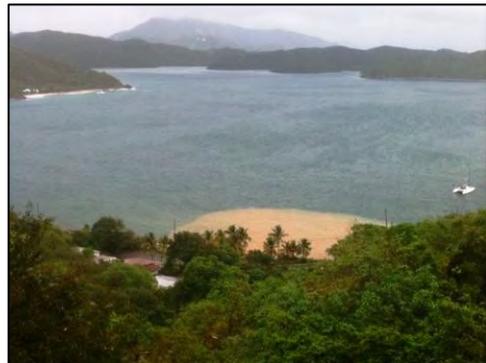
Photo 3: Calabash Boom Ghut Plume into Johnson Bay prior to drainage improvements.

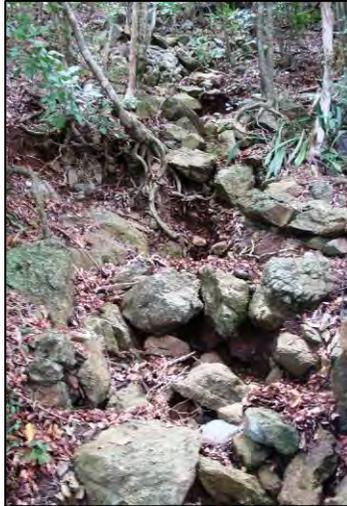
Shipwreck Ghut flows travel down the steep and rocky ghut (Photo 4), then through an approximately 100-yard channel next to a developed area (Photo 5) before emptying into Johnson Bay (Photos 6 & 7). Calabash Boom Ghut flows travel various paths. One sub-path, as it exits Calabash Boom Road, travels through several privately-made step pools dating from the 1980's and later, before continuing downhill in a natural ghut which then passes through an excavated ghut channel in the middle of the

Photo 4: Shipwreck Ghut.

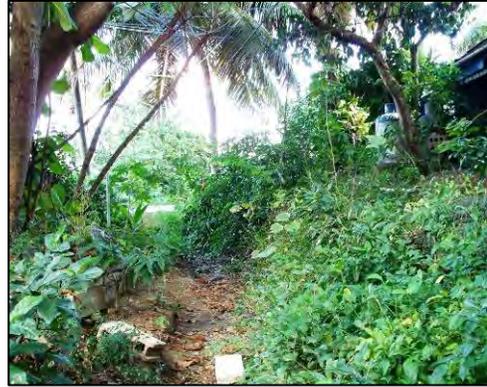
Photo 5: Shipwreck Ghut channel before Route 107 culvert.

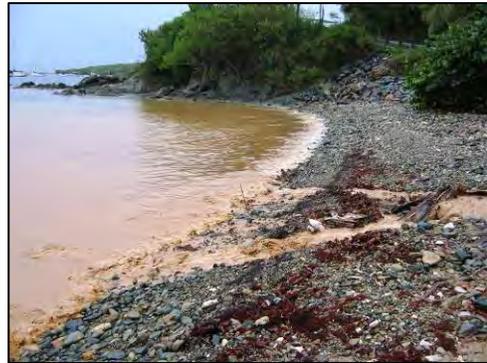
Photo 7: Shipwreck Ghut shore outlet.

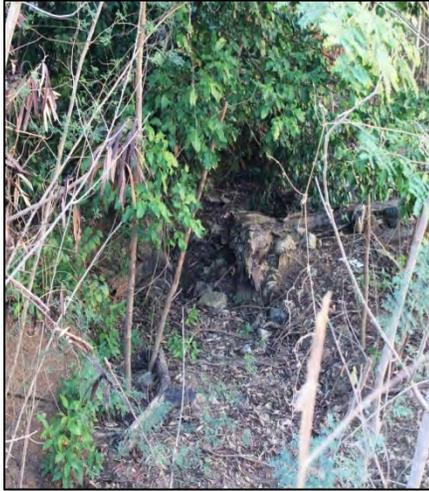
Calabash Boom Housing Complex (Photo 8) and empties into a detention basin (Photo 9). Once this basin overflows, runoff travels through a Route 107 swale (Photo 10), across an undeveloped flat area, and into Johnson Bay (Photo 11).

Photo 8: Calabash Boom Ghut running through housing complex.

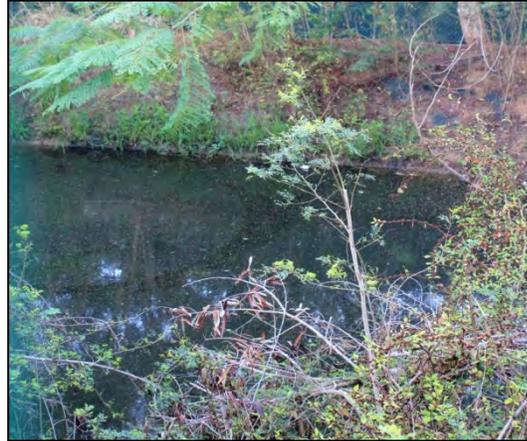
Photo 9: Calabash Boom Housing Complex detention basin.

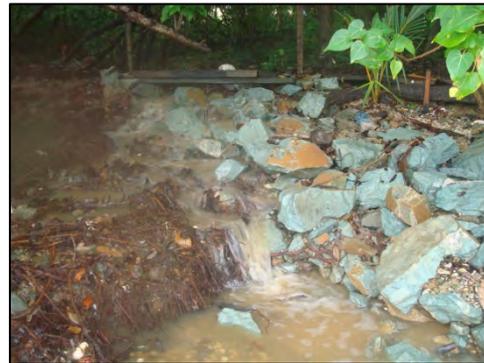
Photo 11: Calabash Boom Ghut outlet.

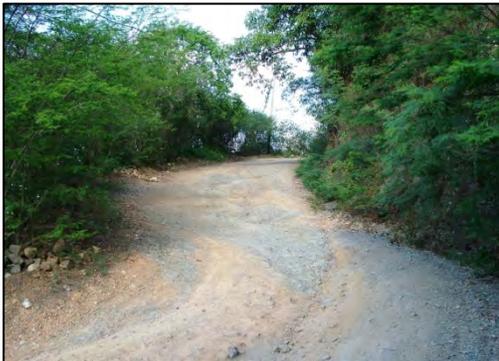
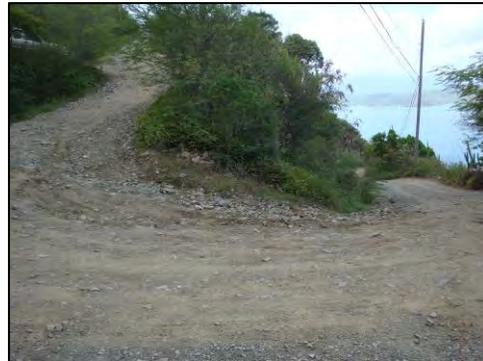
Calabash Boom Road is a steep, winding, unpaved public road (Photos 12 and 13) providing access to 25-30 residences. Public Works (PW) “graded the Calabash Boom Road in anticipation of paving it in spring 2006 altering the drainage and conveying more runoff into the neighboring, steep Shipwreck Ghut” (Kitchell and Claytor 2009). Prior to construction of the Calabash Boom Housing Complex, this water used to flow through the Calabash Boom alluvial plain before draining to the ocean. The alluvial plain provided necessary sediment filtration and stormwater infiltration services. Construction of the Calabash Boom Housing Complex reduced the ability of this area to provide stormwater management. As noted in the watershed

Photos 12-13: Steep unpaved Calabash Boom Road

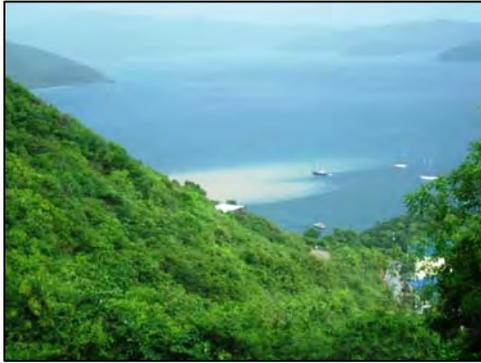
turbidity of ocean waters (see cover photo and Photos 14-15) and contributed to coral die-off of all the patch coral near the outflow by 2007.

Photo 14: Shipwreck Ghut plume into Johnson Bay.

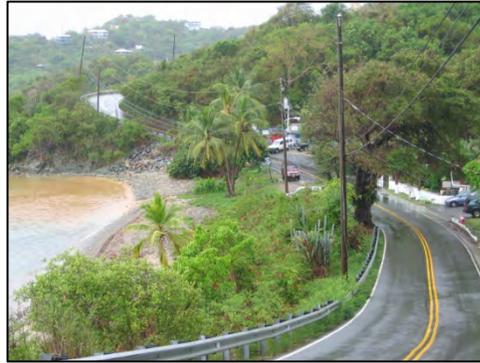
Photo 15: Sediment-laden runoff from Shipwreck Ghut into Johnson Bay.

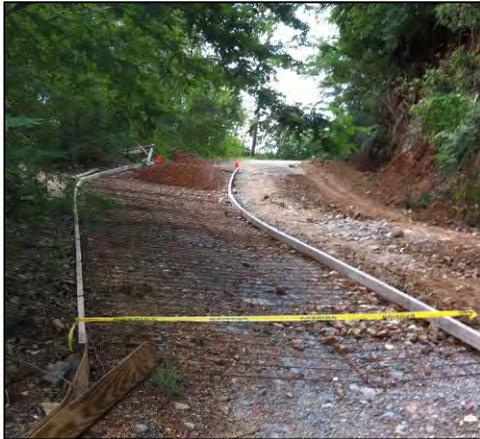
Photo 16: Calabash Boom Road paving – forms and wire mesh.

Where paving connected to another concrete structure, the existing structure was sawcut, as necessary. The contractor connected pavement extensions to existing pavement by epoxy bound rebar dowels. Where paving was 16 or 18 feet wide, the contractor installed pavement in two sections to maintain traffic flow during construction.

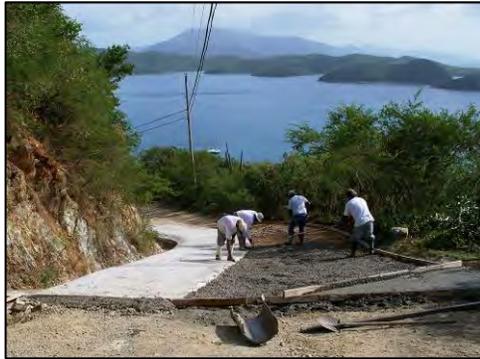
Photo 17: Calabash Boom Road paving – in progress.

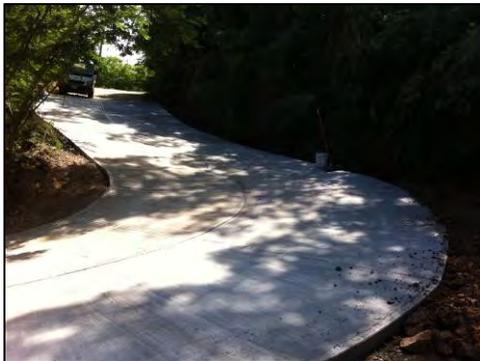
Photo 18: Calabash Boom Road paving – fill to grade to be done.

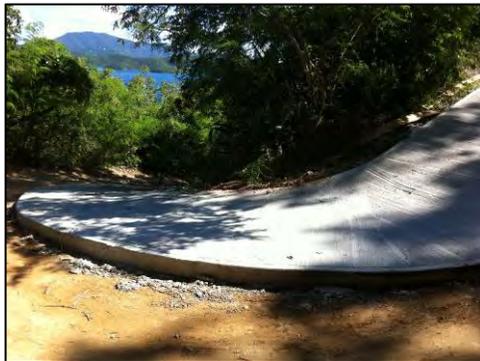
Photo 19: Calabash Boom Road paving - fill to grade to be done.

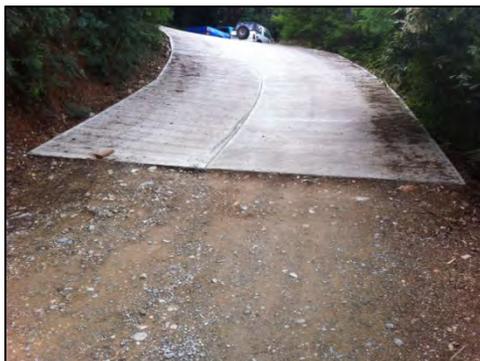
Photo 20: Calabash Boom Road paving - completed.

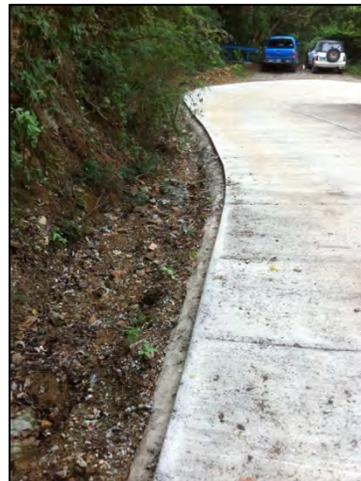
Photo 21: Calabash Boom Road paving - completed.

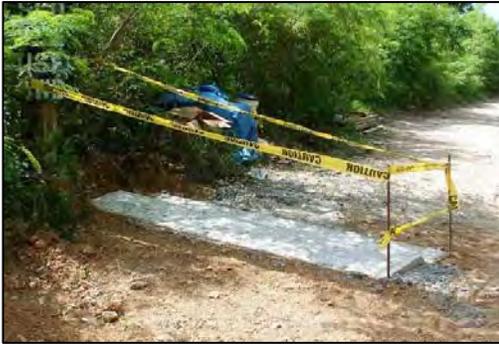
Photo 22: Concrete ridge waterbar.

Waterbars are angled ridges across a road that catch water and divert it to a roadside area to reduce road erosion. They can be constructed from a variety of materials including logs and concrete. At Calabash Boom, the contractor constructed eight concrete waterbars at various points along the road directing water into uphill drainage channels. Construction tasks for the concrete ridge waterbars (Photos 22 & 23) included excavating, forming, and pouring concrete, then backfilling so that the soil is flush with the top of the concrete. The contractor also constructed one double utility pole waterbar by excavating and placing two utility poles essentially flush with the road approximately 6 inches apart forming an “open trench” at an angle across the road (Photo 24). HOA resident feedback after the first phase was that the double utility pole design worked well to capture and control water flows and didn’t jostle car passengers as the concrete ridge waterbar did. Therefore, in the second phase CBCC’s Stormwater Engineer, Mr. Laude, designed and specified installation of a concrete “open trench” style waterbar (Photo 25 and Figure 2). HOA resident feedback is that this new style waterbar is superior, both in directing water flow off the steep roads and not jostling vehicles and passengers. It does require routine maintenance, as do other waterbar designs. Maintenance is

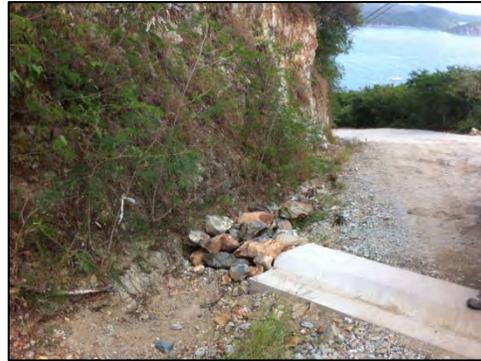
Photo 23: Concrete ridge waterbar with energy dissipater.

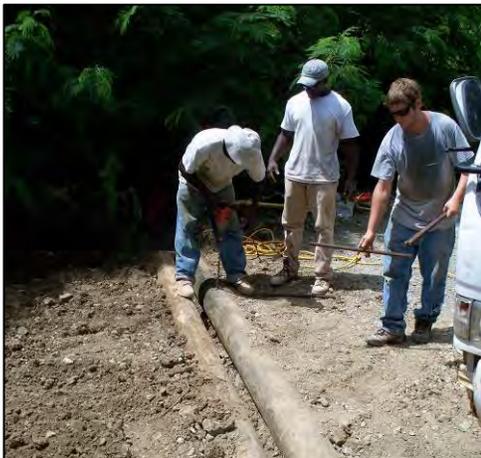
Photo 24: Double utility pole waterbar.

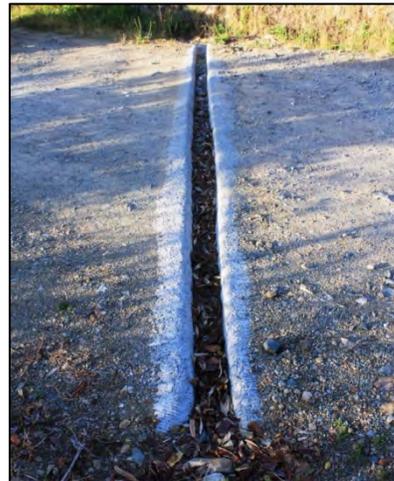
Photo 25: NEW DESIGN
concrete “open trench” waterbar.

Better Waterbar Design: The two construction phases of this project allowed for refinement and evolution of waterbar designs, as was discussed above in Section 4. The new concrete double water bar designed by CBCC Stormwater Engineer, Mr. Laude, was judged by the residents and maintainers as being superior. Thus, this design will be recommended for future use.

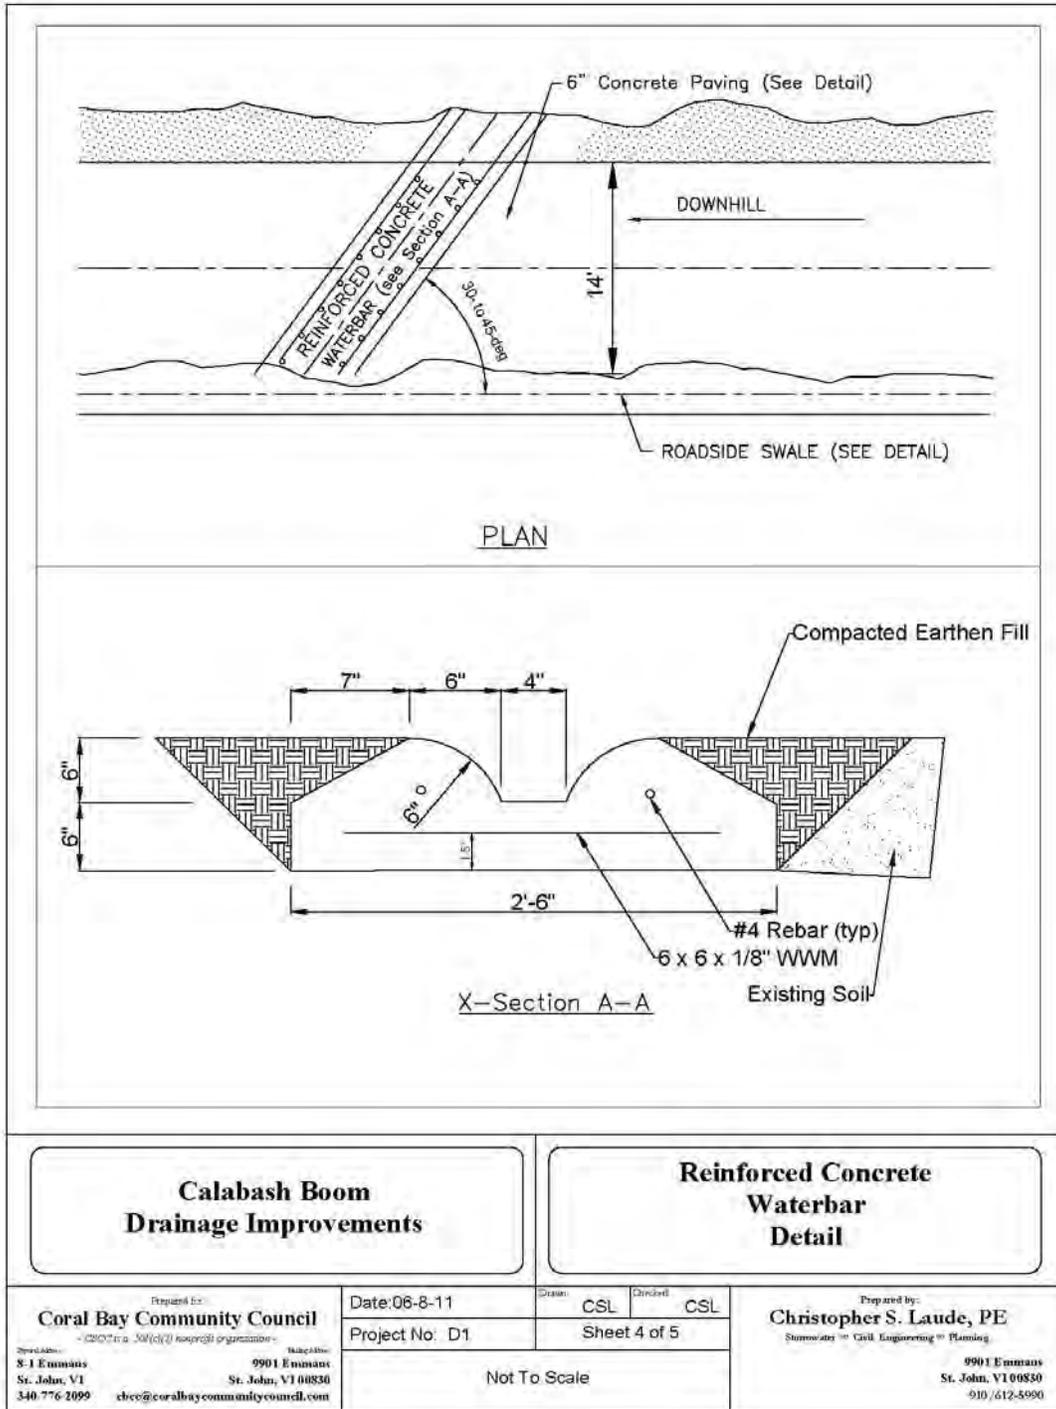
Figure 2: Concrete Open Trench Waterbar Construction Detail.

less important if the bar is angled near 35 degrees downhill and if there is a dropoff into the roadside drainage area, so that accumulation of sediment is less likely in the waterbar structure itself. According to Mr. Laude, it is very important that waterbars be set at a 25 to 35 degree angle on the road, rather than perpendicular, or directly across, the road surface. This allows the water flow to be turned and directed off the road surface, while still retaining sufficient velocity to carry debris off the road surface. If the waterbar is placed directly across the road, water hits the bar, drops its large debris in a pile, and maintenance (removing dirt and rocks) must be done much more frequently to keep the water flowing off the road, rather than jumping the waterbar and continuing down the road surface.

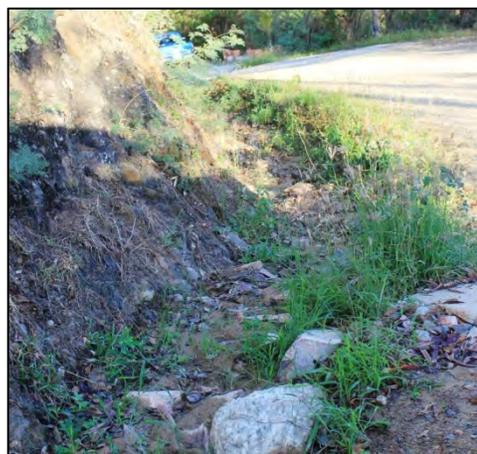
Photo 26: Roadside drainage channel.

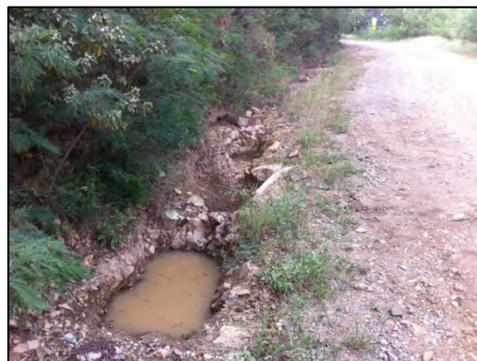
Photo 27: Step Pool.

dams slowing velocities allowing sediment to settle out of solution, cleaning stormwater runoff prior to delivering the stormwater to natural ghut areas. After the stormwater flows into the ghut, it has time to infiltrate or receive natural ghut cleansing before arriving at the lower watershed. This has led to less water on the roads and less-turbid water in the lower watershed. For a total project cost of \$185,926, CBCC was able to reduce roadway erosion; thus reducing sediment eventually discharged into Johnson Bay and at Shipwreck Landing. Attachment A is an interpretive poster that highlights these achievements.

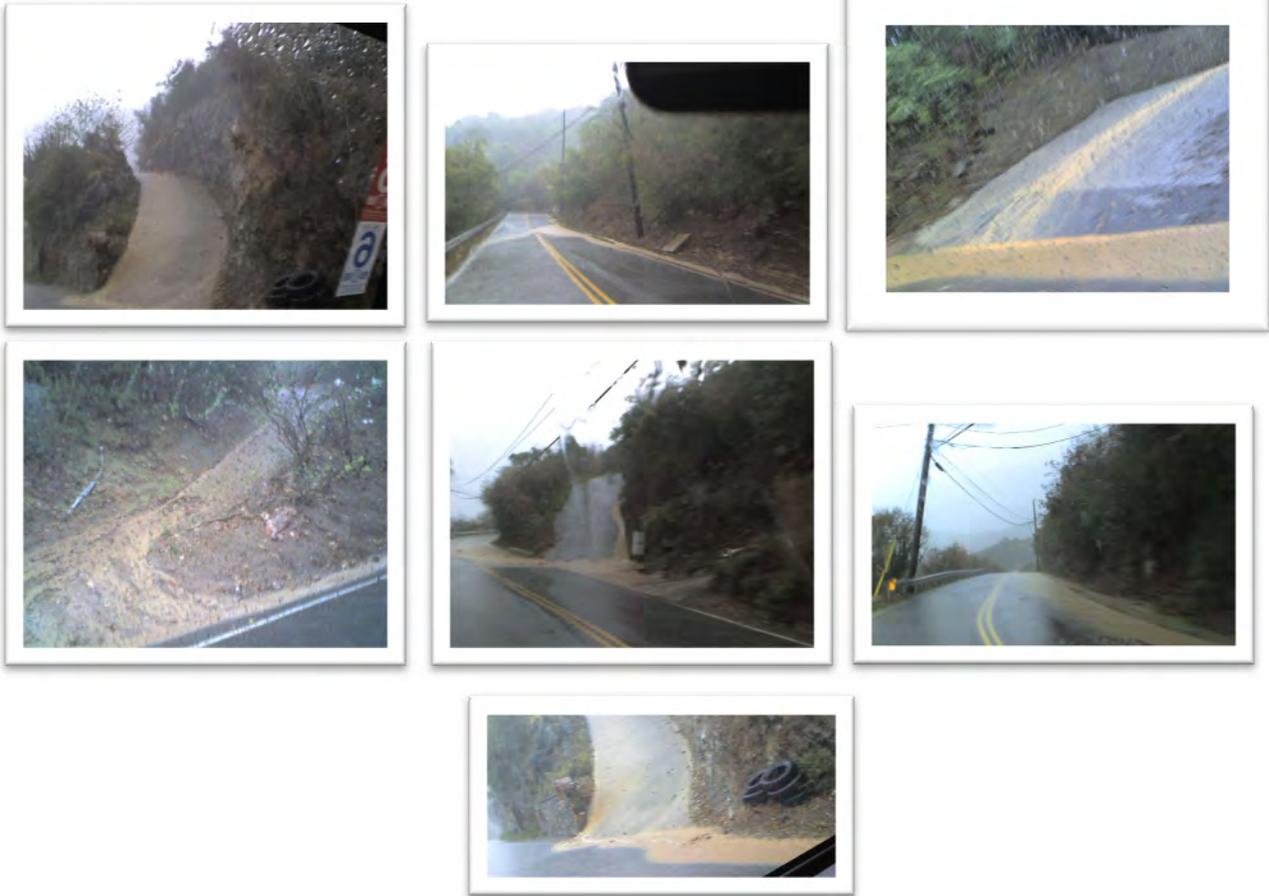
- This Plume emanates from a ghut adjacent to Shipwreck Landing that has a fairly large watershed contributing. However, during my initial observations (before 8AM) the only runoff entering the bay was clearly from the roadway (Rt. 107) and various construction projects in the lowest portions of the watershed. The following pictures illustrate this.

Examples of Roadway Leading up to Shipwreck Ghut

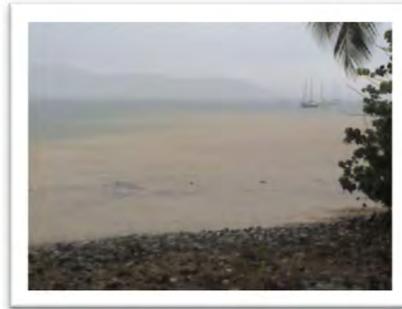
Larger Plume has formed

- The pollution entering the bay at this point is best dealt with by controlling the areas upstream where polluted runoff is observed. Constant monitoring of the construction sites for lack or failure of erosion control devices is necessary. Strong consideration should be given to stabilization of existing dirt roads through installation of paving or a drivable surface aggregate (generally gravel with fines to act as binder – Specs are available). One particular area noted to me previously was Calabash Boom Road which, although concrete at the intersection with Rt. 107, is primarily dirt. This is a large contributor to small storm flows into the bay, and should be paved and stabilized. Finally, any areas in the watershed contributing to Johnson Bay should stabilize open dirt and hillside areas with suitable native quick-germinating grasses and grass like species and eventually let the native shrubs and trees seed the areas. Suitable grasses have been observed on many fallow areas and along many new road cuts, specifically in the road cut highlighted in ERM #1 so it is clear that there are native grasses suitable for establishment of cover.

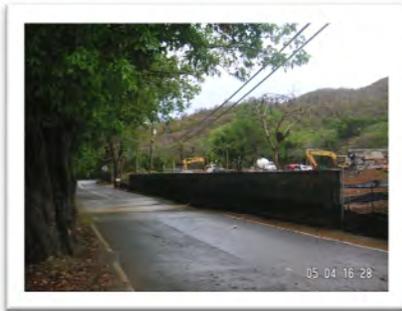
performed a site visit later in the day, and another resident took some photos at about 4PM. In addition to runoff directly from the sediment basin, minor failures of silt fence contributed to the polluted runoff. There was substantial staff present in the early part of the day attempting to repair and keep facilities in working order.

Downstream of Reliance Sediment Basin

- It is clear that a majority of the sediment from this event was a direct result of the Reliance site basin overflowing and silt fence failure. While the site was not necessarily designed for this large magnitude of event, responsibility for damages downstream from the site should fall on the Reliance Project. The most important way to begin solving this problem is for Reliance to provide a positive outflow to the basin other than the simple spillway over the road. An outlet structure with multiple orifices or a perforated riser and a pipe or large box culvert under the road should be installed. This will allow a more moderate discharge from the site in the early parts of the storm to prevent the large amount overflowing late in the storm. In conjunction with this outflow, suitable BMP measures should be installed within the constructed gully on-site and in the basin to provide longer flow paths for small storms and suitable areas for the dropout of sediment. Finally, basin areas that are only dirt should be immediately stabilized with erosion control blanket and seeded and vegetated now that the growing season has begun again.

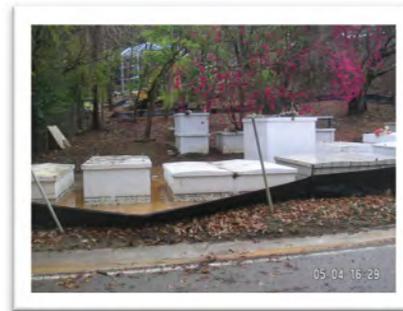
Example of failing silt fence

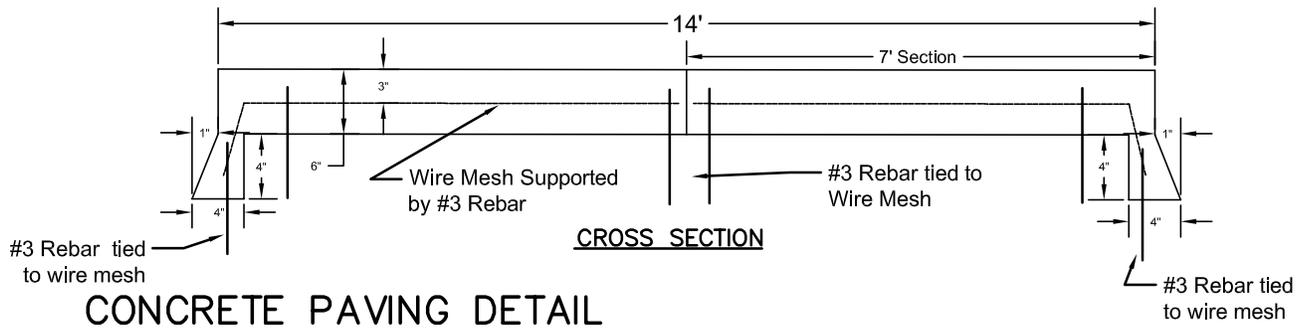
CONCRETE PAVING DETAIL

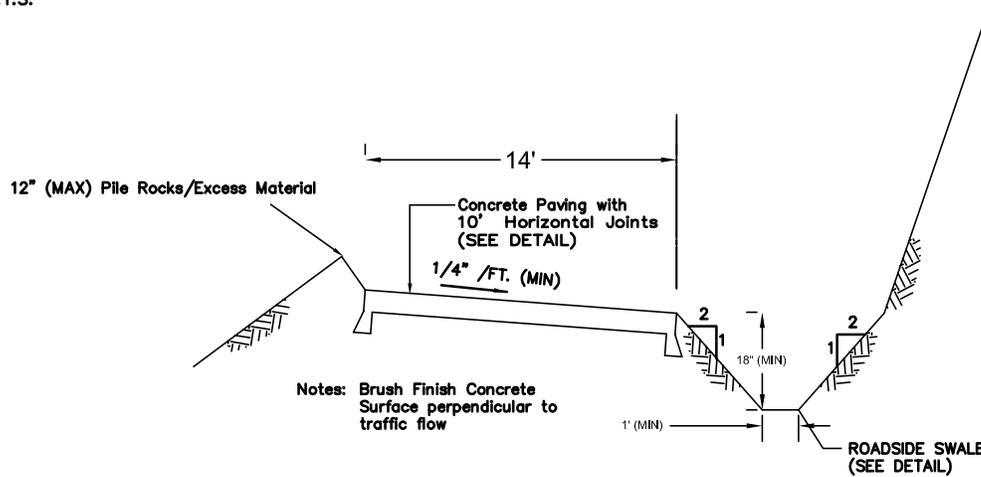
TYPICAL ROADWAY CROSS SECTION – CONCRETE ROADWAY

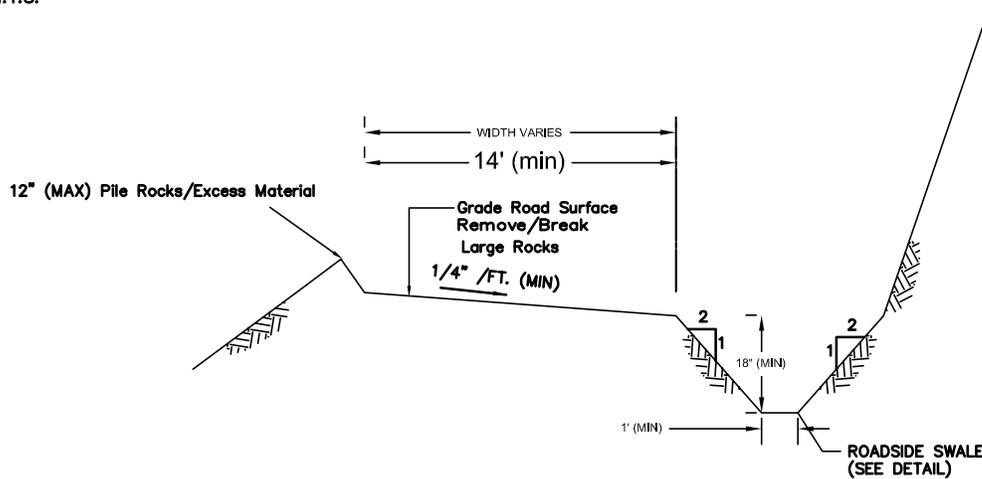
TYPICAL ROADWAY CROSS SECTION – DIRT ROADWAY

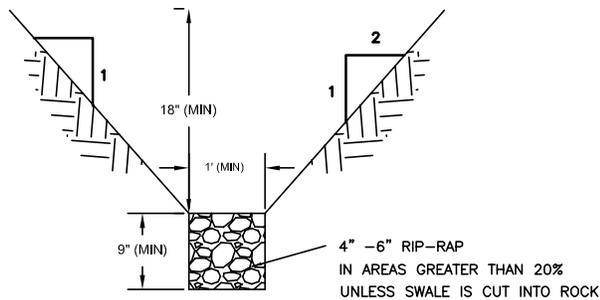
SWALE CROSS-SECTION

TYPICAL ROADSIDE SWALE DETAIL

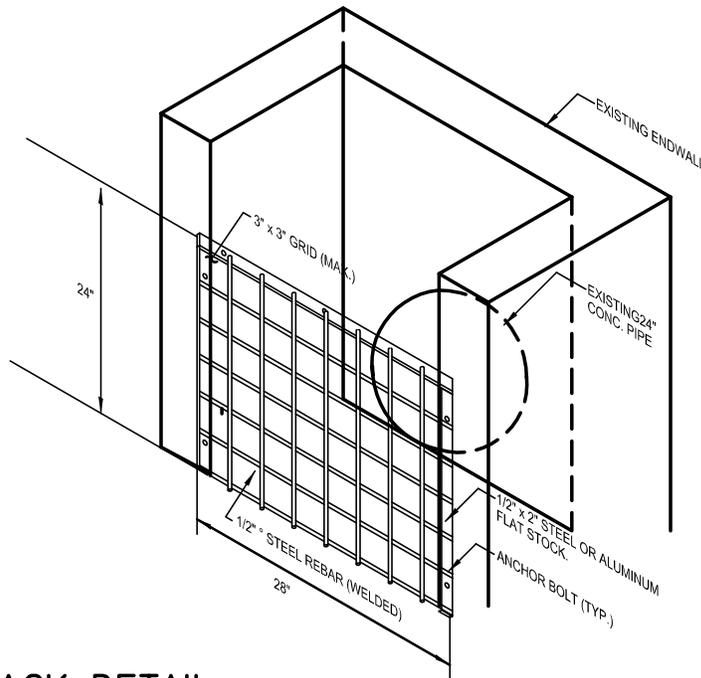
TRASH RACK DETAIL

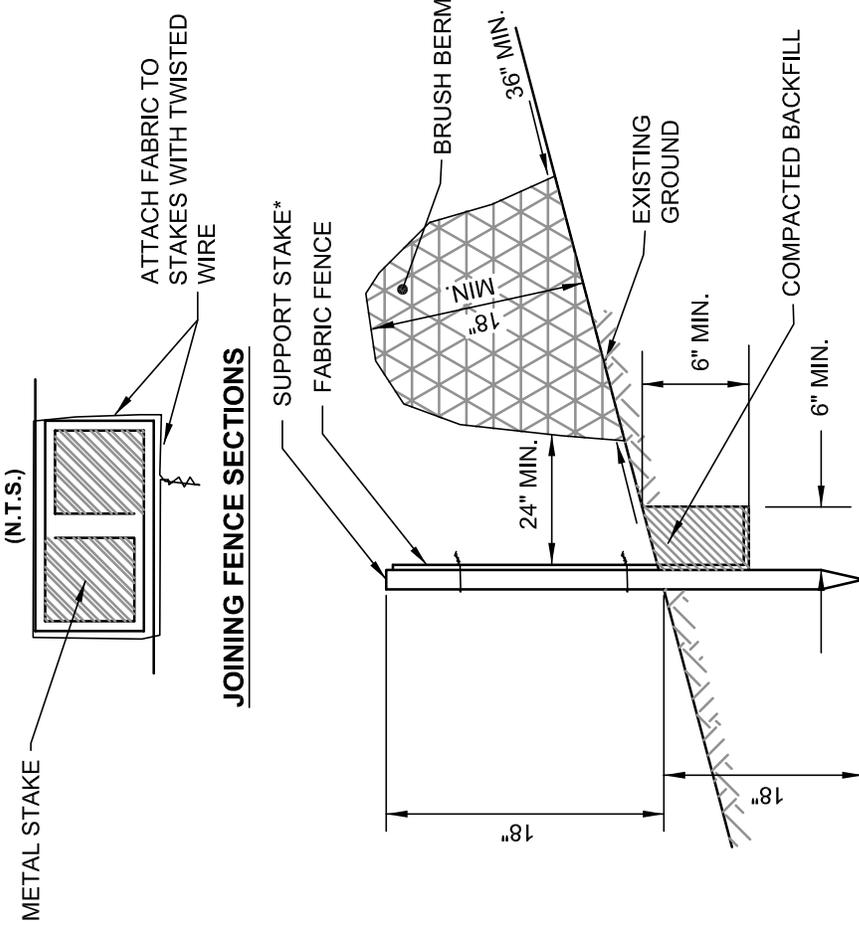
STANDARD FILTER FABRIC FENCE (18" HIGH)

* Stakes spaced @ 8' maximum. Use steel stakes.

Filter Fabric Fence must be placed at level existing grade. Both ends of the barrier must be extended at least 8 feet up slope at 45 degrees to the main barrier alignment.

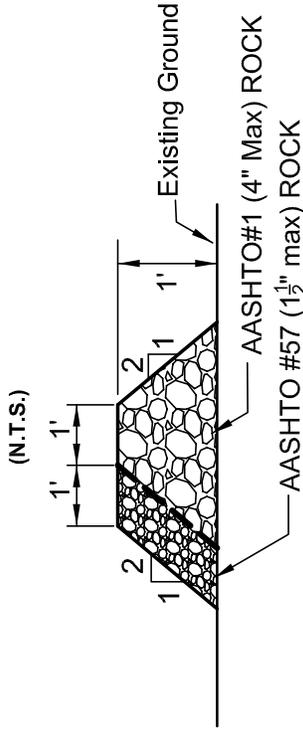
ROCK FILTER OUTLET CROSS SECTION DETAIL

Rock Filter installed along failed Silt Fence shall overlap fencing a minimum of 1' on each side.

Sediment must be removed when accumulations reach 1/2 the height of the filters.

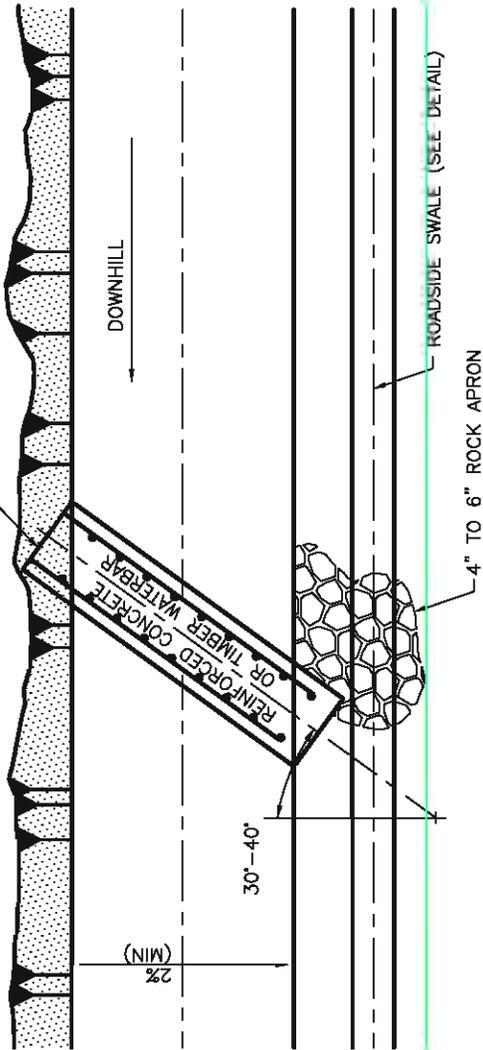
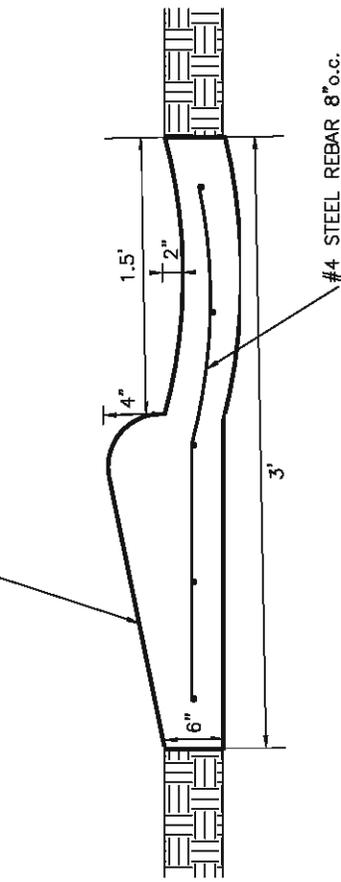
3000 psi. CONCRETE WATERBAR

**Reinforced Concrete
PROFILE**

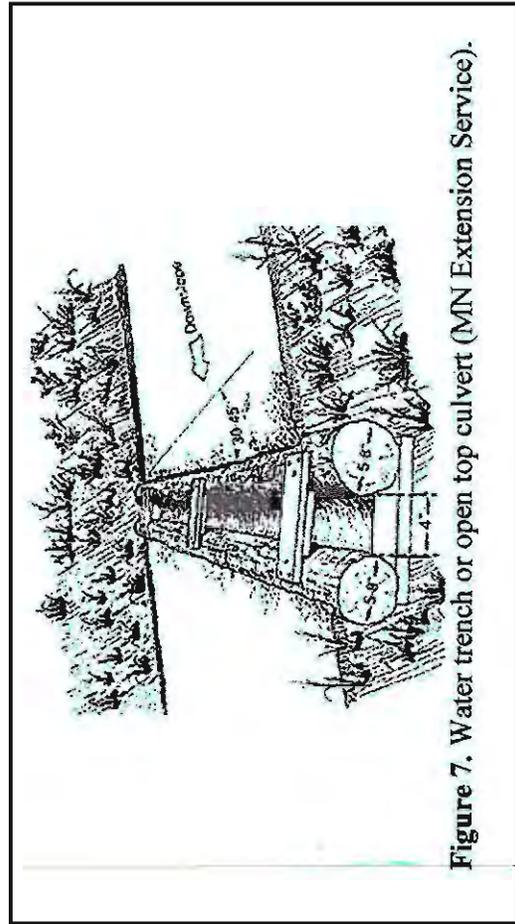
- Make the trench between the logs 6 inches deep and wide enough to be easily cleaned.
- The width of a shovel is convenient.
- Install the trench at an angle similar to waterbars—30-45 degrees. Do not turn the water more than 45 degrees.
- Nail spacers between the side boards or logs to keep them in place and stabilize the structure.
- Remove roadside berms or other obstacles that might block water moving from the outlet.
- Water should flow into a stable, vegetated area or conveyance ditch away from the road.
- Use water bar spacing when the main purpose is to divert water off a traffic surface.
- Follow broad-based dip and cross-drain culvert spacing if cross-drainage is the main goal (Table 2).

Figure 7. Water trench or open top culvert (MN Extension Service).

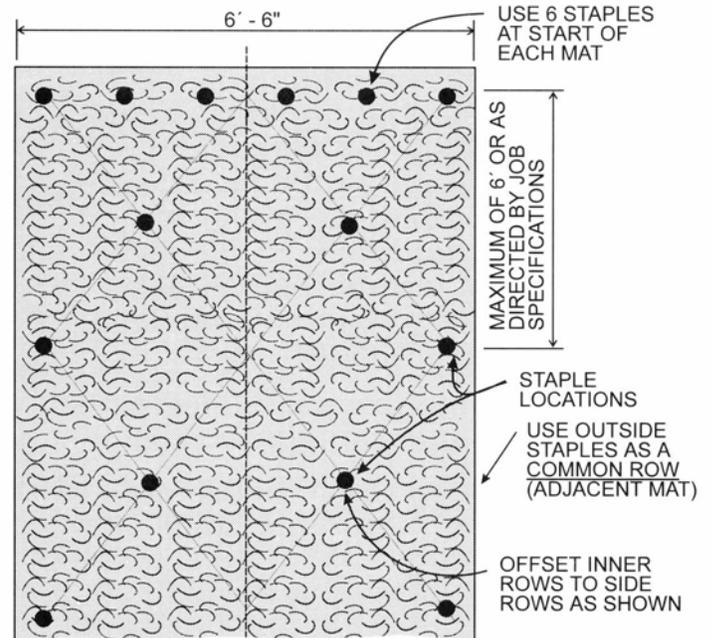
Staples should be driven perpendicularly into the soil. Staple each blanket at every edge, with alternate spacing in the center of each blanket. Use a common row of staples at the seam formed by adjoining blankets. Use six (6) staples at the beginning and end of each blanket (see Figure 1).

Figure 1—Pattern For Anchor Staples

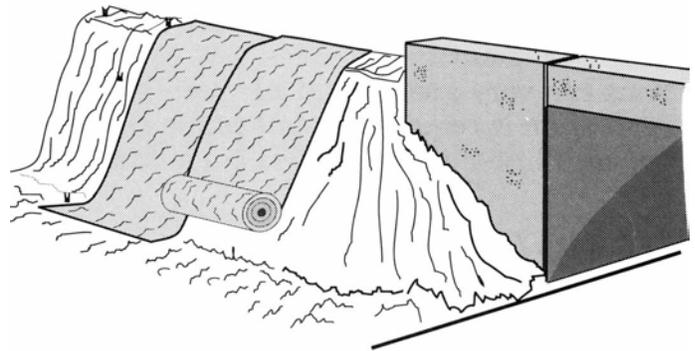
Figure 2—Slope Application

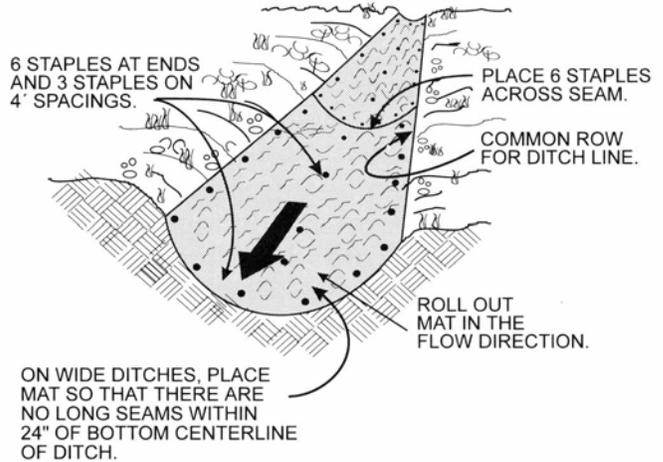
Figure 3—Ditch Line Application

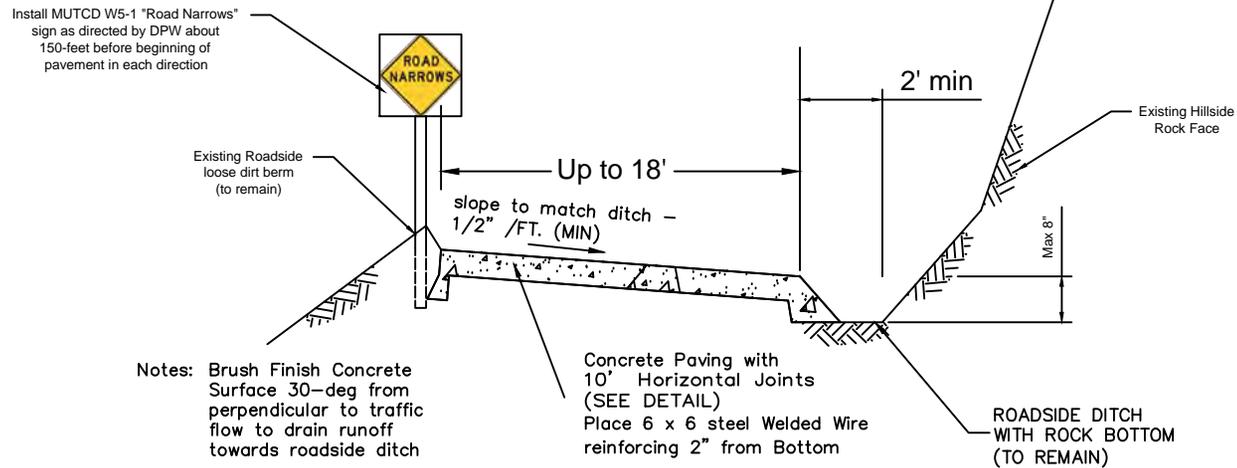
TYPICAL ROADWAY CROSS SECTION - CONCRETE ROADWAY

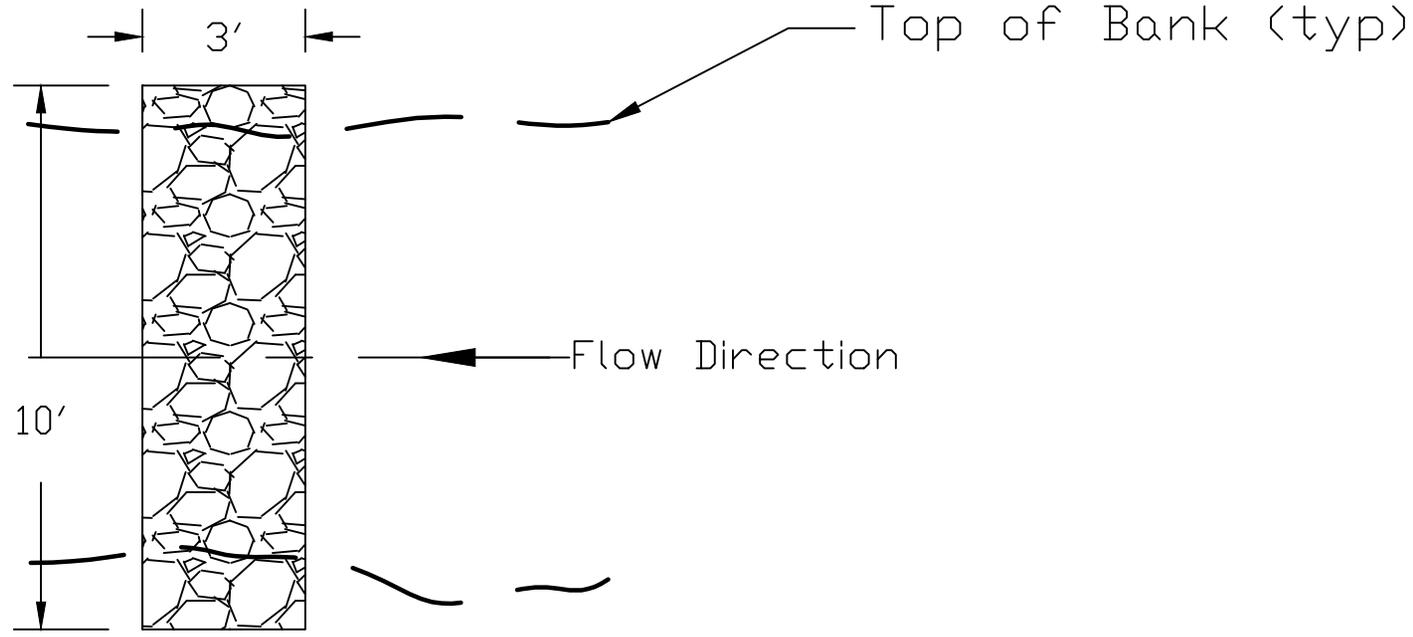
Rock Check Dam

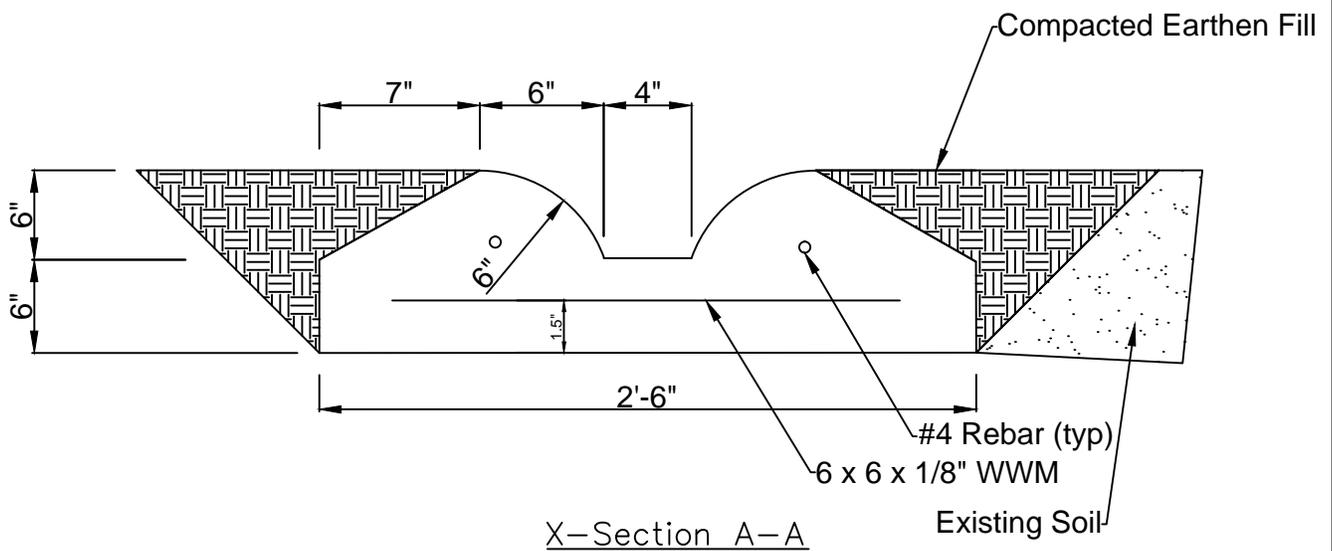
X-Section A-A

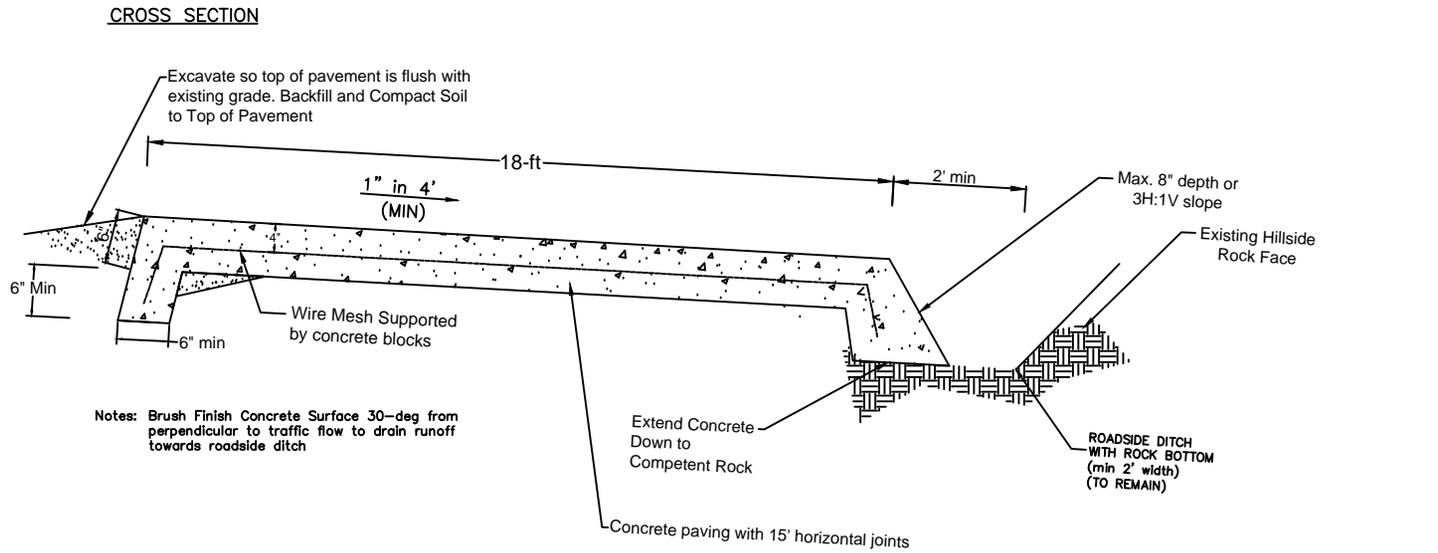
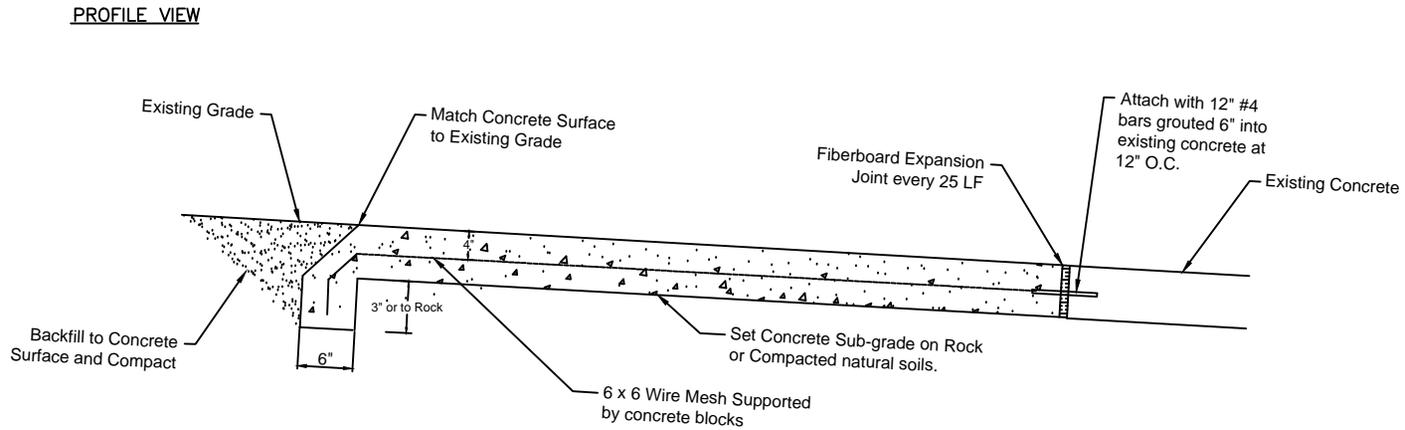
Calabash Boom Roadway Paving Detail

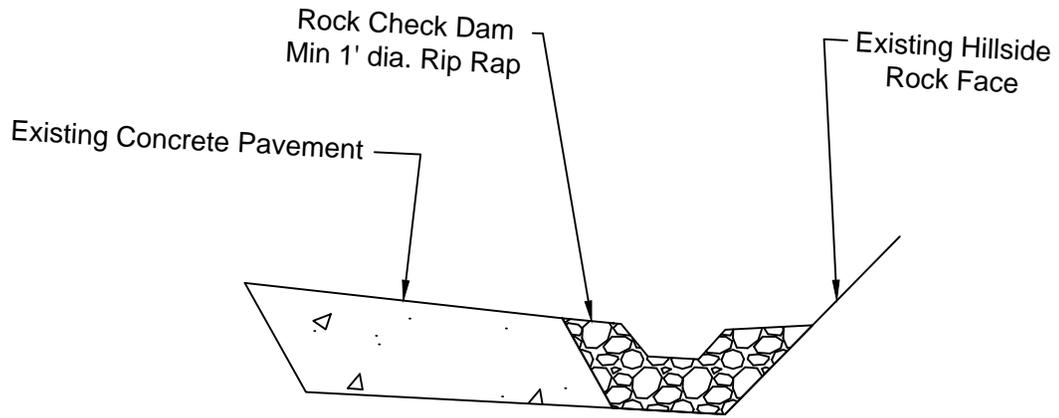
Rock Check Dam Details
