St. Thomas East End Reserves Watershed Management Plan

May 2013

Horsley Witten Group, Inc.

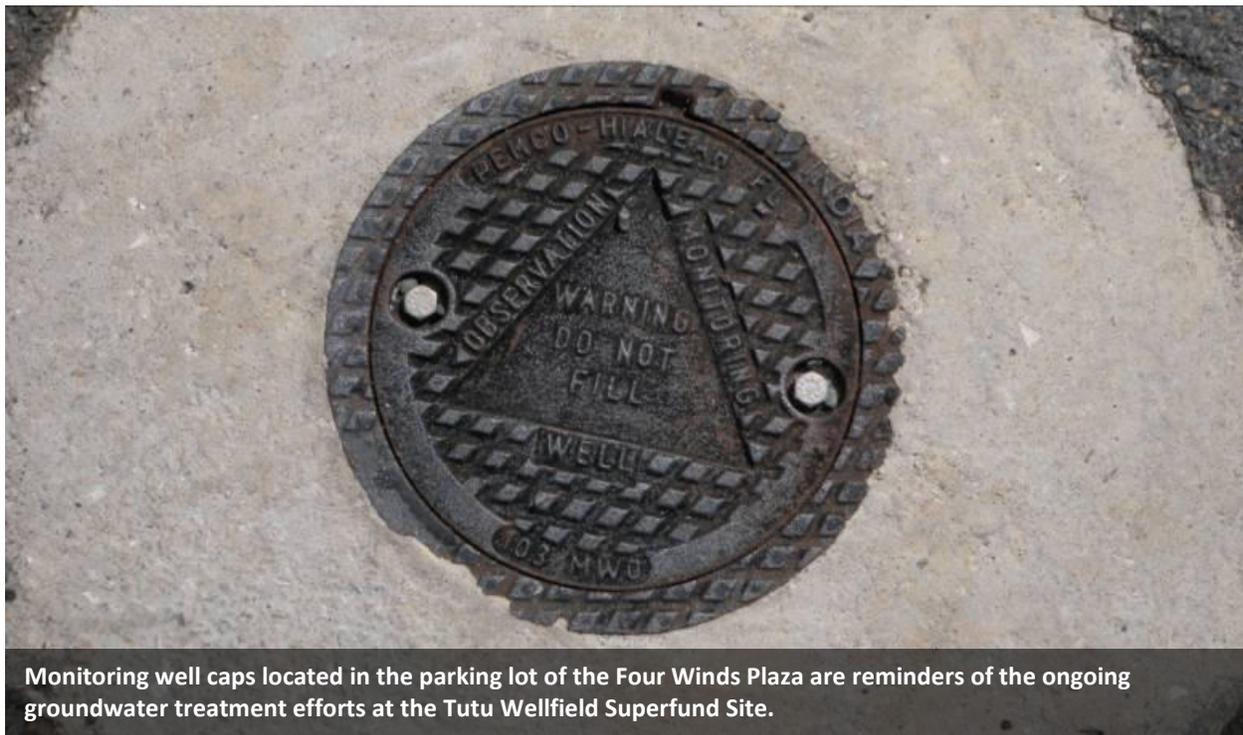
Monitoring well caps located in the parking lot of the Four Winds Plaza are reminders of the ongoing groundwater treatment efforts at the Tutu Wellfield Superfund Site.

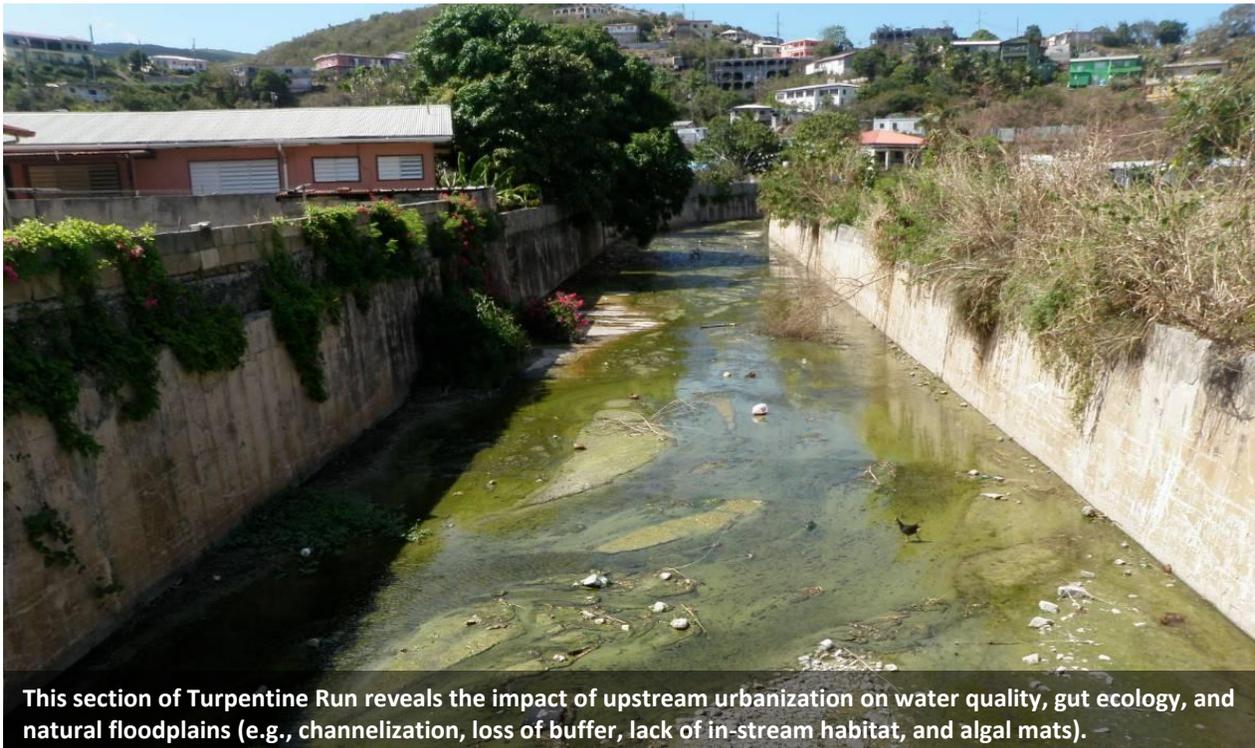
This section of Turpentine Run reveals the impact of upstream urbanization on water quality, gut ecology, and natural floodplains (e.g., channelization, loss of buffer, lack of in-stream habitat, and algal mats).

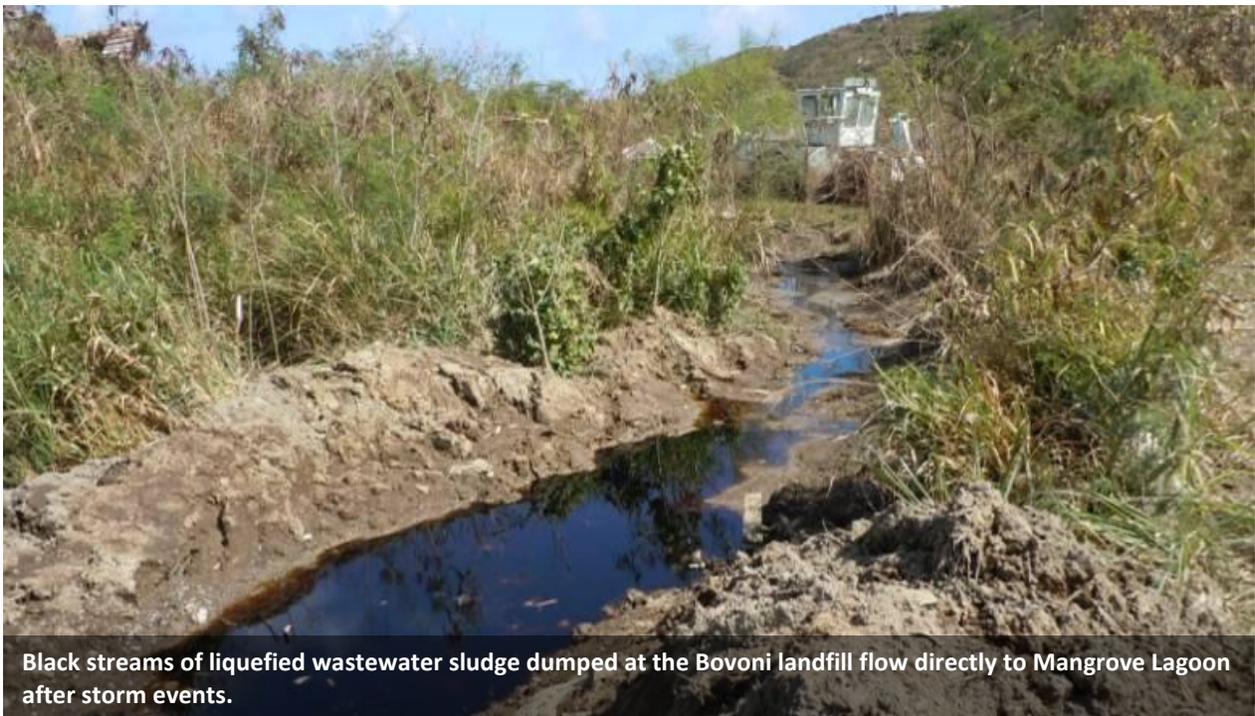
Black streams of liquefied wastewater sludge dumped at the Bovoni landfill flow directly to Mangrove Lagoon after storm events.

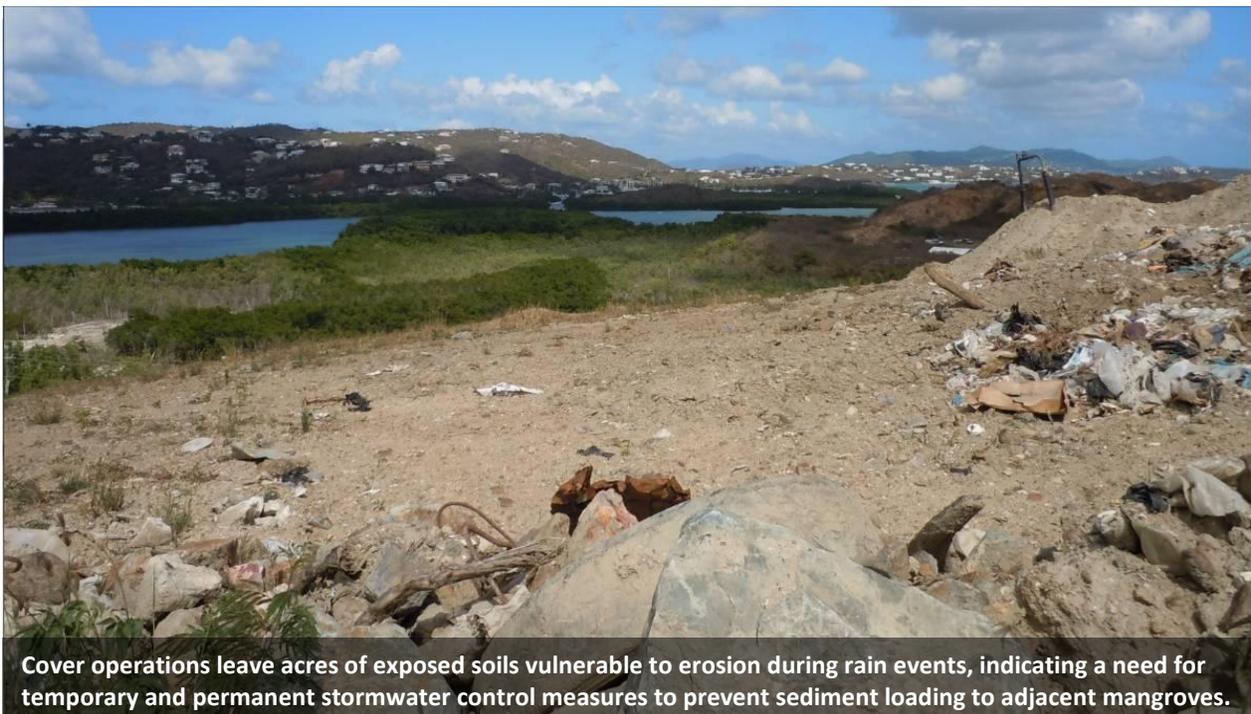
Cover operations leave acres of exposed soils vulnerable to erosion during rain events, indicating a need for temporary and permanent stormwater control measures to prevent sediment loading to adjacent mangroves.

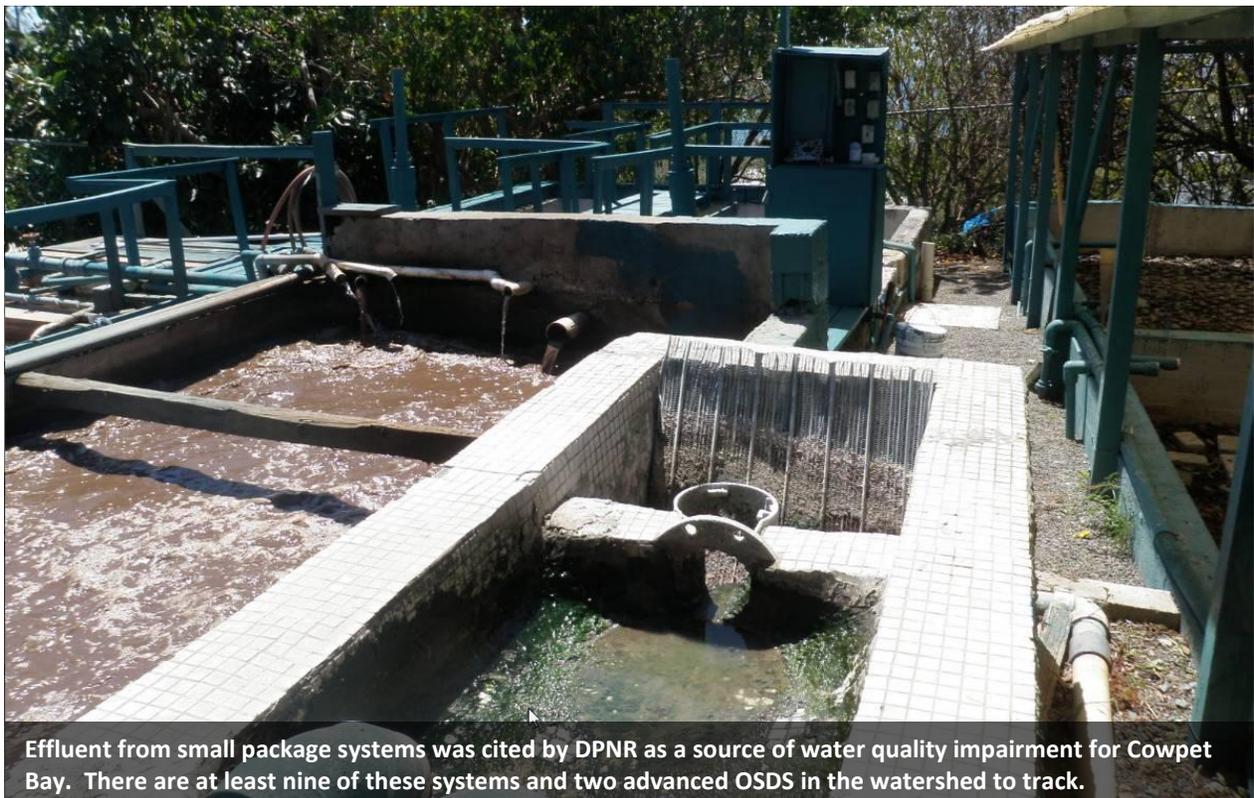
Effluent from small package systems was cited by DPNR as a source of water quality impairment for Cowpet Bay. There are at least nine of these systems and two advanced OSDS in the watershed to track.

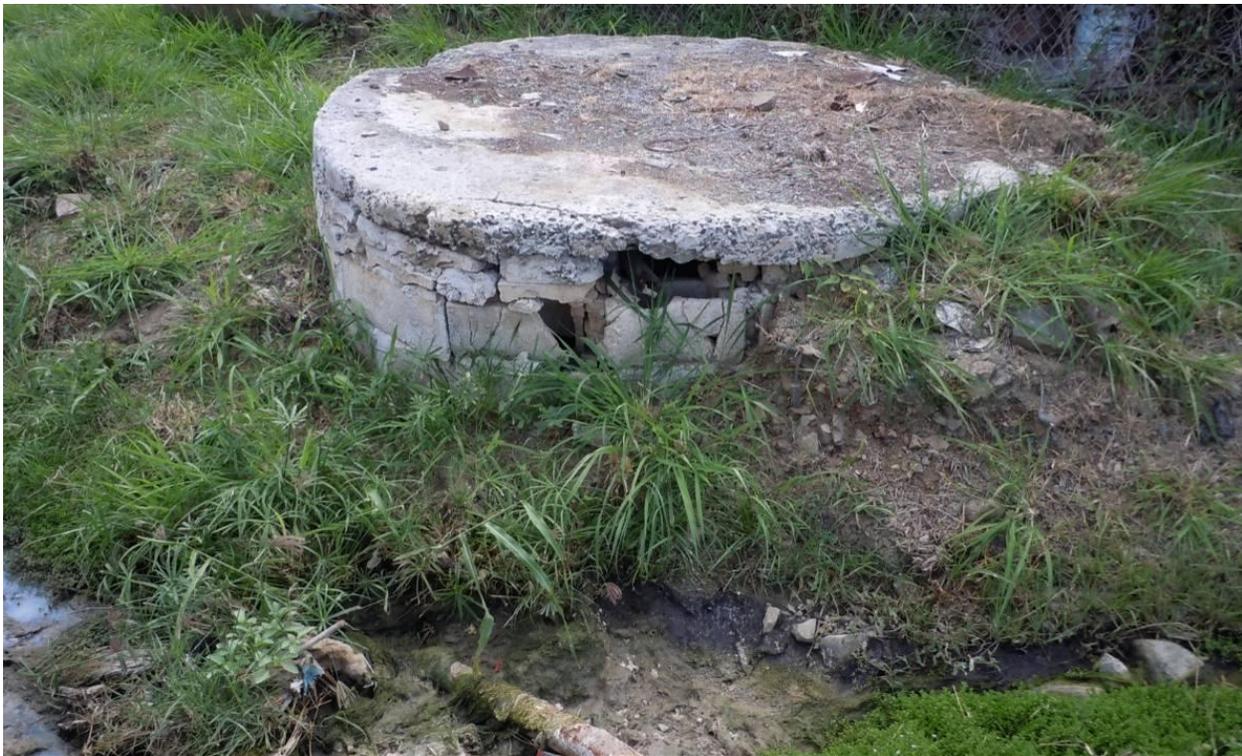
Deteriorating on-site sewage systems and evidence of recent wastewater discharges to guts were observed at multiple locations in the watershed.

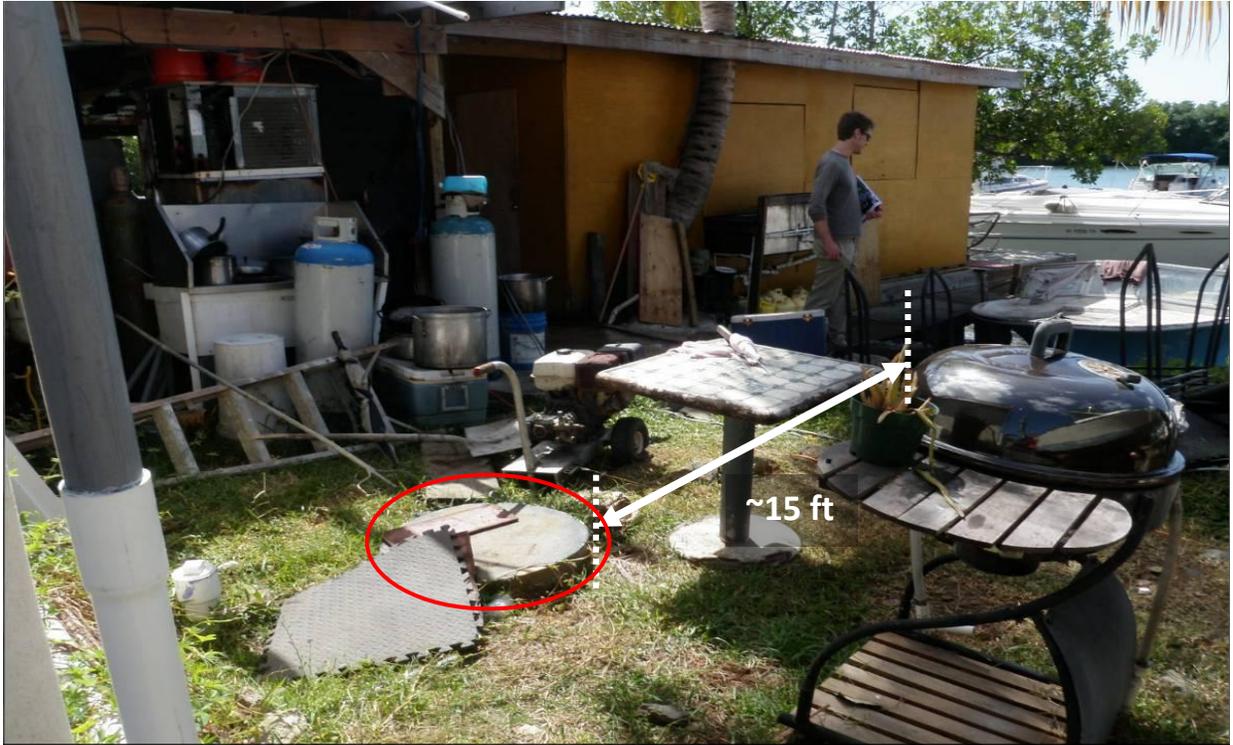
Between the restrooms and Benner Bay is the onsite wastewater system at “the Patch.” The access manhole for this OSDS is less than 15 ft from the water’s edge, leaving little distance for groundwater

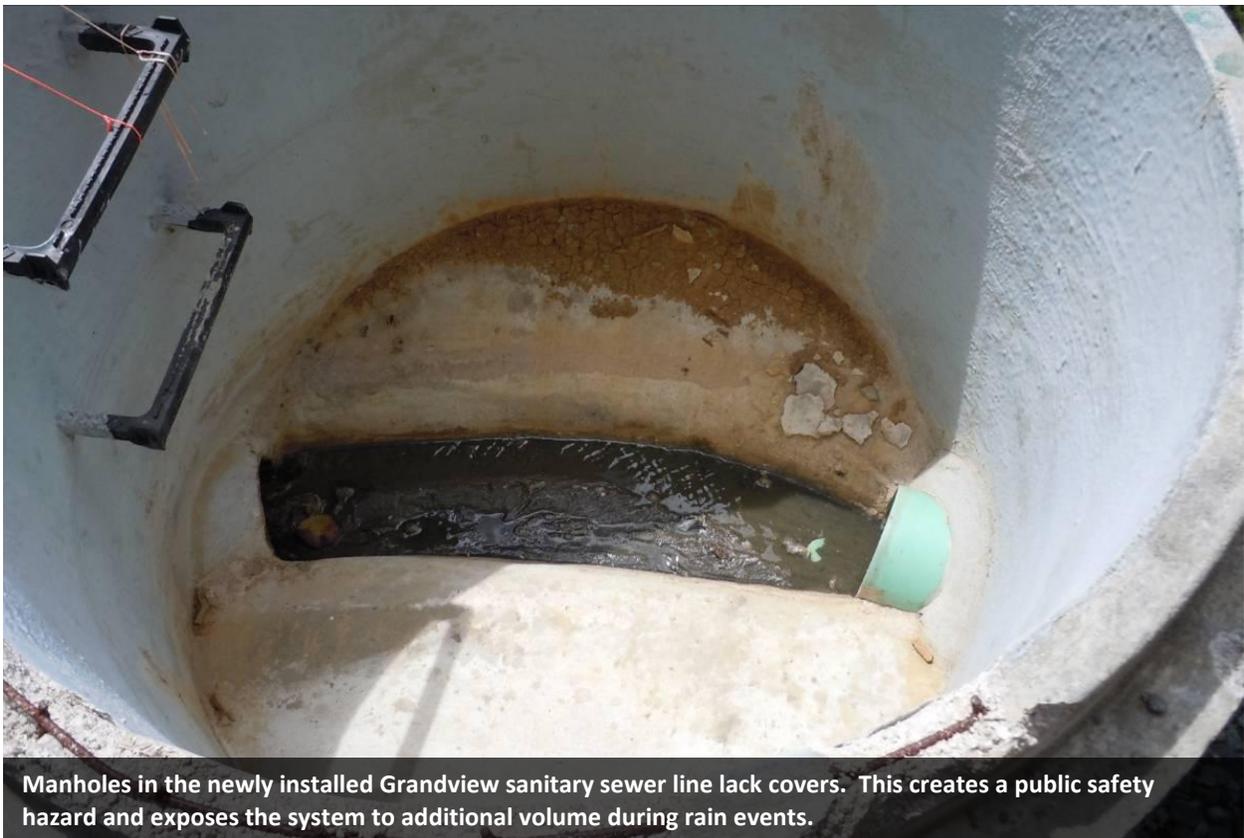
Manholes in the newly installed Grandview sanitary sewer line lack covers. This creates a public safety hazard and exposes the system to additional volume during rain events.

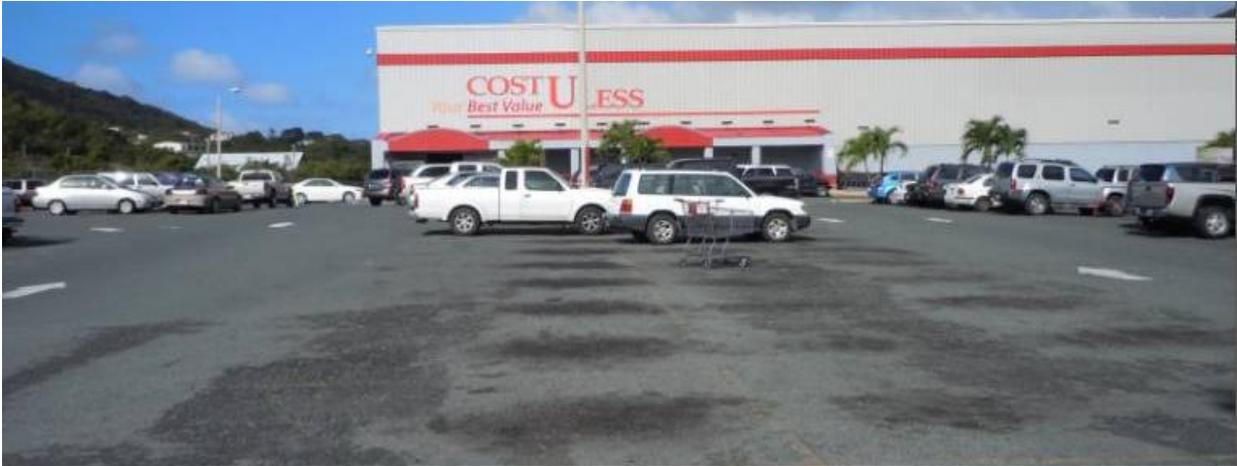
The oil stains seen here are one of a number of pollutants collecting on impervious surfaces throughout the watershed that are washed into Turpentine Run and discharged into Mangrove Lagoon when it rains.

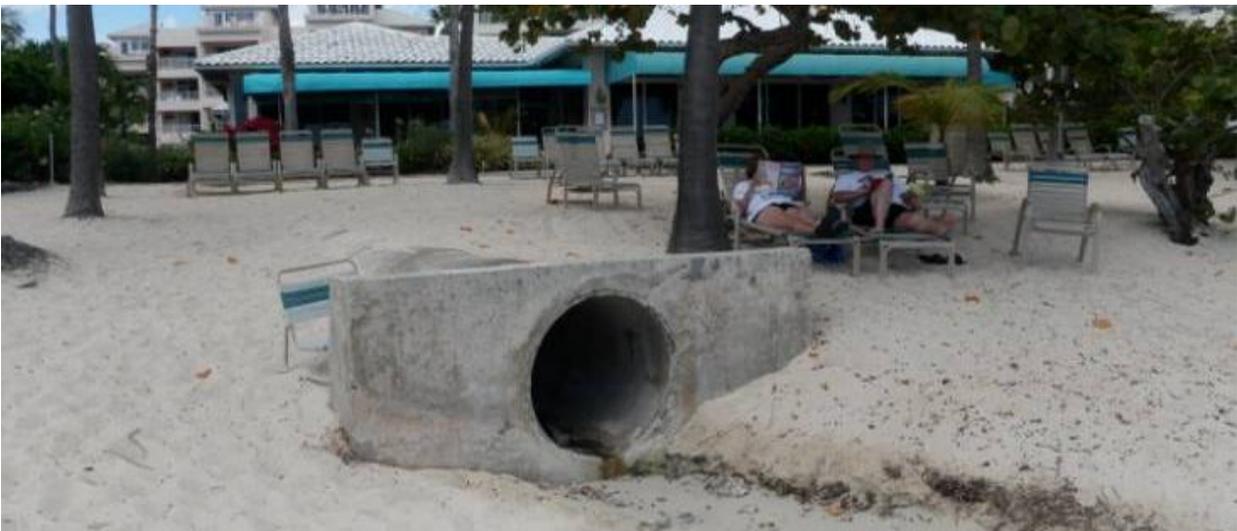
Discharge pipes visible on the beach drain parking lots, roads, and other developed areas in the watershed. In most cases throughout STEER, this runoff is not cleaned prior to discharge.

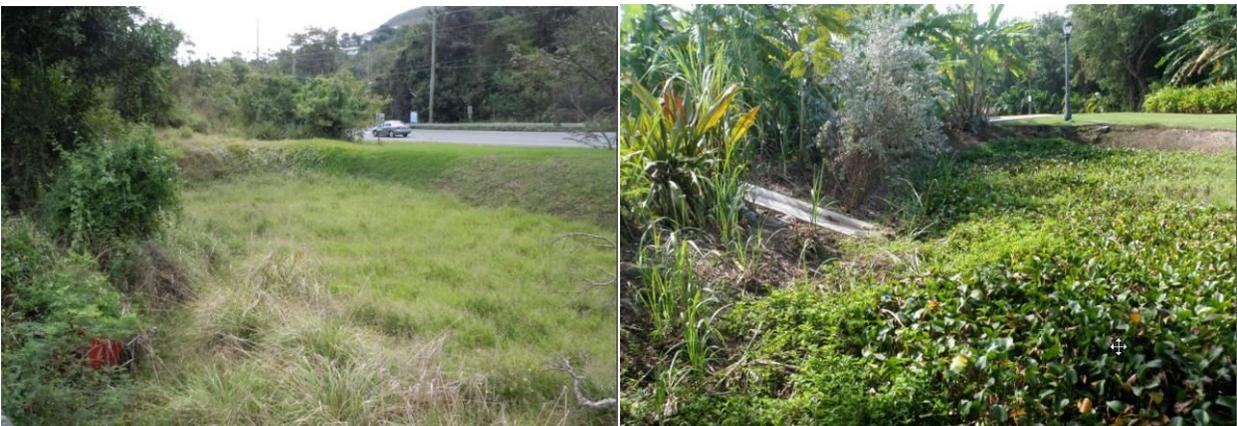
Two examples of existing stormwater management facilities are the dry detention basins at Cost-U-less and the wet basin at the Ritz Carlton.

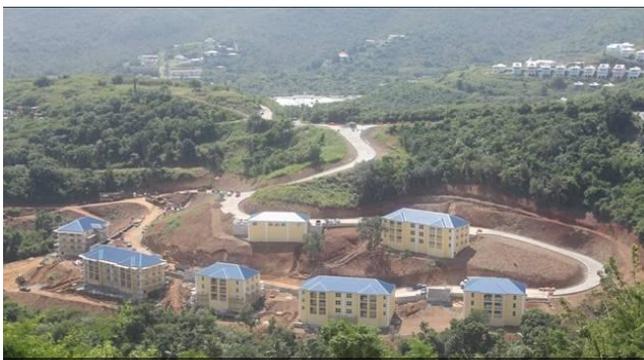
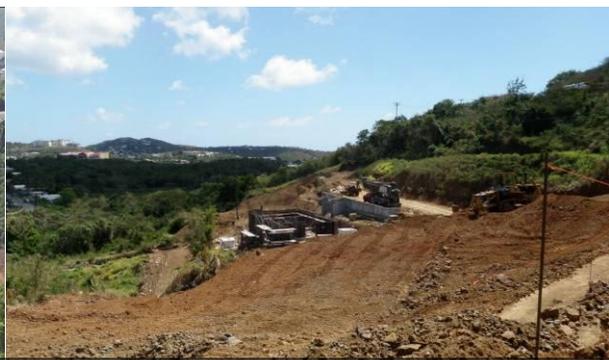
Grandview uses erosion control blankets and riprap to stabilize some slopes, but there remain acres of exposed soils and failing perimeter silt fencing that result in sedimentation downstream.

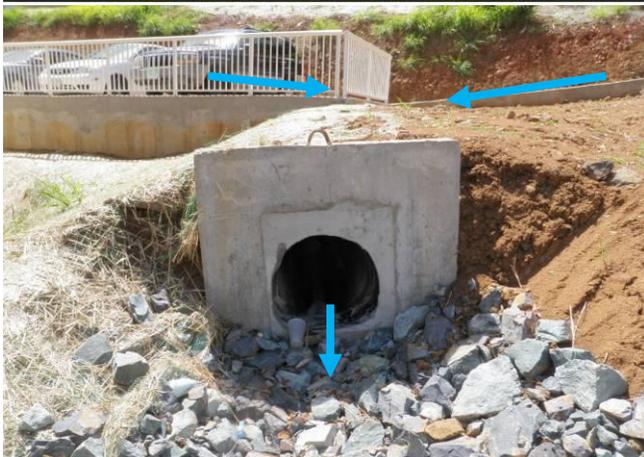
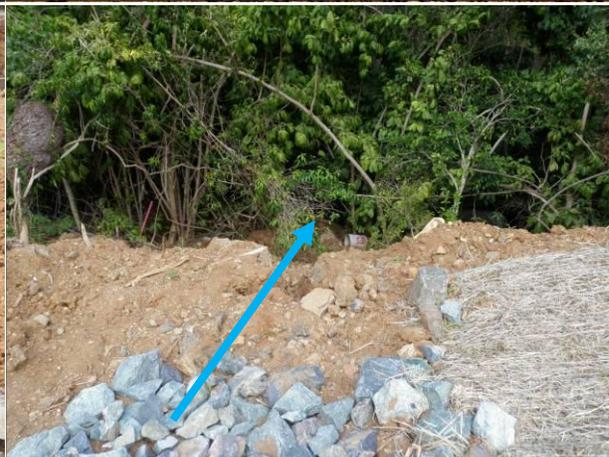
Outfalls discharge stormwater from Grandview roads and parking lots directly to the gut without any form of water quality treatment or flow detention.

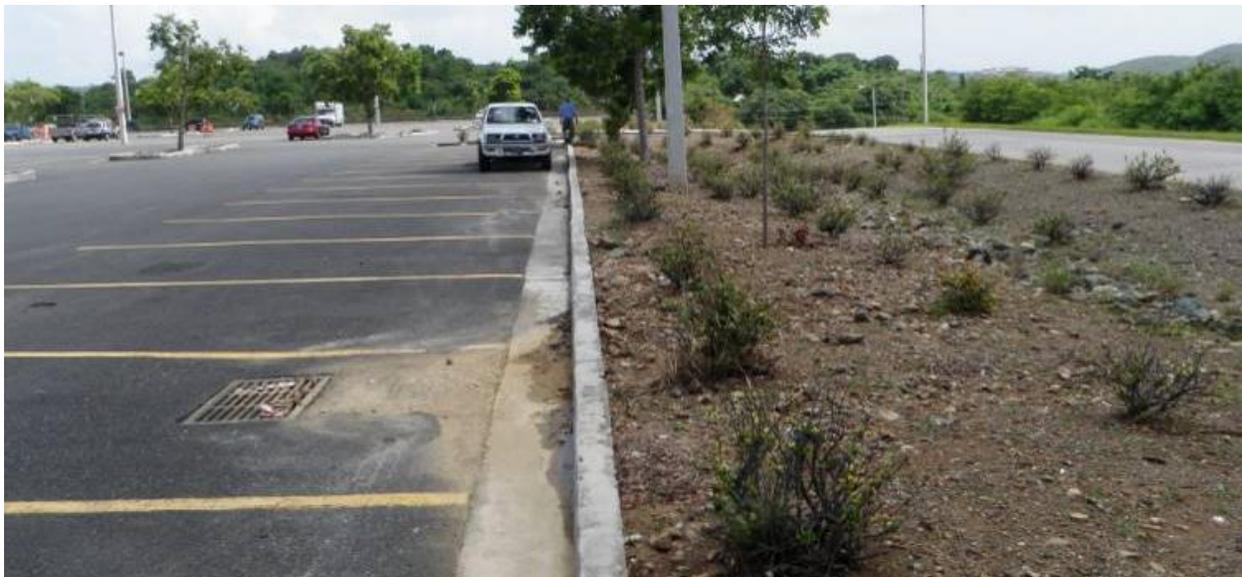
Retrofitting can help improve existing conditions. An easy fix at Home Depot is to block this inlet and allow parking lot runoff to flow into landscaping via curb cuts, allowing for plant uptake, infiltration, and filtering.

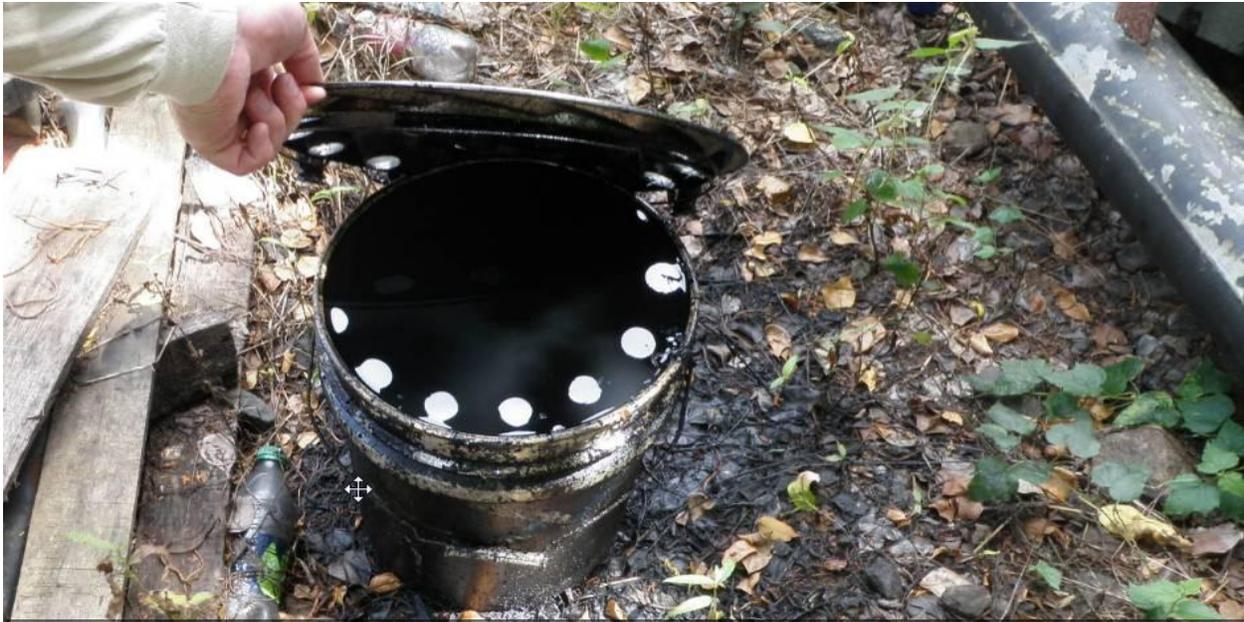
Overflowing buckets of used oil were found along the gut at locations where easy access allows for dumping and the abandonment of vehicular equipment.

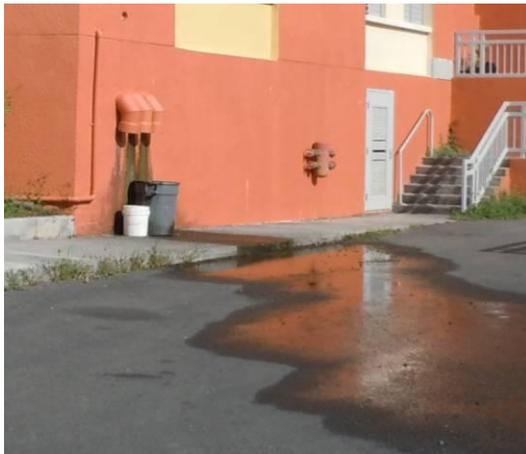
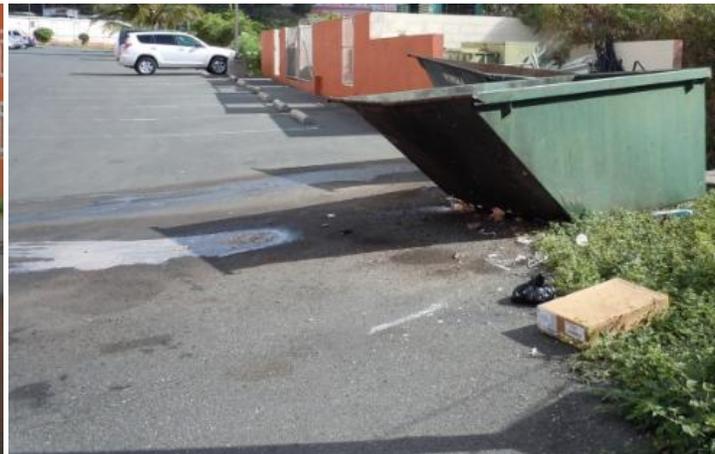
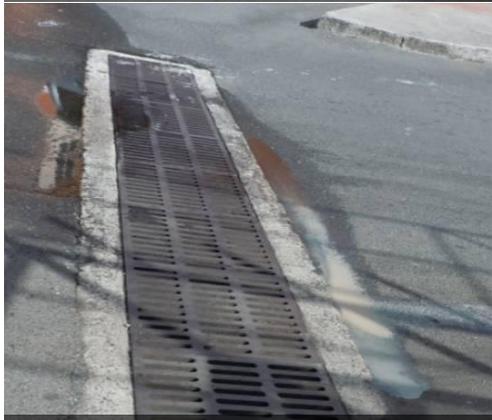
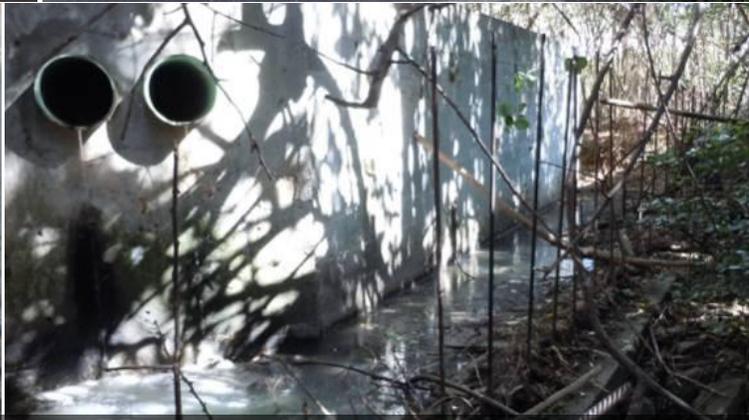
Unused cistern overflows, mop bucket waste, and dumpster juice at this site drain across the parking lot carrying pollutants into the storm drain system and discharging them downstream even when it is not

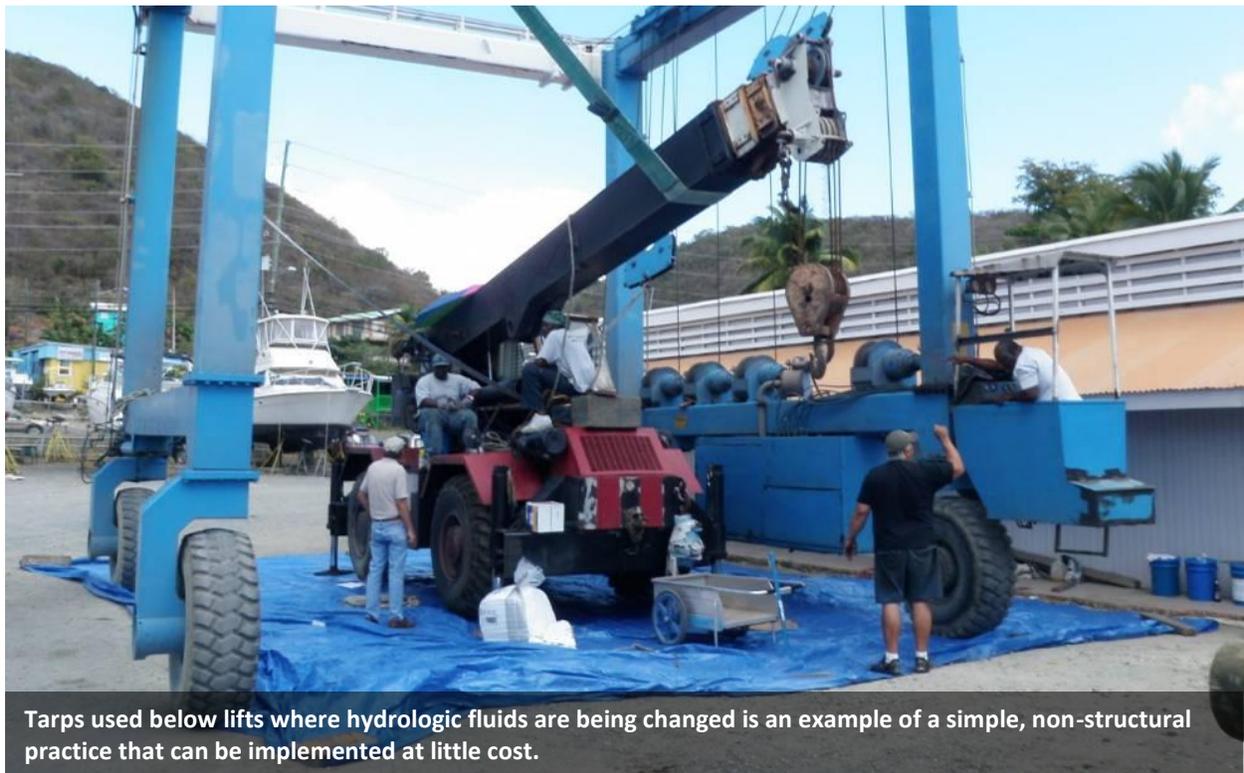
Tarps used below lifts where hydrologic fluids are being changed is an example of a simple, non-structural practice that can be implemented at little cost.

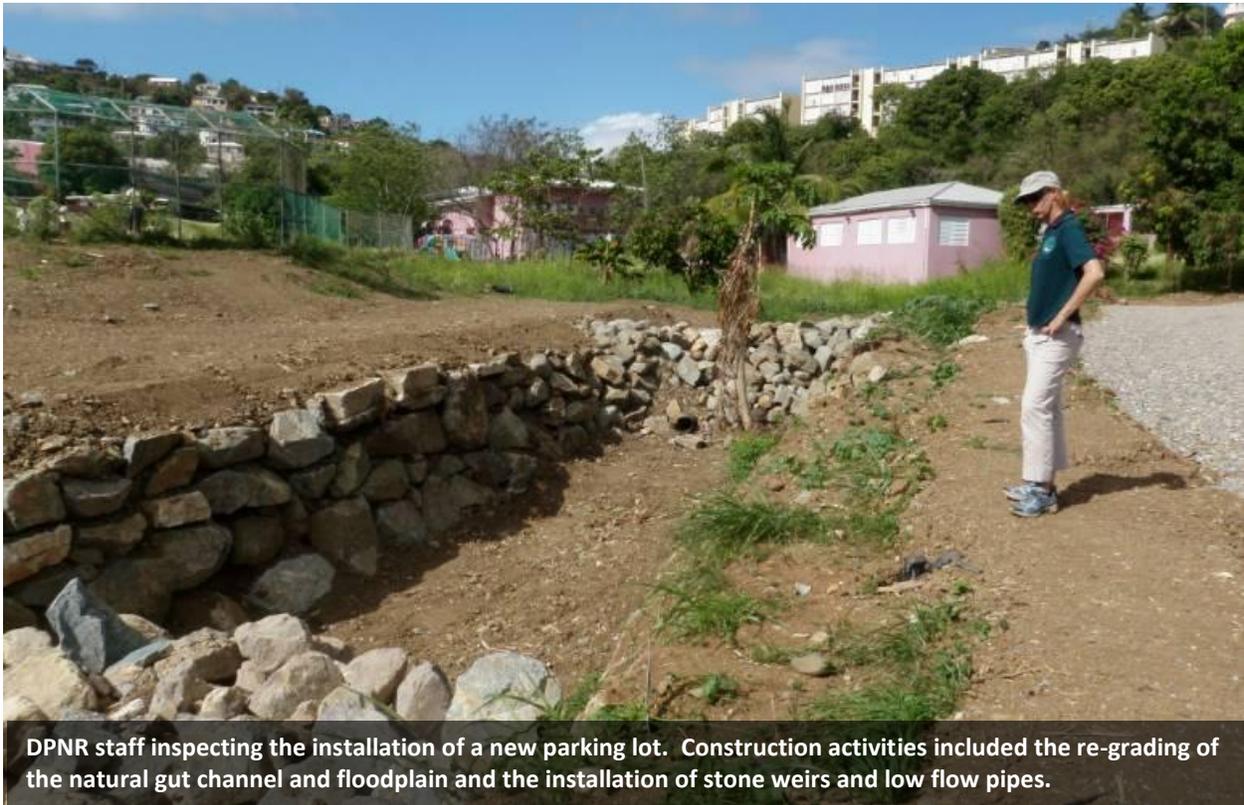
DPNR staff inspecting the installation of a new parking lot. Construction activities included the re-grading of the natural gut channel and floodplain and the installation of stone weirs and low flow pipes.

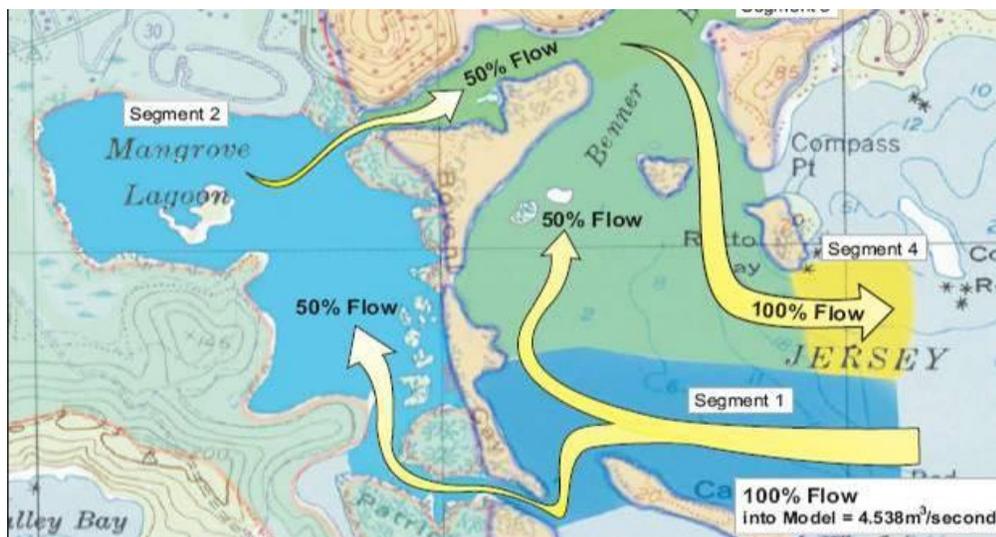
Models used to develop TMDLs for Mangrove Lagoon assumed predominant clockwise currents. A feasibility analysis of opening the second false entrance should more accurately document flow patterns.

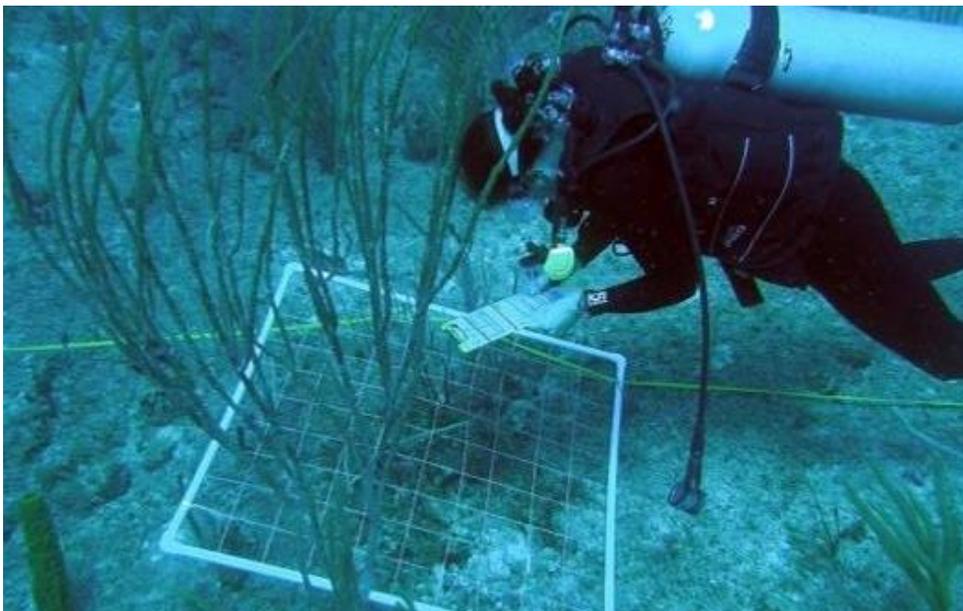
Biological characterizations of STEER included quantifying benthic habitat composition using quadrants (shown here), as well as establishing transects to document the abundance and diversity of fish, debris, and macro-invertebrates.

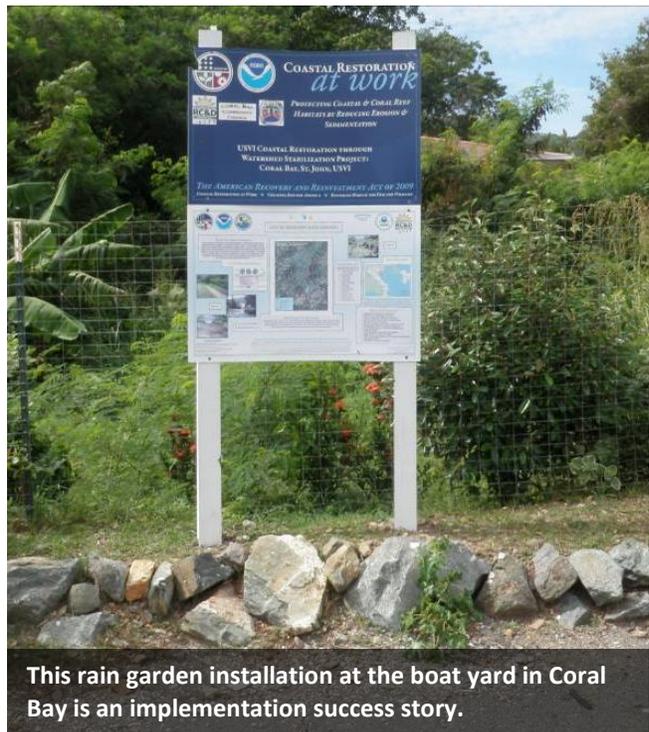
This rain garden installation at the boat yard in Coral Bay is an implementation success story.
