**Preliminary Assessment of Benthic Macrofauna within the  
Kaneohe Bay Yacht Club Harbor, Oahu, Hawaii**

April 2004

## Introduction

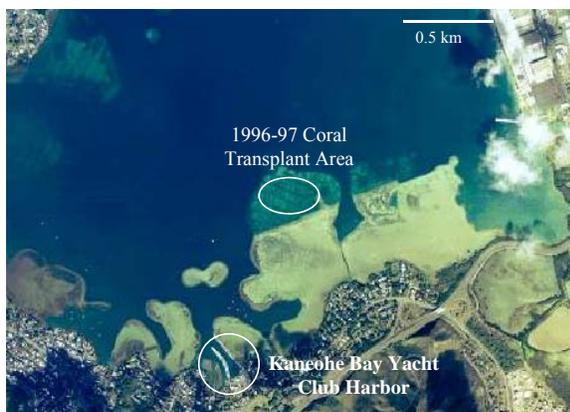
Figure 1. Kaneohe Bay Yacht Club Harbor and Malae transplant receiving reef.

The Kaneohe Bay Yacht Club is preparing to formally request a permit to allow maintenance dredging in their harbor facility to a depth of 8 ft. (2.4 m MLLT) in south Kaneohe Bay, Oahu, Hawaii (Figure 1). Surveys and activities to mitigate damage to biological resources within the harbor were conducted in 1996-97 when dredging was initially planned. The harbor supported a large coral community of *Montipora capitata* and *Porites compressa* with scattered *Pocillopora damicornis* coral colonies in 1996 (Kolinski and Jokiel 1996). Roughly 1000 corals were successfully relocated to a nearby reef at Malae that had been dredged circa 1939 for a seaplane runway (Figure 1). Although the mitigation activities minimized damage to yachts and corals by clearing paths for safe navigation within the harbor, the dredging never occurred. The requirement for a new permit for maintenance dredging introduced the need for reassessment of biological resources within the harbor and consideration of avoidance, minimization and/or mitigation needs.

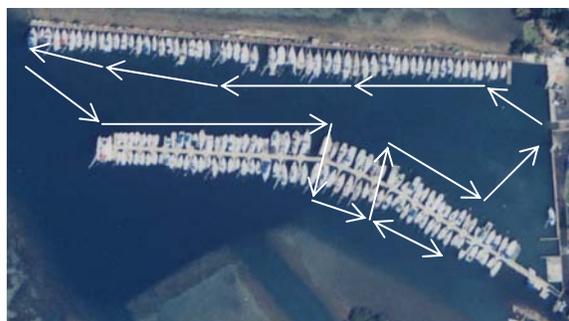
**Methods:** On 22 April 2004, John Naughton and Steve Kolinski (National Marine Fisheries Service, Pacific Islands Regional Office, NOAA Fisheries) conducted a preliminary rapid in-water visual assessment of the benthic resources likely to be impacted by harbor dredging activities. The inner harbor and entrance area were transited and assessed using snorkeling apparatus (Figure 2). The assessment was limited to diurnally active organisms (09:30 – 11:10 am).

Figure 2. April 2004 survey route, Kaneohe Bay Yacht Club Harbor, Oahu.

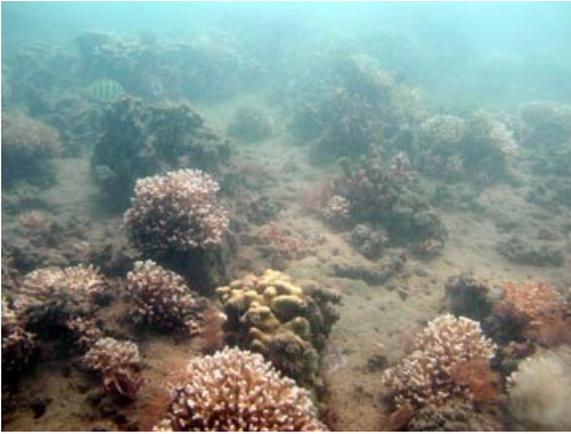
**Status of Benthic Resources:** Three species of coral were noted in the preliminary survey. Scattered colonies of *Pocillopora damicornis*, *Porites compressa* and *Montipora capitata* were located in mid and harbor entrance zones (Figures 3-6). *Pocillopora damicornis* was dominant in terms of abundance of large and mid-sized colonies ( $\leq 10\%$  cover). Recruitment to the area was evidenced by the presence of numerous small sized colonies. The dominance of *P. damicornis* contrasts with the coral community structure of 1996 in which this species was a minor constituent (Kolinski and Jokiel 1996). However, this finding is consistent with noted coral successional processes of recovery on Hawaiian reefs (Grigg and Maragos 1974). Large heads of *P. compressa* and *M. capitata* were identified mainly in the harbor entrance area. Recruits of *M. capitata*, a species that dominated the 1996 harbor community, were encountered in large

Figure 3. Scattered *Pocillopora damicornis* colonies, mid harbor/entrance area.

Maintenance dredging to 8 ft. will negatively impact living coral colonies within the harbor. Mitigation in anticipation of dredging in 1997 had occurred under a previous permit. This involved the successful movement and long-term survival of corals (Kolinski and Jokiel 1996, Kolinski in review). It is recommended that efforts be made to relocate new and/or remaining large colonies of *Porites compressa*, *Montipora capitata* and *Pocillopora damicornis* to the dredged reef area off Malae (Figure 1). This would likely involve one to two pontoon boatloads of corals (if done within the next year), placing corals in large shaded tubs for transport. Extreme care should be taken to ensure corals collected for transport do not contain invasive *Kappaphycus* or other potentially problematic algae. Monitoring of coral transplants over time can be done by NOAA Fisheries personnel, and assistance with the transplantation might be also be provided. In addition, NOAA Fisheries would be interested in conducting a rapid benthic assessment within the harbor following dredging activities to gather baseline data for, over time, assessing the form and rate of coral community recovery.

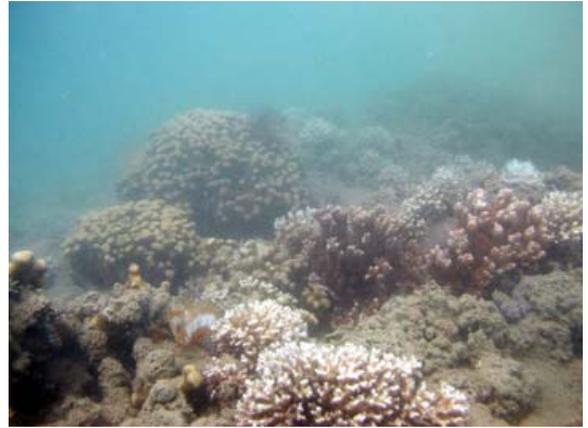
Figure 6. *Pocillopora damicornis*, *Porites compressa* and *Montipora capitata*, harbor entrance.

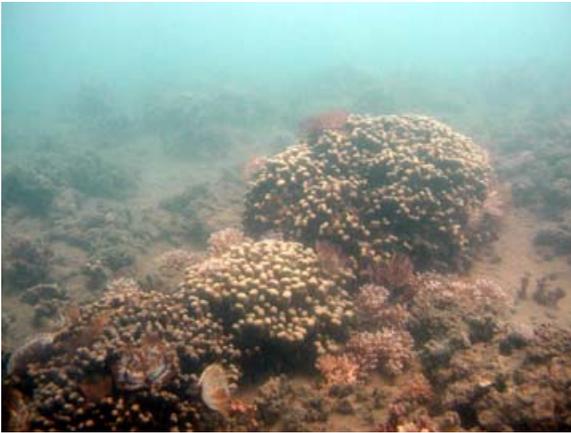
Figure 4. *Porites compressa* colonies, mid harbor/entrance area.

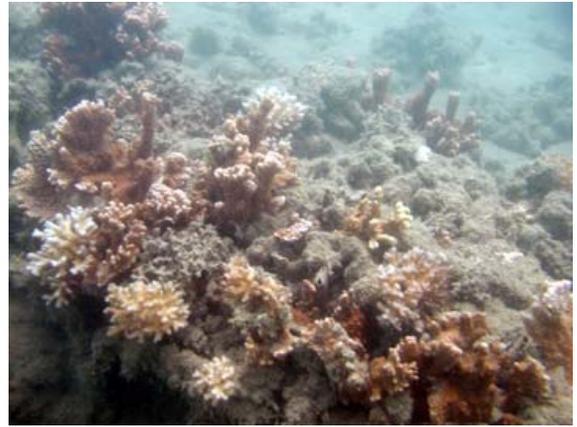
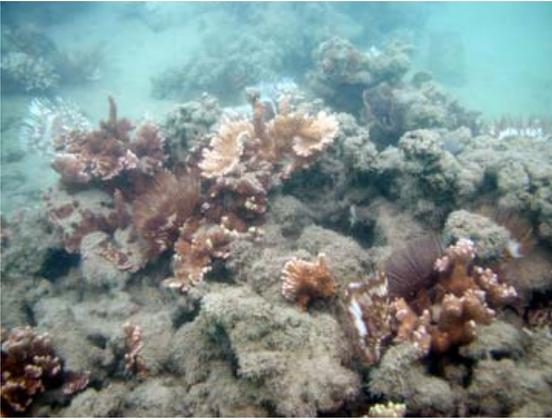
numbers (Figures 7-9). The potential for rapid growth of *M. capitata* once reaching visible sizes in calm water environments suggests that, barring additional disturbance to the harbor coral community, a rapid rebound of this species is set to occur.

Figure 7. *Montipora capitata* and *Pocillopora damicornis* recruits.

Figure 8. *Montipora capitata* recruits.

Figure 9. *Montipora capitata* recruits.

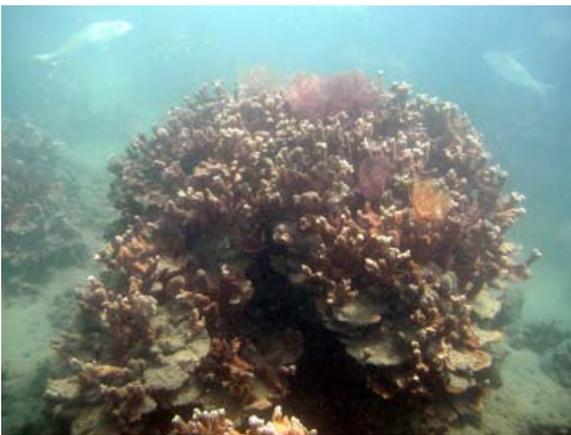
Figure 5. *Montipora capitata*, mid harbor/entrance area.

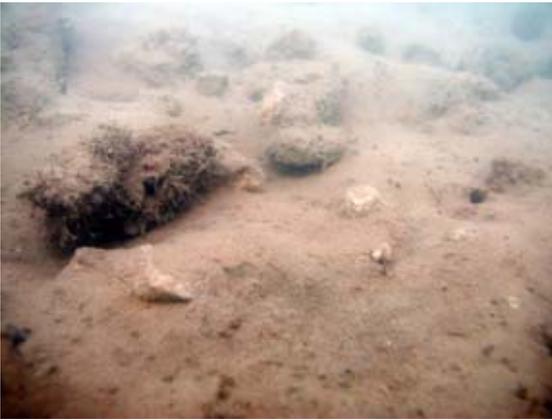
The inner harbor adjacent to shoreline was dominated by fine silt-mud sediment accumulation that was stated to re-suspend into the water column when disturbed by overhead propellers (Harvey Minsky, pers. comm., Figure 10). Infauna was not assessed. Sediment covered hard substrate was apparent throughout the remaining harbor area. Turf algae appeared to be trapping some of the sediment. *Gracilaria salicornia* and *Dictyosphaeria cavernosa* were observed in mid and harbor entrance areas. The inner reef slope underneath the northern-most pier was blanketed by *Gracilaria salicornia* (Figure 11). No seagrass was observed.

Figure 10. Sediment, inner harbor adjacent to shoreline.

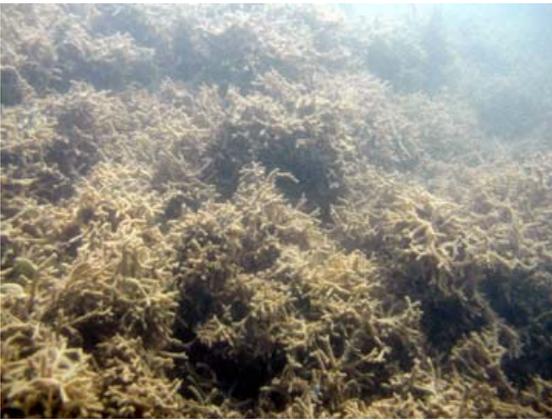
Figure 11. *Gracilaria salicornia*.
