Managing the Salt River Watershed: Where do we go from here ?

Anne Kitchell
Center for Watershed Protection
8/16/06

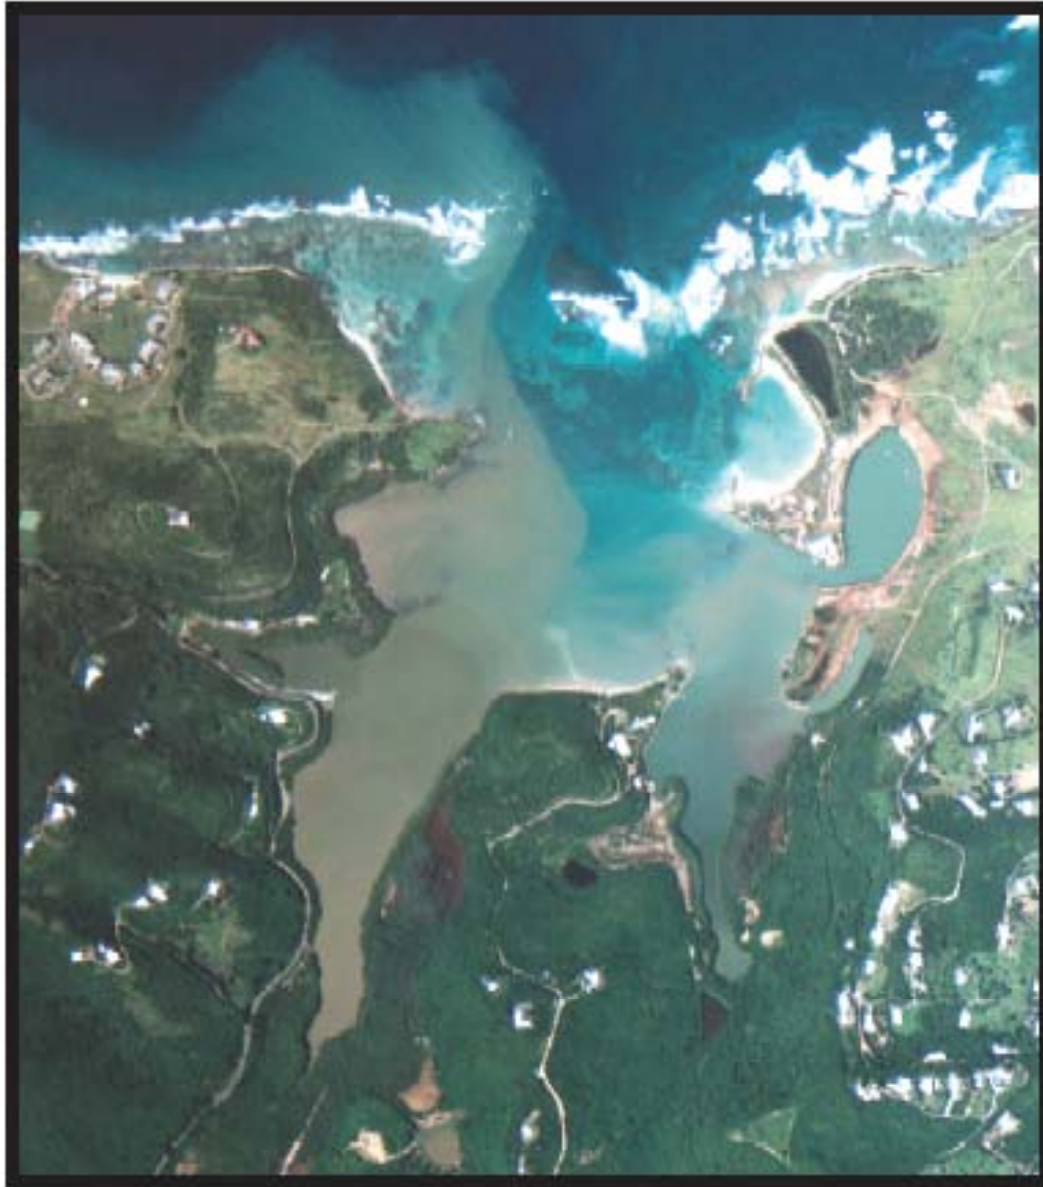
Figure 7.1. Sediment plume flowing from Sugar Bay, visible in 1970's aerial photograph.

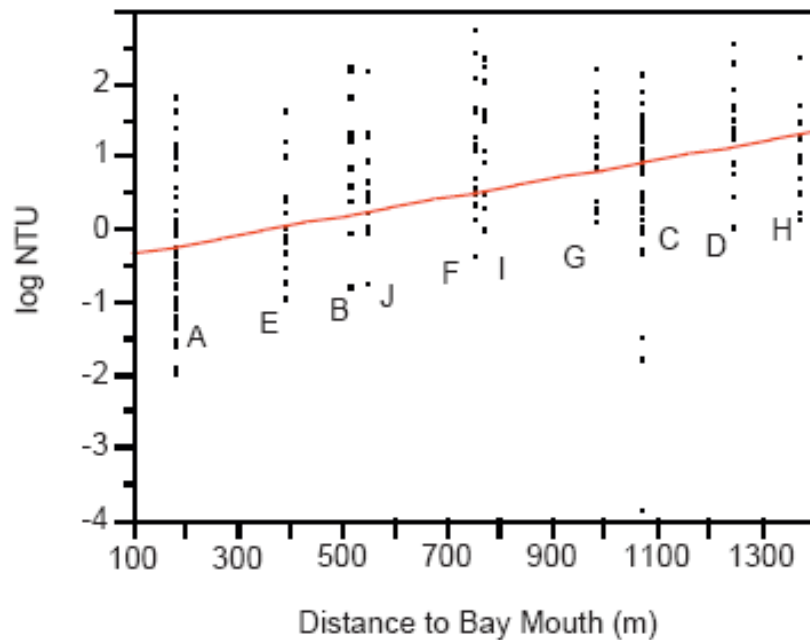
Stations farthest from the bay mouth such as Sugar Bay had over four times higher mean turbidity values.

Figure 7.4. Log transformed NTU (nephelometric turbidity unit) data plotted against distance from the Salt River Bay mouth. Data pooled from all DEP sites sampled during 1981 to 2002 was used in this analysis. Letters denote sampling sites (see Locator Map, Figure 1.1).

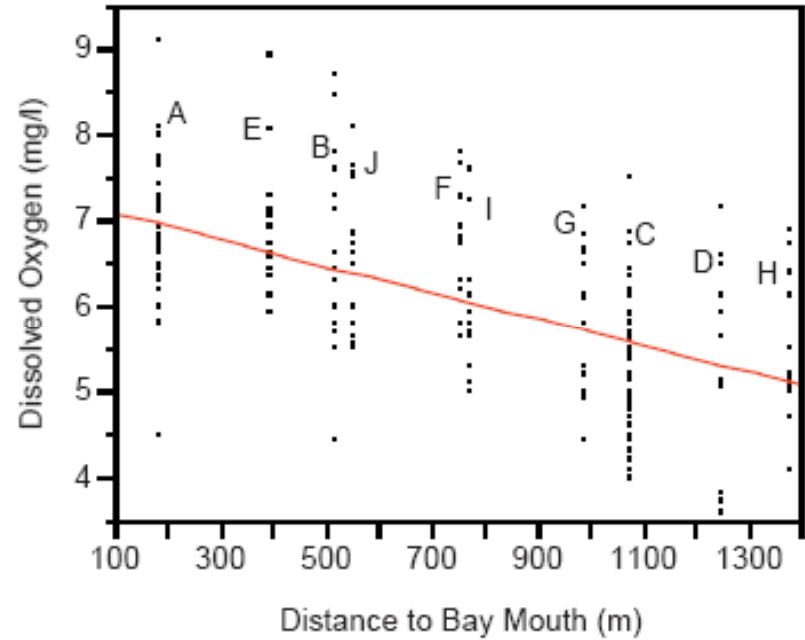
factors contributing to low DO include high turbidity, poor circulation, higher mean T, and proximity to large areas of sediment with high organic content.

Figure 7.5. Dissolved oxygen (mg/l) plotted against distance from the Salt River Bay mouth. Data pooled from all DEP sites sampled during 1981-2002 where used in this analysis. sites (see Locator Map, Figure 1.1).

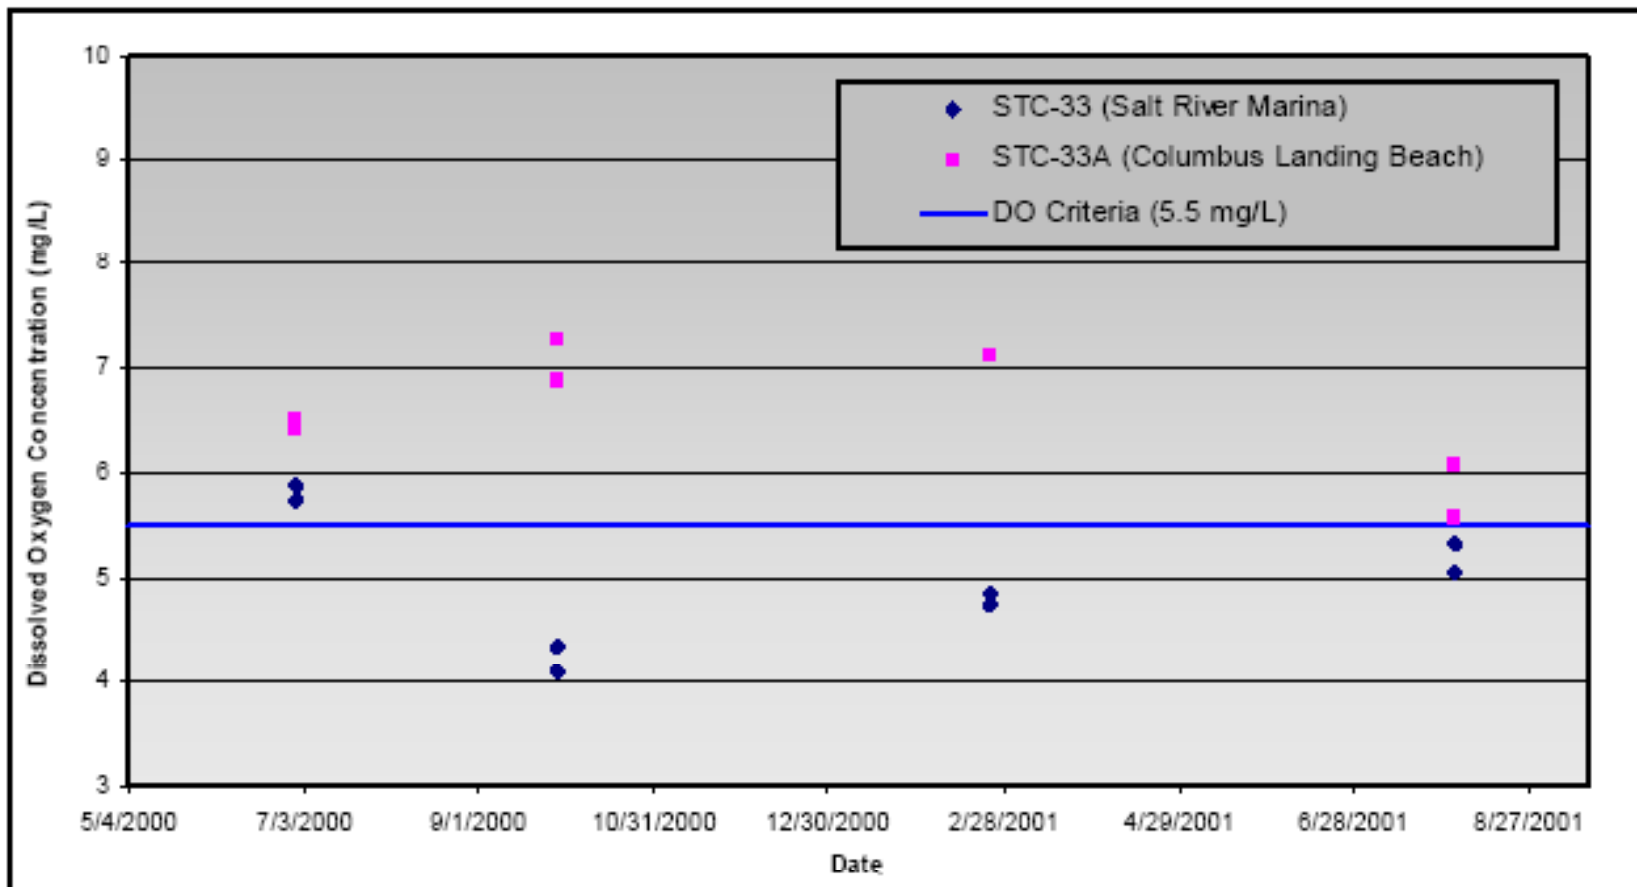
Figure 3-1. Dissolved Oxygen Criteria for Class B Waters, and Observed Data from Stations STC-33 and STC-33A in Salt River Bay.

- ◆ Salt River designated as CLASS B water
- ◆ Average DO at Marina is below allowable levels for Class B waters (< 5.5 mg/l)
- ◆ 2004 TMDL for DO
- ◆ Average turbidity at the Steeple, Sugar Bay, NOAA Dock, and Beach less than allowable (Class B waters not to exceed 3 NTU); the most recent values have been within acceptable limits
