Implementation of an Erosion Control Program to Reduce Sediment Loading Rates from Land-Based Sources to the Coral Reefs of Culebra, Puerto Rico

Punta del Viento Estates Development Area

August 2012

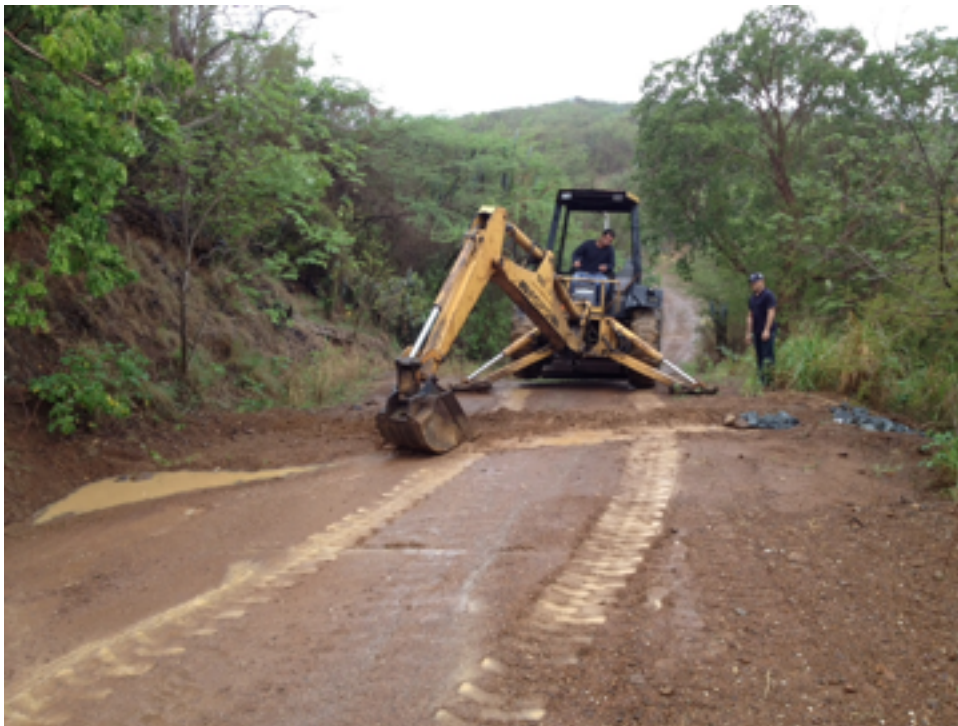
The main practices installed were cross swales (Figure 3), rock check dams (Figure 6) and rock outlet protection (Figure 3). Cross swales were used to distribute the flow into smaller units before return to vegetation; rock check dams were used to slow velocities; and rock outlet protection was used to limit erosion and head cutting at outfalls.

Figure 3. Illustrates the construction of a cross swale and outlet protection

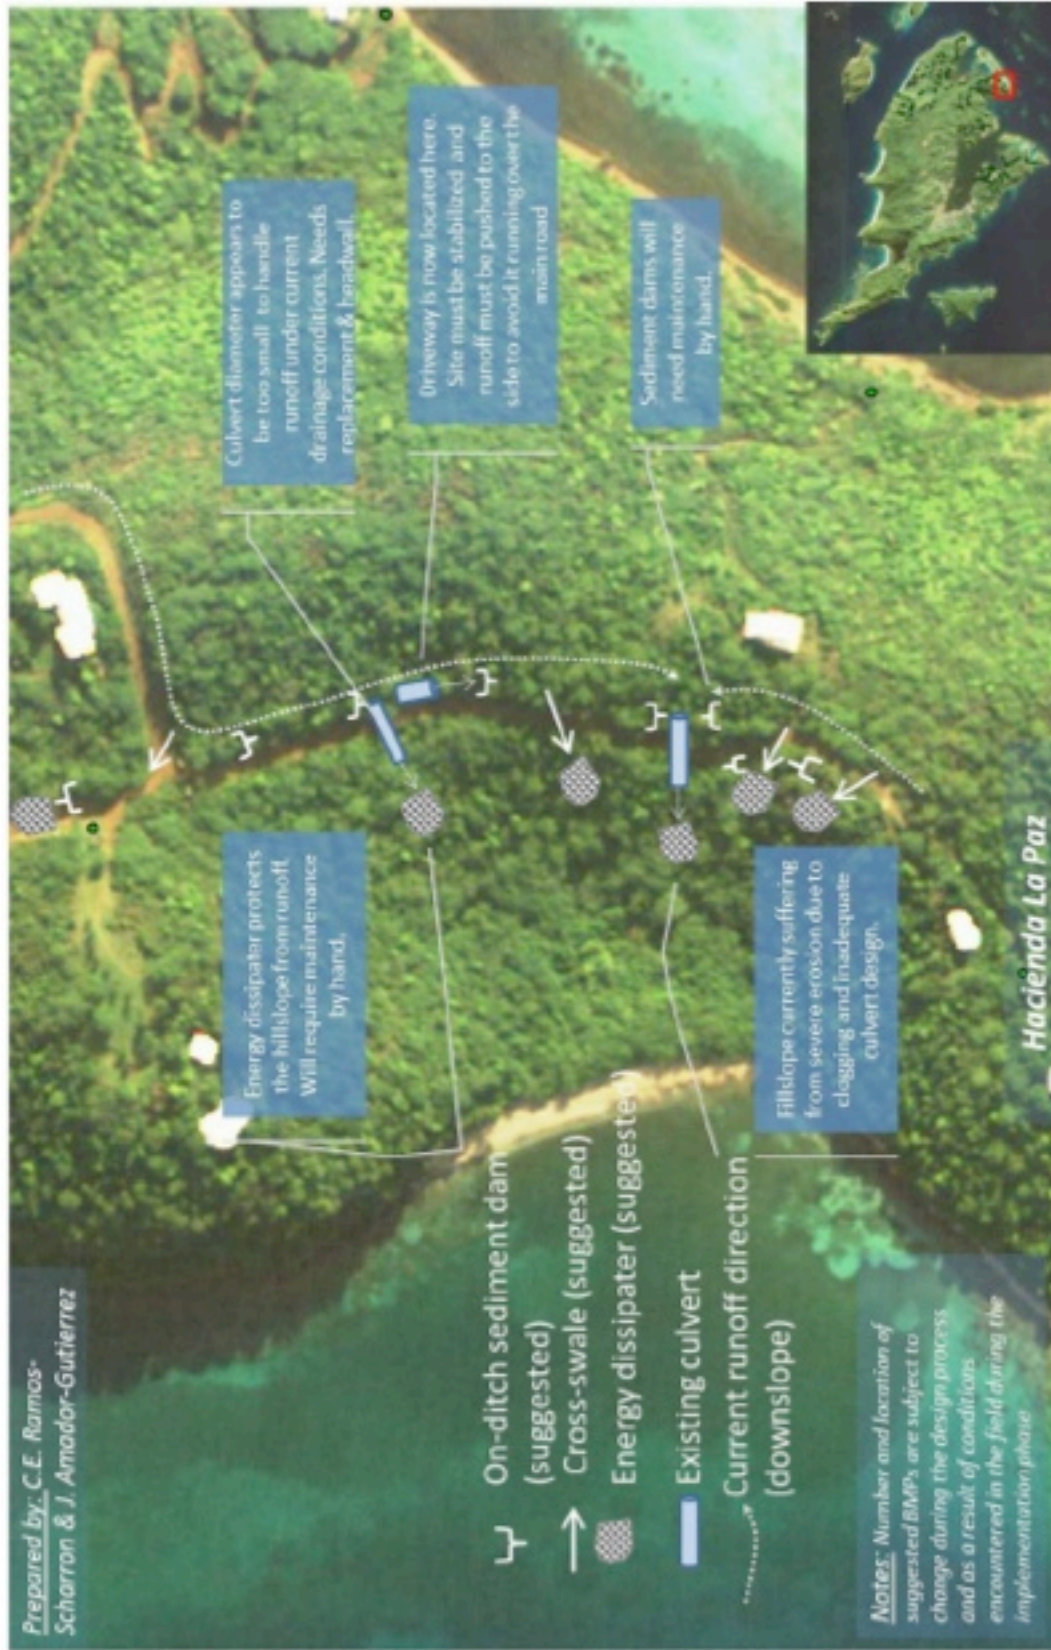
An overview of the work that was to be done is provided in Figure 4 and Figure 5. The main changes to the original design were adding additional check dams to reduce velocity in the drainage channels and the inability to create a cross swale across the road at Restoration Site #2 because of a shallow existing water line (additional check dams were used to reduce the velocity of water flow to compensate for the limitation. Eduardo and Juan, the on-site engineers with GMA COOP, organized the personnel on the four backhoes who were all working on various aspects of the erosion control practices at the same time and they completed the work quickly. Our limitation to accomplishing even more beyond the scope was the limited amount of rock we had for the check dams and outfall protection.

Figure 4. Restoration Site #1 and proposed practices

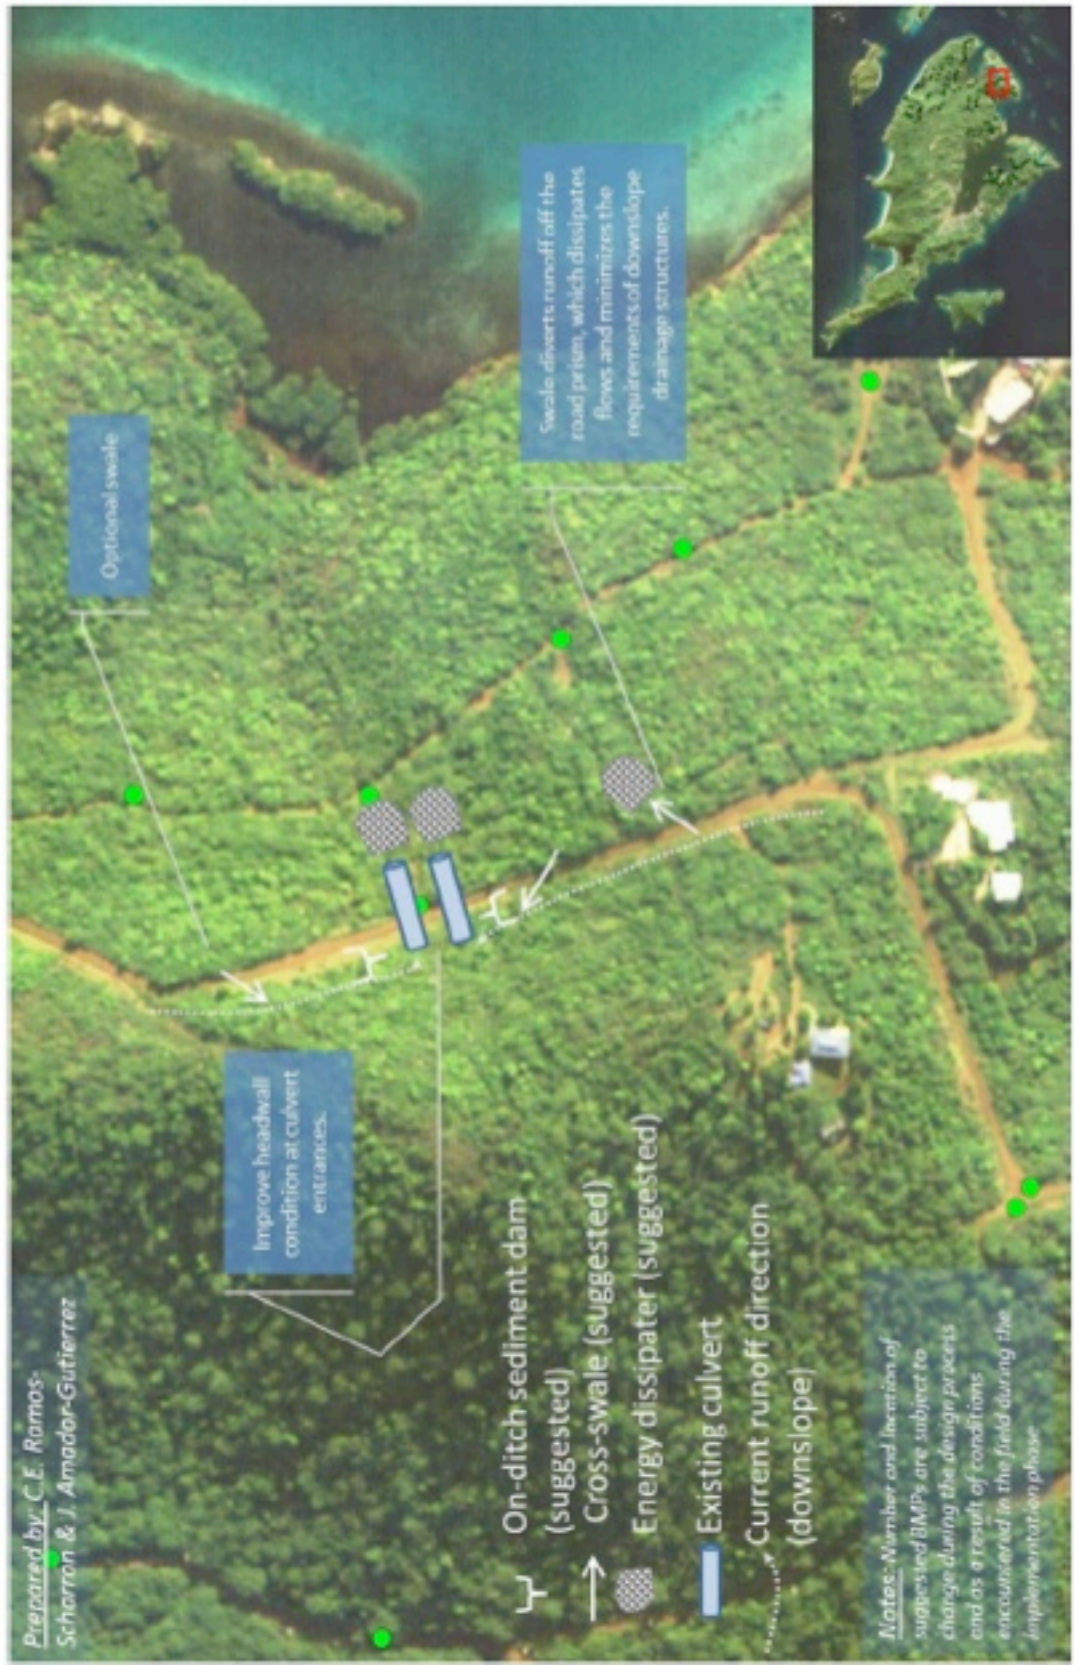
Figure 5. Restoration Site #2 and Proposed Practices

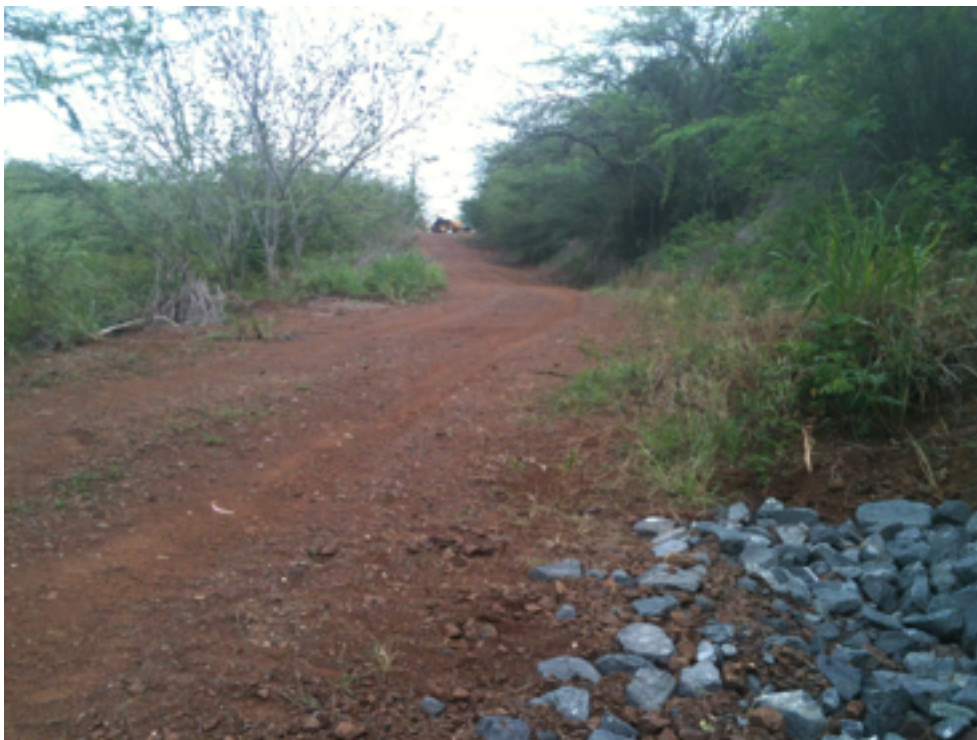
Figure 6. Note a series of check dams up the hill on the right (these slow the velocity of the water and drop out sediments) also the cross swale in Figure 3 was constructed midway up the hill to reduce the drainage area of the flowpath. The rocks in the foreground attenuate flows coming from the opposite direction.
