# Faga'alu Watershed Plan Implementation Supplement

March 2013

**Horsley Witten Group, Inc.**  
90 Route 6A, Sandwich, MA 02563  
508.833.6600  
[www.horsleywitten.com](http://www.horsleywitten.com)

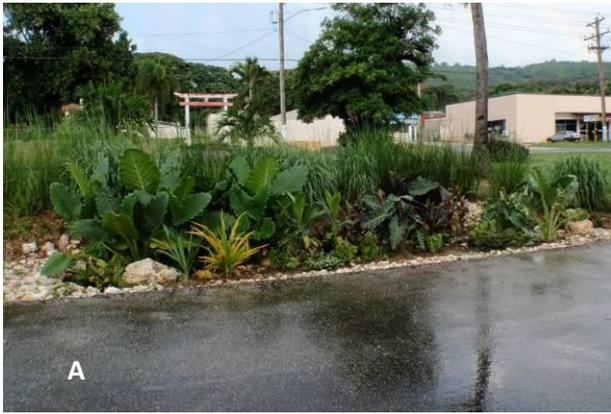
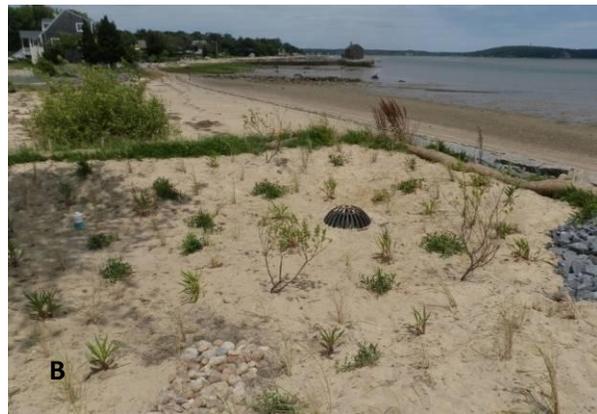
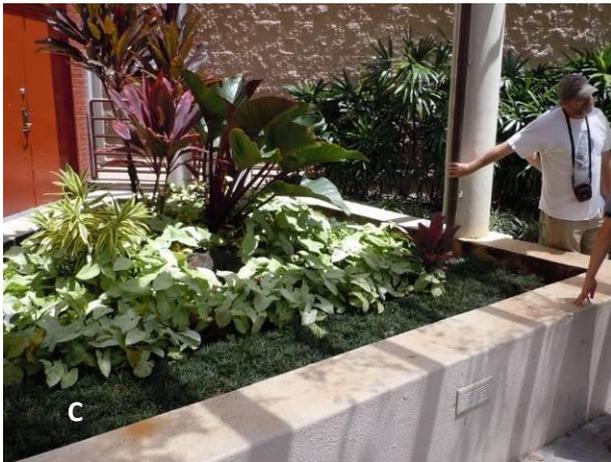
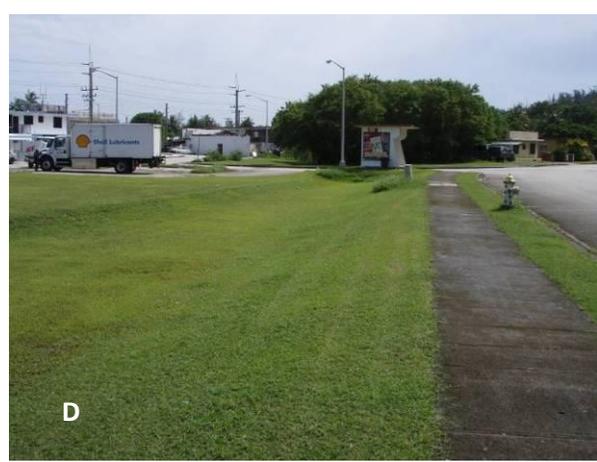
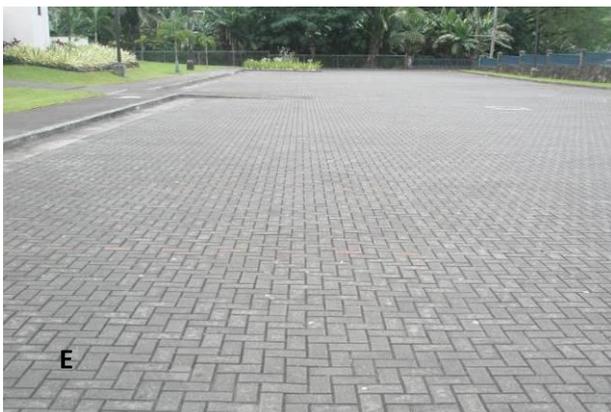
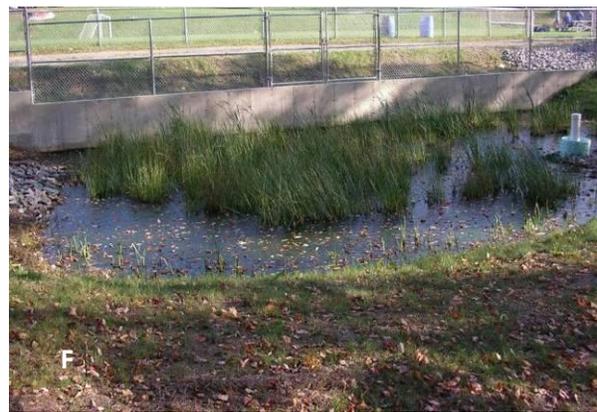
**Figure 2.** Example stormwater retrofit practices. A) Rain gardens, B) bioretention, and C) planter boxes are vegetated depressions with amended soils to filter and/or infiltrate runoff. D) Dry swales are grassed, linear conveyances with engineered soils to enhance infiltration. E) Structured pavers or porous concrete/asphalt allow water to infiltrate through the hard surface into belowground gravel storage beds. F) Gravel wetland/mangroves are treatment systems using native wetland species to uptake pollutants before discharge.

Opportunities for structural restoration projects were identified at 16 locations in the watershed (Figure 1). Structural projects include stormwater retrofits, shoreline stabilization, stream restoration, road and sewer improvements, culvert repair, and piggery conversions, which are all summarized in Table 2. Stormwater retrofits are engineered practices designed to better manage stormwater runoff from existing roads, parking lots and other land surfaces. Figures 2 and 3 illustrate the various retrofit practice types proposed for Faga’alu.

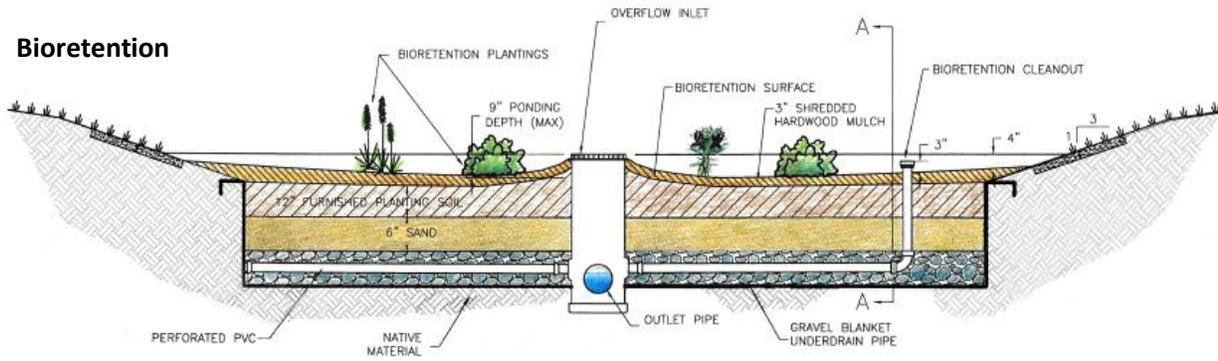
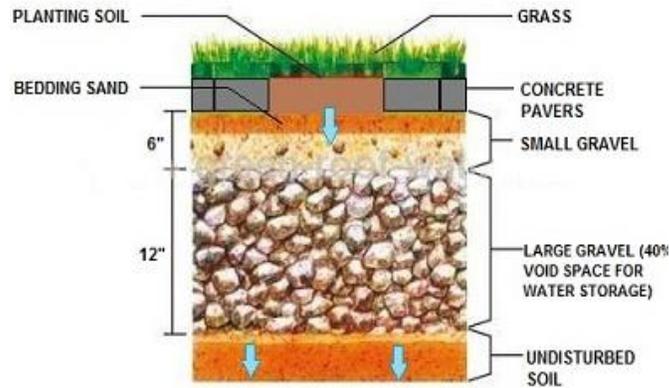
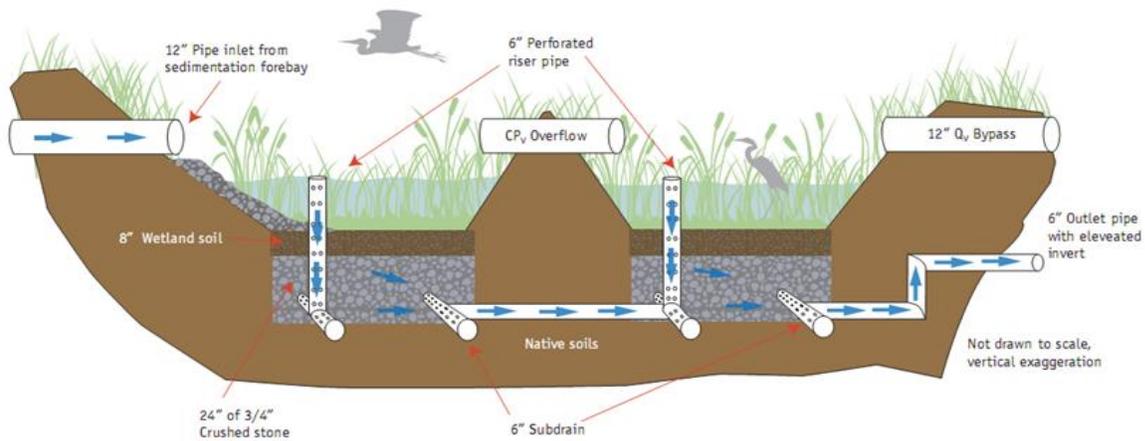
Figure 3. Representative profiles of four recommended retrofit practices in Faga’alu.

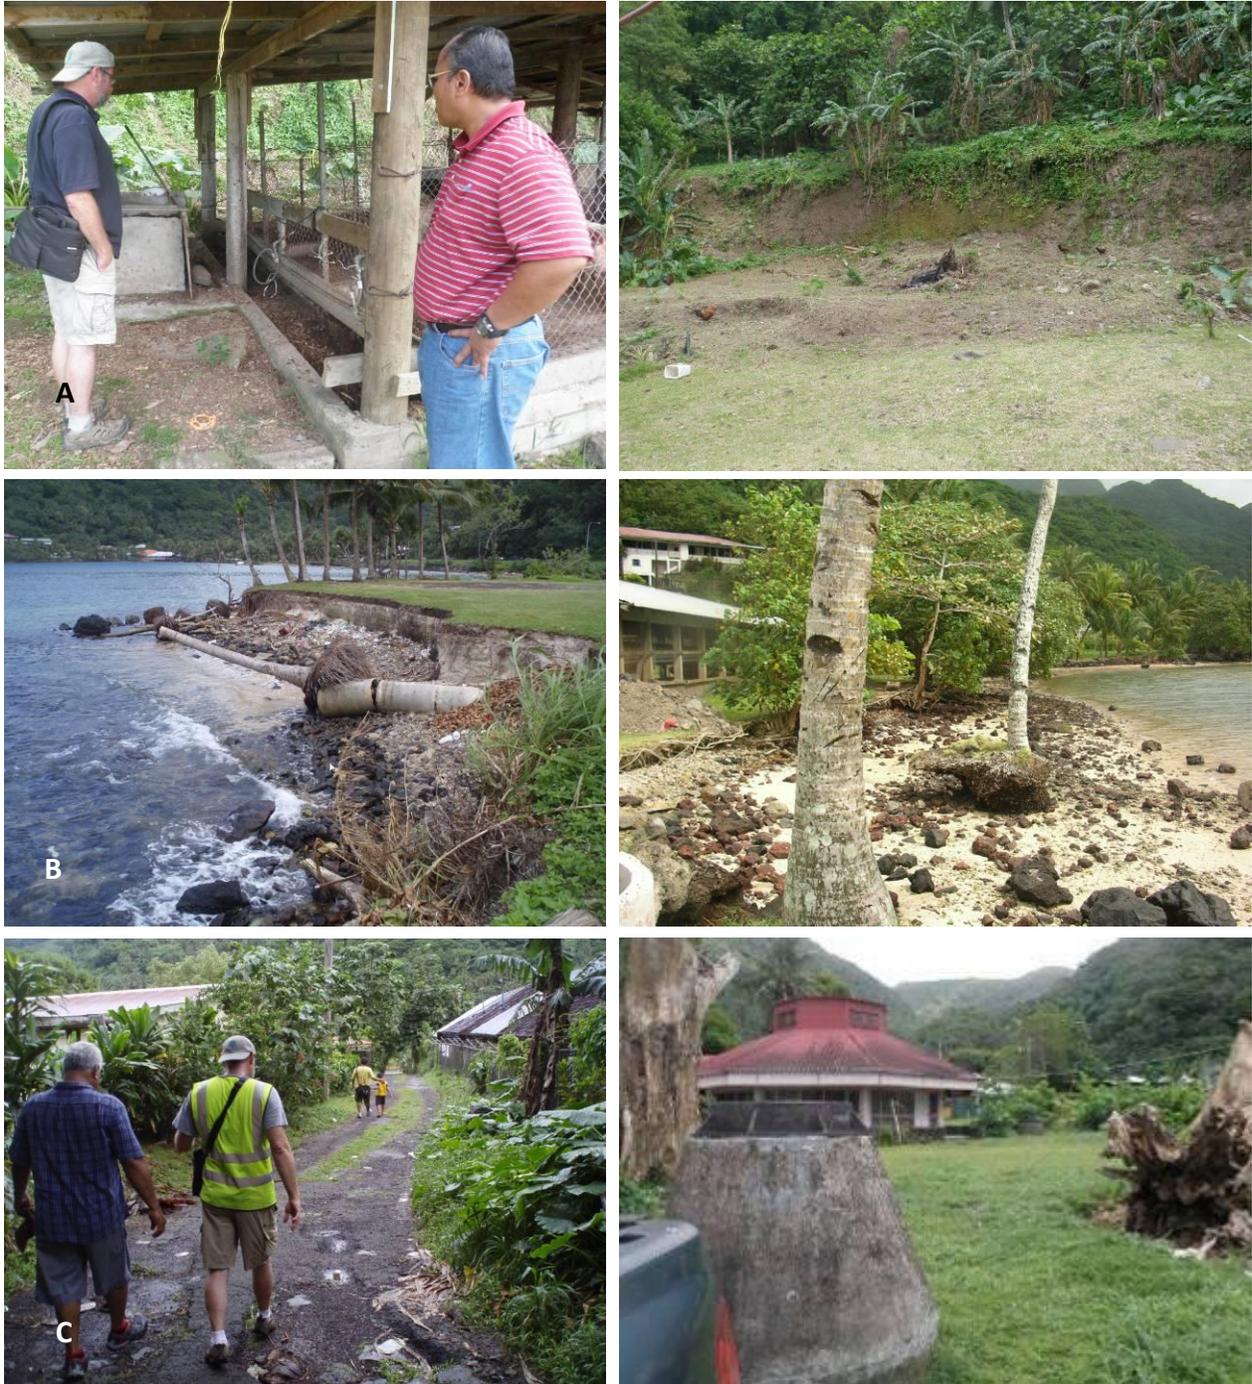
**Figure 4.** Structural projects not further described in Appendix A are: A) Site ID #13 completion of a dry compost piggery expansion project (small upgrade and cut slope at new location shown here); B) ID #9 and #11 shoreline stabilization at Matafao Elementary School and Faga’alu Park shown here, respectively; and C) ID #8 sewer extension and road improvement project for residential area above the Dept. of Health.

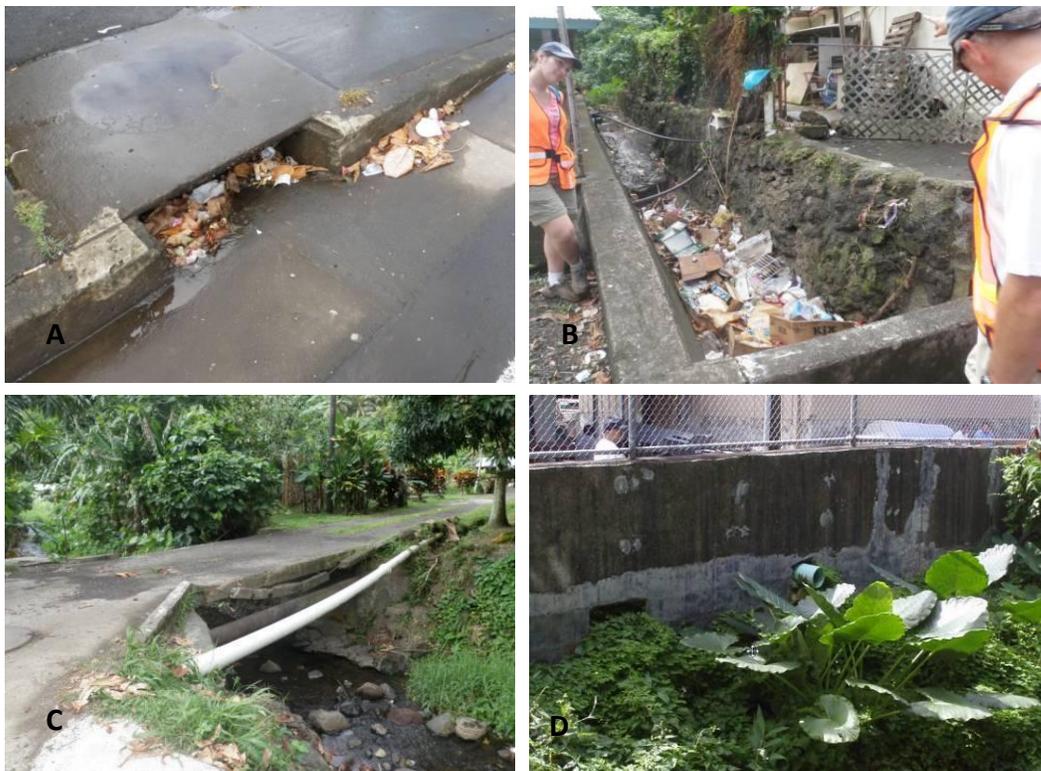
**Figure 5.** Drainage infrastructure that requires both routine and long-term maintenance includes A) catchbasins, B) culverts, C) bridges, and D) outfall pipes.

The stormwater infrastructure in the Faga’alu watershed consists of a network of culverts, drain inlets, catchbasins, drain pipes, and outfalls draining directly to the stream or to the bay. Clogging with debris and trash was observed in many of these structures, and repair or replacement of deteriorating or undersized structures is needed in some cases. Local leaders and agency staff agreed that current maintenance levels are not adequate to ensure proper function of the system (Figure 5). Locally-driven O&M should result in increased inspection frequencies; increased response time to minor drainage complaints, reduced expenditures on costly/emergency repairs caused by years of neglect, and better engagement of residents in watershed management. **Section 4.0** contains a draft O&M plan for consideration by the Village.

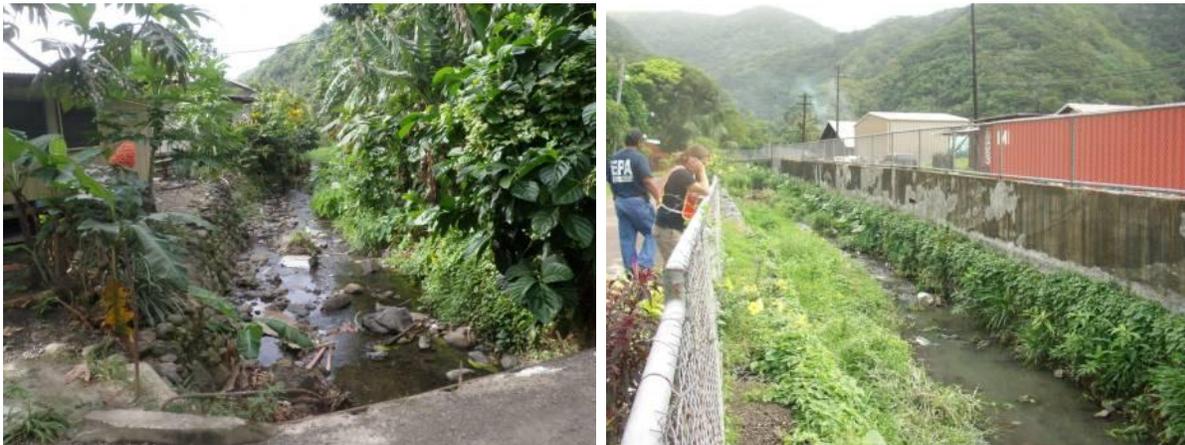
**Figure 8.** Examples of stream reaches where encroachment has occurred and streams are clearly impacted. These locations also illustrate the difficulty of restoring natural buffer conditions without relocating structures or reducing capacity of the system to handle large flows.

Restoration of impacted vegetated buffers is a common and relatively inexpensive strategy for watershed restoration; however, extensive buffer restoration seems impractical for much of the Faga’alu Village due to existing development and/or flow conveyance requirements (Figure 8). The following actions are recommended:

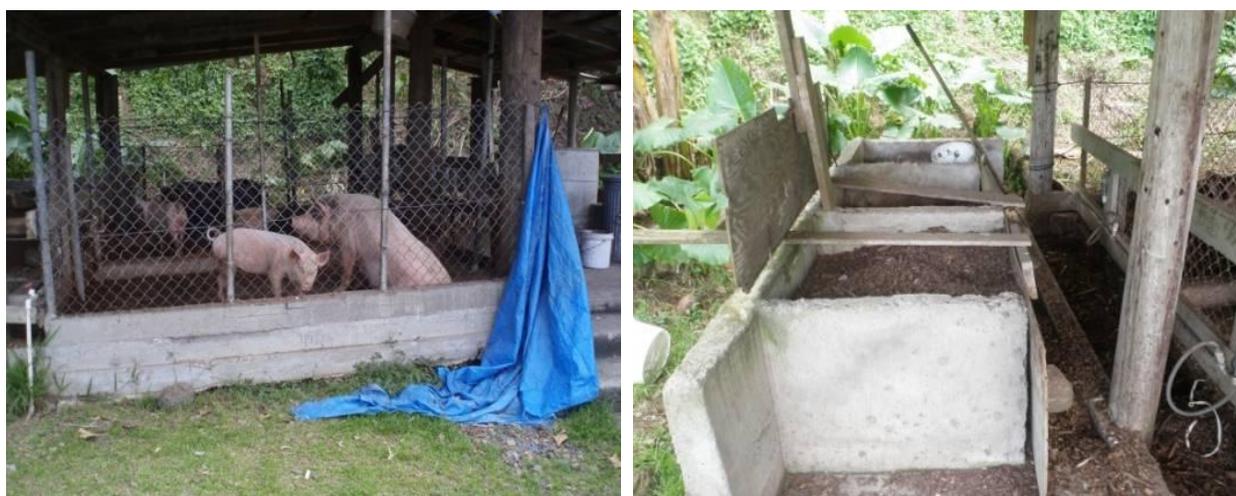
**Figure 9.** This dry litter piggery is a pen with a roof and sloped concrete floor. The waste is collected in a trench and then is composted with dry plant material such as wood chips or coconut husks.

To reduce the impacts of animal waste in American Samoa on human health, the CDC recommended controlling dogs and rodents and improving pig waste management (Minshew and Scales, 2007). AS-EPA inventoried over 1,000 active piggeries (~10,000 pigs) in the territory and adopted a number of piggery compliance requirements including: setback regulations of 100-ft from wells and 50-ft from streams; design features for structural enclosures; and waste disposal procedures (see <http://asepa.gov/piggery-compliance.asp> for more information). Technical and financial support has been made available for residents to convert existing piggeries to dry composting facilities, and significant effort has been made to educate islanders on the link between animals and disease/pollution. In fact, one of the two piggeries in the Faga’alu watershed has already been converted to a dry compost facility (Figure 9).

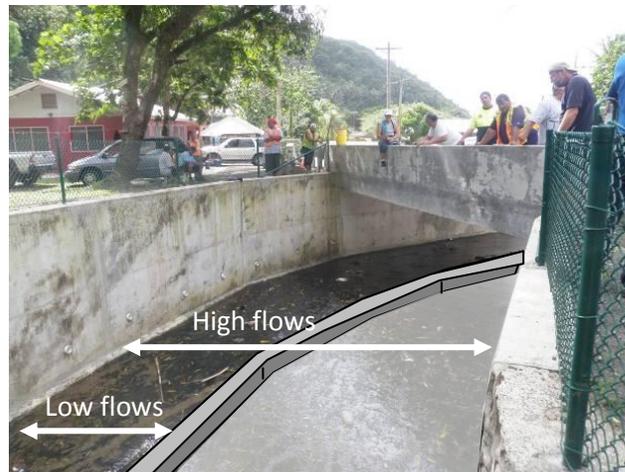
**Figure 1A.** Installation of 6-inch concrete berm to concentrate low flows to one side of channel. Flows higher than separator wall can spread across entire channel width.

This structure has been newly installed; therefore a simple, inexpensive design is recommended. The concept involves the addition of a narrow concrete separator wall or berm (approximately 4 inches wide and 6 inches high) along the channel bottom to concentrate low flows on one side of the channel (Figure 1A and 1B). High flows can overtop the wall in order to utilize the full width of the channel. Variations in the wall thickness or the addition of baffles can provide additional diversity in the low flow regime to support various aquatic fauna. Temporary stream diversion during the construction to create a dry work area could be accomplished using sandbags or piped bypasses.

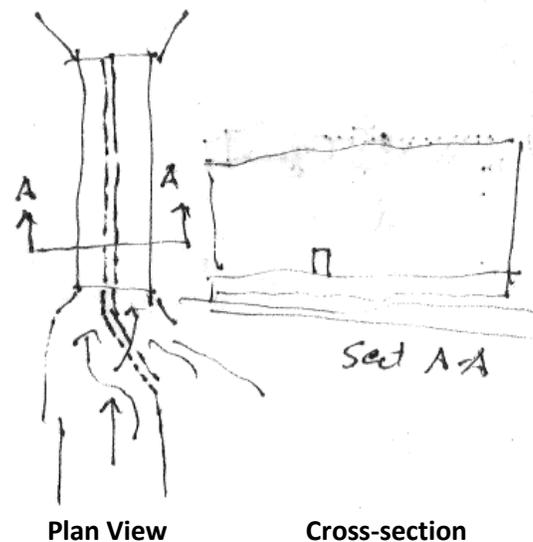
**Figure 1B.** Plan view and cross-sectional sketch of simple concept design.

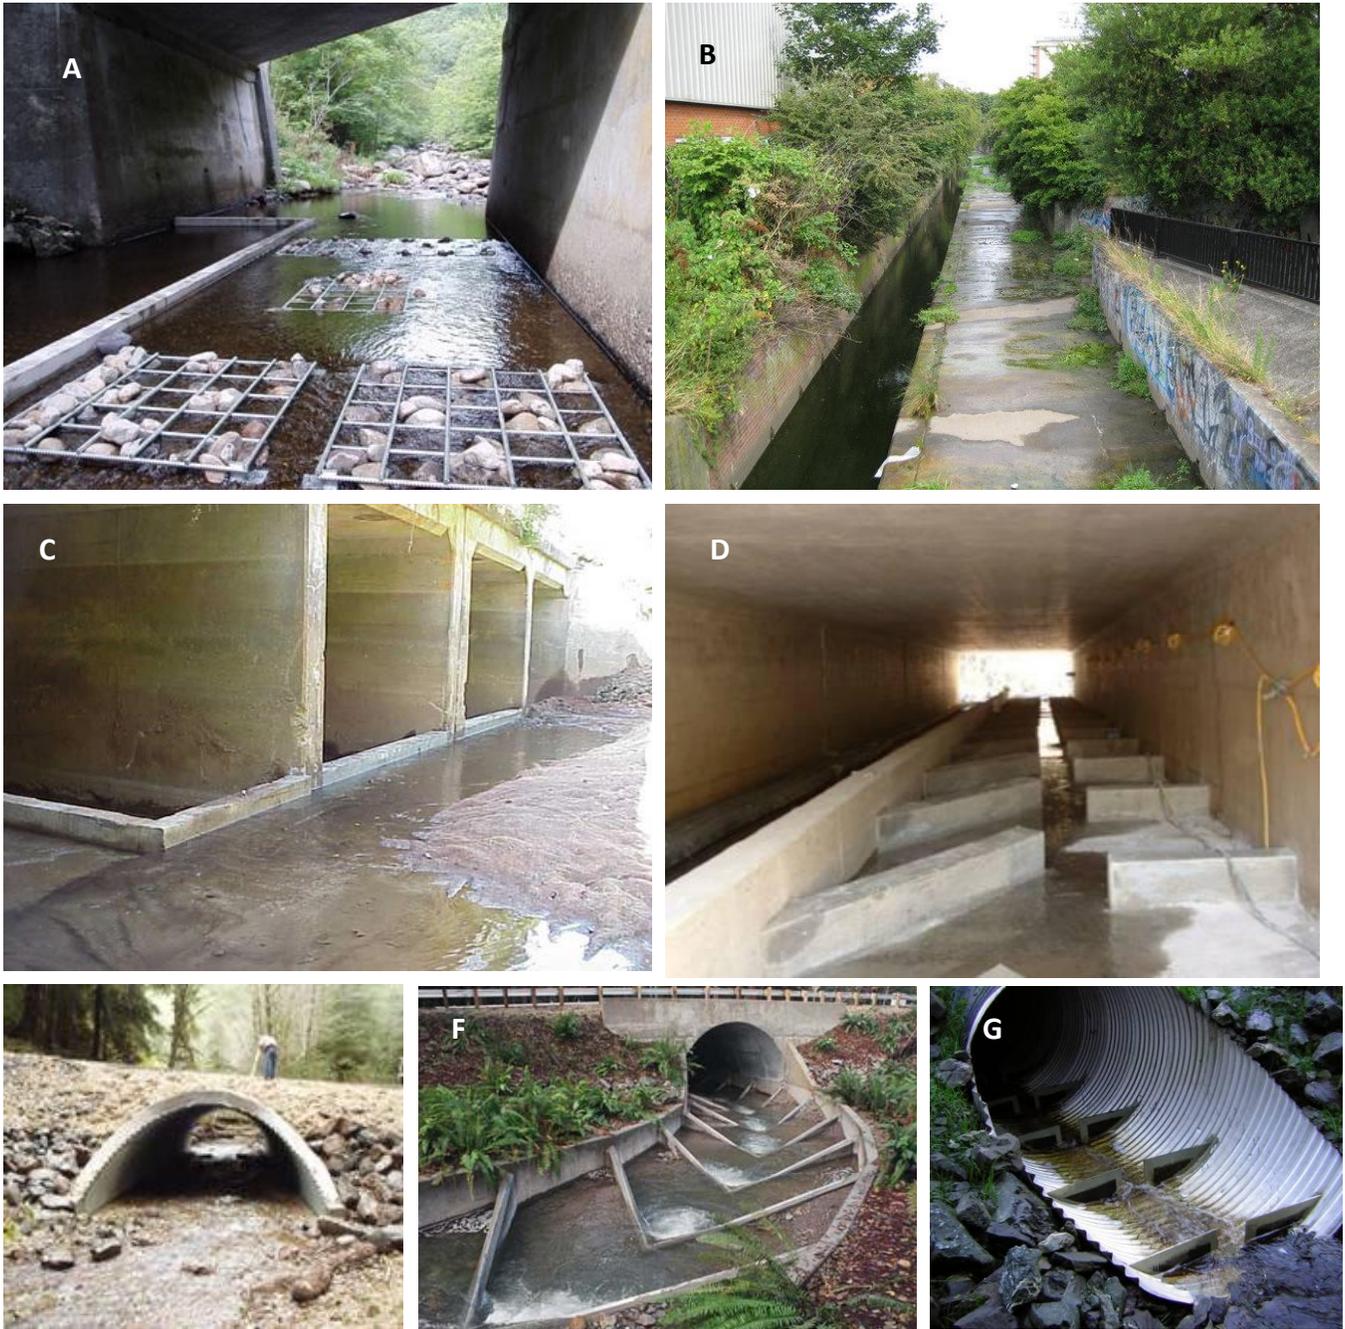
**Figure 1C.** Photos of various alternatives to create low flow channels using separator walls (A, C, D) coupled with baffle devices (A,D,F, and G); low flow channel within a larger high flow channel (B); and using open bottom/arched culverts to allow for natural bottom habitat.

New projects in the future, however, could be designed differently (see Figure 1C).

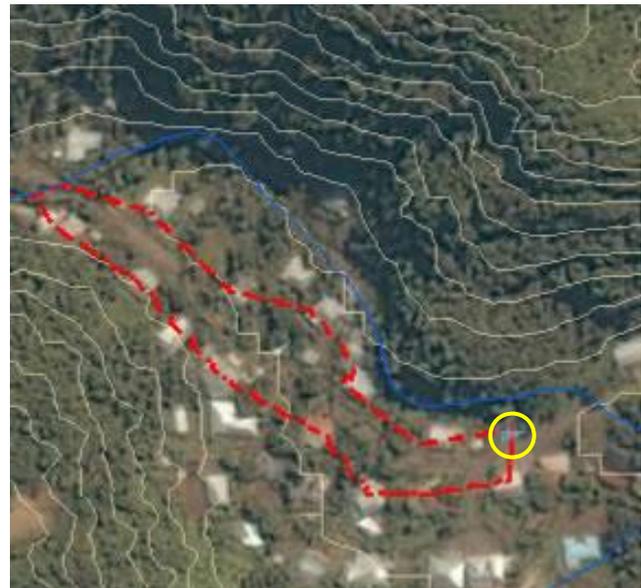
Map showing location of proposed bioretention (blue polygon in yellow circle) and drainage area to practice (red dotted line).

The sizing of bioretention is based on the drainage area, available surface area, and a ponding depth above the soil media. The target size for a bioretention cell is based on managing the first two (2) inches of runoff from impervious surfaces; in this case, the available practice area estimated from the initial site visit is not quite adequate to manage this total volume. However, significant treatment is possible.

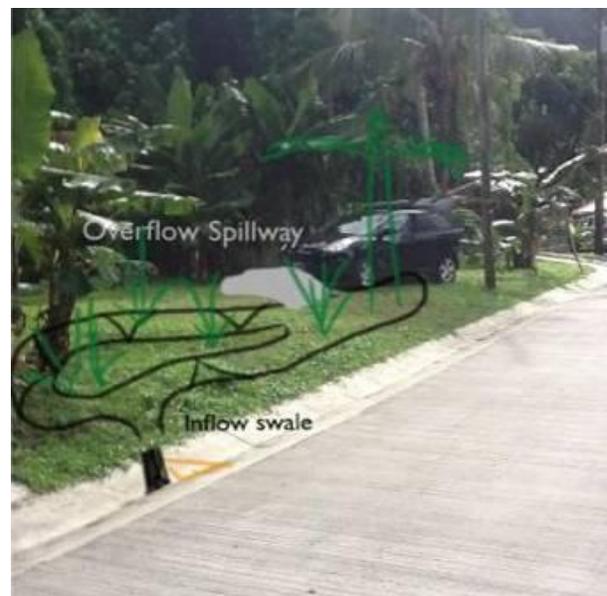
Figure 2A. Potential location for community bioretention to capture and treat a portion of the runoff conveyed in existing concrete roadside swale.

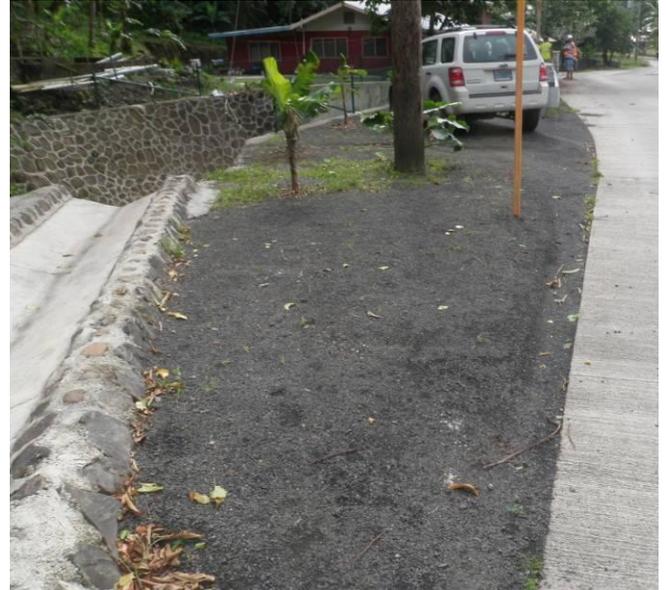
**Figure 2B.** Existing concrete swale discharges directly to stream. There is additional evidence of flow paths eroding gravel parking pad.

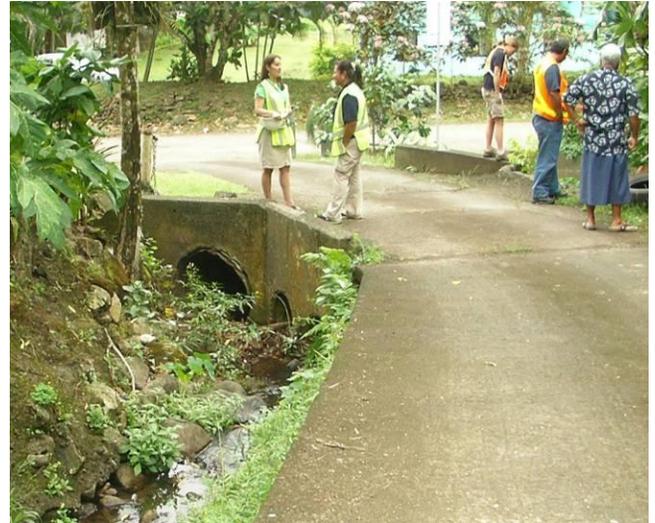
**Figure 3A.** Looking downstream towards the upper end of the three-pipe culvert.

The culverts at this location may not be large enough to convey the desired design storm runoff. Or, the small diameter of the two additional pipes may be getting clogged by the debris being washed down through the forested watershed above the culverts, reducing the overall capacity even further.

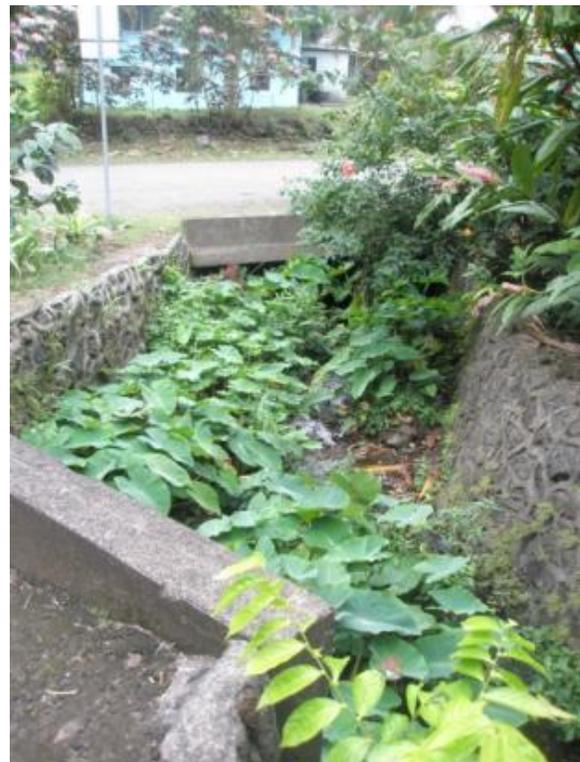
**Figure 3B** – Looking downstream at rectangular culvert under main road (outlet of existing culverts hidden by vegetation – no picture available).

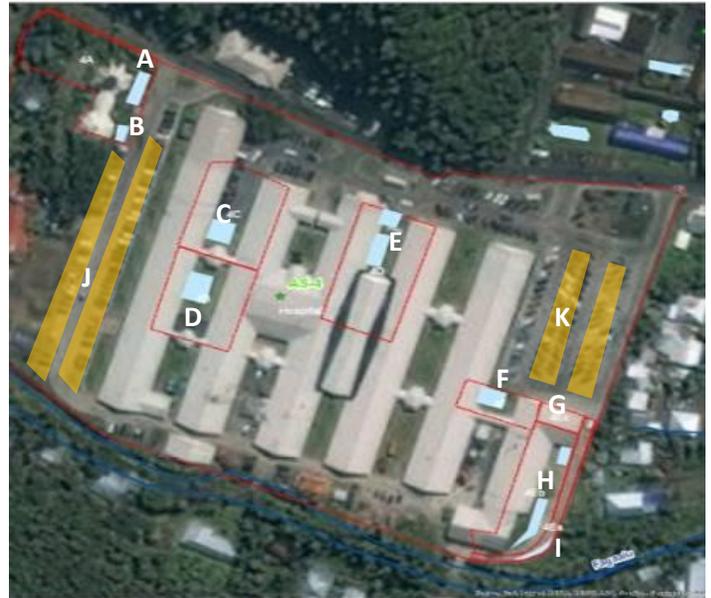
Map showing location of proposed rain gardens/bioretention practices (blue polygons) and porous pavers (orange). Drainage areas to the practices are denoted by red dotted lines.

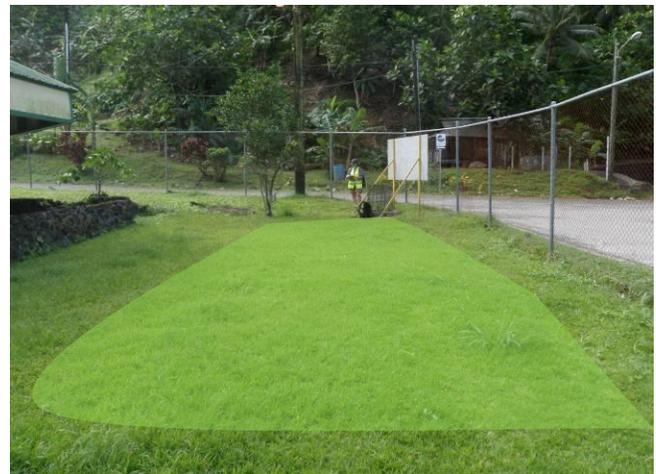
**Figure 4A.** Proposed location for small bioretention near the administrative building.

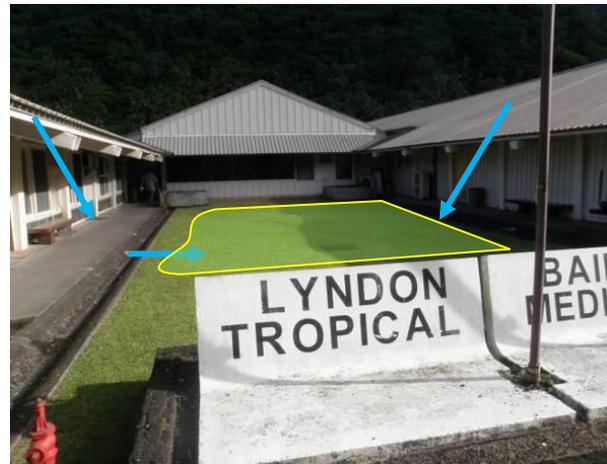
**Figure 4D.** Proposed location for small bioretention between building rows. An inlet is in the middle of the area (red arrow).

**4D.** A bioretention is proposed within the grassy area at the hospital entrance (Figure 4D). The surrounding rooftops drain to concrete channels along the walkways. Runoff in the channels is directed into shallow pipes that pipe discharge underground into the yard inlet in the center of the grassy area. A shallow excavation of the grassed area would allow flows from the concrete channel outlet pipe to discharge to the

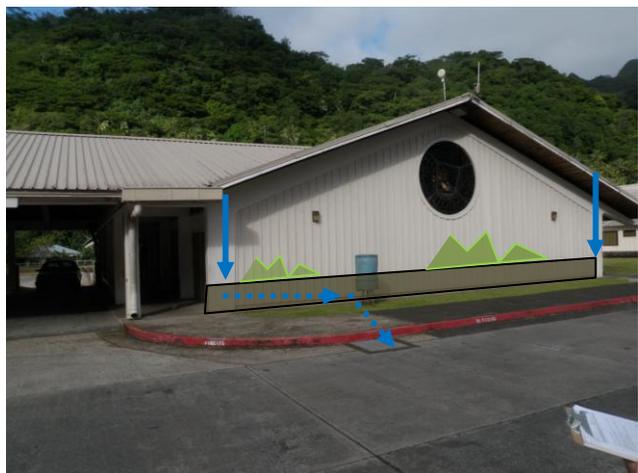
**Figure 4F.** Location of potential planter boxes to enhance aesthetics of the chapel and reduce runoff contribution from rooftop. Overflow can tie into existing drain near adjacent downspout or at sidewalk.

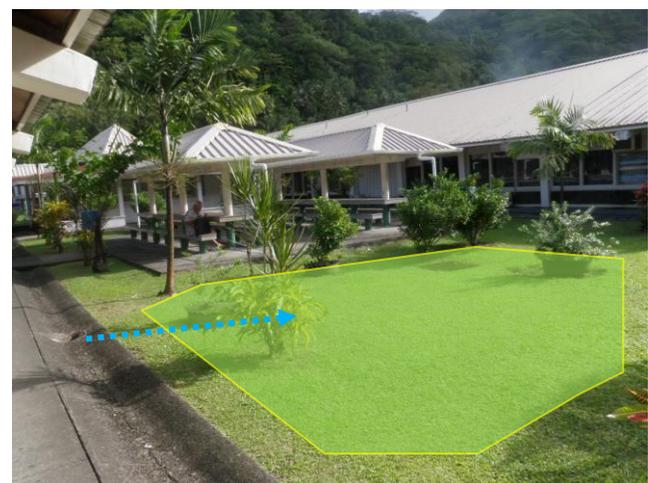
**Figure 4C.** Not described here, but another location is in the interior courtyard using existing drainage infrastructure for conveying flows in and out of practice.

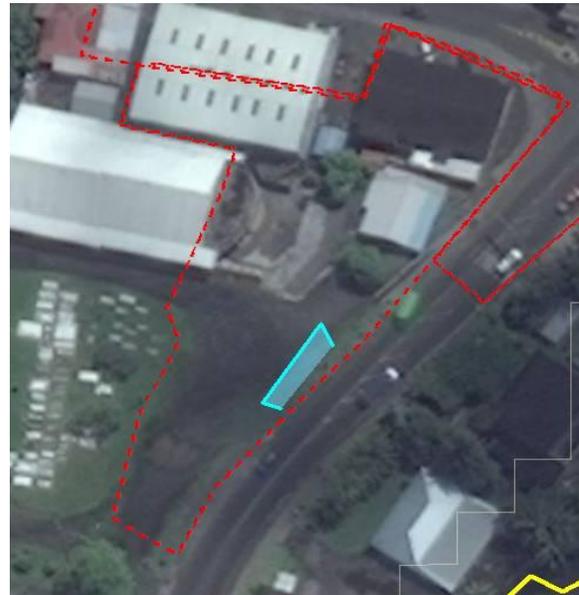
Map showing location of proposed dry swale (blue polygon) and drainage area to practice (red dotted line).

Similar to bioretention, the sizing of the dry swale is based on the drainage area, available surface area, and the ponding depth above the soil media. The target size for a dry swale is based on managing the first two (2) inches of runoff from impervious surfaces; in this case, the available practice area estimated from the initial site visit provides only enough space for about half of this target total volume. However, some treatment is possible, and in terms of priority, the potential pollutant loading from the contributing area is moderate.

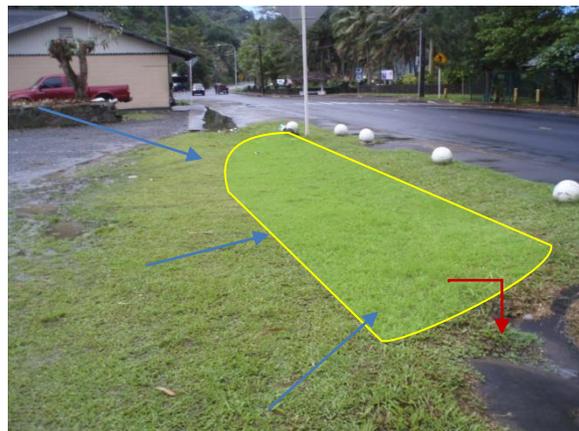
Figure 5A. A dry swale with vegetation and underdrain is proposed in the grassy area of the church. Outlet is shown with red arrow.

The Church has approximately a 0.87 acre contributing drainage area (60% impervious cover) consisting of building rooftops, a gravel parking lot, a cemetery, and roadway. Drainage for the site is routed to an existing catch basin that runs across the highway and into Pago Pago Bay (Figure 5A). Currently there are no stormwater treatment practices at the church. The church is near Hwy 001 at the Faga’alu Village center and therefore a good opportunity for water quality improvements. Educational signage could be installed at the practice location to inform visitors of the functions and values of the control measure, and to raise awareness of potential impacts from stormwater on Pago Pago Bay.

A paved inflow flume would be required to convey flows into the dry swale.

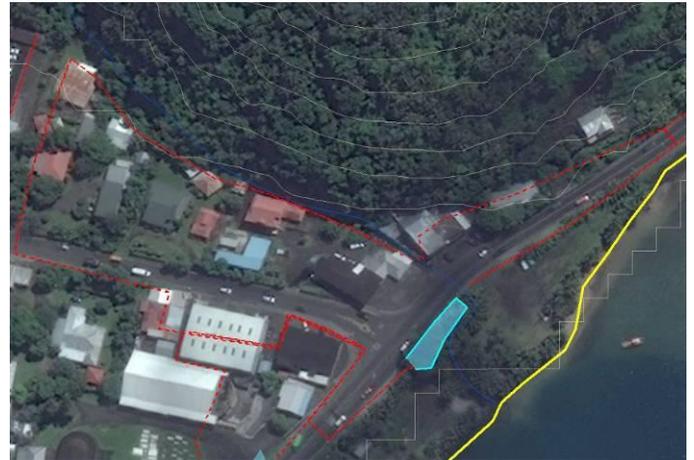
Map showing location of proposed gravel wetland (blue polygon) and drainage area to practice (red dotted line).

The gravel wetland would be sized to manage the first two (2) inches of runoff from the up-gradient impervious area. The available surface area in this location is approximately 3,050 SF which substantially exceeds the minimum surface area recommended for effective treatment. Unfortunately, given the elevation of the diversion, relative to sea level, there is only about three feet available for storage in a permanent pool; this equates to about half the target volume for water quality treatment. Again, some treatment is possible, and in terms

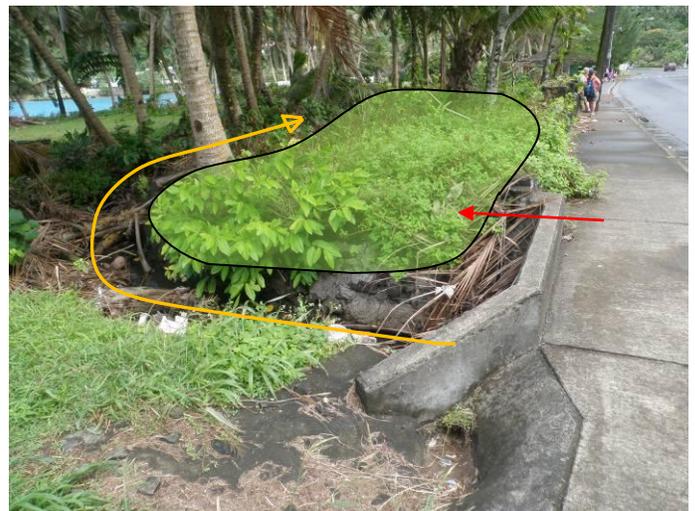
Figure 6A: Gravel wetland area, inflow diversion from new pipe across Hwy 001 shown in red arrow, bypass of flow from existing channel in orange.

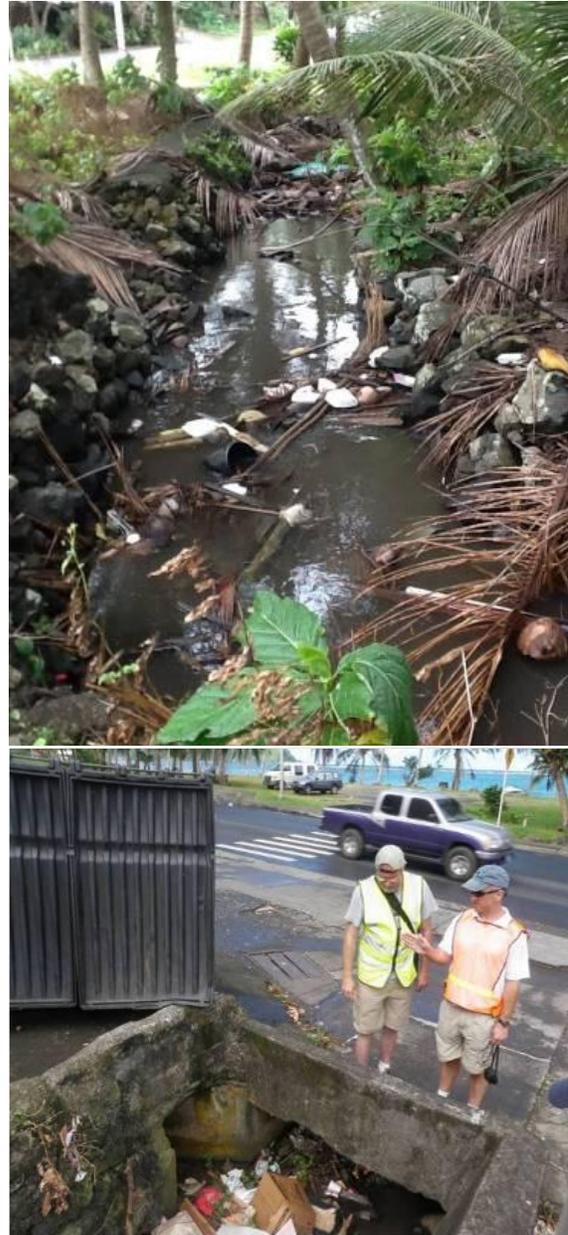
**Figure 6B.** Impacted stream section through park (top photo) and trash collected at upstream end of culvert (bottom).

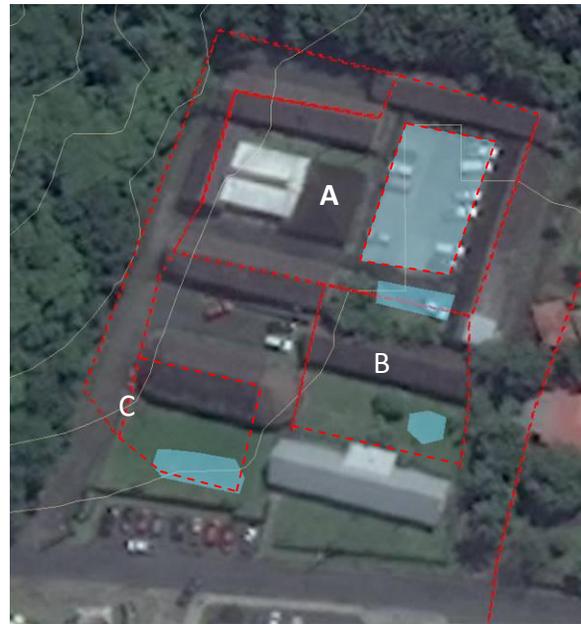
Map showing proposed practice locations (blue) and the areas draining to them (red line).

Also, this south east corner has been identified for possible expansion of one of the adjacent offices (Tuberculosis Clinic) which may require complete reworking of this drainage, so final location and design of the proposed bioretention basin must be coordinated with the expansion plans. The outlet of this retrofit area currently drains to the adjacent access road on the eastern side of the site (possibly proposed for re-construction). As an alternative, the outlet can be redirected to wrap around the corner of the building and directed to Retrofit B.

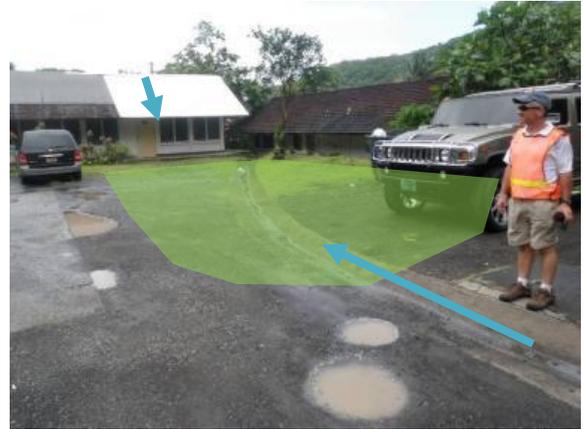
**Figure 7A.** Proposed location for small bioretention in upper parking lot. A portion of the parking lot is also proposed to be converted to permeable pavers.

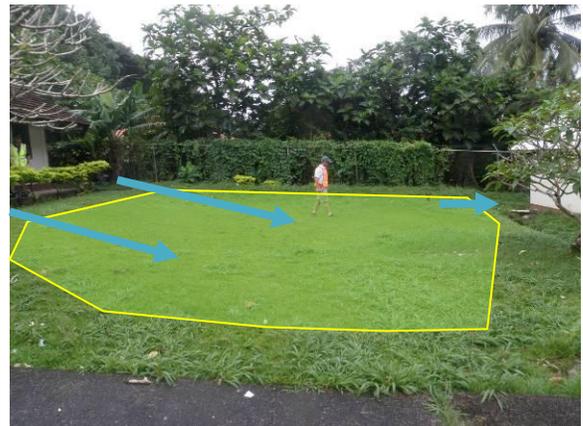
**Figure 7B.** Proposed location for small bioretention between building rows. Exposed sanitary sewer line and stormwater converging in one location at the outlet of Area B.

**B.** Bioretention within the grass area between the two buildings (photo 7B). The bioretention will capture the entire rooftop of the uphill building (north), as well as any overflow from Retrofit A (if not directed to the street). The discharge of this retrofit will be to the southeast corner of the green area at the corner of the next building. This location is complicated by a partially exposed sewer connection that is currently blocking the flow of runoff, causing erosion and undercutting the building foundation and possibly the sewer connection itself (photo 7C). This outfall will require careful design in order to protect both the building and sewer connection. Ideally this flow should be directed to the adjacent road improvements and the sewer connection properly protected.

**B.** This area is very simple in concept. The entire grass area is potentially available for a bioretention cell. The slope of the ground may require some grading to capture the entire roof of the upper building. The difficulty is in the outlet where the sanitary sewer connection is exposed (photo 7B). The improvements to the adjacent access road, and improvements to the sewer connection should be coordinated with the drainage improvements

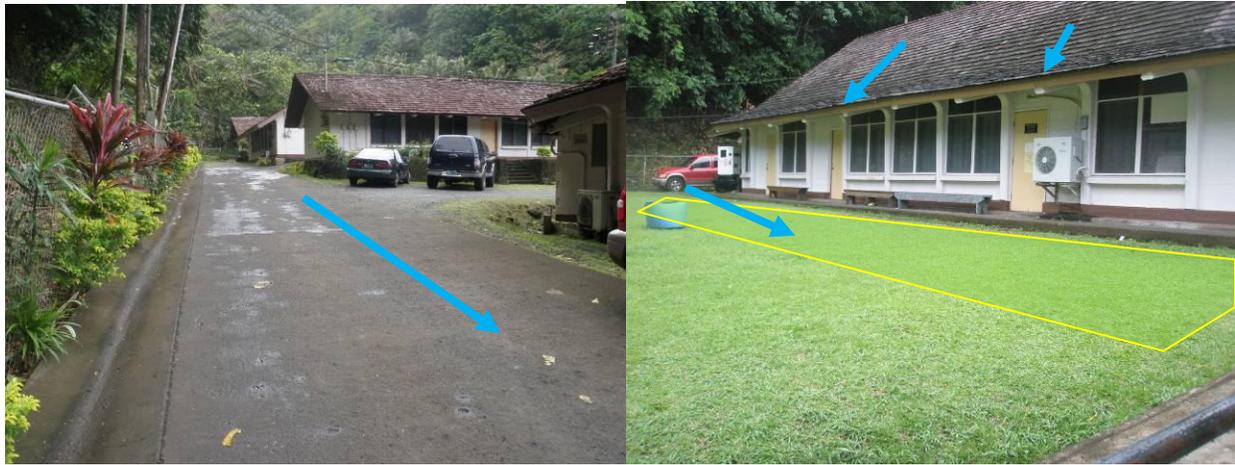
Figure 7C. Proposed location for small bioretention to capture runoff from drive aisle. .

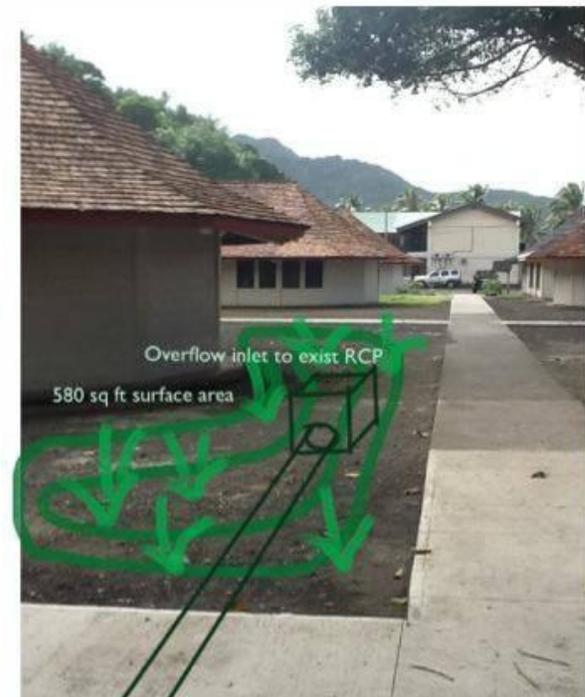
Figure 10A. Looking east at 13-A bioretention cell locations (potential installations on both sides of sidewalk) and partial view of contributing drainage area.

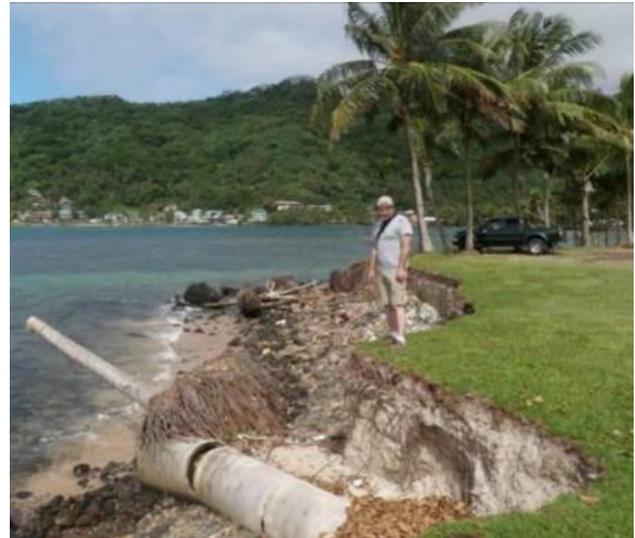
**Figure 10B.** Outfall of existing/historic storm drainage pipe

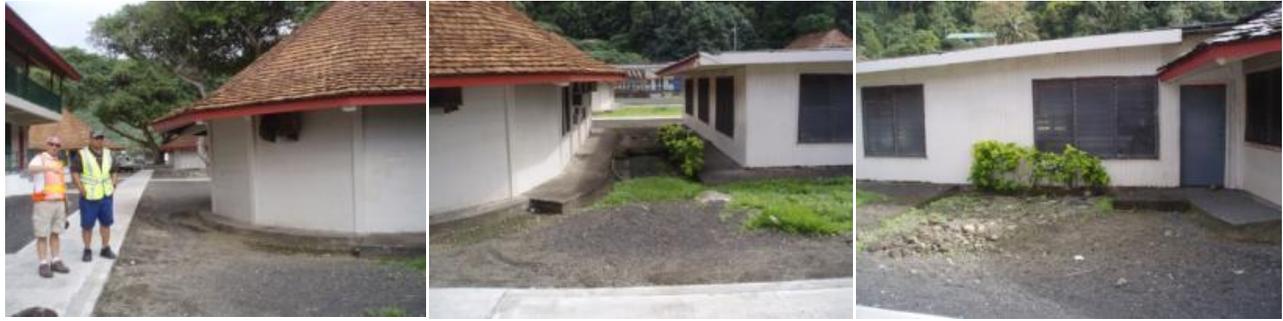
Figure 10C. Broken panorama of location of bioretention location 10B.

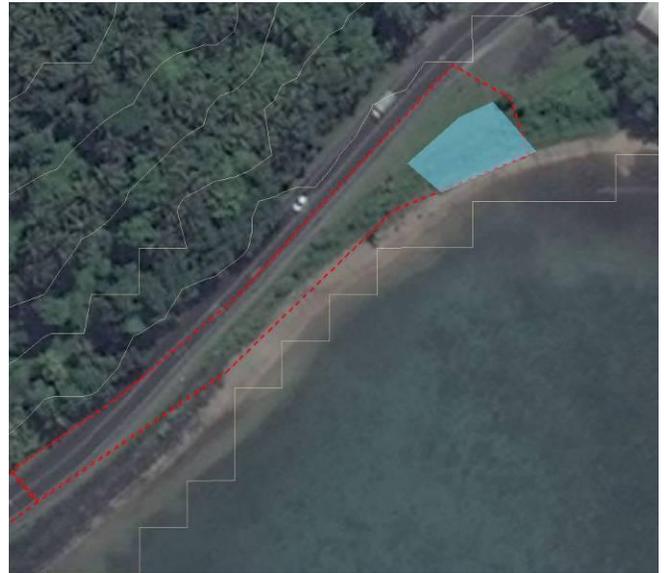
Map depicting the location of proposed bioretention (blue) and area draining to it (red line).

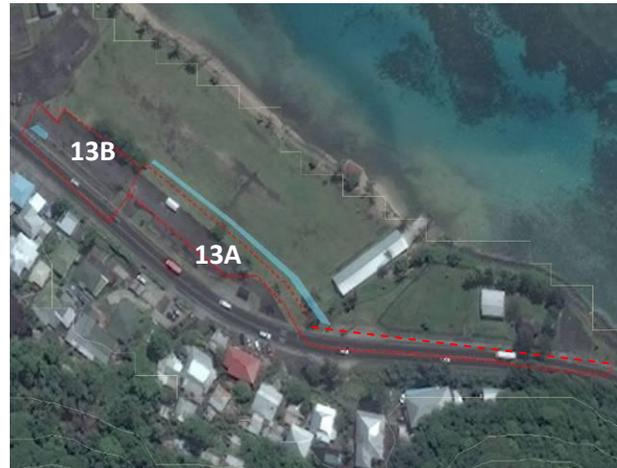
Map depicting retrofit locations (blue polygons) and drainage areas to each site (red dashed line).

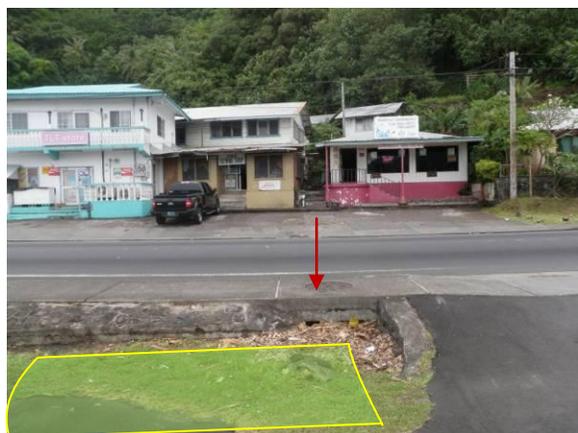
13B. A rain garden is proposed in the parking lot. Outlet into existing drain inlet is shown with the red arrow.

would be difficult to intercept runoff at the second inlet, which would include flow in the existing pipe and runoff coming from the restaurants across the street. However, there is space adjacent to the inlet in the parking lot closer to the road to divert parking lot runoff into a rain garden or bioretention facility. Overflow can tap back into the existing drainage inlet.

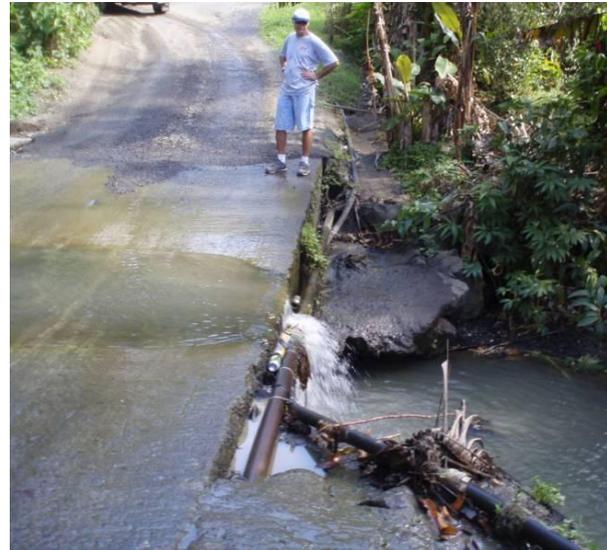
**Figure 15A.** Stream baseflow pouring across the road surface.

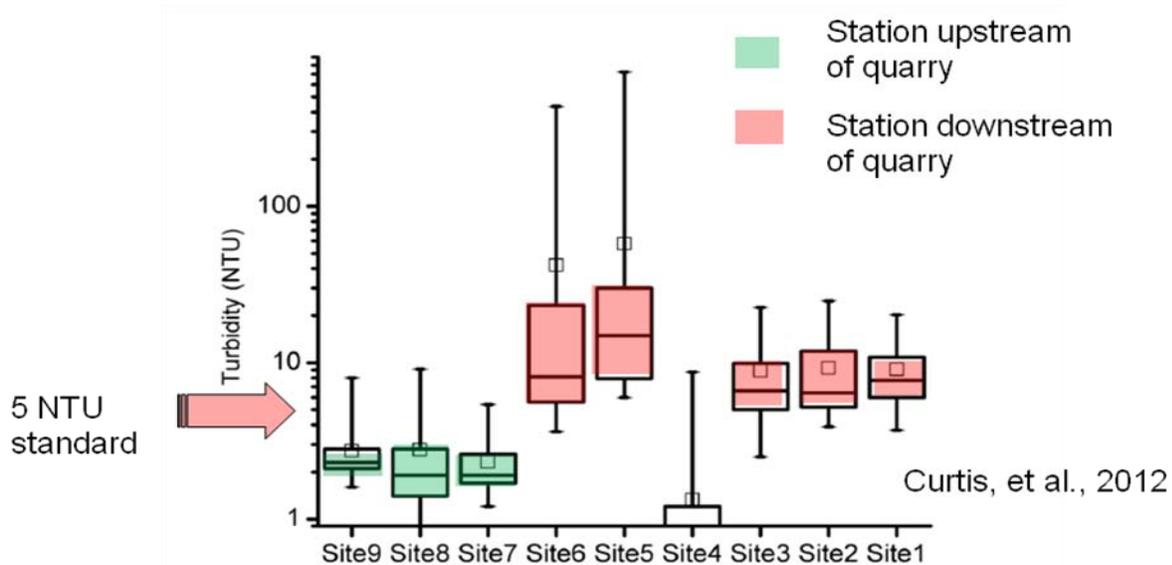
Figure 3. Illustrates the box-and-whisker plots for each sample site. The scale is logarithmic in order to capture entire samples.
