# Faga'alu Watershed Plan Implementation Supplement

March 2013

**Horsley Witten Group, Inc.**  
90 Route 6A, Sandwich, MA 02563  
508.833.6600  
[www.horsleywitten.com](http://www.horsleywitten.com)

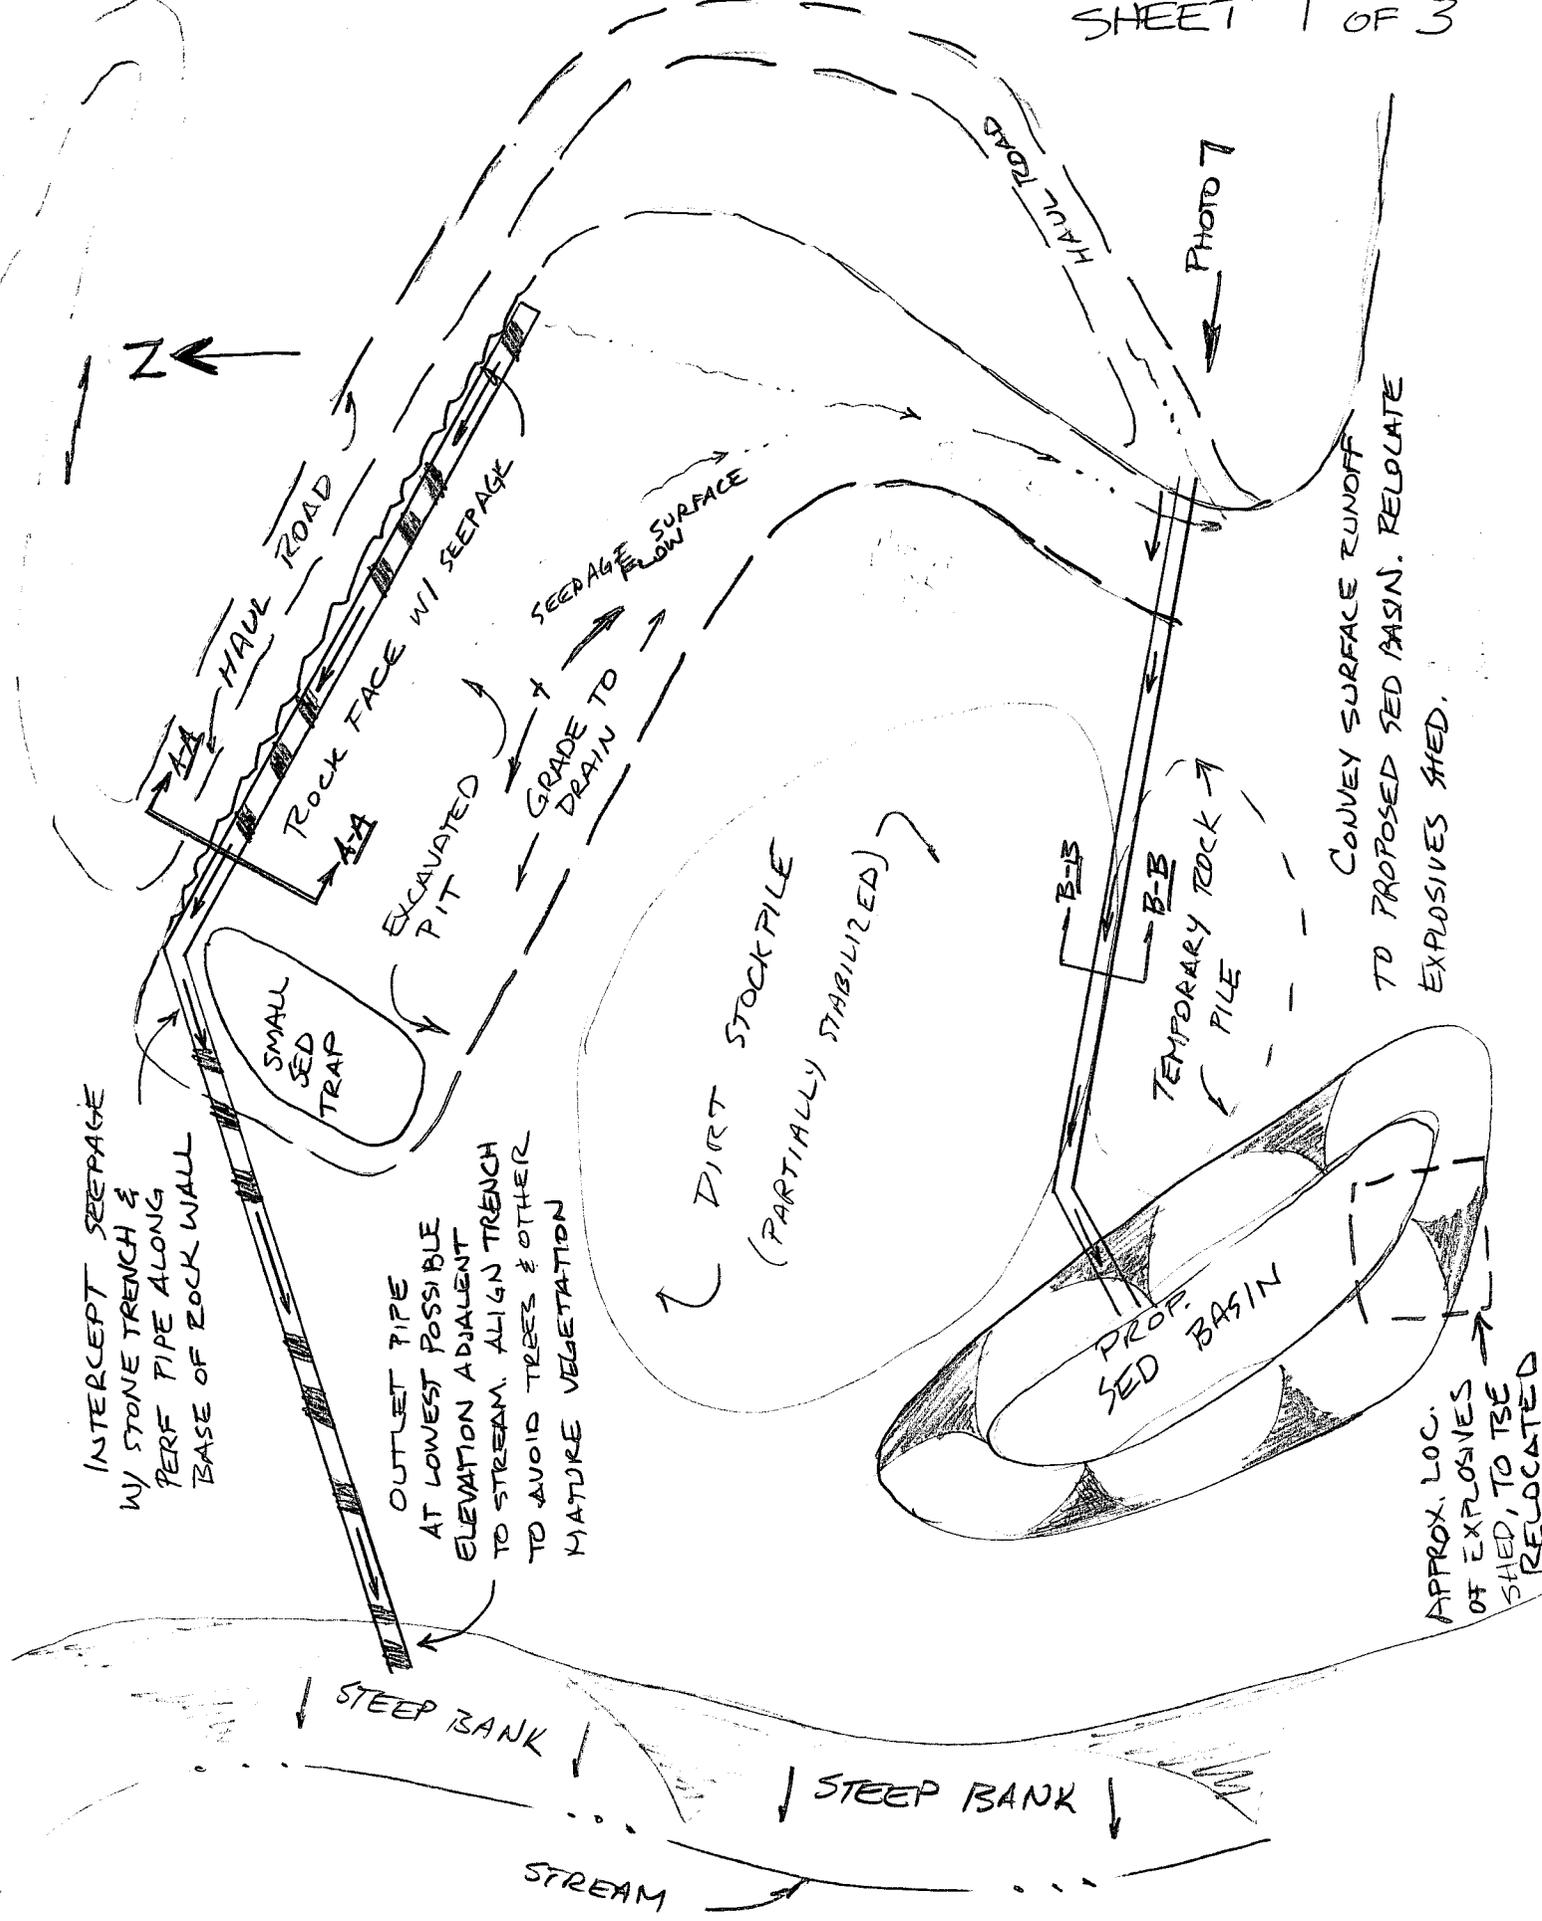
INTERCEPT SEEPAGE  
W/ STONE TRENCH &  
PERF PIPE ALONG  
BASE OF ROCK WALL

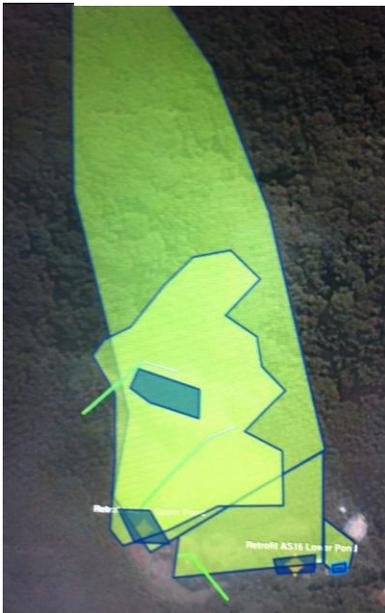
### Field Data Collection- iPAD: initial area calcs and pipe lengths

#### Upper Pond

Watershed Area = 11.9 acres  
 Disturbed Area = 4.6 acres  
 Underdrain Pipe = 267 ft  
 Surface Runoff Pipe/Channel to Pond = 295 ft  
 Pond Surface Area = 7,000 sq ft.

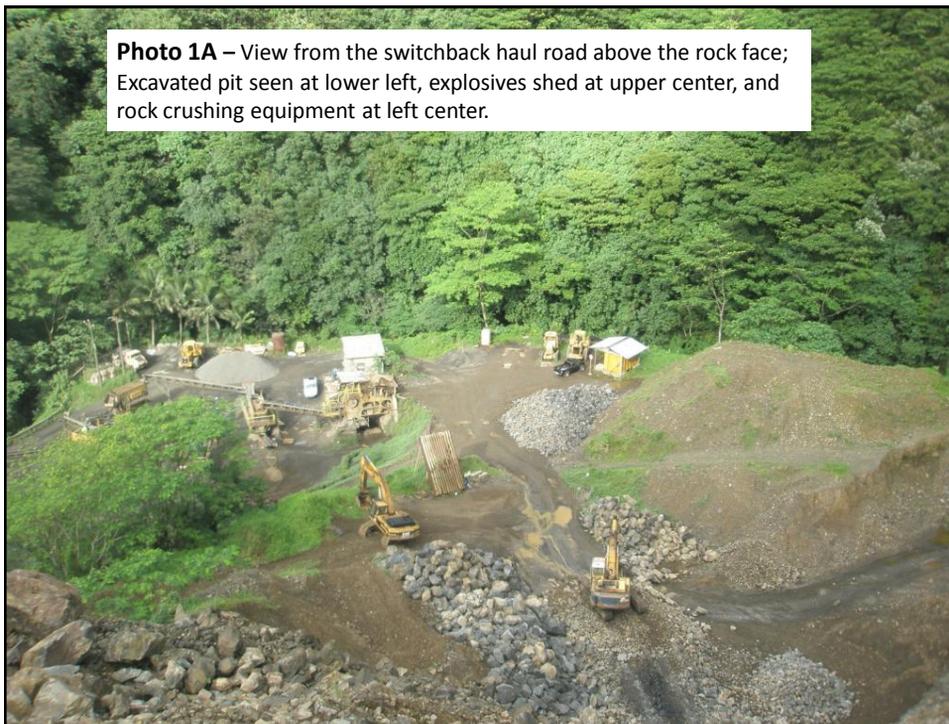
**Photo 1A** – View from the switchback haul road above the rock face; Excavated pit seen at lower left, explosives shed at upper center, and rock crushing equipment at left center.

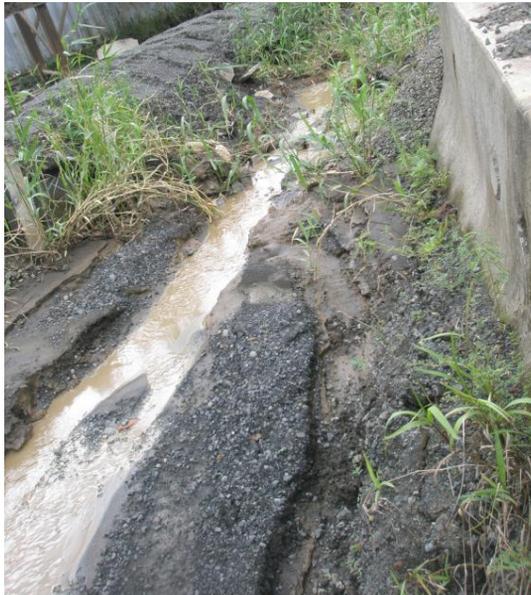
**Photo 7A** – Schematic of Upper Pond location. Image shows culvert under access road to Excavation Platform, and the alignment of the conveyance channel to the proposed settling pond.

3. Discharge culvert into a stone lined surface channel diversion channel (Design Concept Sketch Sheet 1 of 3, Section B-B). Conveyance channel drains to proposed sediment basin (Upper Pond or settling pond in figure below). (Also reference to Photo 7, and Photo 7A in Photo Album)

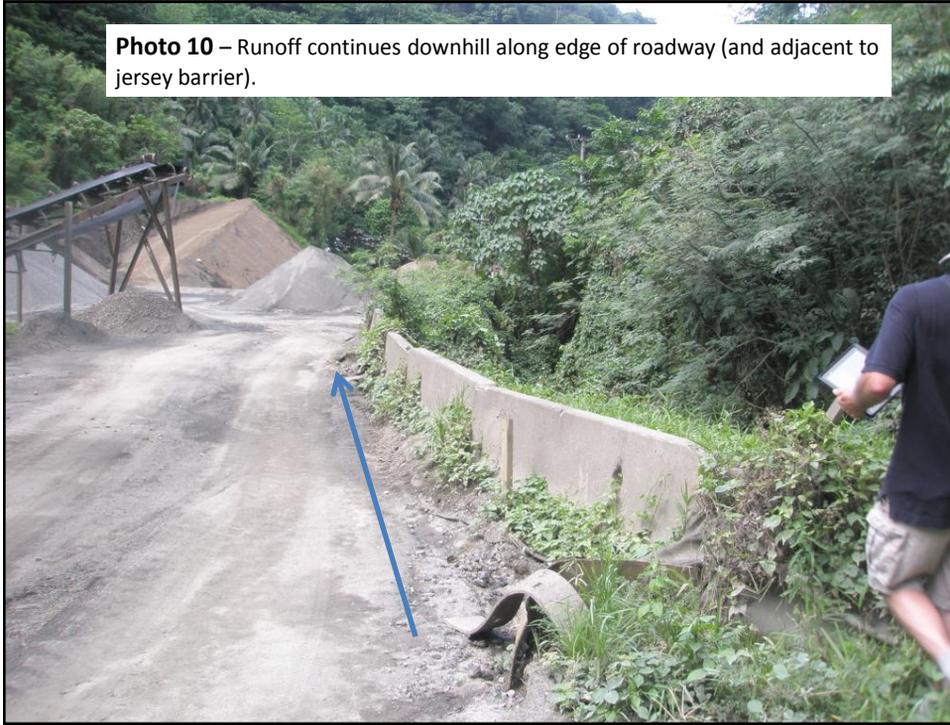
**Photo 10** – Runoff continues downhill along edge of roadway (and adjacent to jersey barrier).

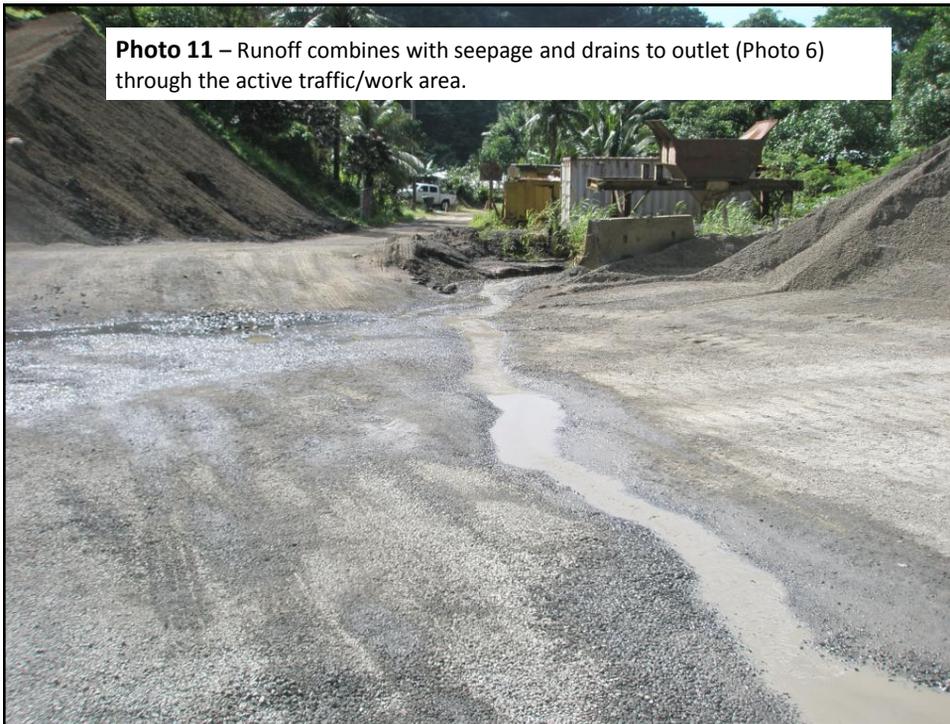
**Photo 11** – Runoff combines with seepage and drains to outlet (Photo 6) through the active traffic/work area.

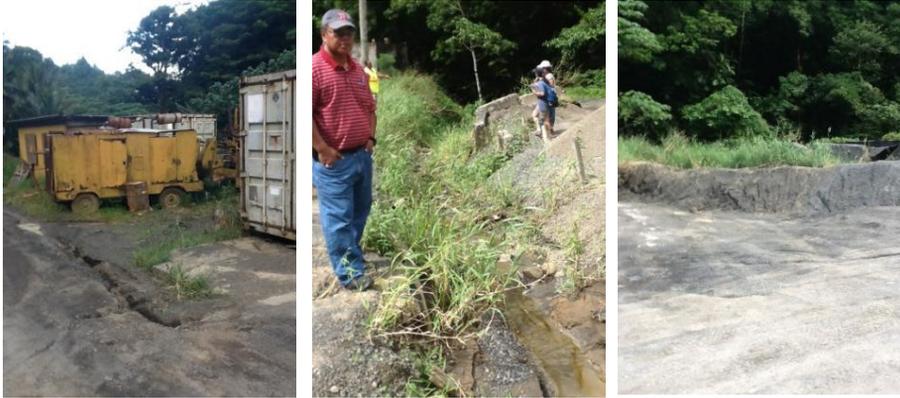
**Photo 12** – Construction equipment and port-a-john located adjacent to stream bank with minimal buffer.
