Guánica Hydroseeding 2013-2014

Paul Sturm, Ridge to Reefs

Roberto Viqueira and Louis Meyer, Protectores de Cuencas

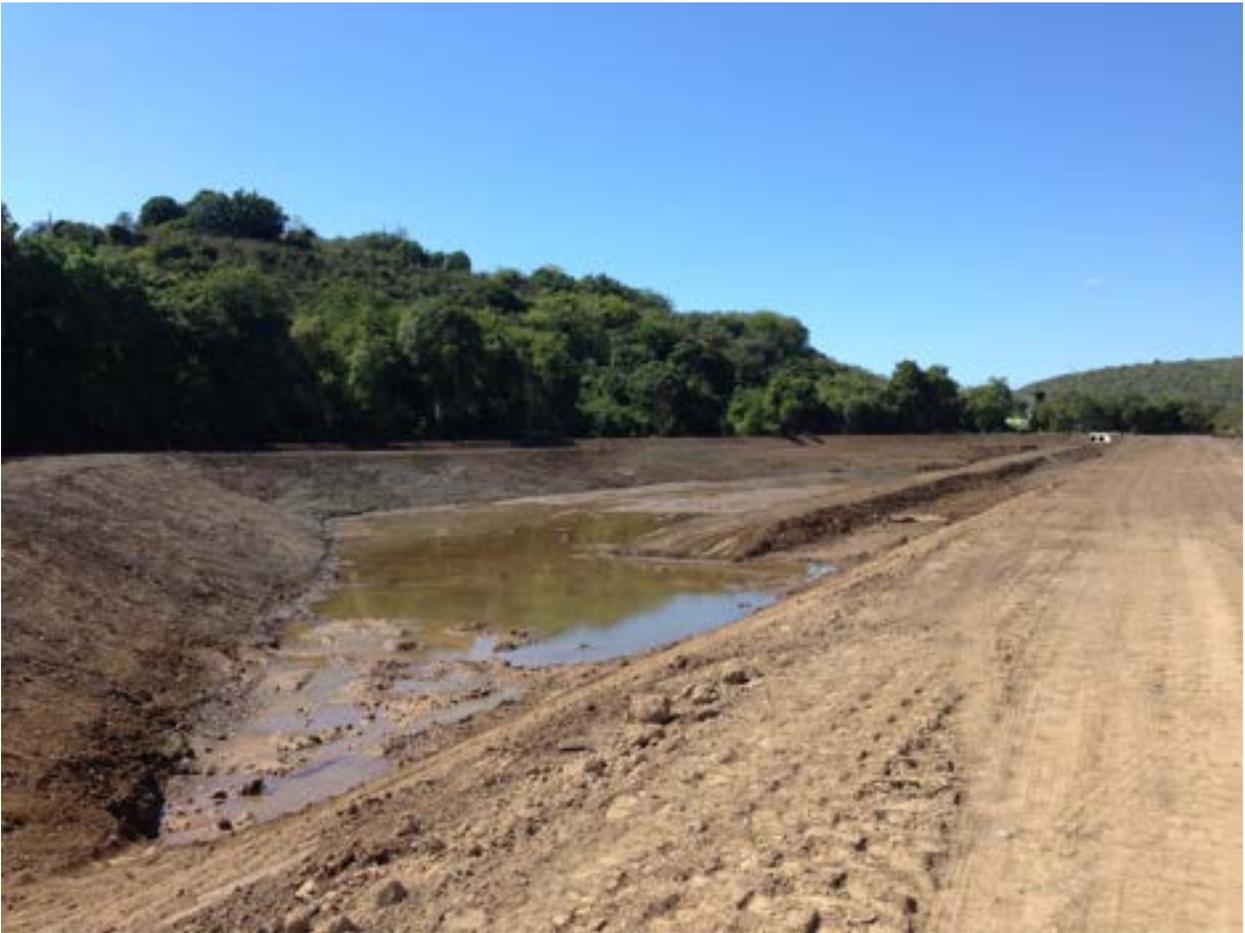
Figure 2. Sediment pond prior to stabilization efforts

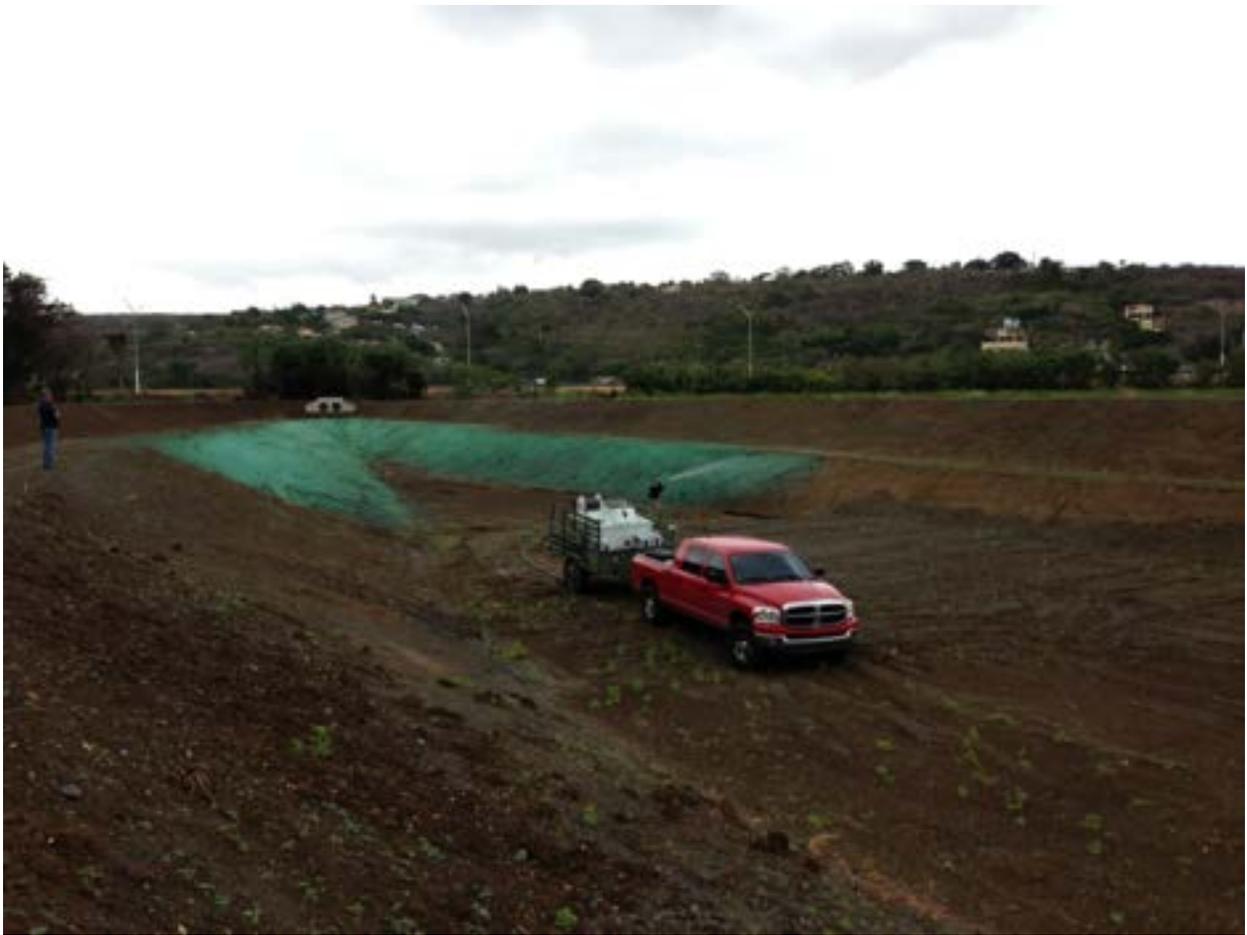
Figure 3. Hydromulch application in the sediment basin working with the Southwest Soil Conservation District and NRCS

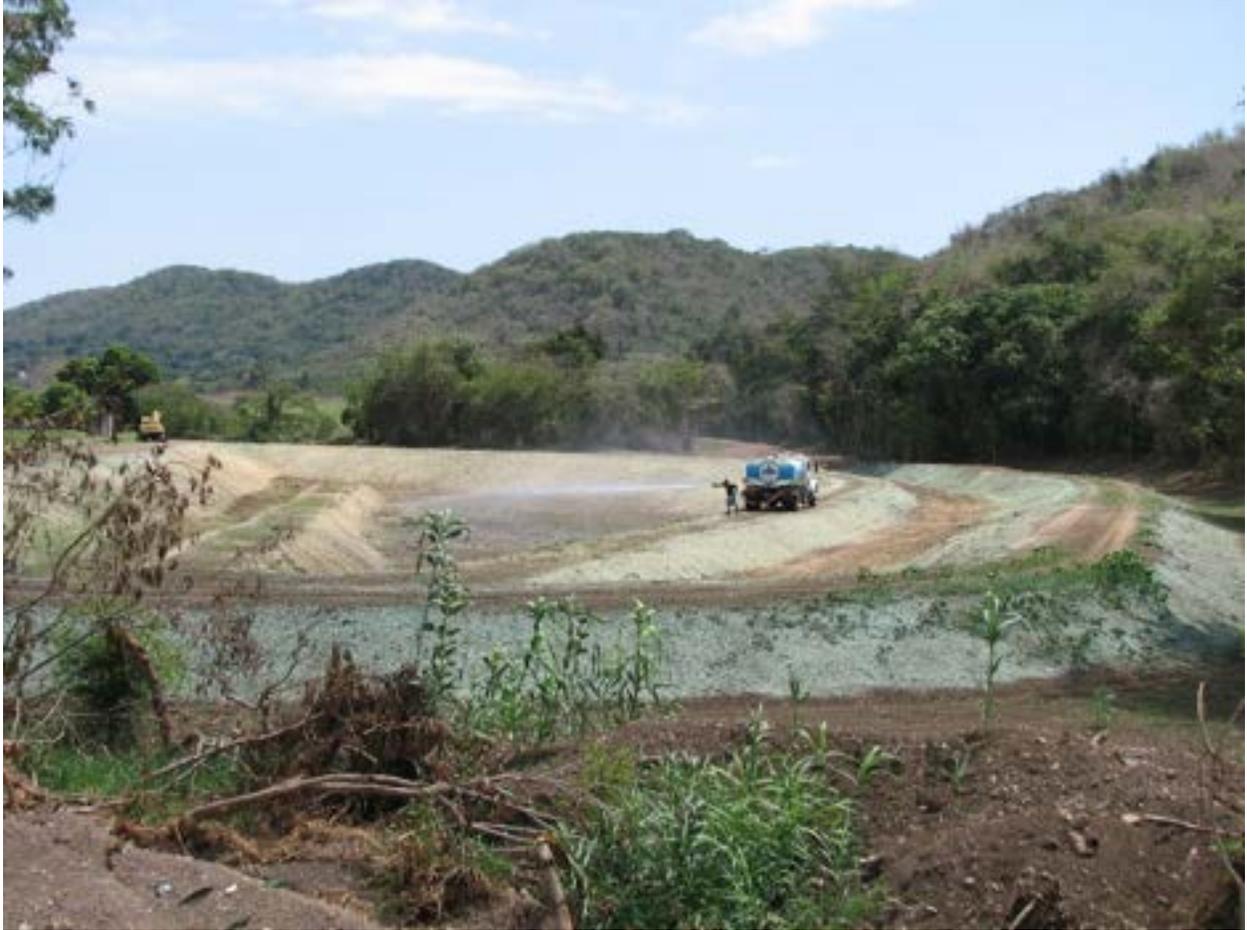
Figure 4. Watering the sediment pond project site using assistance from Department of Natural and Environmental Resources

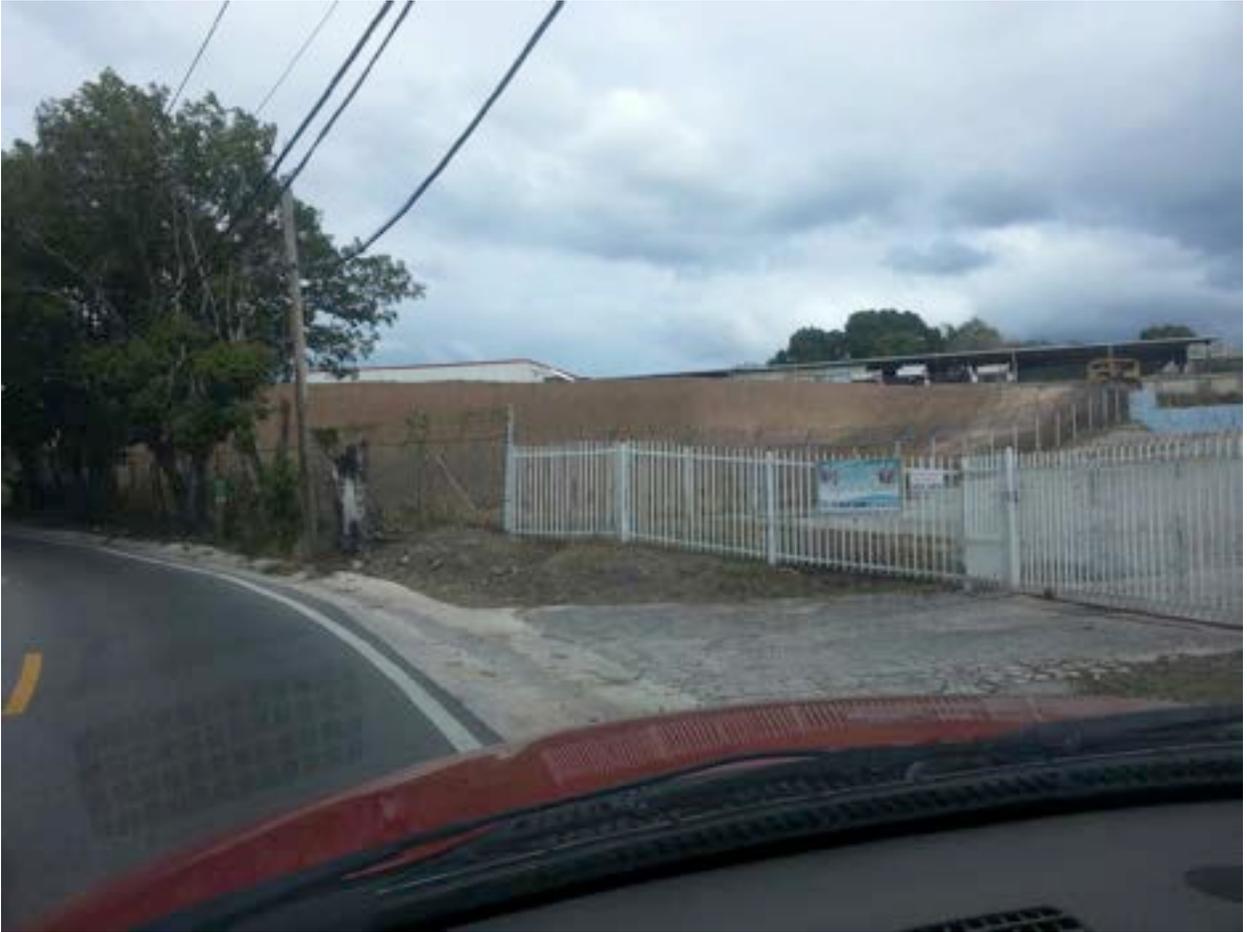
Figure 5. Bare soil from the hardware site

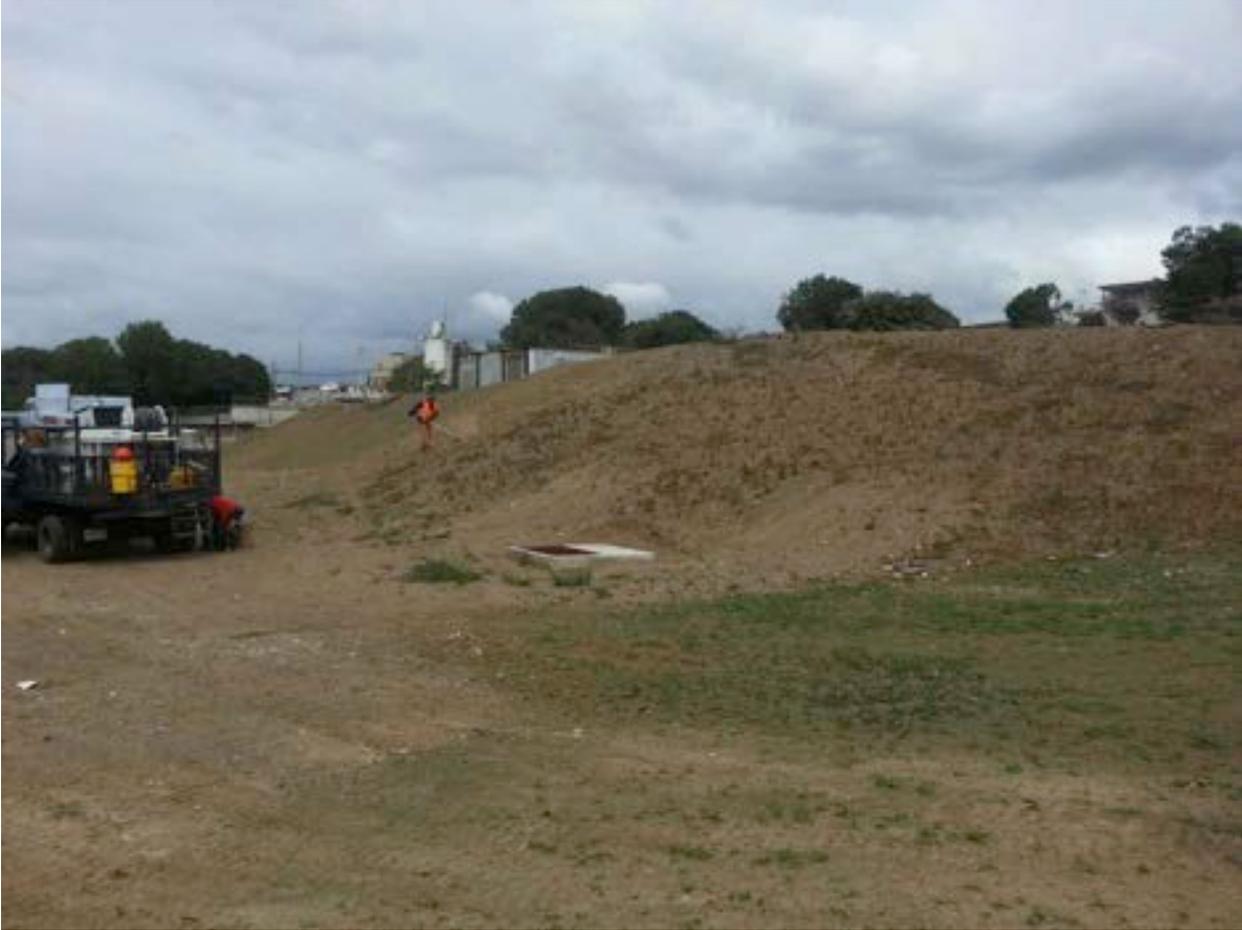
Figure 6. Preparing the site for hydroseeding

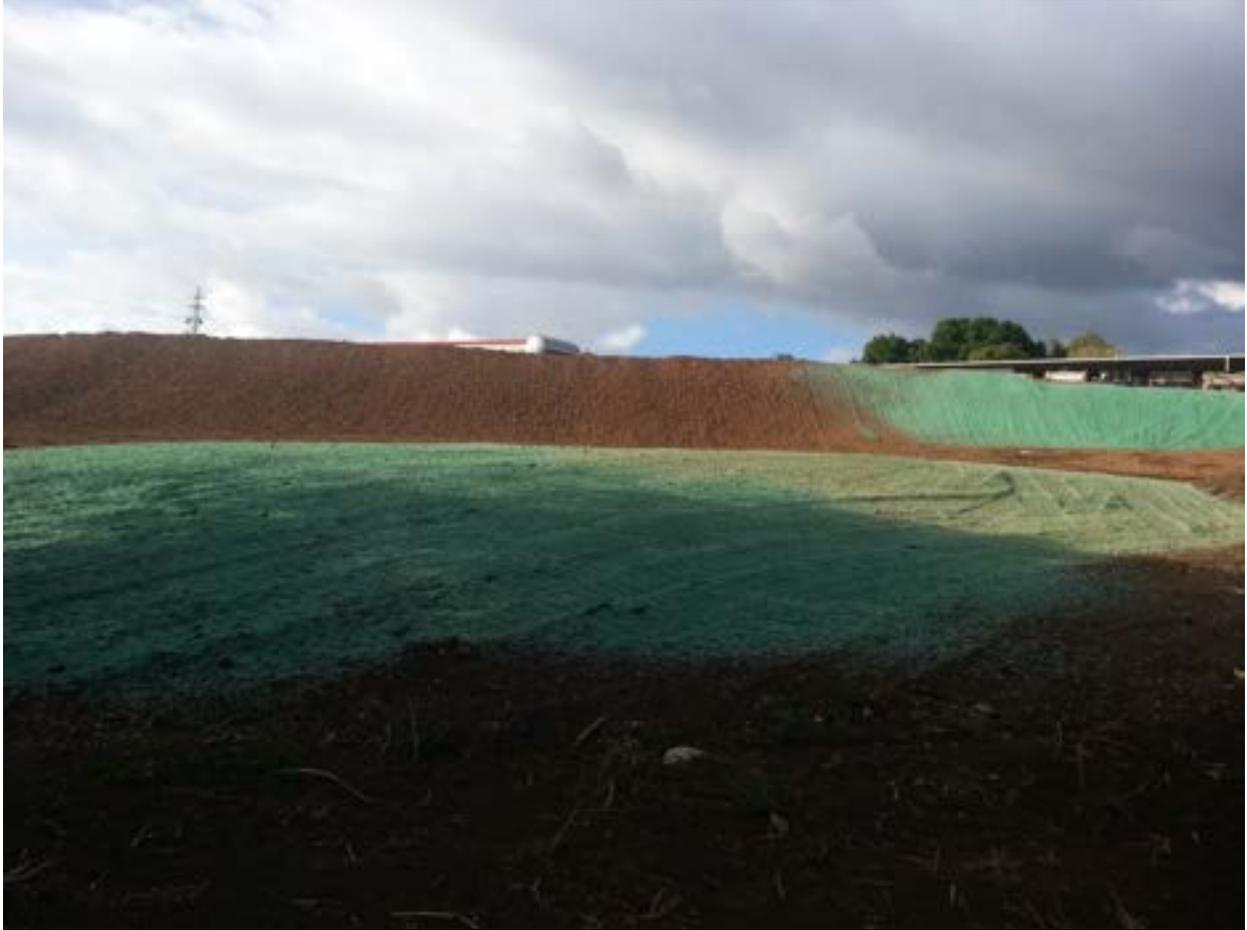
Figure 7. Hydroseeding in process at the hardware store site

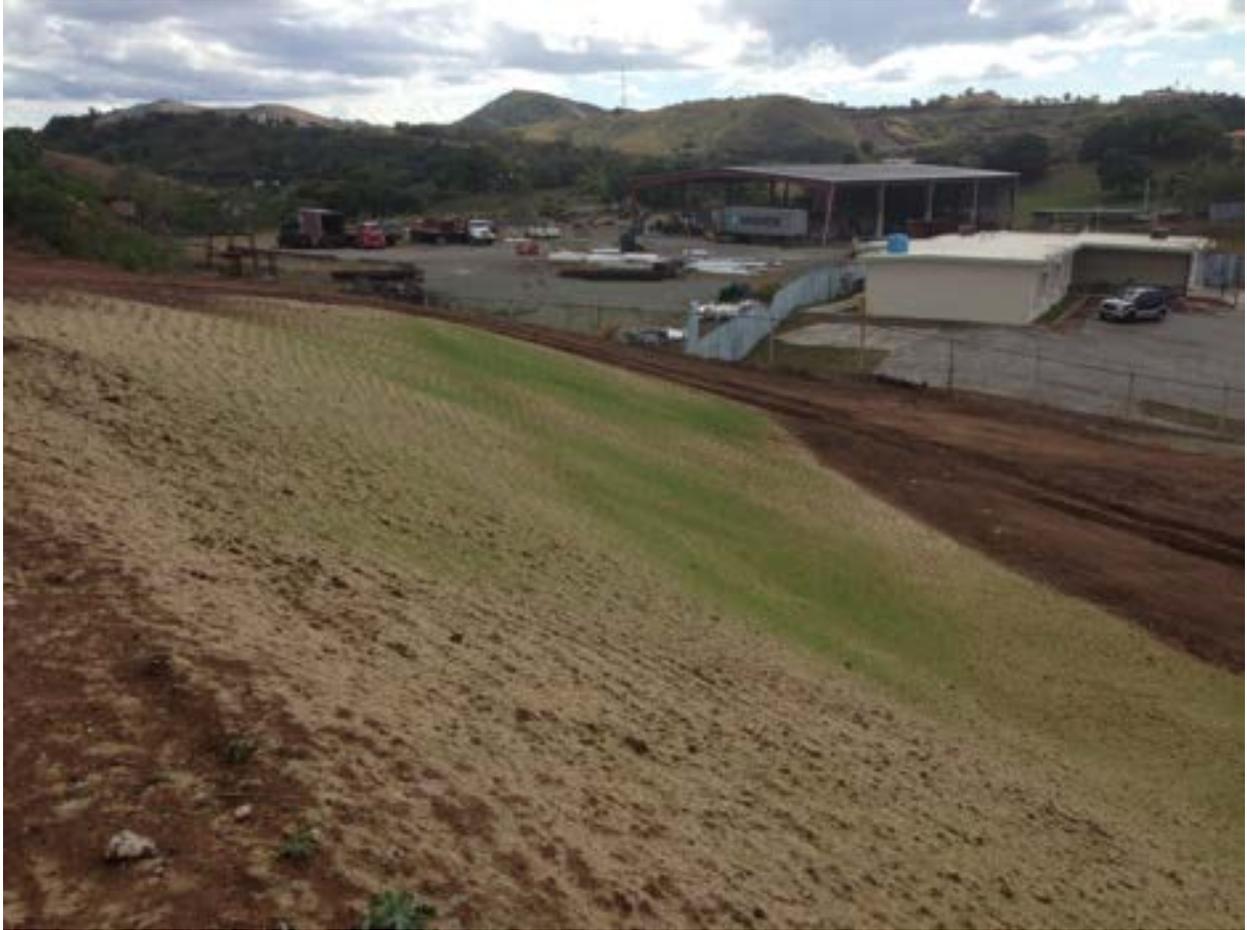
Figure 8. Stabilization and initiation of germination of hardware site

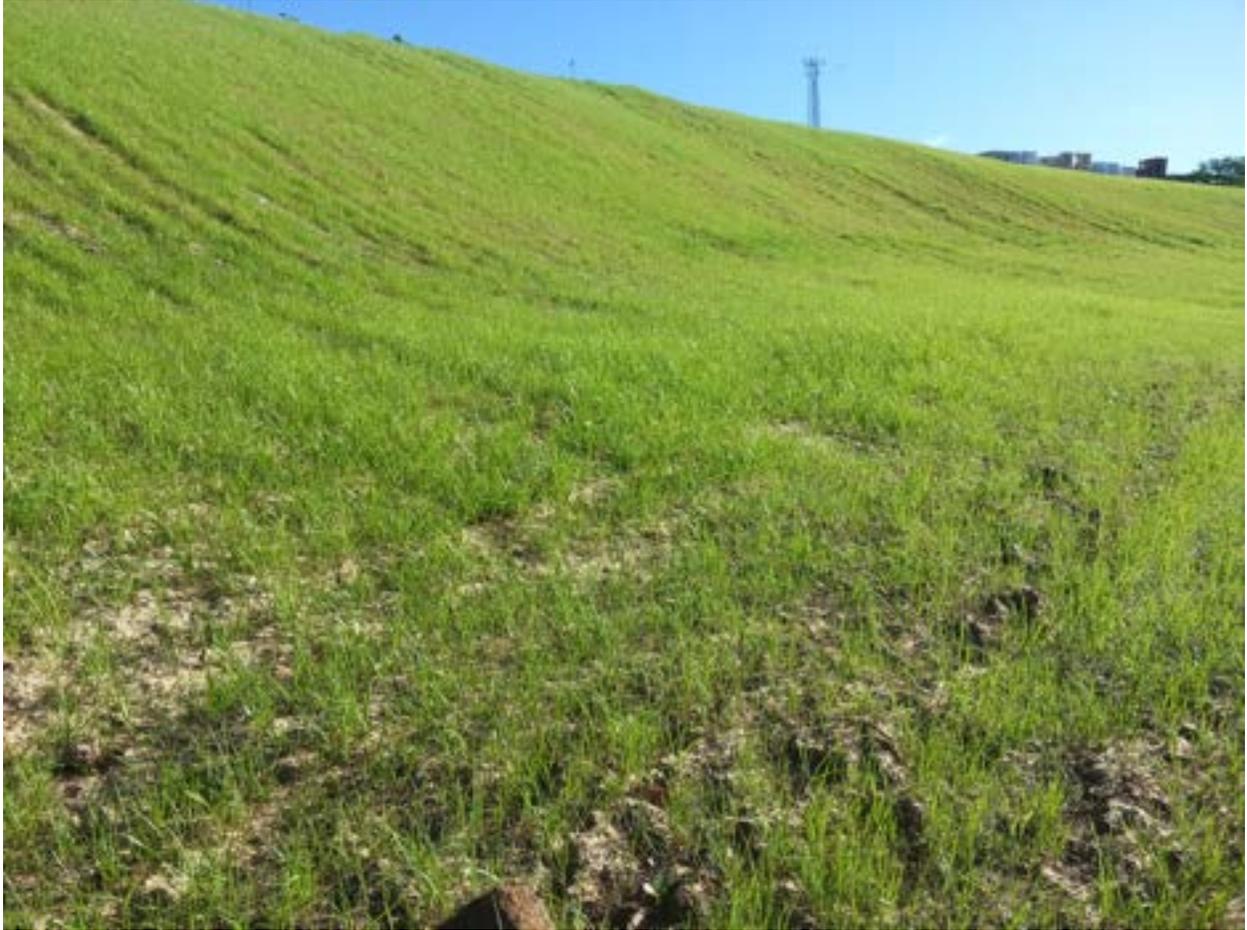
Figure 9. Re-establishment of grass at the site

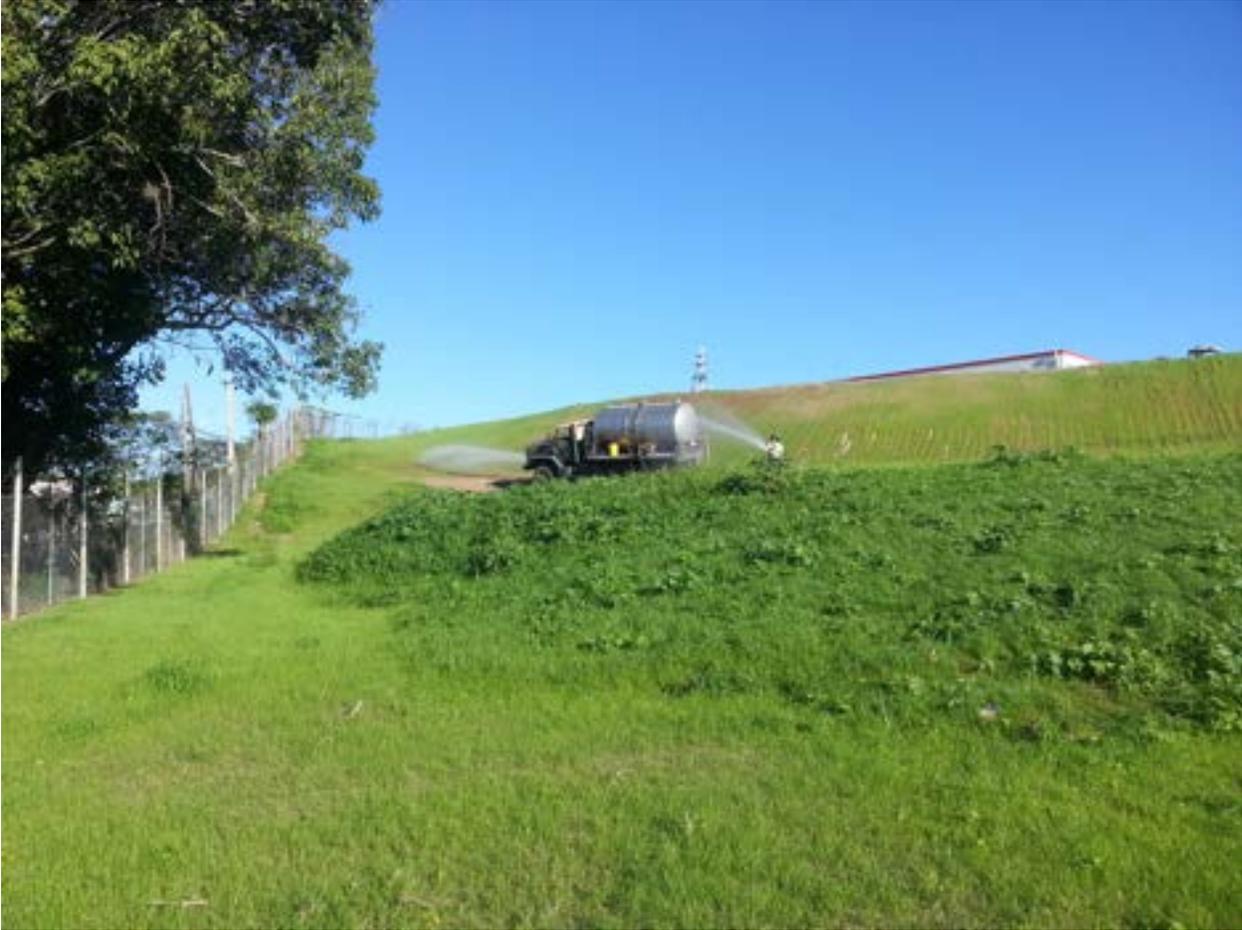
Figure 10. Vegetative stabilization and watering at the hardware store site

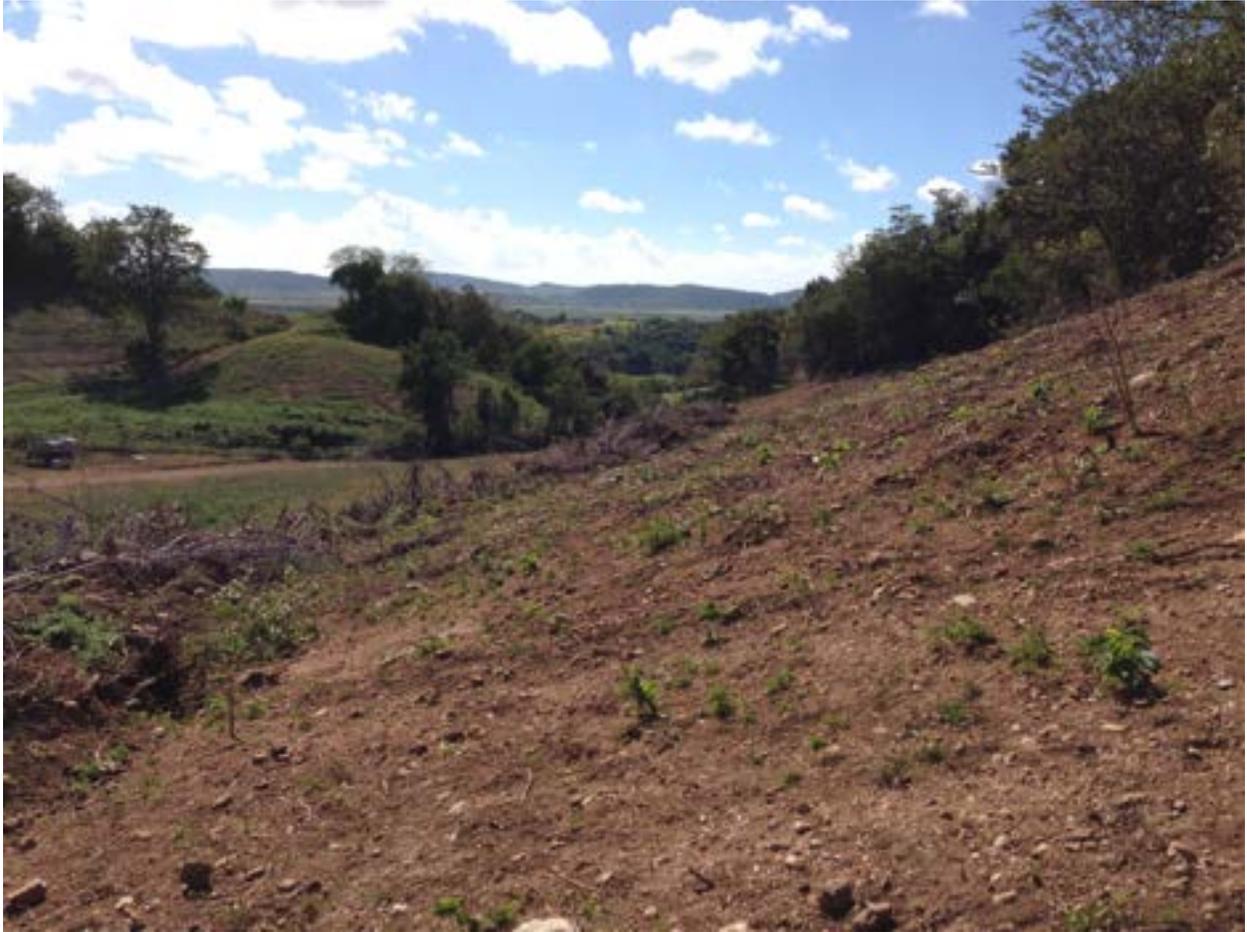
Figure 11. Bare soil cleared on Finca La Paz -- note piling of woody debris to break the slope and reduce concentrated runoff from the hillslope

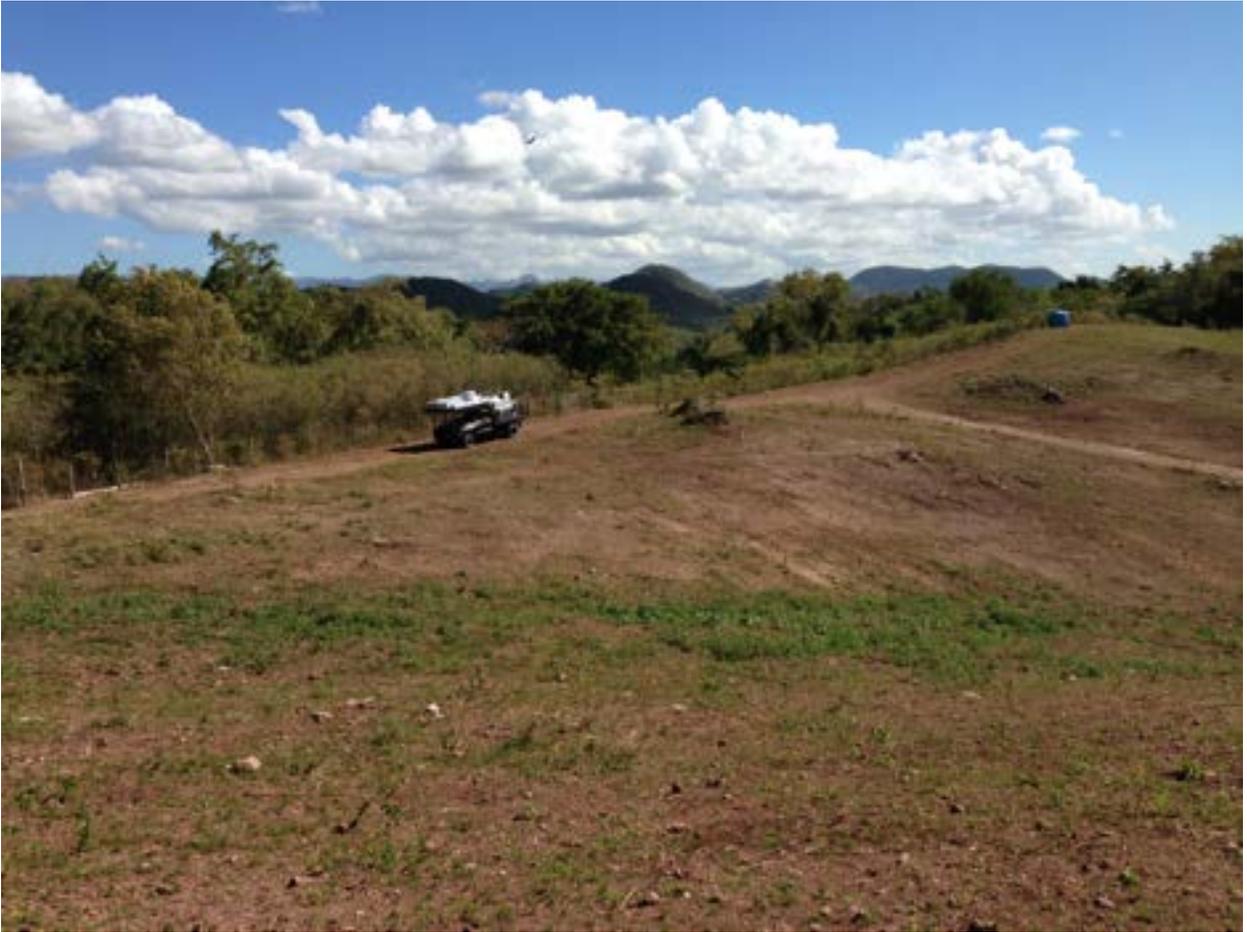
Figure 12. Part of the La Paz site prior to stabilization

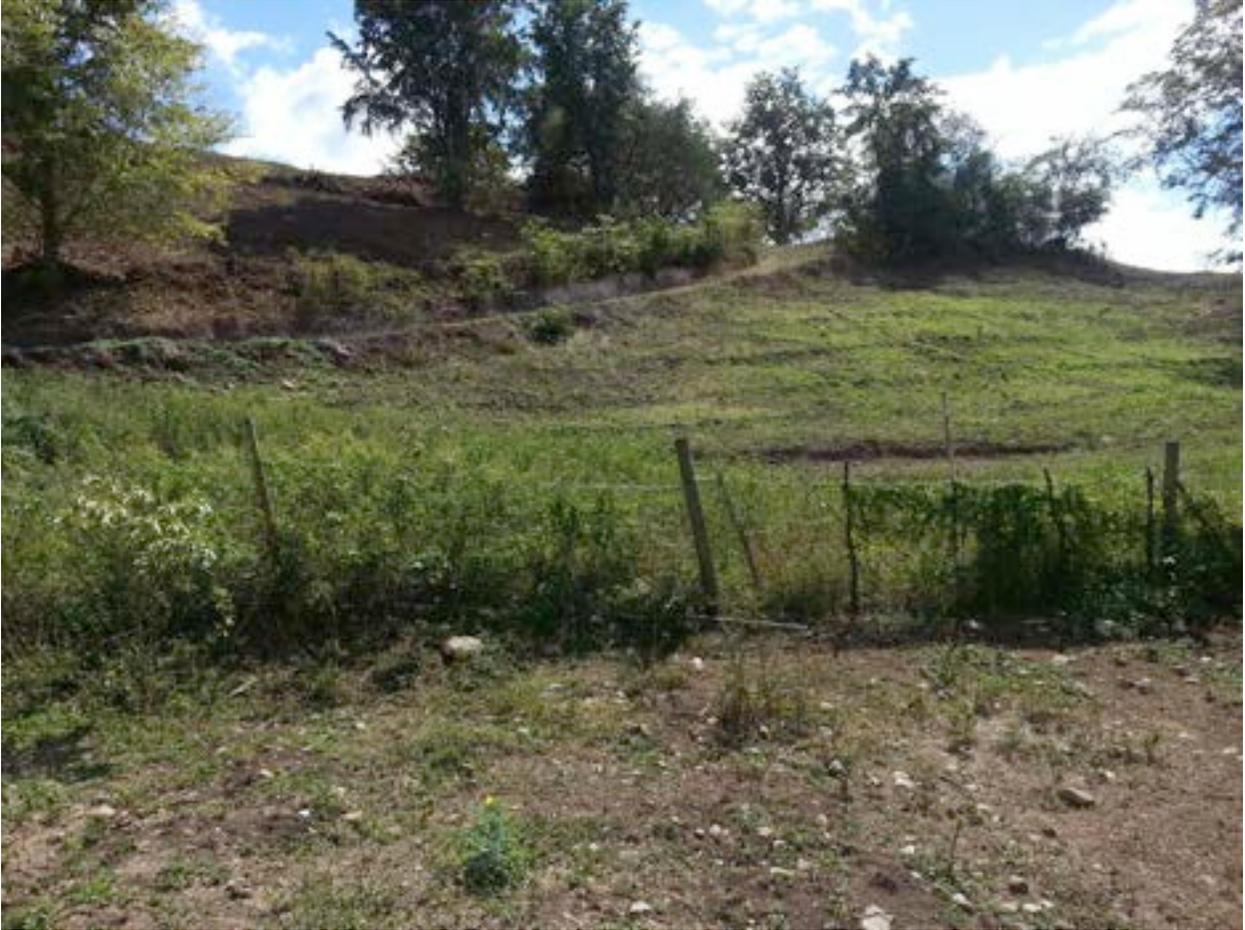
Figure 13. Germination of the La Paz site

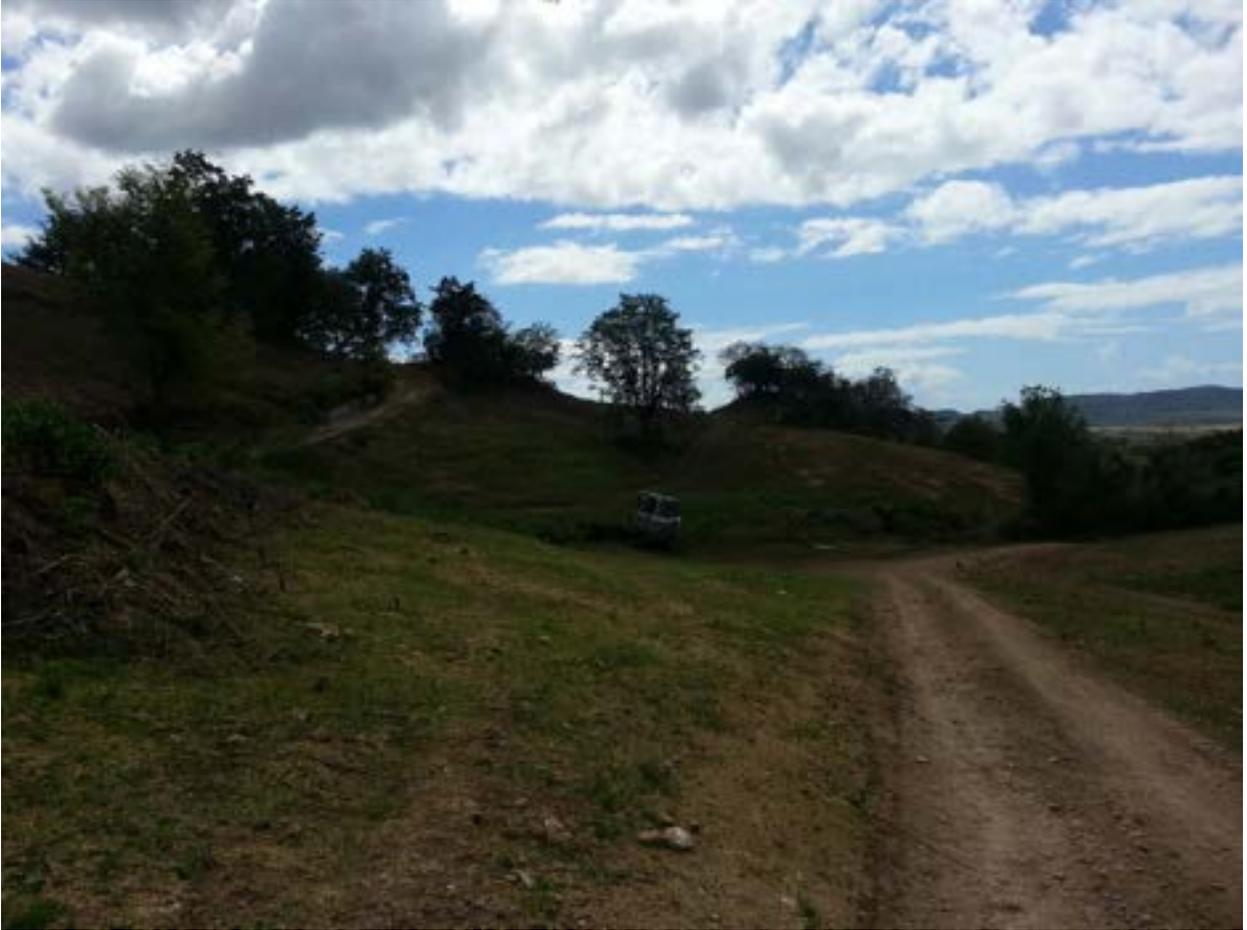
Figure 14. Germination and greening of the La Paz site

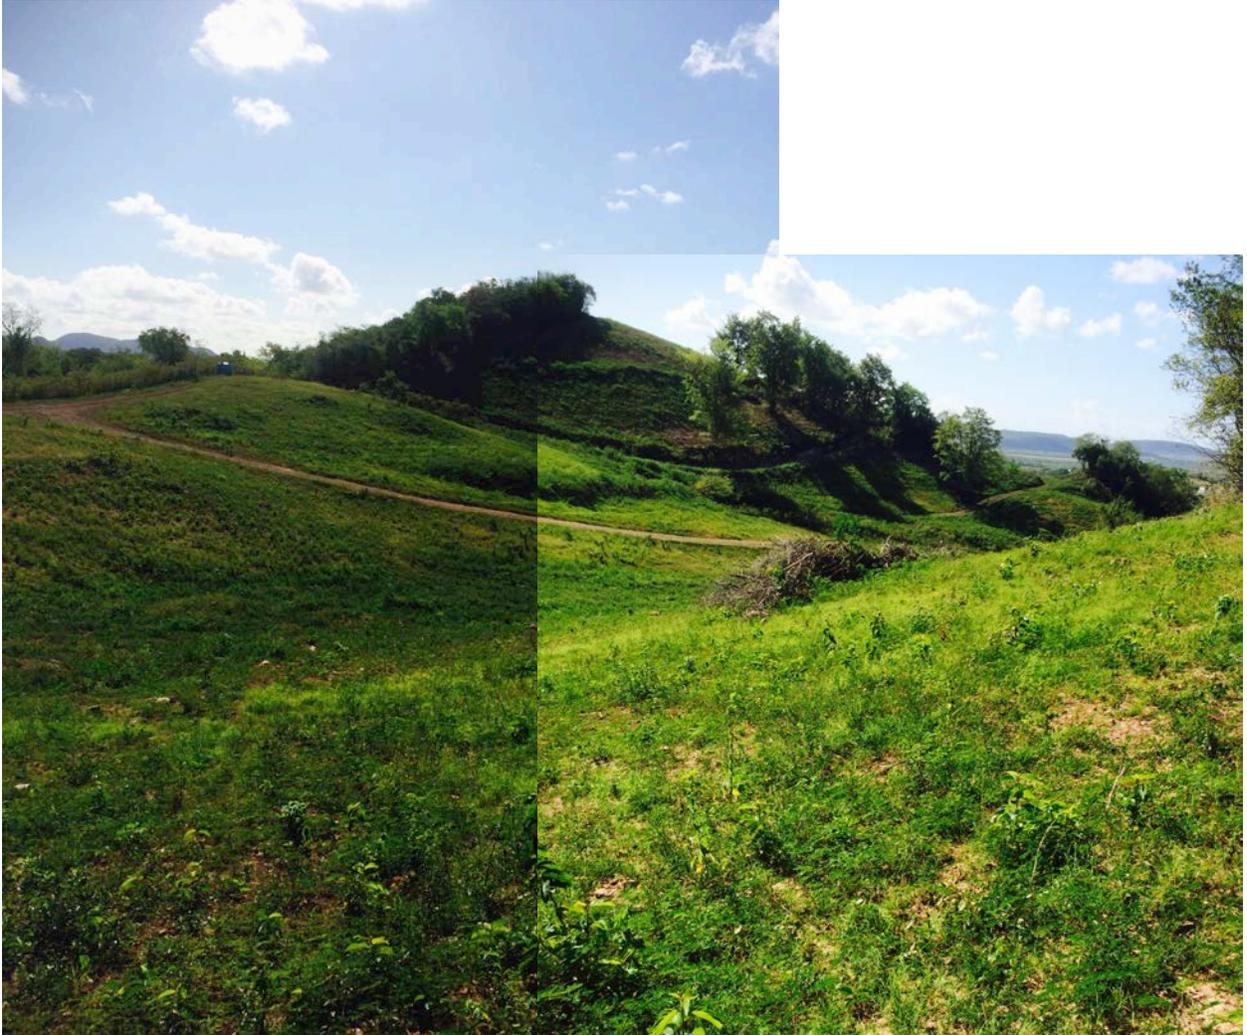
Figure 15. Stabilization at the Finca La Paz site

Percent vegetative cover was restored to the sites at the respective rates >95%, 90% and >95%, the Finca La Paz farm site stabilization was diminished slightly due to the age of the site as it has been over 60 days since the site was cleared by the farmer –this resulted in lost soil, more sporadic growth at first and compacted soil making stabilization more challenging including lengthening the amount of time we needed to water than a freshly cleared site (Note: re-clearing the farm site would have increased cost and the risk of even more soil loss if a storm were to happen).
