## 4.0 Solitude Bay Watershed

### 4.1 General Description

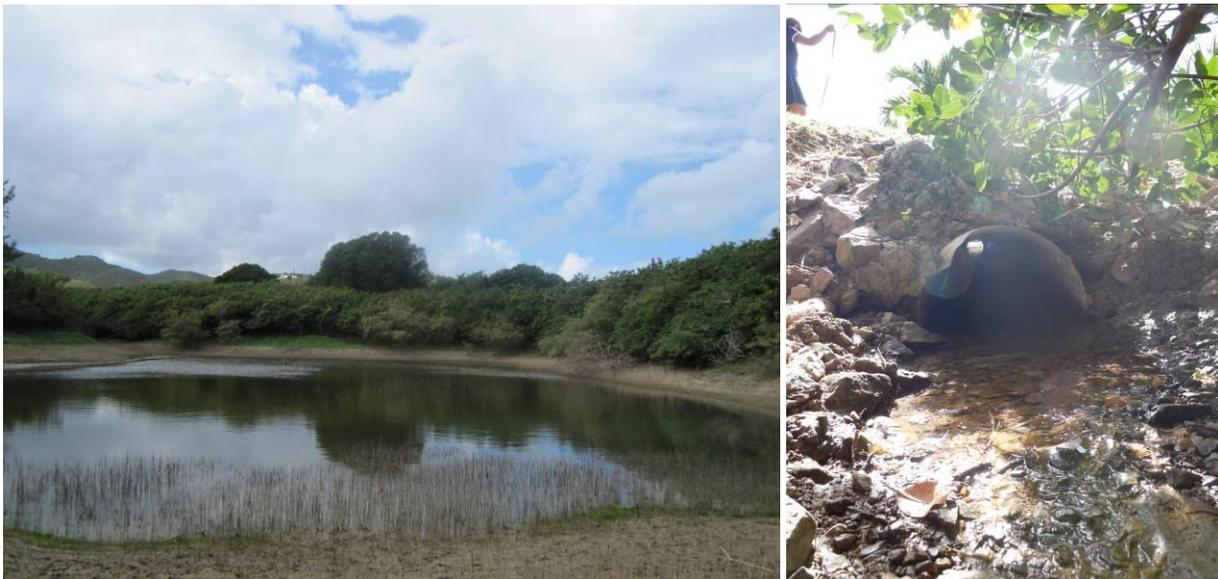
**Figure 4.1.** Pond along gut in Cotton Valley Neighborhood (left) and culvert at East End Road discharge location to Yellowcliff Bay (right).

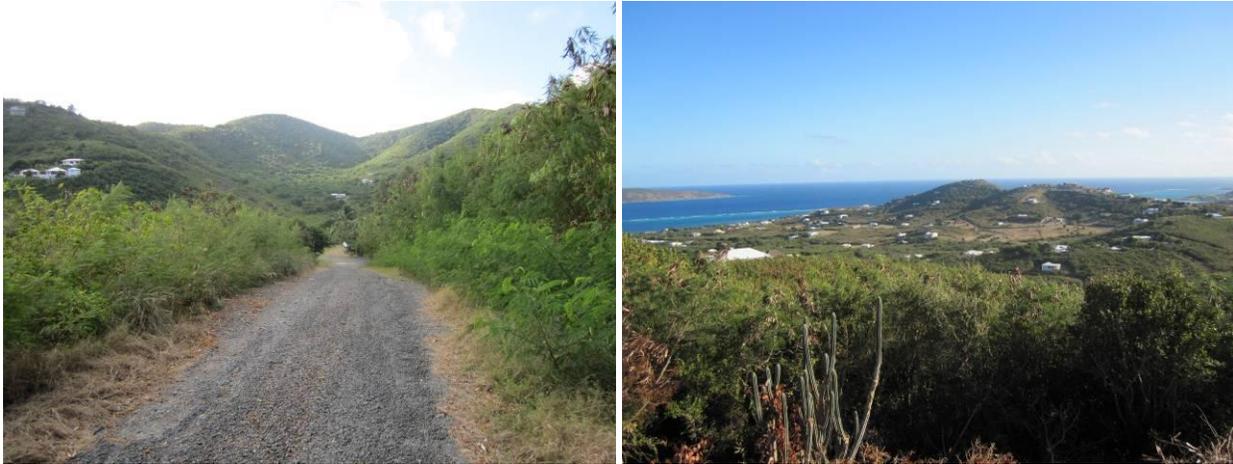
**Figure 4.2.** Characteristic landscape of Solitude Bay Watershed; views from Pleasant Valley and Hope and Carton Hill neighborhoods (left to right).

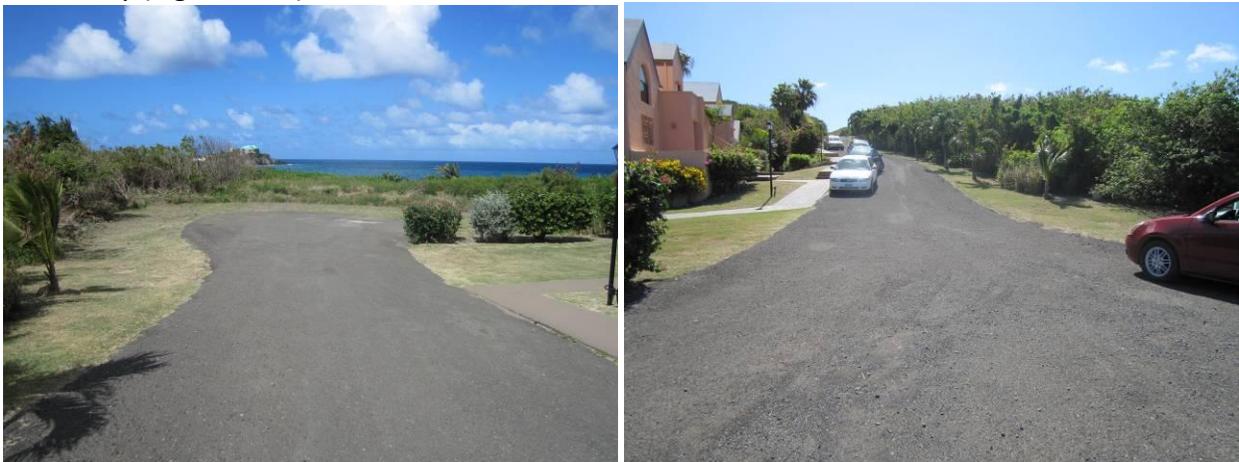
**Figure 4.23.** Prune Bay can be seen just beyond this large cul-de-sac near Candle Reef Condos II (left) and the drainage area to the cul-de-sac, consisting of roadway, parking areas, and walkways (right).

The Candle Reef II Condominiums are located in the west edge of the Solitude Bay watershed. This location is ideal for a demonstration project to not only improve water quality but also help to educate the residents about the East End Marine Park, stormwater pollution, and how they can help reduce land-based sources of pollution to the marine environment. The proposed BMP includes a bioretention area in or around the cul-de-sac providing access to Prune Bay (Figure 4.23).

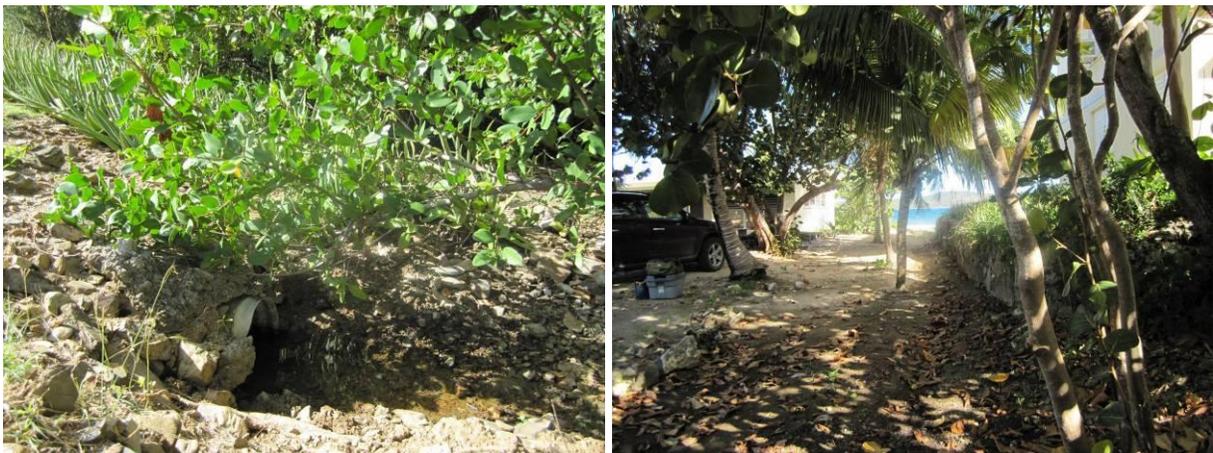
The major gut system in this watershed carries flow from an approximately 600-acre area and channels it under East End Rd. through a 30-inch CMP culvert into a private lot at 30 Cotton Valley (Figure 4.30), where it then flows under a private driveway through a 15-inch CMP culvert before discharging to Yellowcliff Bay (Figure 4.31). The resident at 30 Cotton Valley indicated that the now permanent pool of water in the swale is a nuisance, and breeds

**Figure 4.31.** The second culvert underneath a driveway (left) leads to a shallow channel out to Yellowcliff Bay (right).

mosquitoes. She is eager to have conditions restored to a functioning conveyance system that does not maintain standing water year-round. Runoff from East End Rd., and most likely from the gut itself when it overflows during large storm events, flows into a grassy depression on the south side of the road, and then into a swale and depression on the north side of the road on an adjacent private lot (Figure 4.32). Potential projects at this location include 1) analyzing the existing culverts to ensure they are sized correctly and fix as needed; 2) perform simple maintenance to remove sediment and stabilize outfalls; 3) convert the stagnant swale into a functioning stormwater treatment practice such as a constructed wetland or filtering practice; and 4) convert the grassy area to the south of East End Rd. into a bioretention area to manage road runoff.

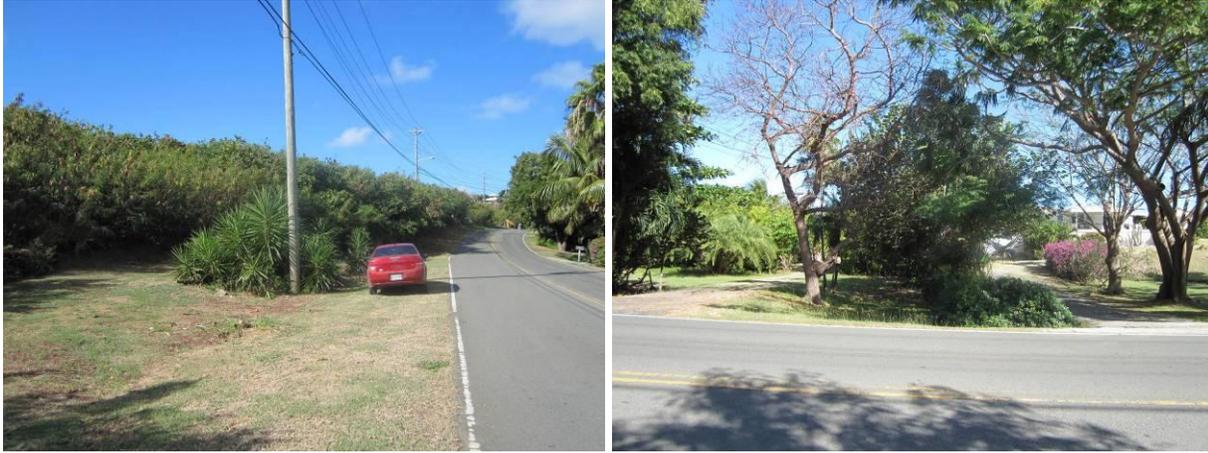
**Figure 4.32.** Runoff from the East End Rd. flows into the grassy depression along the south side of the road (left) as well as the swale and depression between and to the left of the driveways, respectively (right).

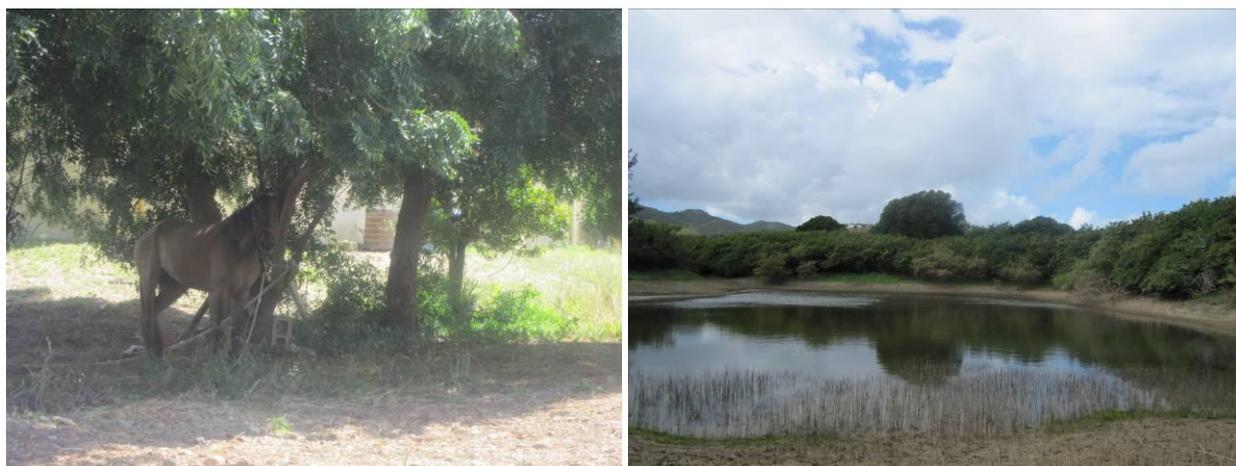
Three pond areas were also observed within the neighborhood, two of which had standing water. One of the ponds with standing water was located along the gut on the western side of the neighborhood, and the other was located along the gut on the eastern end of the neighborhood. Wildlife, such as deer and waterfowl, were observed at both ponds.

**Figure 4.39.** Horse kept on private lot (left) and pond with standing water (right) within Cotton Valley neighborhood.

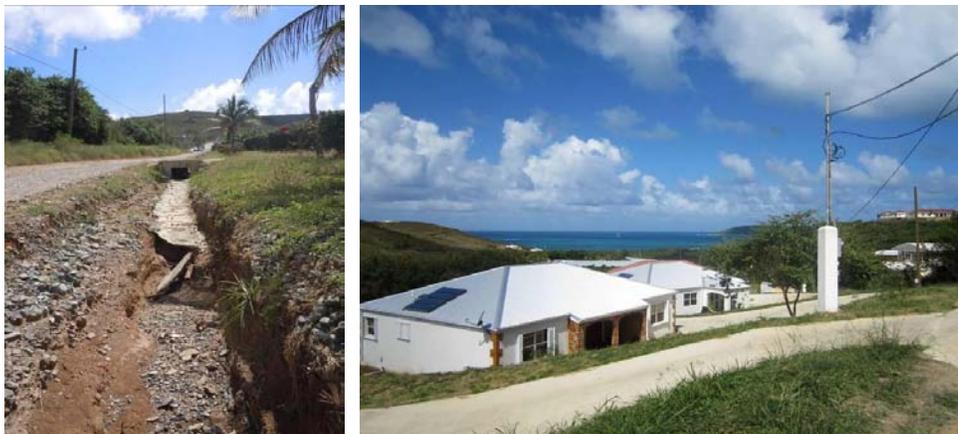
Roadways within the Seven Flags neighborhood are a mix of paved and unpaved roads. The approximately 1,000-foot road segment of Seven Flags Rd. at the entrance from East End Rd. is unpaved and is significantly eroded. There are two partially clogged culverts at the intersection of Seven Flags Rd. and East End Rd. The owner of the Seven Flags Rd. industrial properties has also installed large concrete culverts beneath their driveways to divert drainage off the road and driveways and through these culverts. Despite these drainage facilities, the roadway is significantly eroded and contains large gullies. Roadway conditions are much better throughout the rest of the neighborhood.

**Figure 4.40.** View from Rt. 82 south of dirt portion of Seven Flags Road (left) and new single family dwellings constructed along steep paved portion of Seven Flags Road (right).

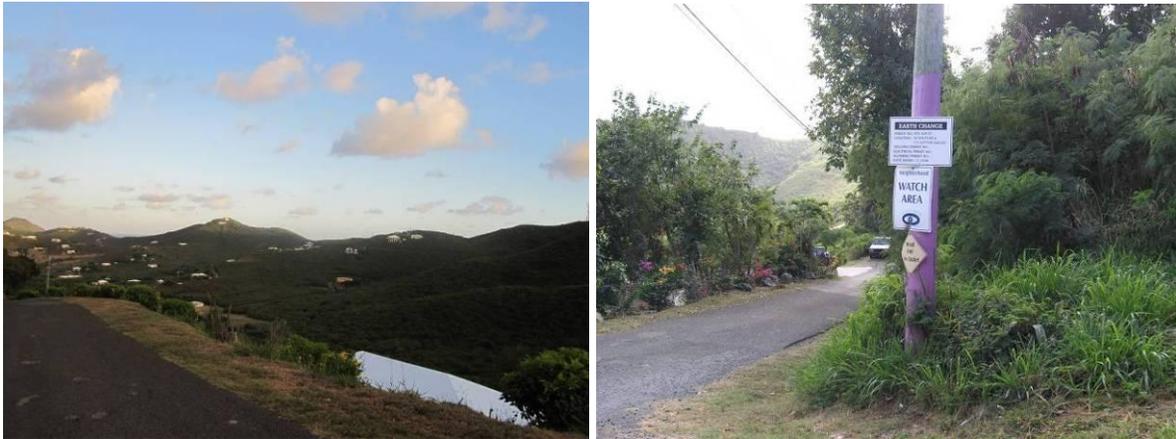
**Figure 4.41.** View from paved road within Seven Flags neighborhood (left) and posted Neighborhood Watch sign and Earth Change permit (right).

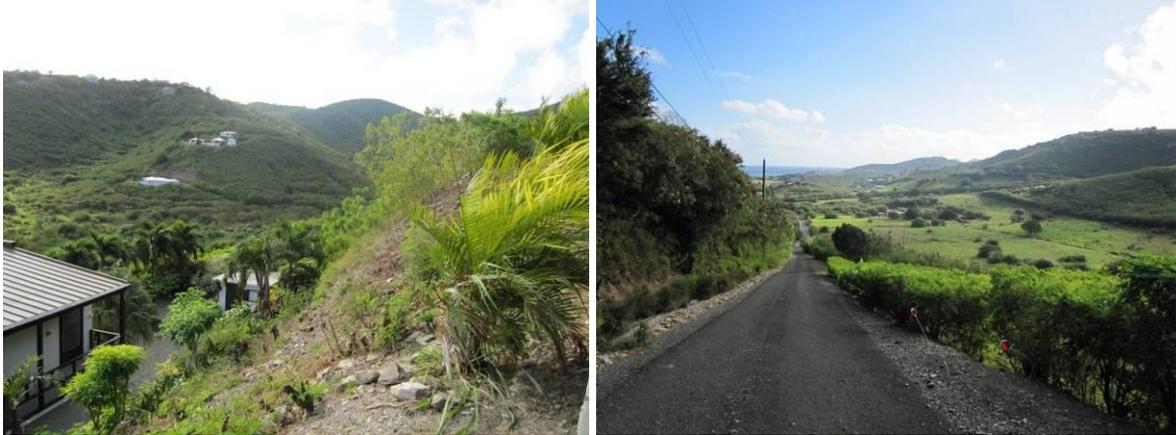
**Figure 4.42.** Single-family home built on steep slope within Pleasant Valley neighborhood (left) and paved Solitude Rd. adjacent to Roebuck Goat Farm in Pleasant Valley neighborhood (right).

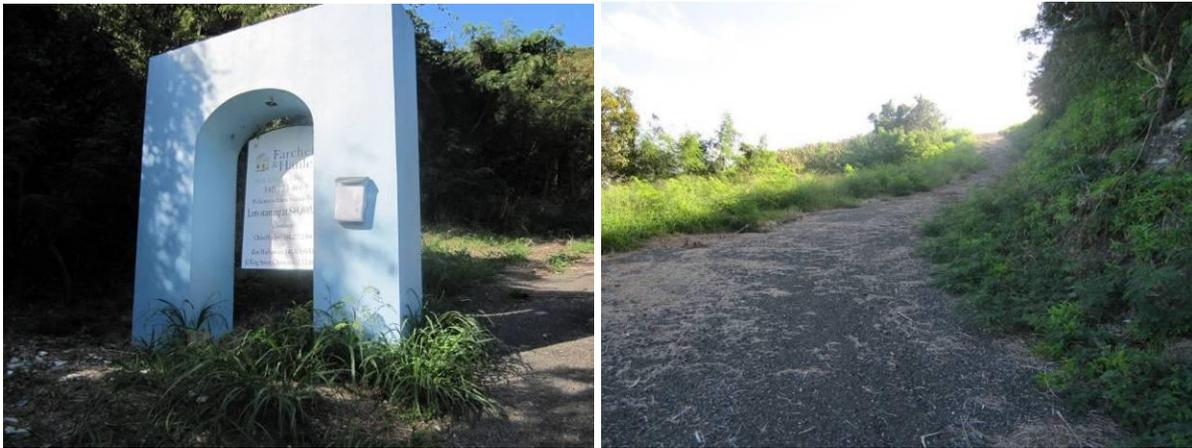
**Figure 4.43.** Entrance to undeveloped Estate Solitude Ridge subdivision (left) and paved roadway within undeveloped Estate Solitude Ridge subdivision (right).

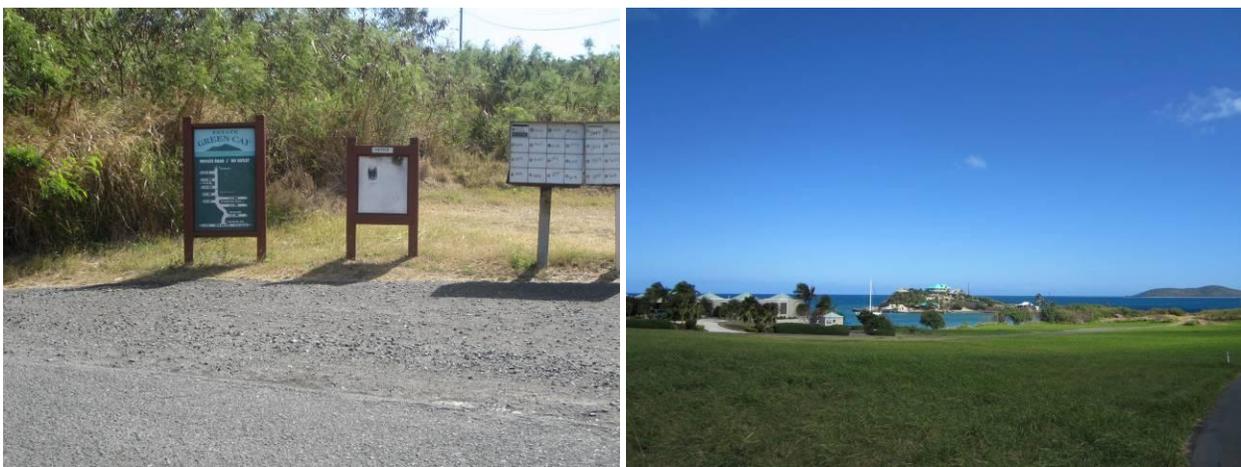
**Figure 4.44.** Entrance to Green Cay neighborhood (left) and manicured grass field within the neighborhood; high-end residential properties on peninsula within the community with Prune Bay in the distance (right).

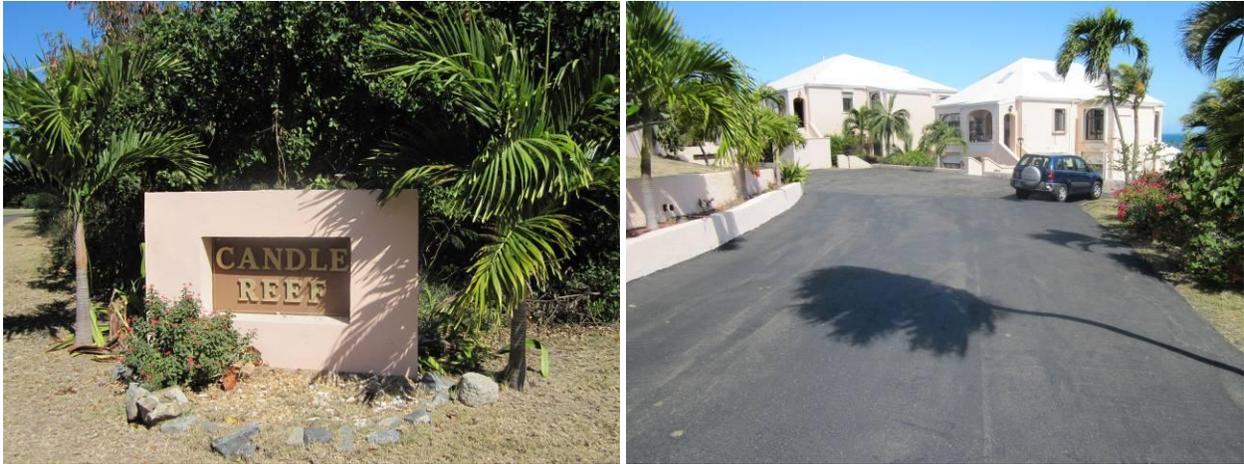
**Figure 4.45.** Entrance to Candle Reef condominium complex (left) and paved road leading to condominium units (right).
