STX EE WATERSHEDS

RETROFITS

Site Name/ID: GP-R-1 / Great Pond Parking

Watershed: Great Pond

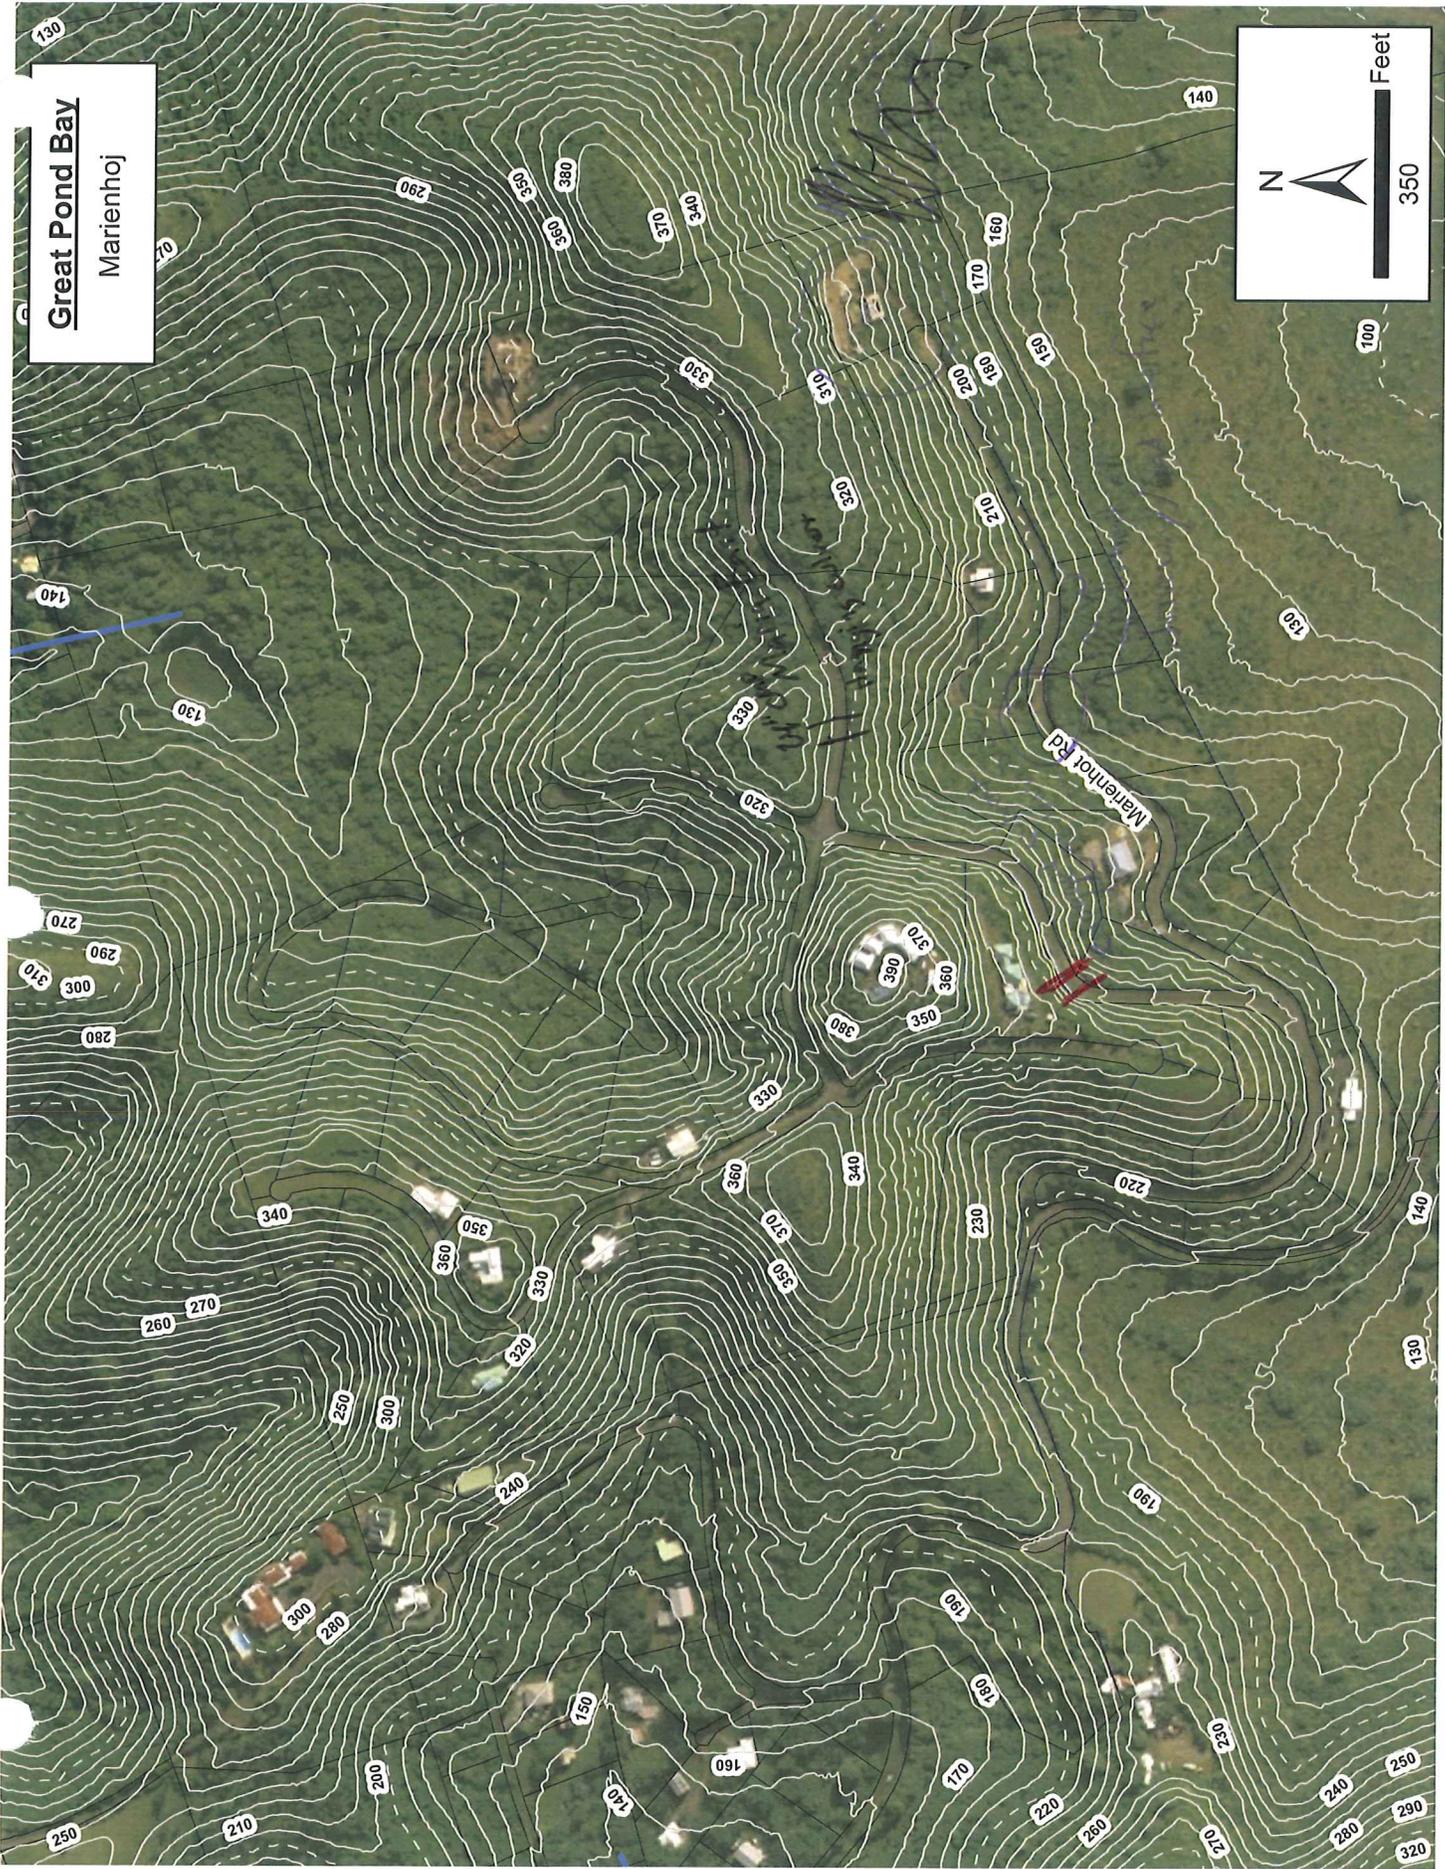
Site/Road Name/ID: RC-33

DESCRIPTION OF EXISTING CONDITIONS:
*water pitches to left side (facing uphill) some erosion in
 could do something now to help prevent more problem*
