STX EE WATERSHEDS

RETROFITS

Site Name/ID: Cheesburgers SG-R-1

Watershed: Southgate

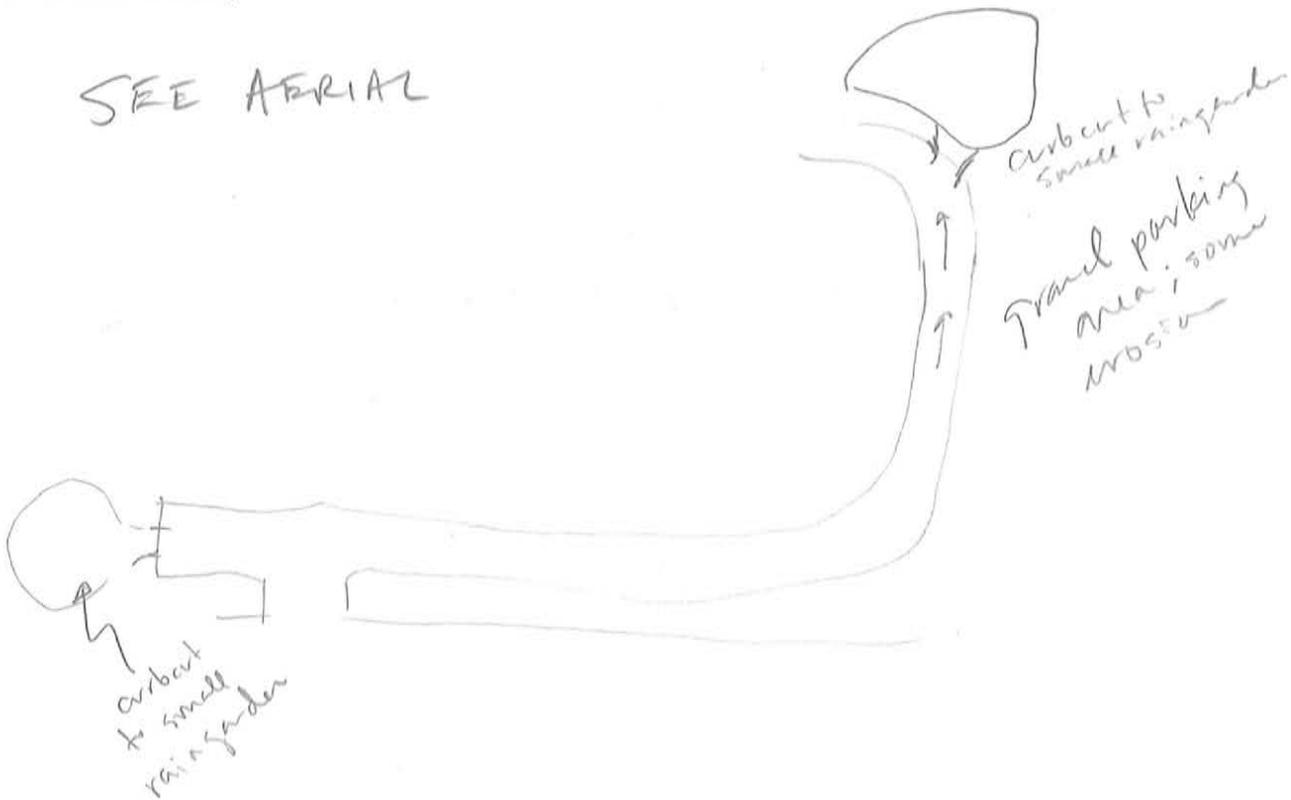
SEE AERIAL

Describe Existing Stormwater Conditions, Including Existing Site Drainage and Conveyance:
- No formal drainage infrastructure - Swale along road. Some erosion/channeling evident in gravel parking lot draining from dumpster to street.
- Stabilization along gut in rear (SG-61)

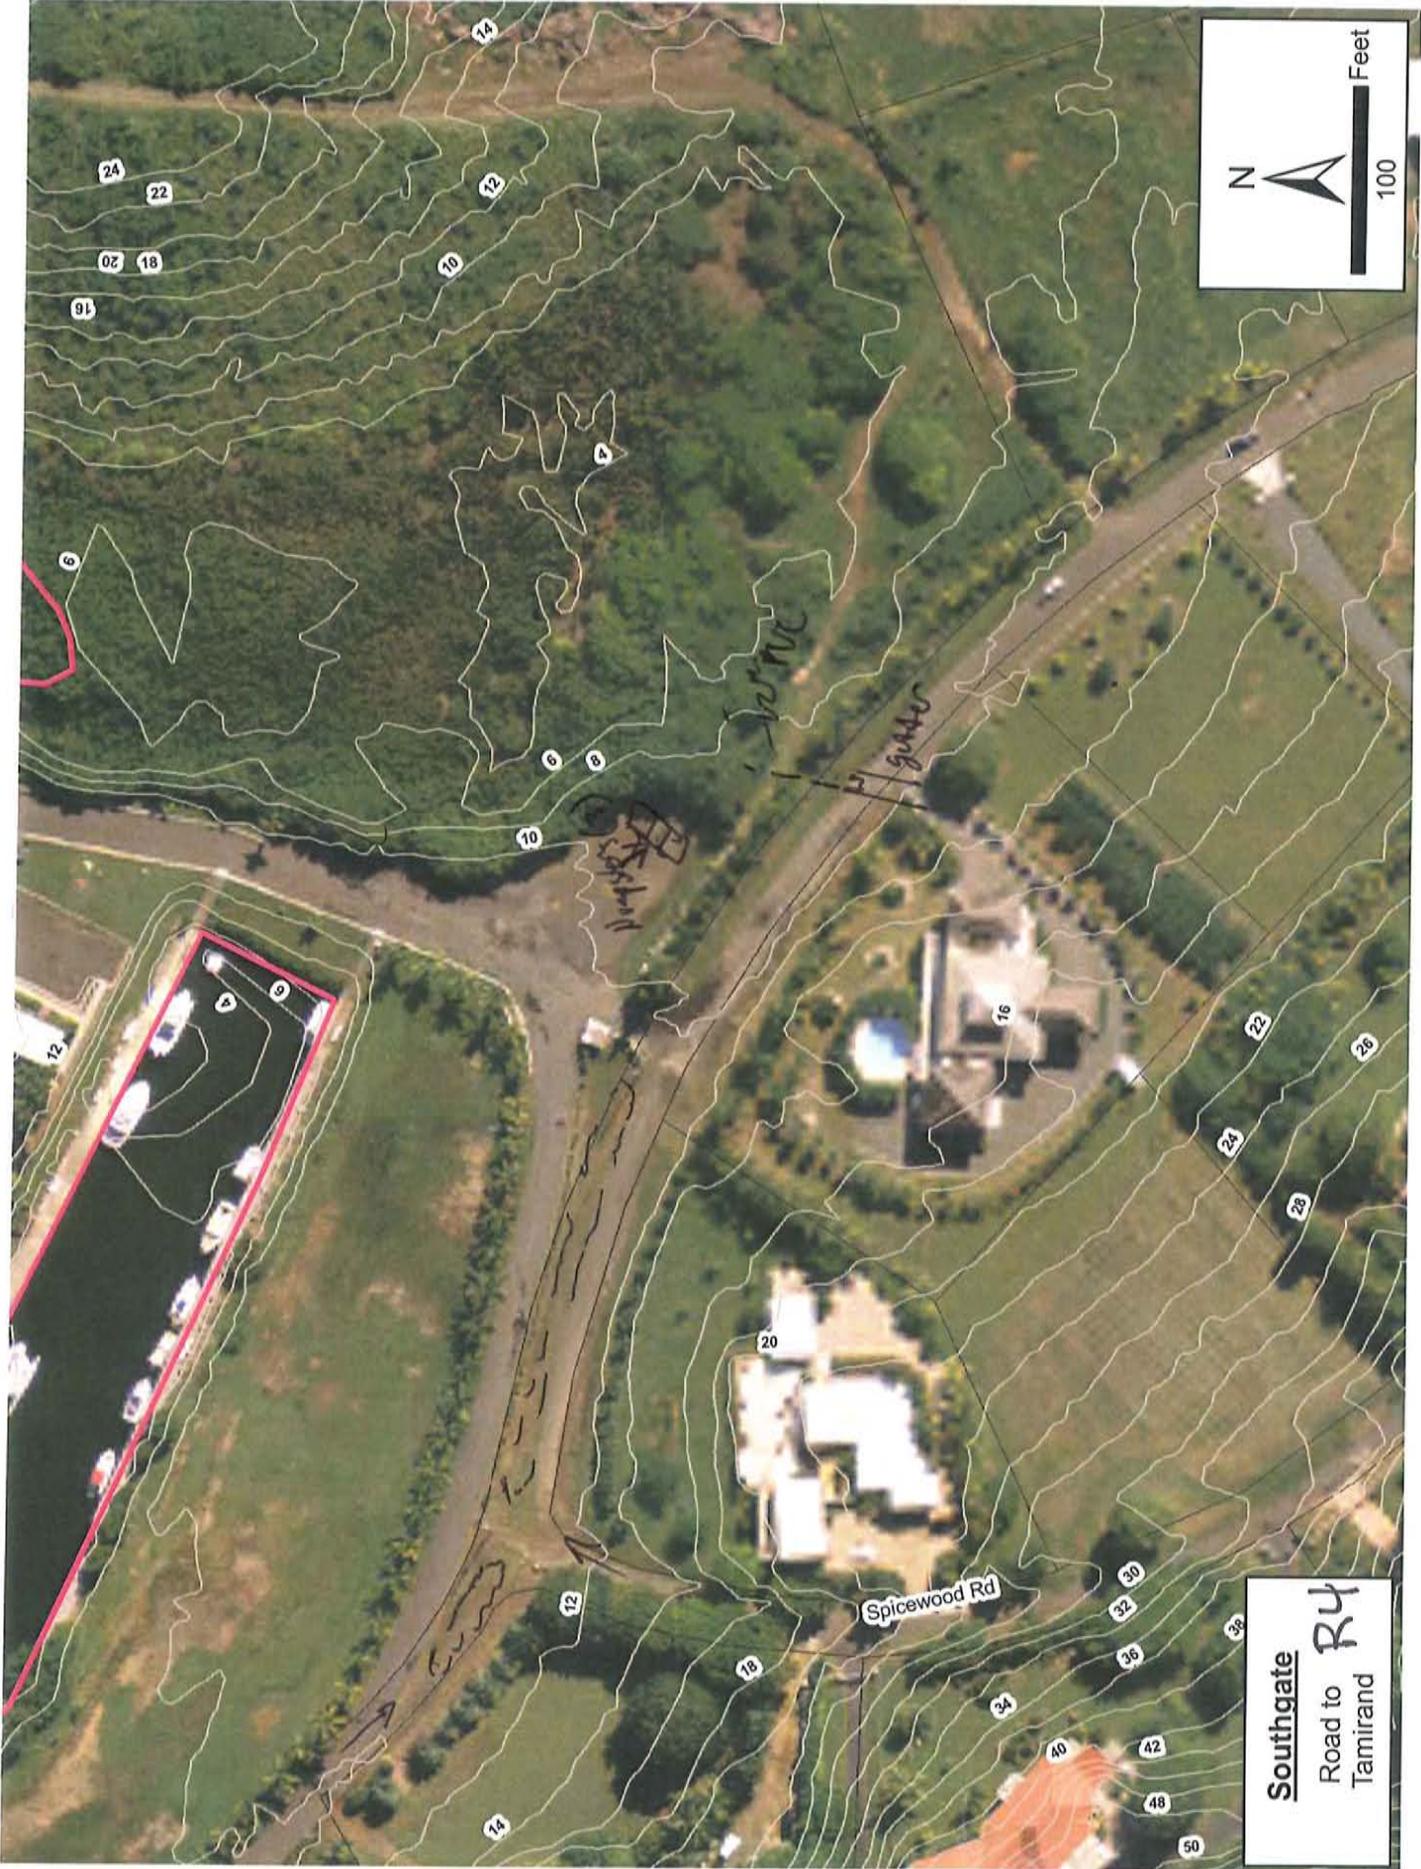
Southgate
Road to **R4**
Tamirand

Describe Existing Stormwater Conditions, Including Existing Site Drainage and Conveyance:
turf ROW areas, water ponds for long time
Marina has dug a swale on one side to help improve drainage.

<p>Possible Conflicts due to: <input checked="" type="checkbox"/> Soils <input type="checkbox"/> Access <input type="checkbox"/> Adjacent Land Use <input type="checkbox"/> Existing Utilities <input type="checkbox"/> Contamination <input type="checkbox"/> High water table <input type="checkbox"/> Limited access to water <input type="checkbox"/> Other: _____</p>	<p>Describe conflicts: <u>Fence & palm</u> <u>NO INFILTRATION</u></p>
---	---

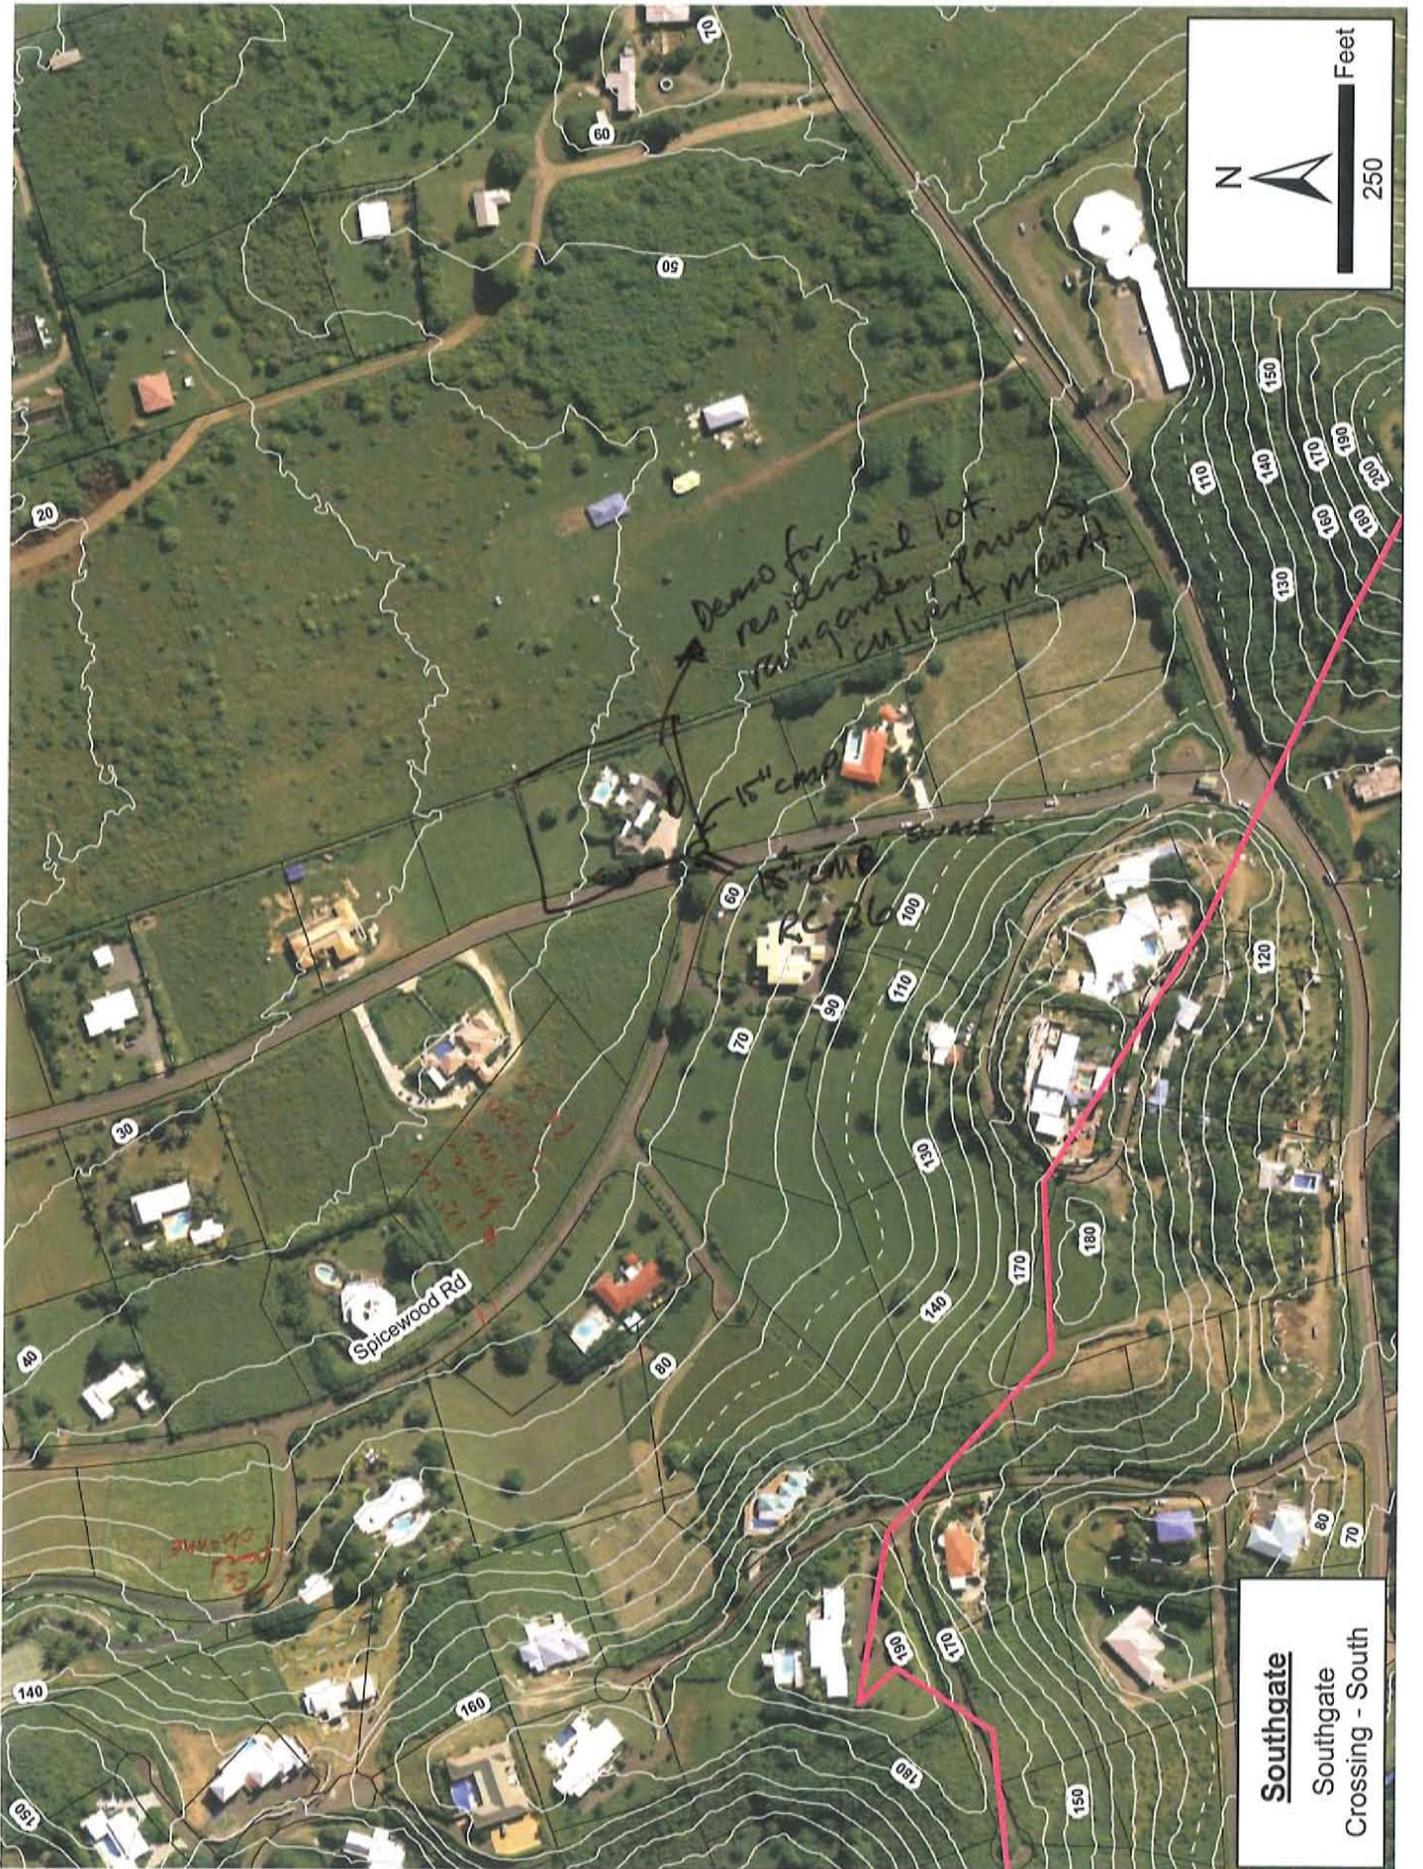
Southgate
Southgate
Crossing - South

→ wealthy area, some examples of driveways w pervious pavers
could install rain gardens, but maybe better
to make sure using low fertilizer... native
plants, etc.

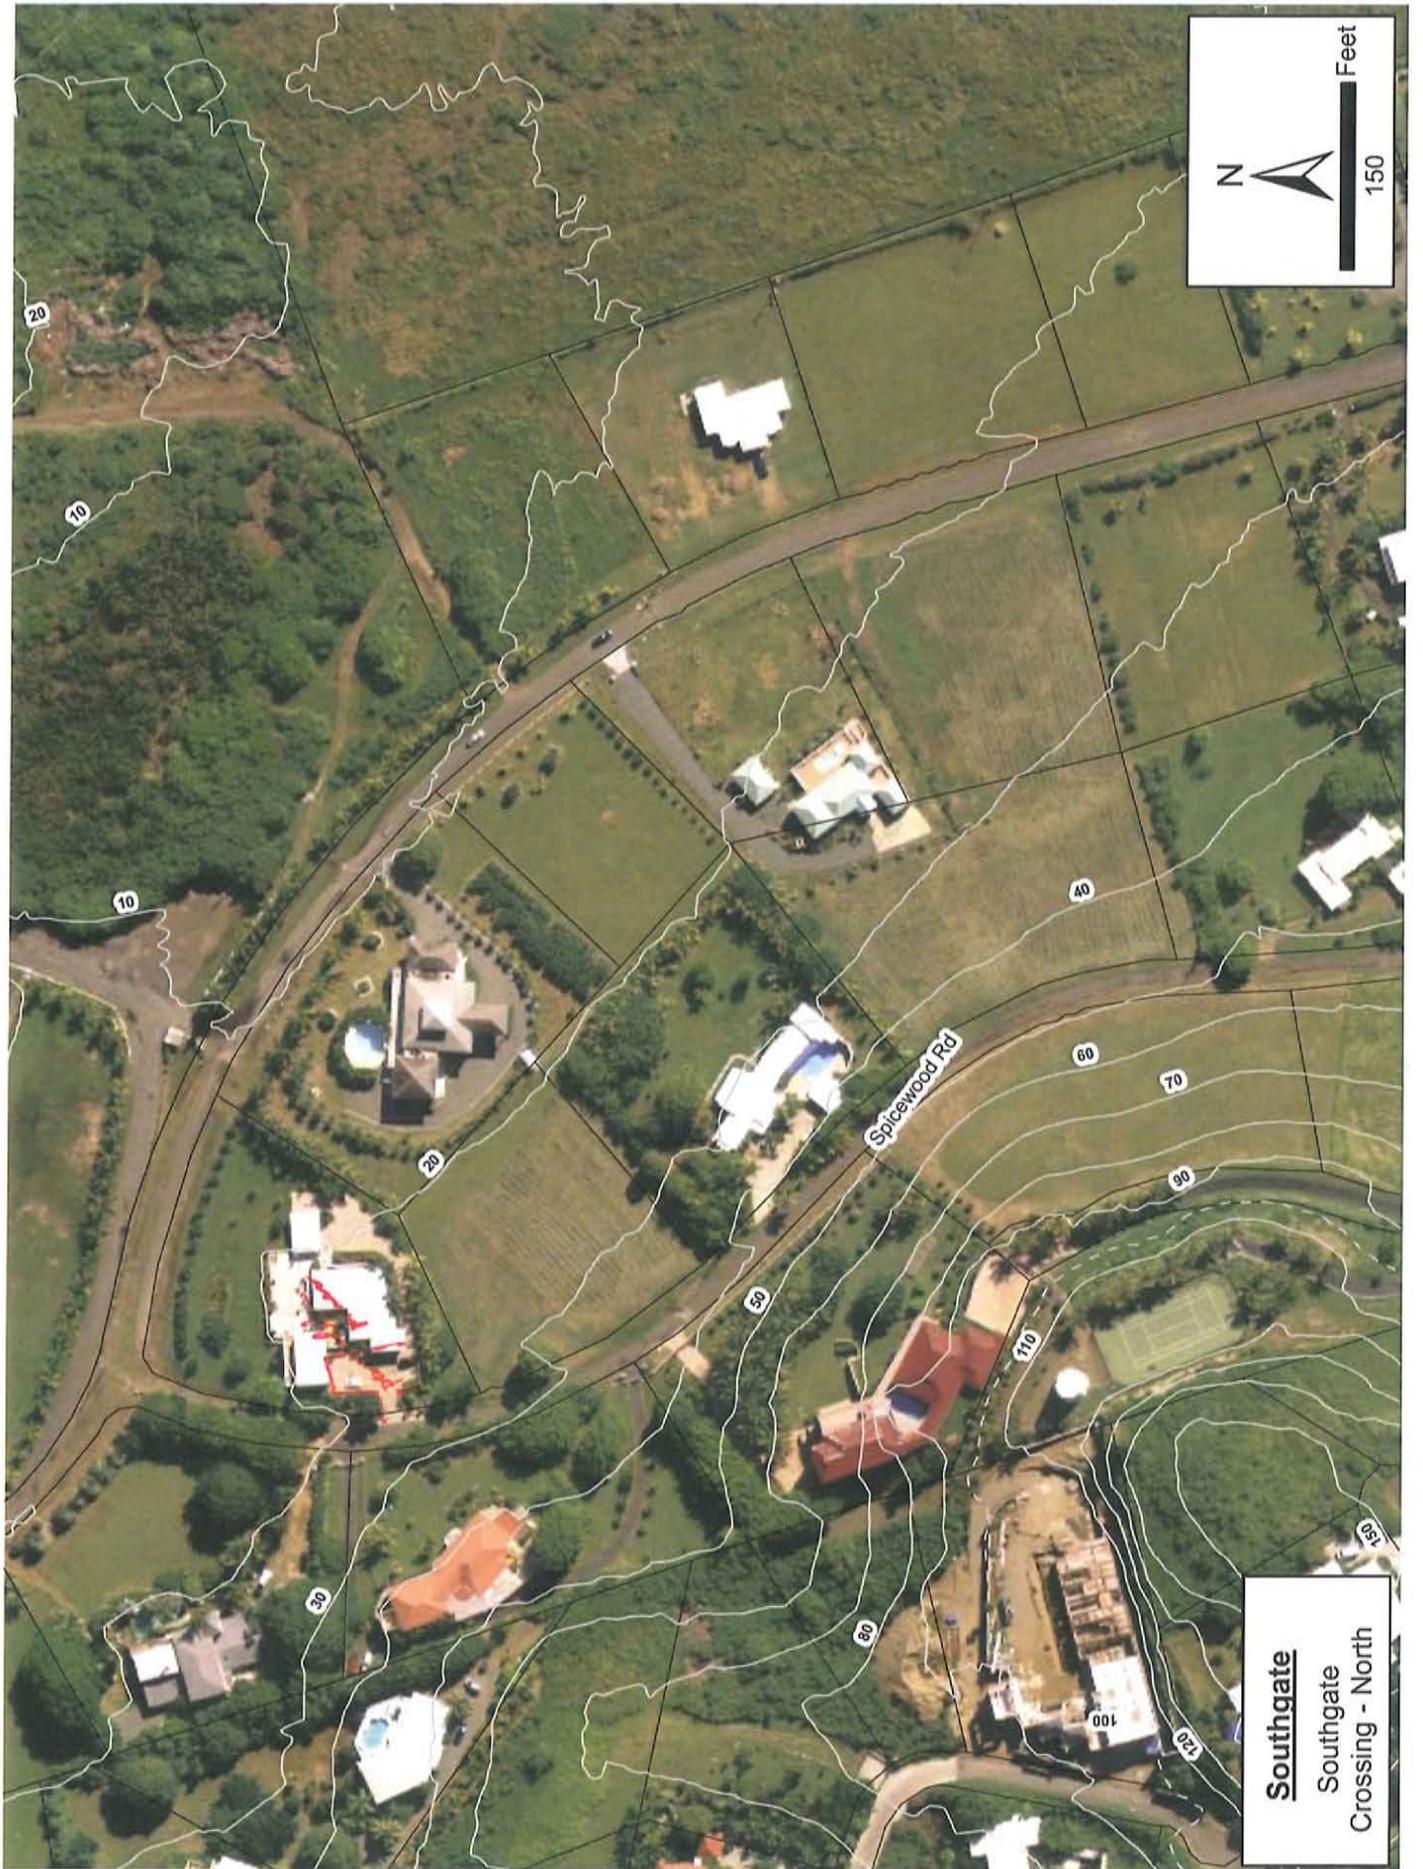
Southgate
Southgate
Crossing - North

Groundwater seepage causing problems.
wet yards, pavement issues, new curbs
Some properties (undeveloped) back up to gut
