# Initial Observations on Biological Damage Arising from the Cape Flattery Ship Grounding at Barbers Point, Oahu with Recommendations for Quantitative Surveys and Substrate Stabilization to Minimize Further Loss of Coral Reef Resources

Steven P. Kolinski

13 February 2005

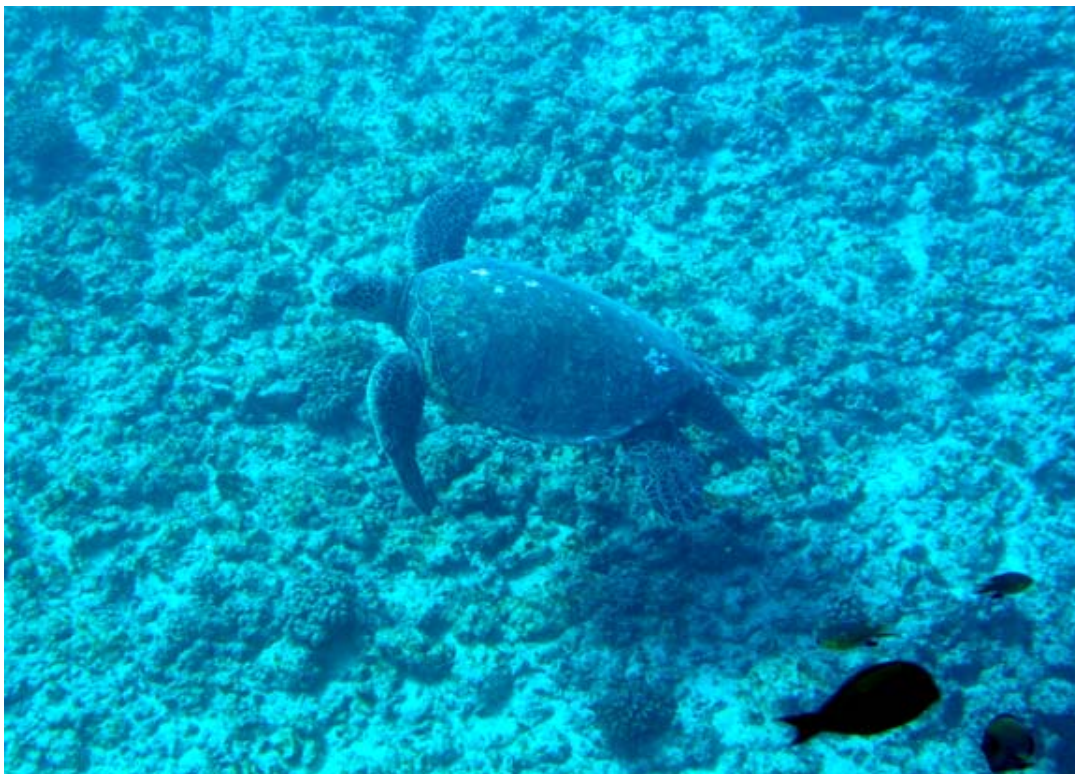
Figure 1. Male green turtle, *Chelonia mydas*, swimming from a resting area at the edge of the escarpment (55 ft depth).
