**SURVEYS OF ABANDONED VESSELS:
AMERICAN SAMOA**

Christine L. Boring
Research Planning, Inc.
Columbia, South Carolina 29202

Doug Helton and Ian Zelo
NOAA Office of Response and Restoration
Seattle, Washington 98115

January 2008

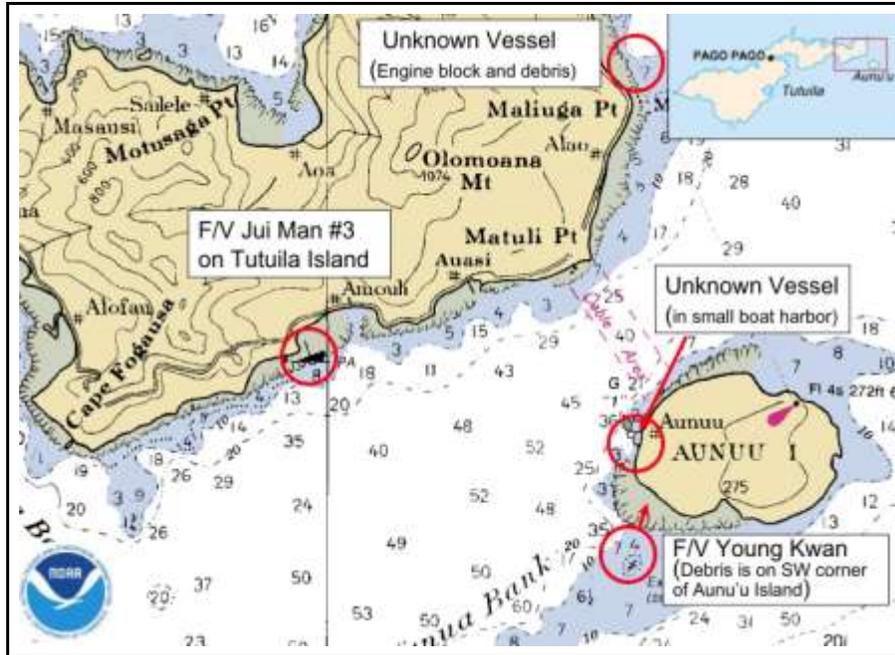
FIGURE 1. Location of four vessels surveyed in 2005.

Five vessels were located and surveyed on the 2005 trip (Figure 1 depicts locations of 4 of the surveyed vessels). These vessels are summarized below and described in the following pages. Several of the vessels surveyed in American Samoa broke apart and created extensive debris fields. This process was also noted in AVP surveys of vessels in the Caribbean and elsewhere in the Pacific. While vessels that are abandoned in port areas may stay essentially intact for years, vessels grounded and left exposed to high-energy environments rapidly break up into many pieces, creating large and potentially mobile debris fields. These vessels and debris pose an increased threat to coral and hardbottom habitats because the vessel fragments can roll across the bottom breaking corals, crushing benthic organisms, filling in gaps and generally reducing the structural complexity of the environment. Corals may recruit on this debris but periodic storms will roll the wreckage and shear-off the corals. This scattered wreckage also presents unique removal challenges since locating and removing all of the pieces requires increased man-hours and additional salvage equipment. In addition, marine debris is an eyesore and may be a public health threat. This problem was noted on Aunu'u Island where large fragments and spikes of jagged metal were observed protruding from the reef flats. Local residents expressed concern regarding use of the area because of the sharp metal.

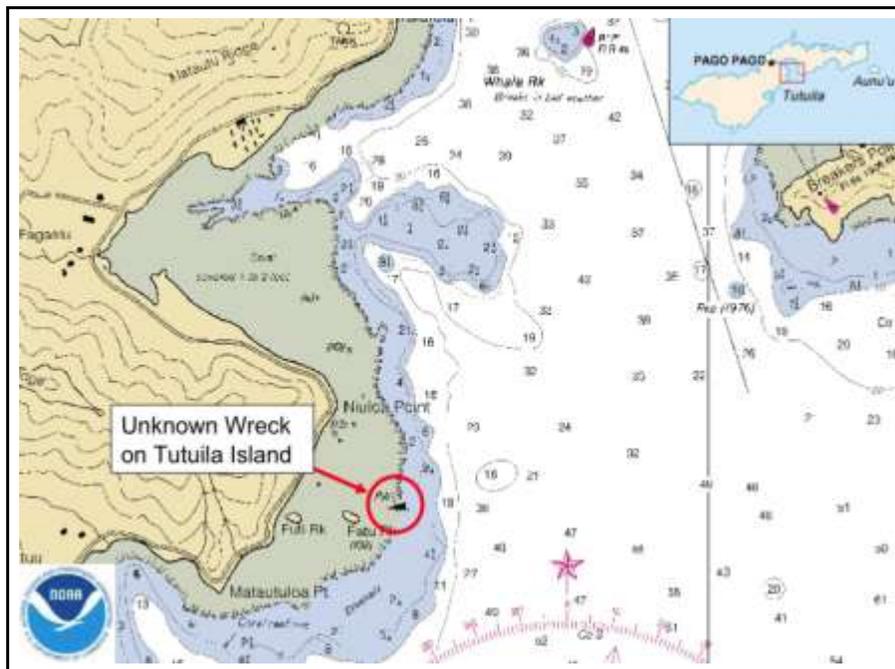
FIGURE 2. Location of Unknown 1270 on Tutuila Island.

Unknown 1270, a vessel grounded in the 1960s, was located at Niuloa Point on Tutuila (Figure 2). The vessel was present at 1-10 feet of depth on a wide reef flat and debris was widely spread (Figures 3 and 4). The reef was heavily used by residents for subsistence (invertebrates were abundant) and recreation.

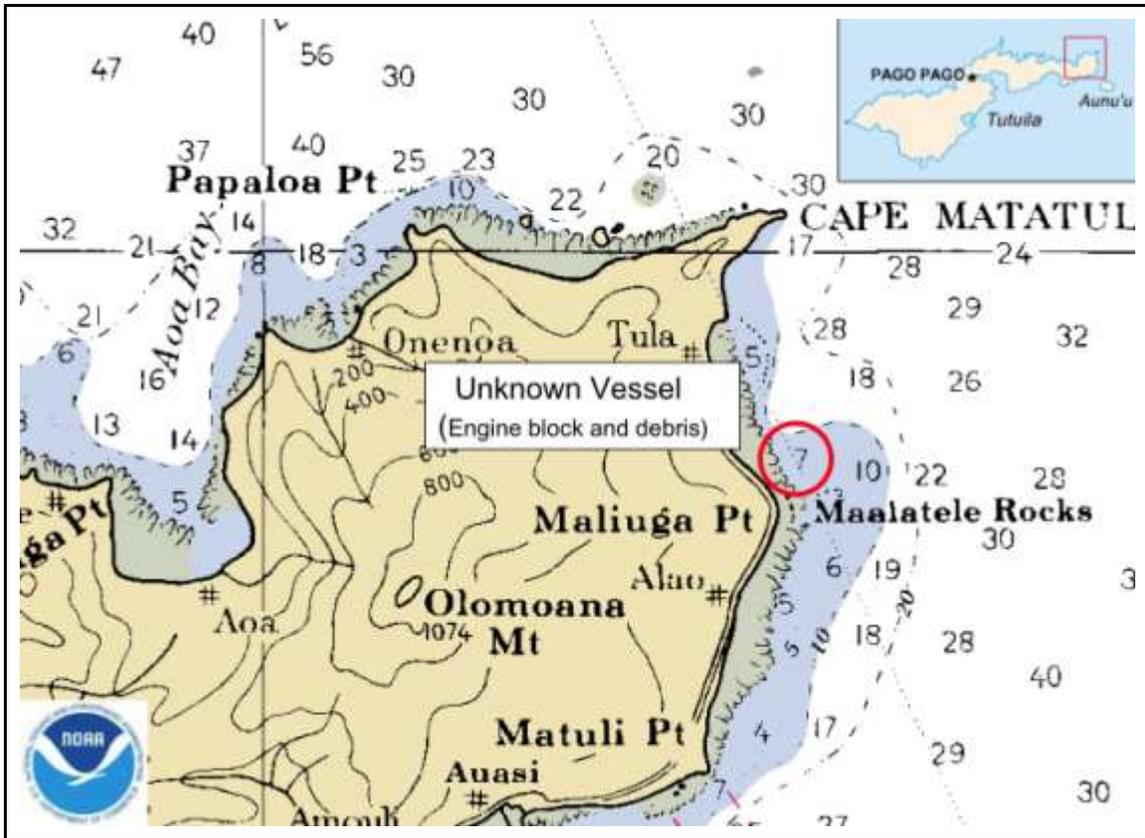
FIGURE 5. Location of engine block and debris (*Yien Len 3*) on Tutuila Island.

Yien Len 3 was located at Alao on Tutuila Island (Figure 5). The vessel is grounded between 1-10 feet in depth and may be a public health hazard to recreational beach users because there is a large engine block within 20 m of shore (Figures 6 and 7).

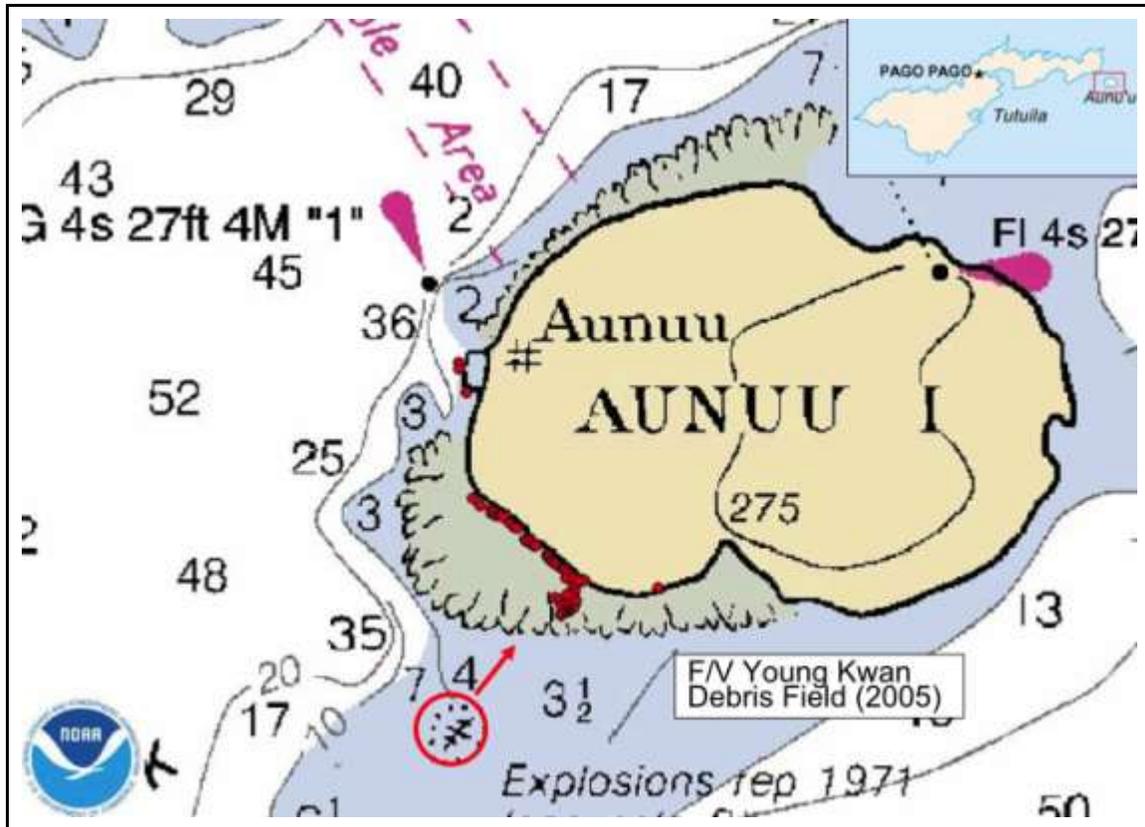
FIGURE 14. Location map of F/V *Young Kwan* debris field on Aunu'u Island.

Along the west shore of Aunu'u there is a large debris field, believed to be from the wreck of the F/V *Young Kwan* that grounded in 1986 (Figure 14). Local residents recalled the vessel breaking apart during Typhoon Val in 1991. Debris stretches from the supratidal to the subtidal along over a kilometer of shoreline (Figure 15). The benthic habitat consisted of soft and coralline algae and some hard coral which may be threatened by mobile debris pieces (Figure 16). The vessel is located on a public beach and children were observed playing on the wreckage (Figure 17). February 2008 surveys showed the debris in a further deteriorated condition (Figures 18 and 19).
