St. Croix East End Watersheds Existing Conditions Report

July 2011

Prepared by:
Horsley Witten Group, Inc
90 Route 6A, Sandwich, MA, 02563
508-833-6600

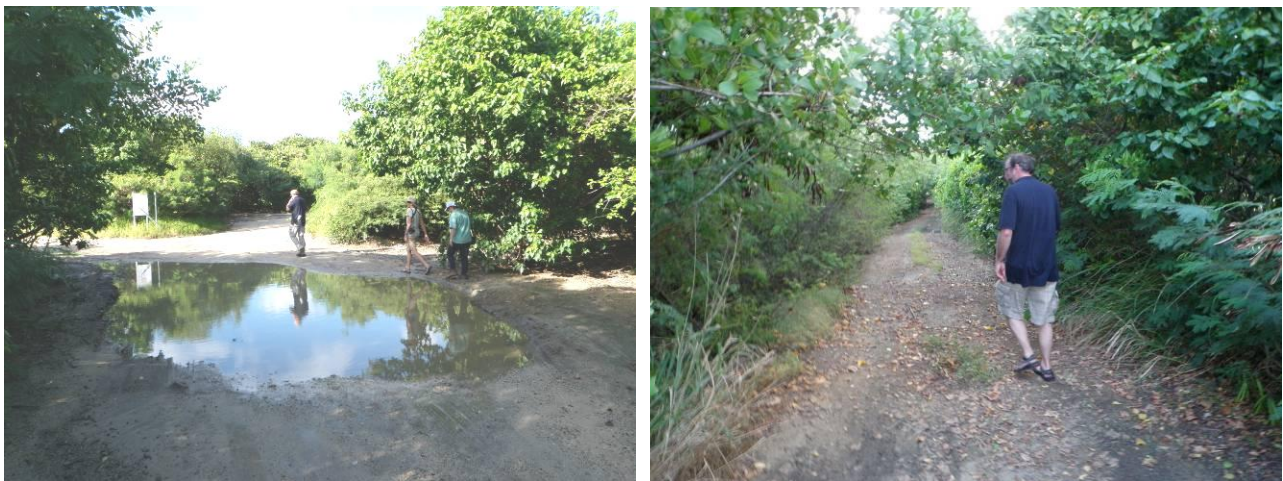
Figure 3.4. Standing water in the current road/parking area (left); the embankment (right).

According to the St. Croix Environmental Association, there are a number of restoration activities being pursued at the Preserve including: 1) Raising the existing embankment which separates Southgate Pond from the marina, 2) removing the existing building near East gut, and 3) installing permeable pavers on the entrance road and relocated parking area (Figure 3.4). Raising the embankment is intended to increase capacity of the pond and help expand fringing vegetation and associated habitat. Reconnecting the floodplain of the East gut on the Preserve property may also be a restoration opportunity.

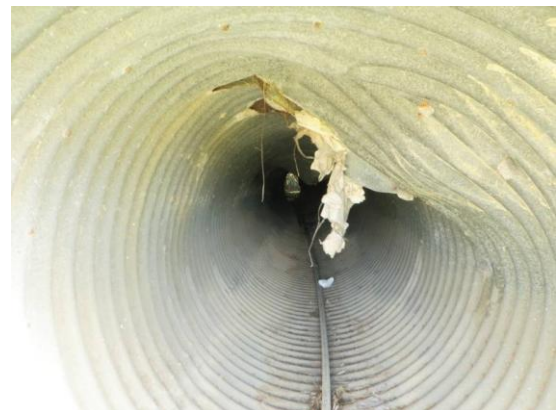
Across the street from Cheeseburgers is the entrance drive to the Seven Seas Water Supply Company. The culvert under this driveway is a large, 36-inch corrugated metal pipe capturing a significant amount of drainage area. On inspection, it was noticed that there is pipe failure below the driveway (Figure 3.11).

Figure 3.11. Pipe failure evidenced in culvert.

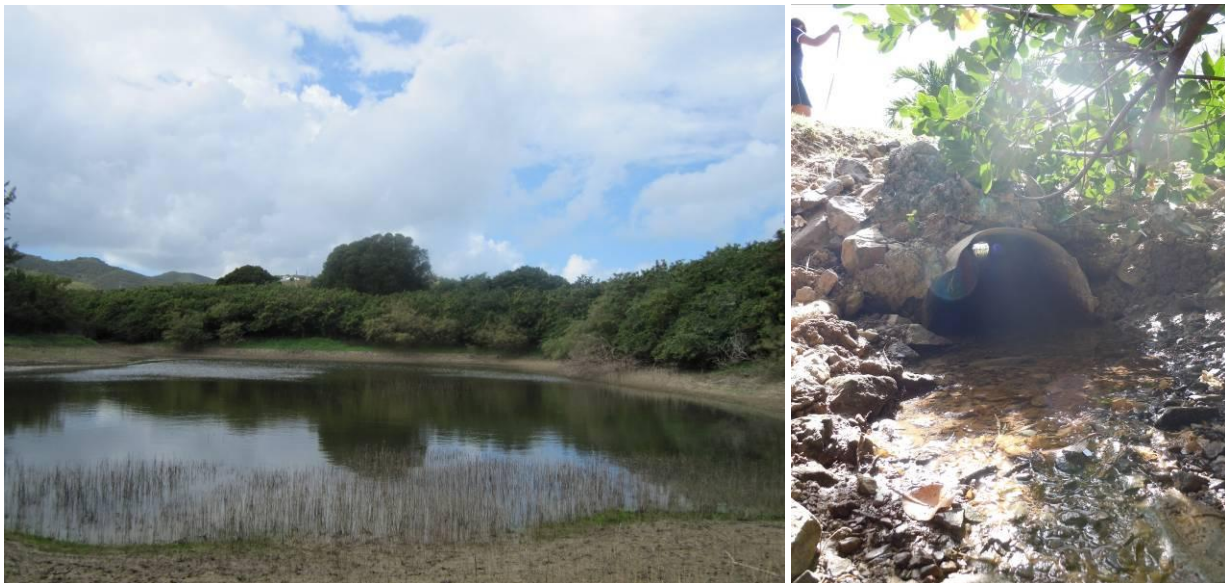
Figure 4.1. Pond along gut in Cotton Valley Neighborhood (left) and culvert at East End Road discharge location to Yellowcliff Bay (right).

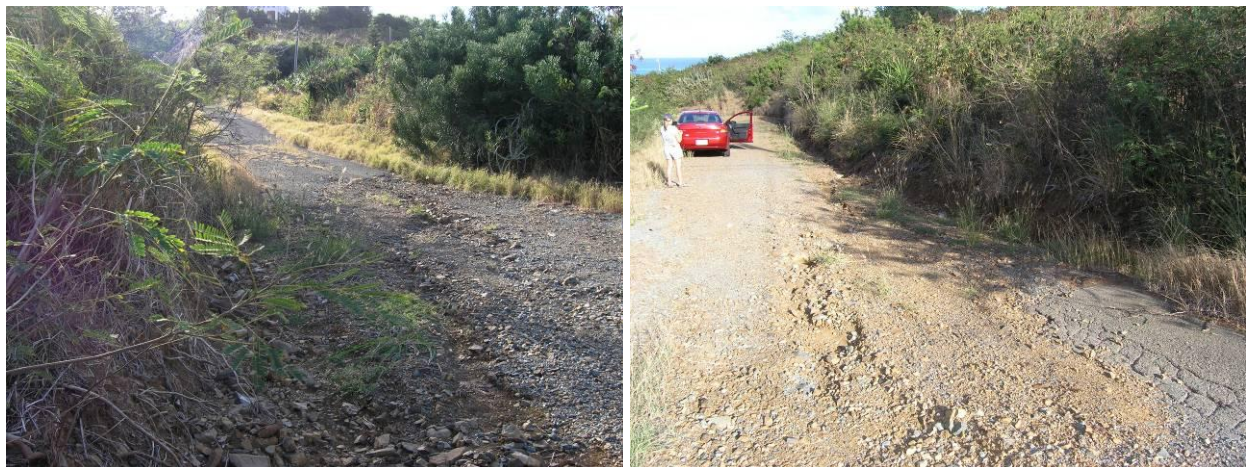
This private road currently serves two houses in the Sierra Verde Neighborhood. While the individual driveways are paved, the private road is unpaved and eroding. Concentrated runoff flows from the southwest side of the road to the northeast where the surface transitions from paved to unpaved, creating deep ruts and gullies (see Figure 4.3). This gully continues along the side of the road, eventually discharging to a small gut that crosses East End Rd. near the intersection with Sierra Verde Road. This eroding road may serve as a source of sediment into Yellowcliff Bay.

Figure 4.3. Erosion gully at the transition from paved driveway to unpaved private road looking up-gradient (left) and down-gradient (right).

Some minor, low maintenance improvements could be conducted along the road. A water bar and stabilized swale along each side of the road would reduce erosion and, therefore, the associated potential sediment load from this area would be reduced.

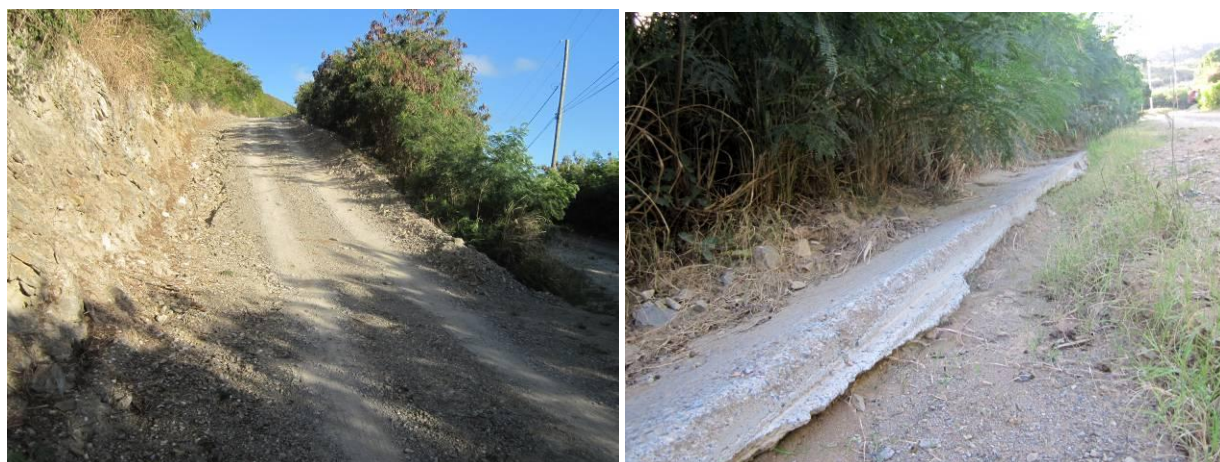
runoff and sediment load ultimately discharge to the main gut at the Pony Club Trail Culvert (SB-RC-3; described in detail below). Large quantities of sediment can be seen along the road at this location. At some point, paved water bars and swales were constructed to try to reduce the erosion issue on these roads, but runoff has bypassed and scoured around these structures. Only one section of this road network, a portion of Divi Divi Trail, is relatively flat; this section has issues with ponding water during and after storms due to poor drainage.

Figure 4.4. Roads in the Hope and Carton Neighborhood are unpaved and very steep (left). Runoff from this road bypasses and undermines the paved swale (right).

In general, the roads in this neighborhood likely provide a large sediment source to the gut, the associated ponds, and eventually Yellowcliff Bay. These steep roads are ideal candidates for paving to stabilize the roads and reduce the sediment load to the gut. Drainage infrastructure should be constructed at the time of paving.

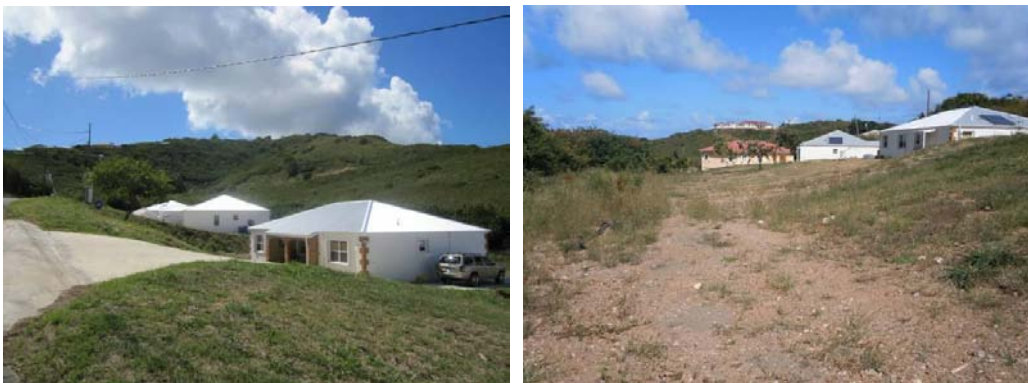
Figure 4.7. New homes were built in the gut upstream from the Seven Flags Rd. erosion (left). The areas behind the houses should be retrofitted to create a series of terraced depressions to help provide more storage and decrease velocities (right).

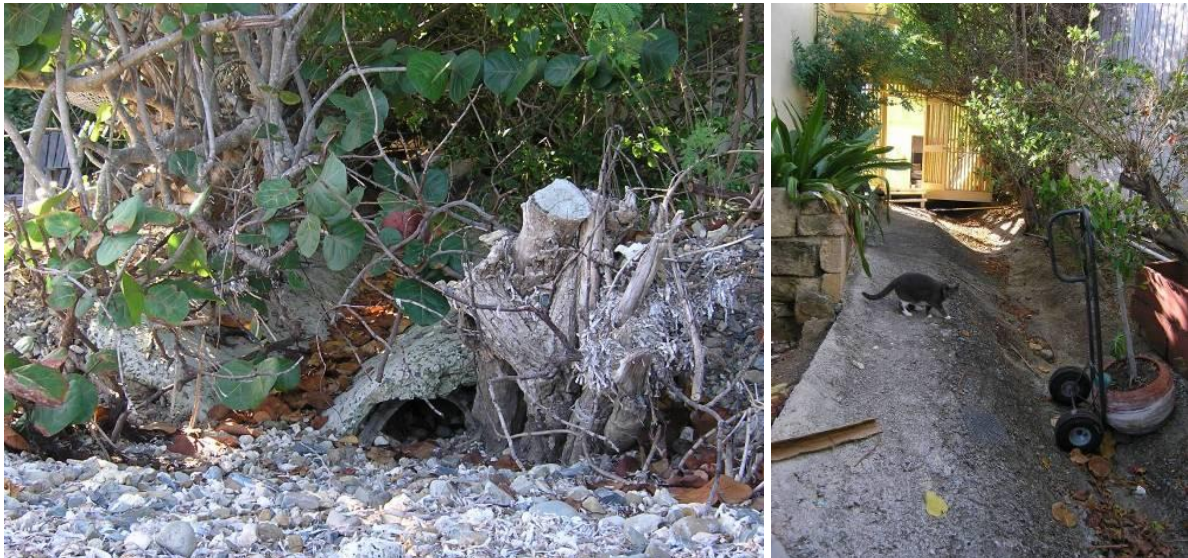
The gut located along the Blue Water Terrace property joins with another gut and crosses the East End Rd. through a 15-inch RCP (Figure 4.12), where flow enters Yellowcliff Bay between the homes at addresses 22 and 21 Cotton Valley. This culvert appears to be mostly blocked (Figure 4.13), and homeowners have constructed a concrete swale on top of the culvert, seemingly to handle stormwater that flows over East End Rd. onto their property.

Figure 4.13. The outlet of the culvert is barely visible from the beach, with a crumbling concrete swale on top of it (left). Better view of the concrete swale constructed to convey runoff that overflows over East End Rd. between two private residences, bypassing the culvert (right).

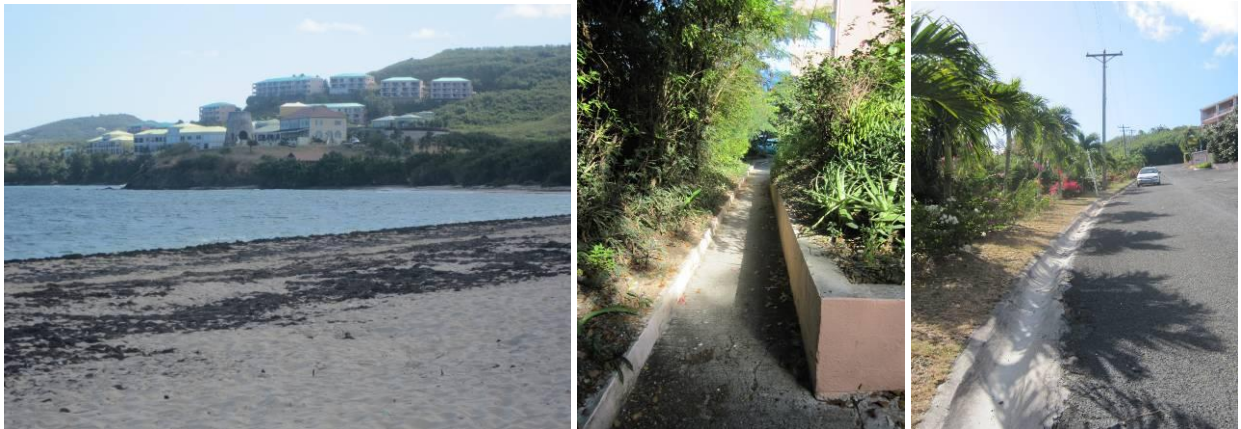
The Coakley Bay Condominiums are located on a very steep slope to the south of East End Rd. There are 14 buildings, including a restaurant and a pool, and several parking areas connected by two extremely steep driveways. The existing stormwater management at this site is very minimal, comprised of various shallow, paved conveyance channels along the driveways (Figure

Figure 4.16. Coakley Bay condos are located on a steep hillside overlooking Coakley Bay (left). Stormwater is conveyed through the site via paved swales (middle and right).

4.16). Some of the runoff is directed into the vegetation on either side of the development, but the majority of runoff is carried down to the entrance and discharged into the shallow roadside swale on the south side of East End Rd. (Figure 4.17). Stormwater retrofits should be implemented throughout this site to direct runoff into stabilized treatment areas along the pavement edges.

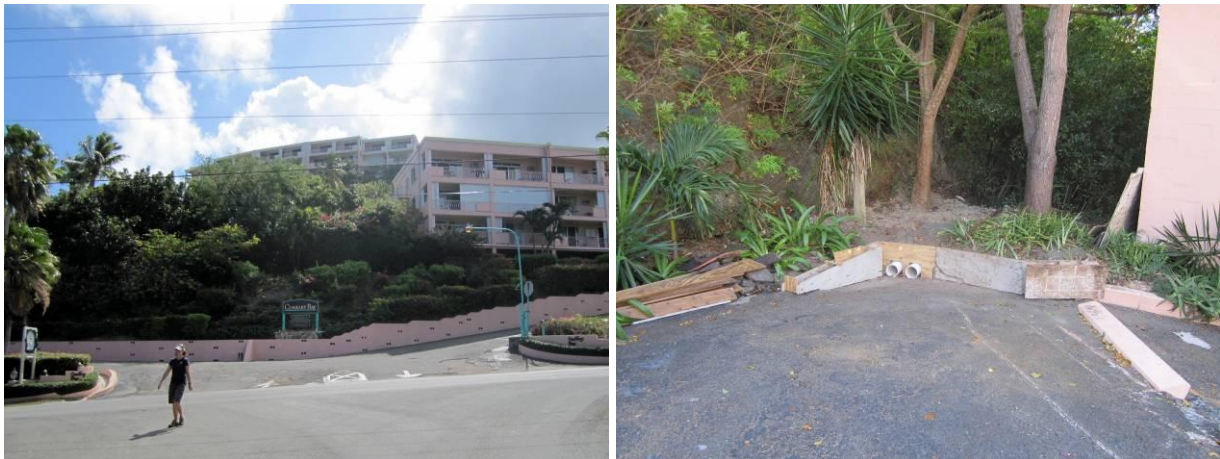
Figure 4.17. The majority of uncontrolled stormwater from the site flows down to the entrance and then along the edge of East End Rd. (left). This is an area in the southwest corner of the upper parking area where water would puddle after rain events. Small PVC pipes have recently been added to drain this area, creating an ideal location for a retrofit BMP (right).

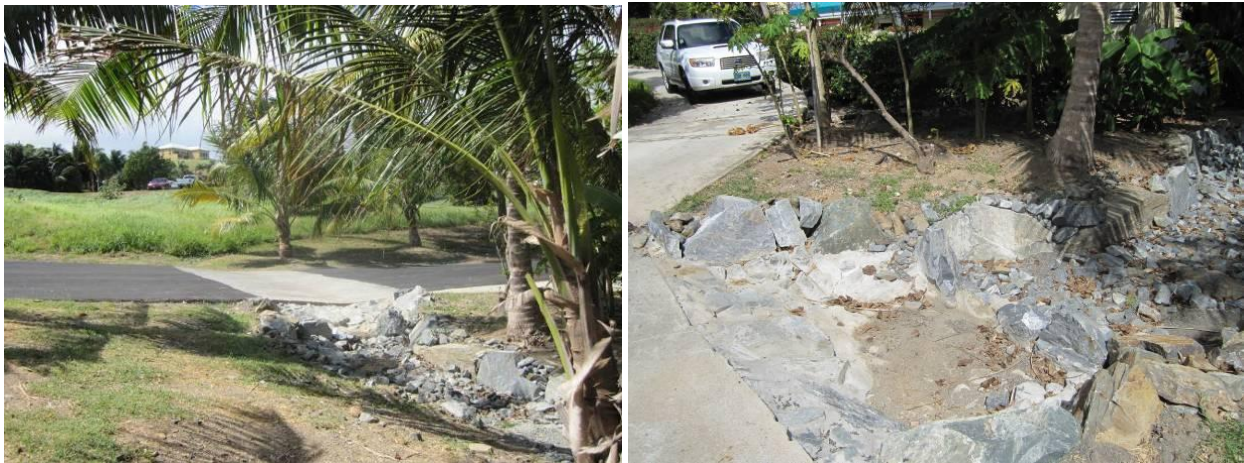
and into a riprap-lined channel with a sediment forebay that carries flow out to Coakley Bay (Figures 4.21 and 4.22). This channel is experiencing erosion at the downstream end. Residents at the stakeholder meeting indicated that this area has experienced flooding recently due to new construction.

Figure 4.21. Stormwater flows from the grass depression and the cul-de-sac to a riprap-lined channel (left). A sediment forebay was constructed with a rock weir (right).

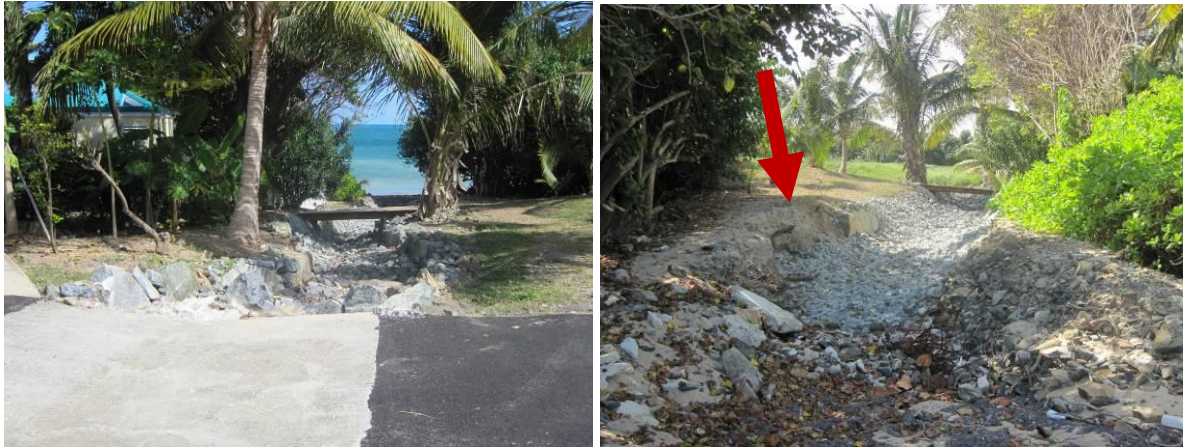
Figure 4.22. The channel flows directly to Coakley Bay (left). A portion of the downstream end of the channel has eroded (right).

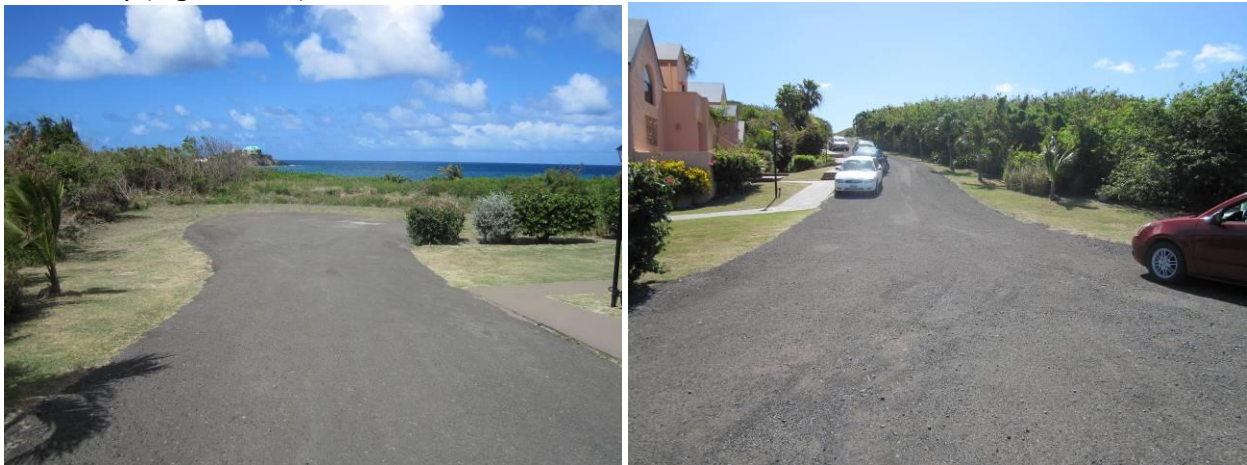
Candle Reef II Condos Cul-de-sac (SB-R-8)

Figure 4.23. Prune Bay can be seen just beyond this large cul-de-sac near Candle Reef Condos II (left) and the drainage area to the cul-de-sac, consisting of roadway, parking areas, and walkways (right).

The Candle Reef II Condominiums are located in the west edge of the Solitude Bay watershed. This location is ideal for a demonstration project to not only improve water quality but also help to educate the residents about the East End Marine Park, stormwater pollution, and how they can help reduce land-based sources of pollution to the marine environment. The proposed BMP includes a bioretention area in or around the cul-de-sac providing access to Prune Bay (Figure 4.23).

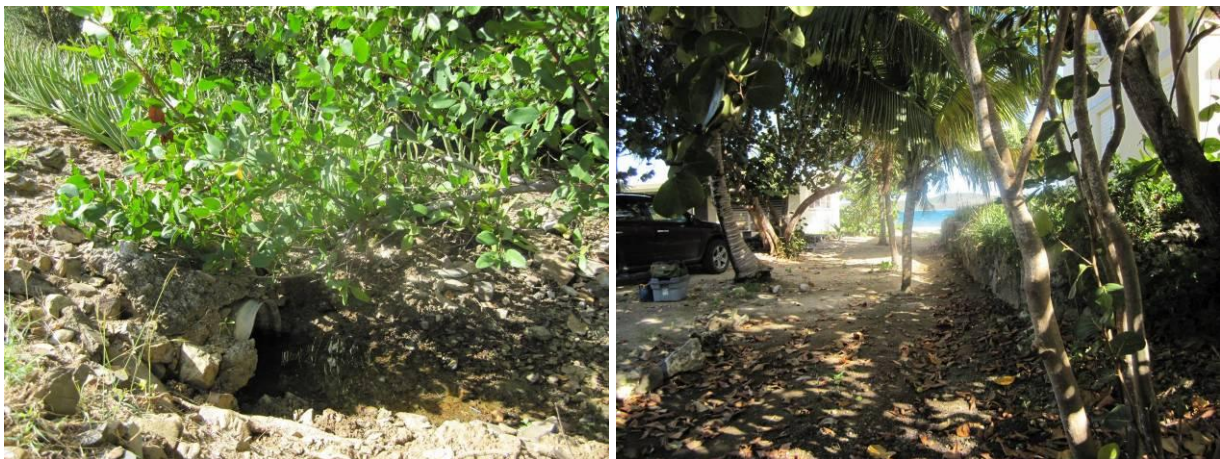
The major gut system in this watershed carries flow from an approximately 600-acre area and channels it under East End Rd. through a 30-inch CMP culvert into a private lot at 30 Cotton Valley (Figure 4.30), where it then flows under a private driveway through a 15-inch CMP culvert before discharging to Yellowcliff Bay (Figure 4.31). The resident at 30 Cotton Valley indicated that the now permanent pool of water in the swale is a nuisance, and breeds

Figure 4.31. The second culvert underneath a driveway (left) leads to a shallow channel out to Yellowcliff Bay (right).

mosquitoes. She is eager to have conditions restored to a functioning conveyance system that does not maintain standing water year-round. Runoff from East End Rd., and most likely from the gut itself when it overflows during large storm events, flows into a grassy depression on the south side of the road, and then into a swale and depression on the north side of the road on an adjacent private lot (Figure 4.32). Potential projects at this location include 1) analyzing the existing culverts to ensure they are sized correctly and fix as needed; 2) perform simple maintenance to remove sediment and stabilize outfalls; 3) convert the stagnant swale into a functioning stormwater treatment practice such as a constructed wetland or filtering practice; and 4) convert the grassy area to the south of East End Rd. into a bioretention area to manage road runoff.

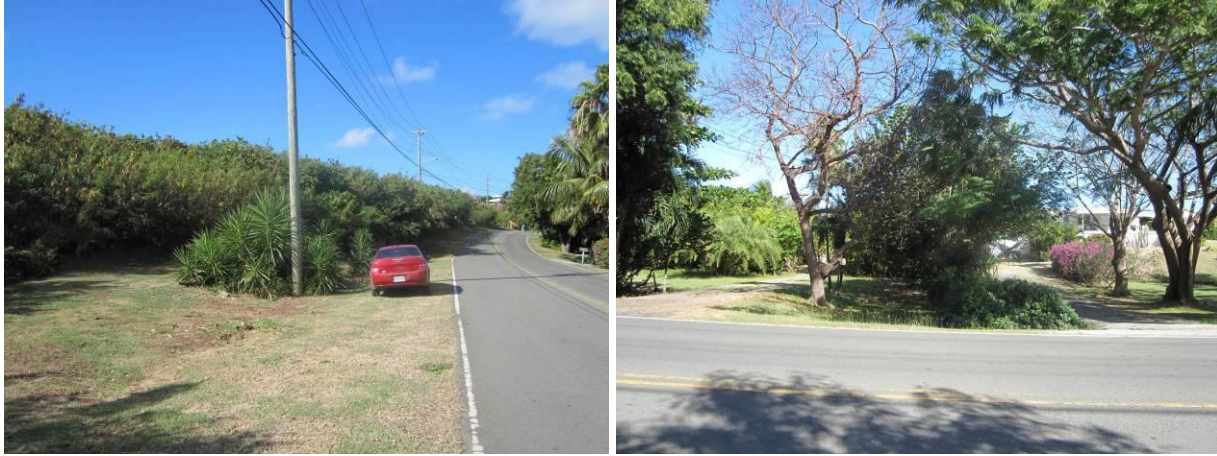
Figure 4.32. Runoff from the East End Rd. flows into the grassy depression along the south side of the road (left) as well as the swale and depression between and to the left of the driveways, respectively (right).

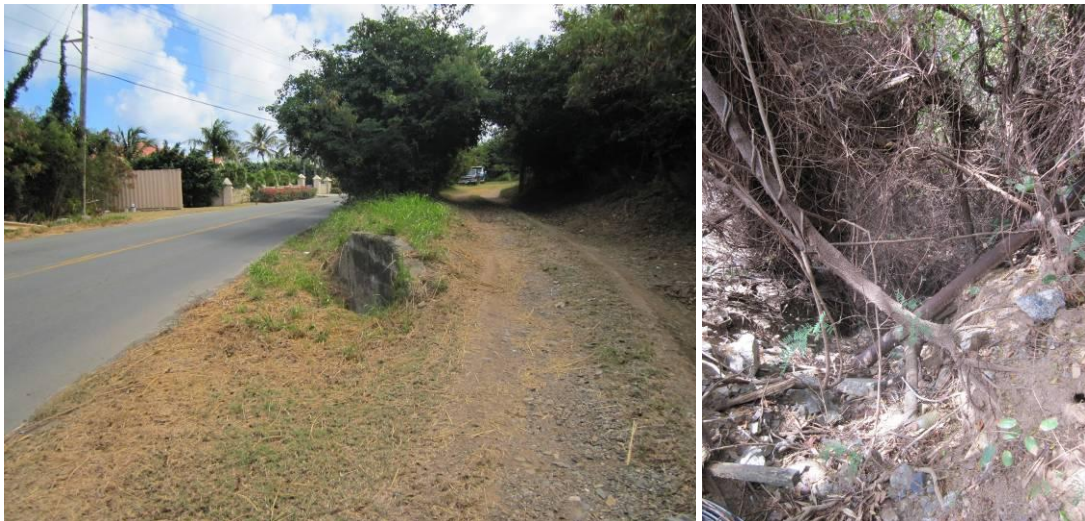
East End Rd. Culvert – East of Coakley Bay Condos (SB-RC-17)

This culvert is a 24-inch RCP culvert that has a large scour hole at the downstream end. The outlet area should be stabilized and a larger culvert may be needed in this area (see Figure 4.34).

Figure 4.34. Upstream end of culvert has large headwall separating it from an unpaved drive (left); the downstream end is scoured out and clogged with vegetation (right).

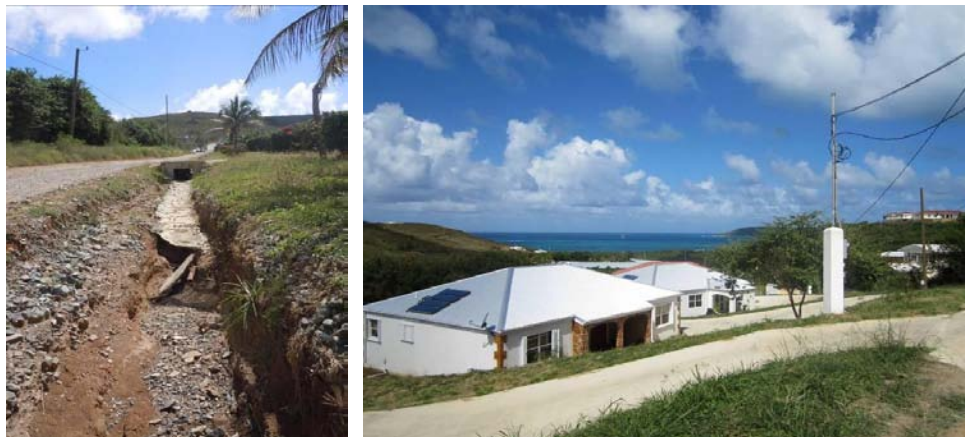
Roadways within the Seven Flags neighborhood are a mix of paved and unpaved roads. The approximately 1,000-foot road segment of Seven Flags Rd. at the entrance from East End Rd. is unpaved and is significantly eroded. There are two partially clogged culverts at the intersection of Seven Flags Rd. and East End Rd. The owner of the Seven Flags Rd. industrial properties has also installed large concrete culverts beneath their driveways to divert drainage off the road and driveways and through these culverts. Despite these drainage facilities, the roadway is significantly eroded and contains large gullies. Roadway conditions are much better throughout the rest of the neighborhood.

Figure 4.40. View from Rt. 82 south of dirt portion of Seven Flags Road (left) and new single family dwellings constructed along steep paved portion of Seven Flags Road (right).

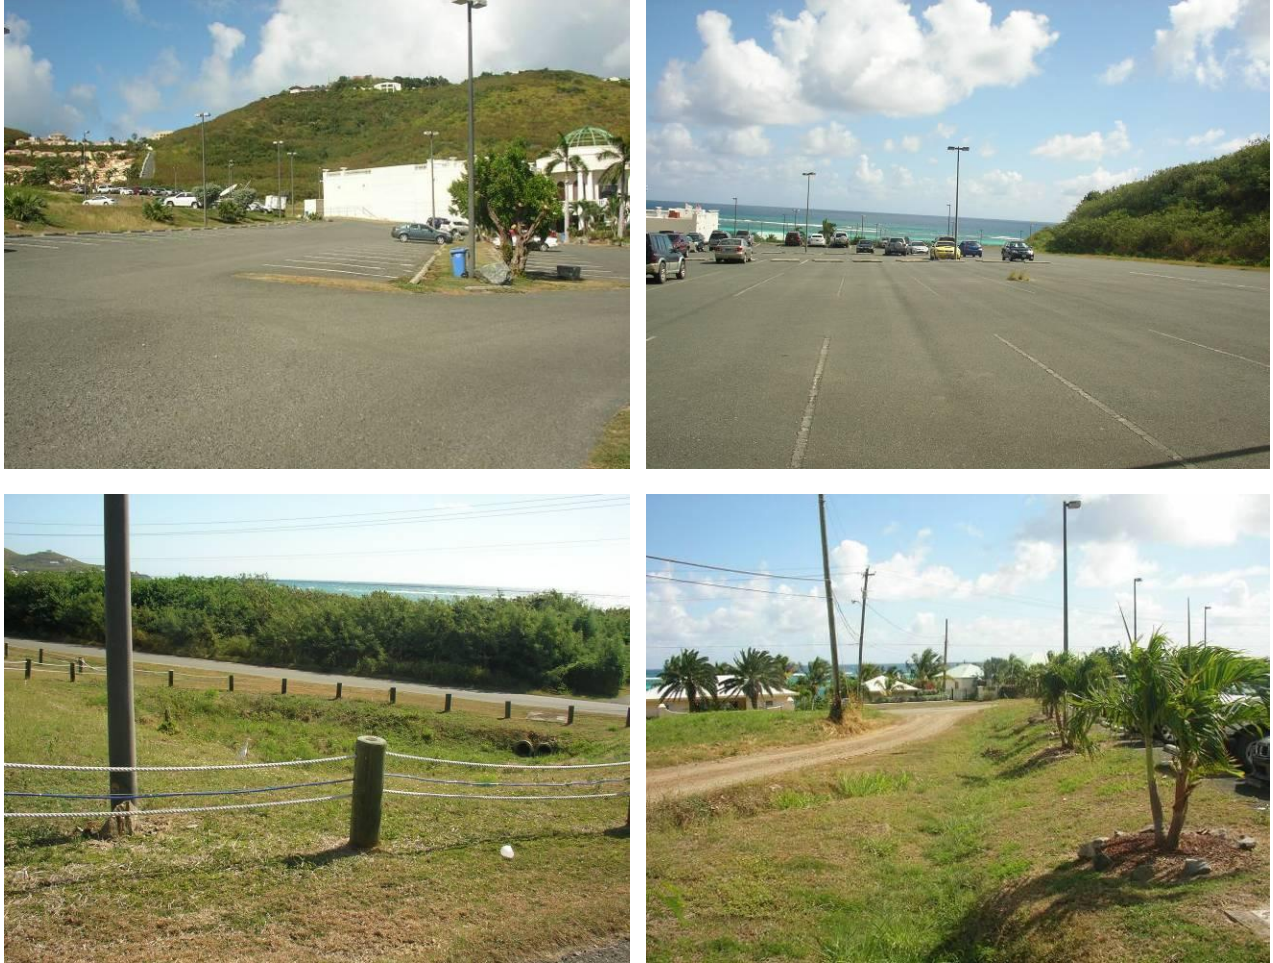
The existing drainage channel between the parking lot and roadway is filled with sediment. Modifying the existing detention basin to create a micropool wetland with a long flow path and baffle would increase storage and would help capture higher amounts of sediment. This would be an excellent location for a demonstration project, as the nearby facilities receive high amounts of public use.

Figure 6.3. Existing parking facilities at Divi Carina Bay Casino (top left and right). Existing detention basin at southwest corner of main parking lot (bottom left). Drainage channel around casino parking lot to the east and south (bottom right).

Stormwater management in the rear parking lot may be improved by constructing additional paved flumes that will discharge to an existing shallow swale along the east edge of the parking lot (Figure 6.3). Additional stormwater management can be provided within the primary parking lot via installation of several rain gardens and/or bioswales between parking aisles, in existing grass areas. This would aid in disconnecting impervious area, reduce the velocity of stormwater, and would help to reduce sediment and other pollutants.

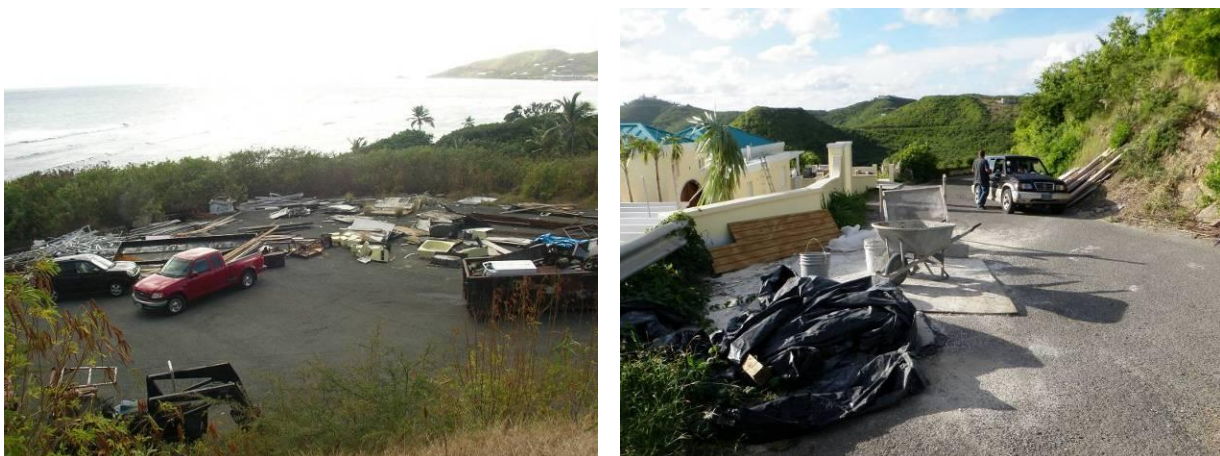
Grapetree Bay Hotel Restoration (TH-R-4)

The existing Grapetree Bay Hotel building is located on South Grape Tree Rd. in the central portion of the Turner Hole Watershed overlooking Grapetree Bay and is currently in the process of being renovated. Extensive debris and demolition material from the interior of the building are being stockpiled in the parking lot. Stormwater sheet flows over this impervious area towards the ocean. There are currently no stormwater practices present on site. Installation of a rain garden within or adjacent to the parking area would assist in the treatment and attenuation of stormwater discharging to nearshore waters and would serve as a highly visible demonstration project for educational and outreach purposes, particularly since residential construction projects are also challenged by proper management of construction debris and material storage (Figure 6.5).

Figure 6.5. Parking lot and construction materials/debris storage at the Grapetree Bay Hotel (left). Material storage and staging at small residential construction site in Turner Hole (right).

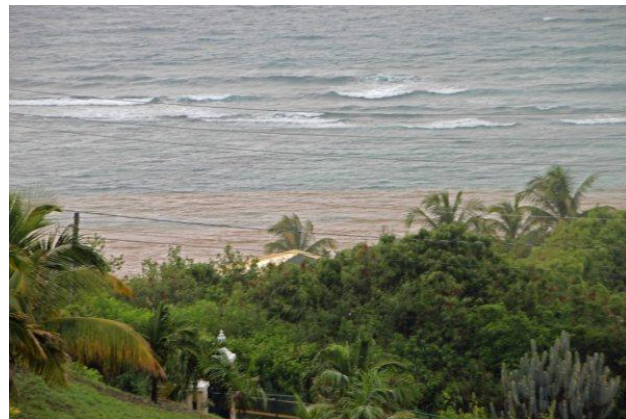
A new culvert was installed in July, 2010 on a residential lot in an effort to reduce active erosion of an existing gut, which accepts drainage from South Shore Rd. A sediment plume in Grapetree Bay observed by residents during the heavy rain events on July 19-20, 2010 was reported to have originated from this location (Figure 6.8). Property owners report that since culvert installation was completed, no additional sedimentation issues have occurred. HW did not visit this site during our field assessment and are unable to verify these reports; however, EEMP staff did conduct a

Figure 6.8. Sediment plume in Grapetree Bay in July 2010 (photo courtesy of Kathy LeGrange/Dave Rivers)

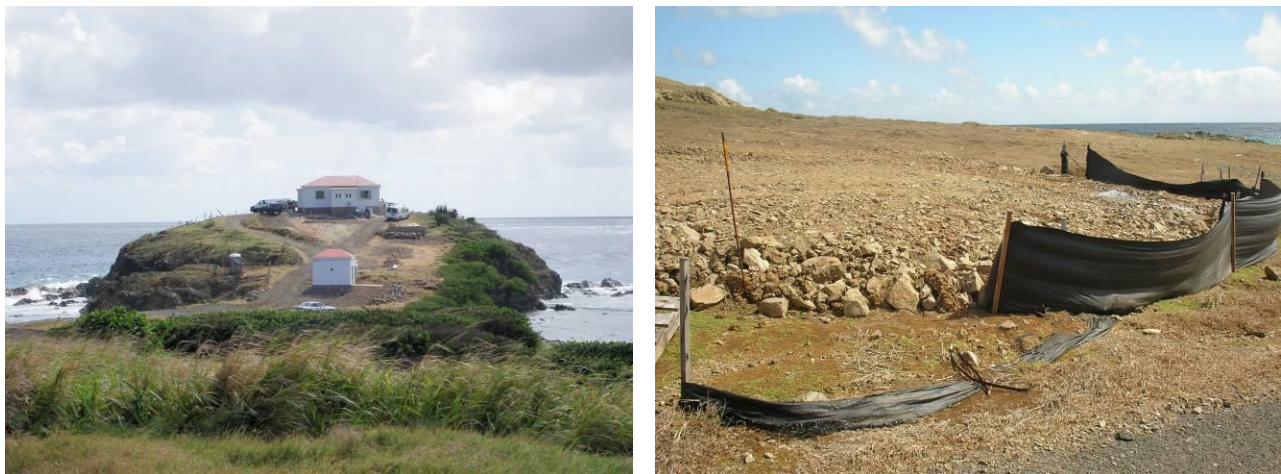
Figure 7.3. Residential construction (left) and ESC practices (right) on Grass Point associated with the Pt. Elizabeth development.

No specific neighborhoods currently exist in this watershed, though the Pt. Elizabeth community on Grass Point is anticipated. Septic standards and ESC requirements for new single lot development of the Elizabeth Point community should be enforced, particularly given the extremely shallow and stony nature of the soils of Grass Point and proximity to the Bay (Figure 7.3).

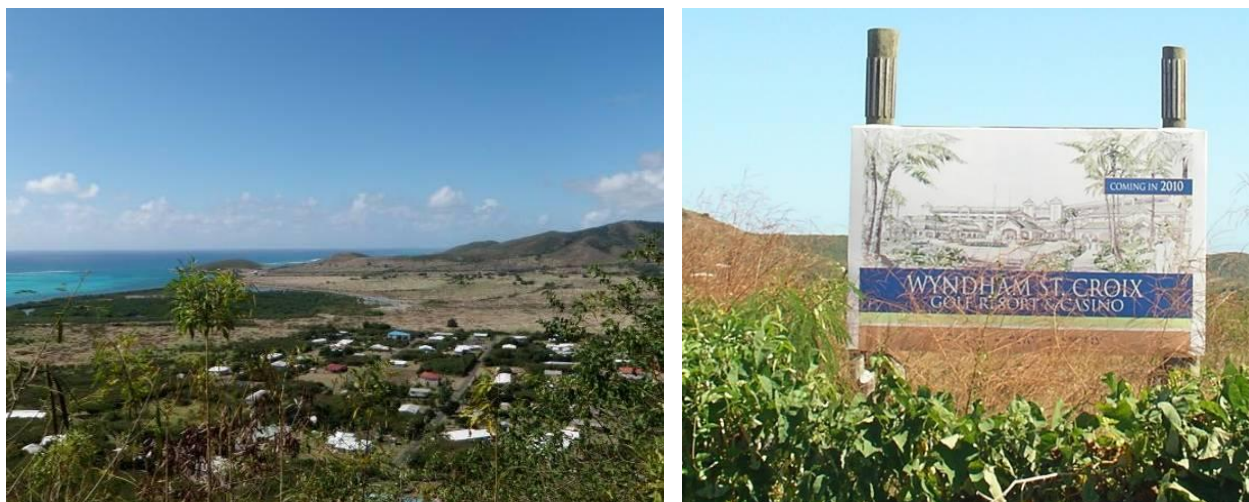
Three main roads effectively separate the Pond and surrounding lowlands from the steeper terrain: South Shore Road in the east, Southside Road (Rt. 62) in the west, and Route 624 connecting the two. Land use in the watershed consists of a large Boy Scouts of America Camp in the west, a public camping ground (Arawak) and the East End Marine Park (EEMP) Offices in the east, and a small grocery store (Milgie's). Several low-density, single family neighborhoods are located in the watershed: Union & Mt. Washington, Marienhoj, and Sally's Fancy. The watershed is mostly zoned for agriculture and low density residential; however, a portion of the watershed was up-zoned high density, associated with the proposed Robin Bay Resort development and, presumably, the Wyndham Golf Resort/Casino (Figure 8.1). North of Rt. 624 is a proposed commercial retail center, the Muddy Mongoose.

Figure 8.1. Overlooking Great Pond and the Union neighborhood from Mt. Washington (left), and signage indicating new proposed development (right).

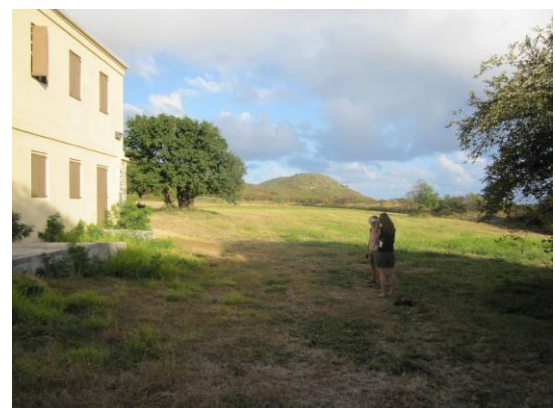
East End Marine Park (EEMP) Office (GP-R-2)

The EEMP office is a small, two-story building just east of Great Pond, adjacent to the historic Great House. Since rooftop runoff is collected in cisterns, the area is generally flat, and there is limited erosion evident in the parking lot or immediate vicinity, no stormwater drainage demonstration projects were identified. However, the park office is surrounded by a lot of open area, which could potentially be converted into a demonstration/study area for growing native plants for use in demonstration projects elsewhere on island (Figure 8.10). Part of the educational program of the EEMP could include how to convert residential lawns to native landscaping.

Figure 8.10. Eastern side of EEMP office building is a potential location for demonstration garden.

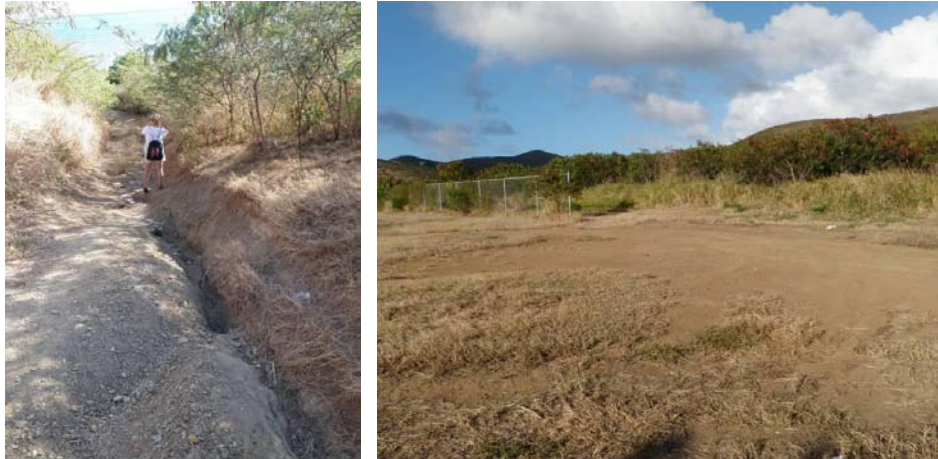
Proposed Arawak Campground/Eroded Trail near EEMP Office (GP-R-3)

The adjacent open area north of the EEMP is currently being considered for a large campground. In the northeastern corner is an active parking area that connects to an eroded trailhead leading down to the beach. EEMP staff indicated that observable erosion occurs during rain events and that trail stabilization and parking management at this location would help reduce sedimentation. The trail is approximately 150 feet long at a 2:1 to 3:1 slope. Deep gullying has occurred in the trail (Figure 8.11). Basic trail stabilization techniques including waterbars and steps, as well as management of flow from the parking area could help stabilize the trail. Ownership of the trail is uncertain.

Figure 8.11. Eroded trail to beach (left) and parking area (right)

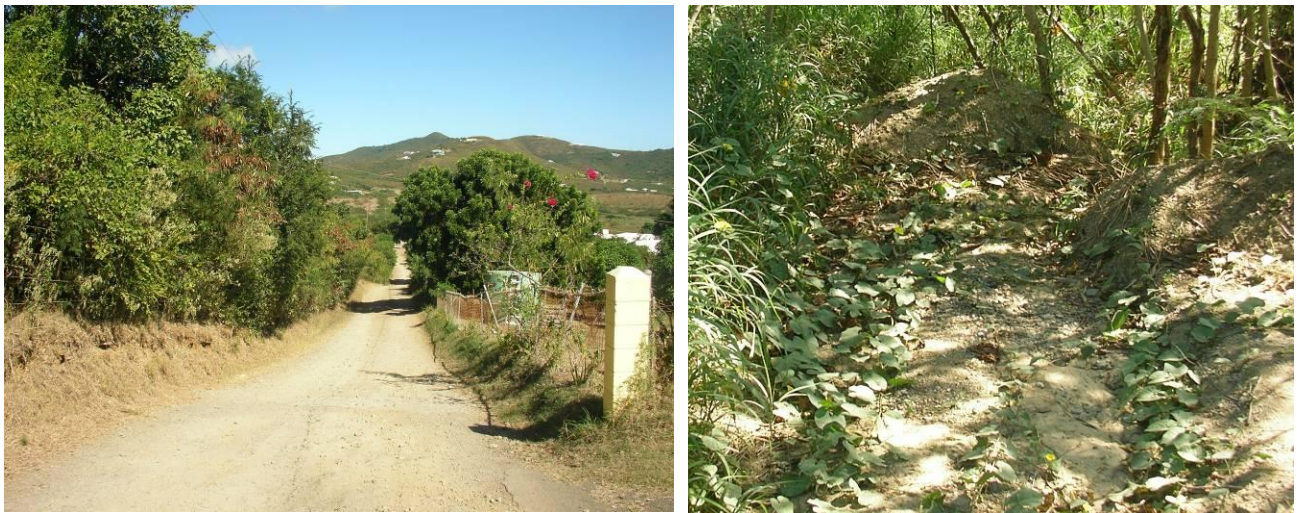
The Sally's Fancy neighborhood is located northeast of the Southside Rd./Rt. 624 intersection. The neighborhood includes a mix of topography, landuse, and parcel size and has two guts flowing through it (Figure 8.12). The topography varies from moderate in the north and very flat topography in the south. The parcels, which are primarily developed, range from quarter-acre to three-acre lots. The larger parcels are primarily brush or tall grass that may include some agricultural activities. At least two lots were identified as possible automobile junk yards. Other than the two highways that border the neighborhood, the roads are mostly dirt or gravel. Severe rutting was observed in the low-lying areas. Some of the ruts were in the process of repair with crushed stone. A high density of dogs was observed in this neighborhood.

An area of future concern near Sally's Fancy is the proposed Wyndham Golf Resort & Casino, which is directly across from Milgie's Grocery. The local gut flows directly into this property and the topography is extremely flat. Any impoundment to the gut will likely contribute to more severe flooding problems in Sally's Fancy neighborhood. Any future downstream development should evaluate these potential impacts during the planning phase.

Figure 8.12. Sally's Fancy neighborhood (left); sediment dumping in gut (right).

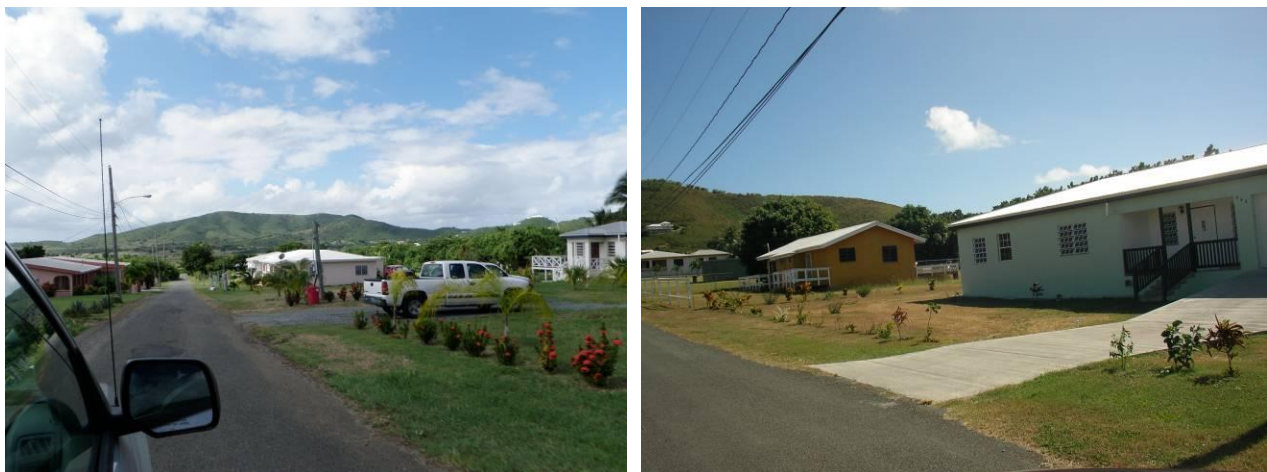
The Union area is the flatter portion of the greater Union/Mt. Washington neighborhood. It is located northeast of Great Pond and off of South Shore Rd, and is relatively flat compared to many of the other residential areas in the East End (Figure 8.14). The primary roadways within this area are Sunset Road, Corry Road, Tamarind, David Oliver, Seaview, Blue Dolphin, Kenjo, and Acacia. The Union area is approximately 115 acres with 302 lots, less than 25% of which remain undeveloped. Average lot size for the single family homes in this neighborhood is around 0.25 acres, however, there are larger lots. Average lot cover is 70% turf, 25% rooftop, and 5% bare soil. Wastewater is managed via on-site septic systems and no problems with septic were observed. Road cover was mixed, but mostly paved. One section of Kenjo Road was unpaved and eroded with large ruts. All roads had open drainage and there was no evidence of water bars or culverts. A few roads had shallow grass swales on the road shoulder. This neighborhood does not appear to pose as a source of pollutants or sediment to down-gradient resources.

Figure 8.14. Street view of the Union area.
