C3 Fluorometer report and observations
 R/V Brooks McCall, 20 May 2010
 Michael C. Murrell, Ph.D.

Below are graphs and explanations of the 3 C3 tows done today.

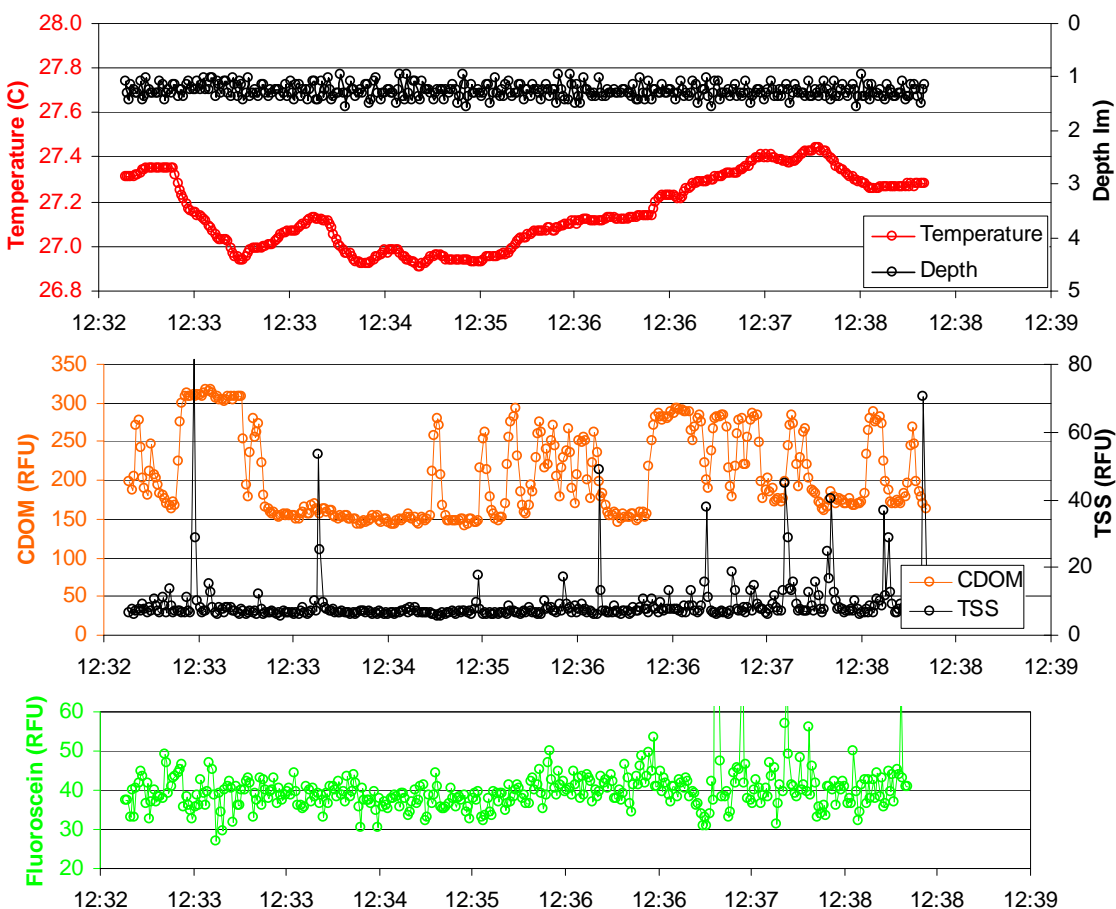
Figure 1: First tow of 20 May. It was only ~6 minutes duration between B35 and B36. Depth was very stable at ~1.5 m. Temperature varied in a lazy cyclical fashion from 26.9 to 27.4 °C. The CDOM (oil) channel varied from ~150 to slightly over 300 FSU, with peaks presumably due to patches of oil. The CDOM channel does not appear to covary with any other variables. The TSS (turbidity) channel is mostly low varying from 5 to 20 FSU with occasional spikes up to ~65 FSU., perhaps indicating large clumps of oil passing by the sensor. The fluorescein channel appears to show mostly noise, varying between 30 and 50 with occasional spikes above 60 units.

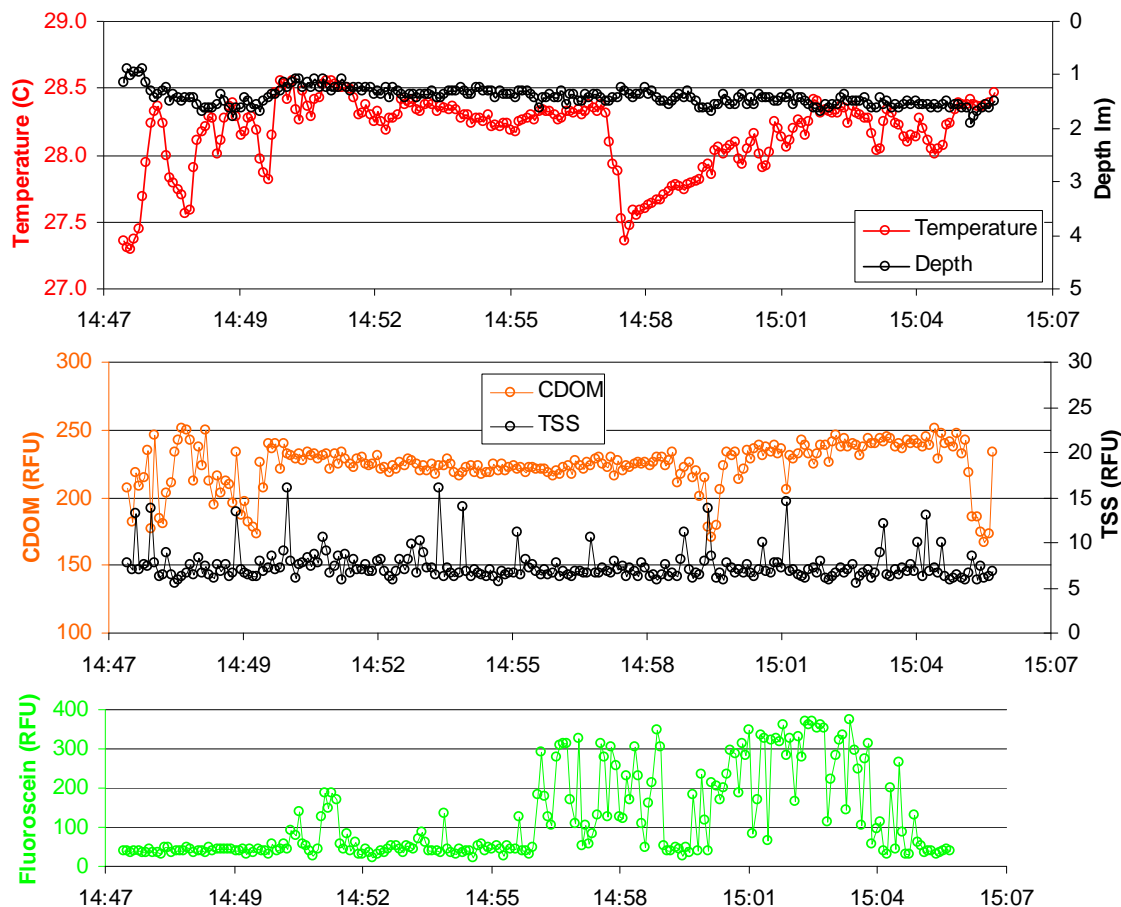
Figure 2: Second tow of 20 May of ~20 minutes duration between B36 and B37. Depth was very stable, varying between 1 and 1.5 m. Temperature varied in a cyclical fashion from 27.2 to 28.5 °C. The CDOM (oil) channel varied from ~170 to 250 FSU, with long periods of quite stable readings. I'm suspecting the window is getting fouled and hence the relatively constant high readings. Tomorrow I will be more conscious of this possibility and thoroughly clean the sensors before each deployment. Up until now, I assumed no significant oil fouling, but I did not actually clean the sensors. As before, the CDOM channel does not appear to covary with any other variables. The TSS (turbidity) channel is mostly low varying from 5 to 10 FSU with occasional spikes up to ~15 FSU, much smaller than spikes in first tow. Perhaps much smaller clumps of oil passing by the sensor? The fluorescein channel started out ~ 50 FSU and then abruptly jumped into a much higher but variable readings (100-300 FSU). By the end of the tow, the readings returned to those seen at the beginning. This pattern is not consistent with a fouling mechanism and thus may indicate oil, however this was not confirmed with visual observations.

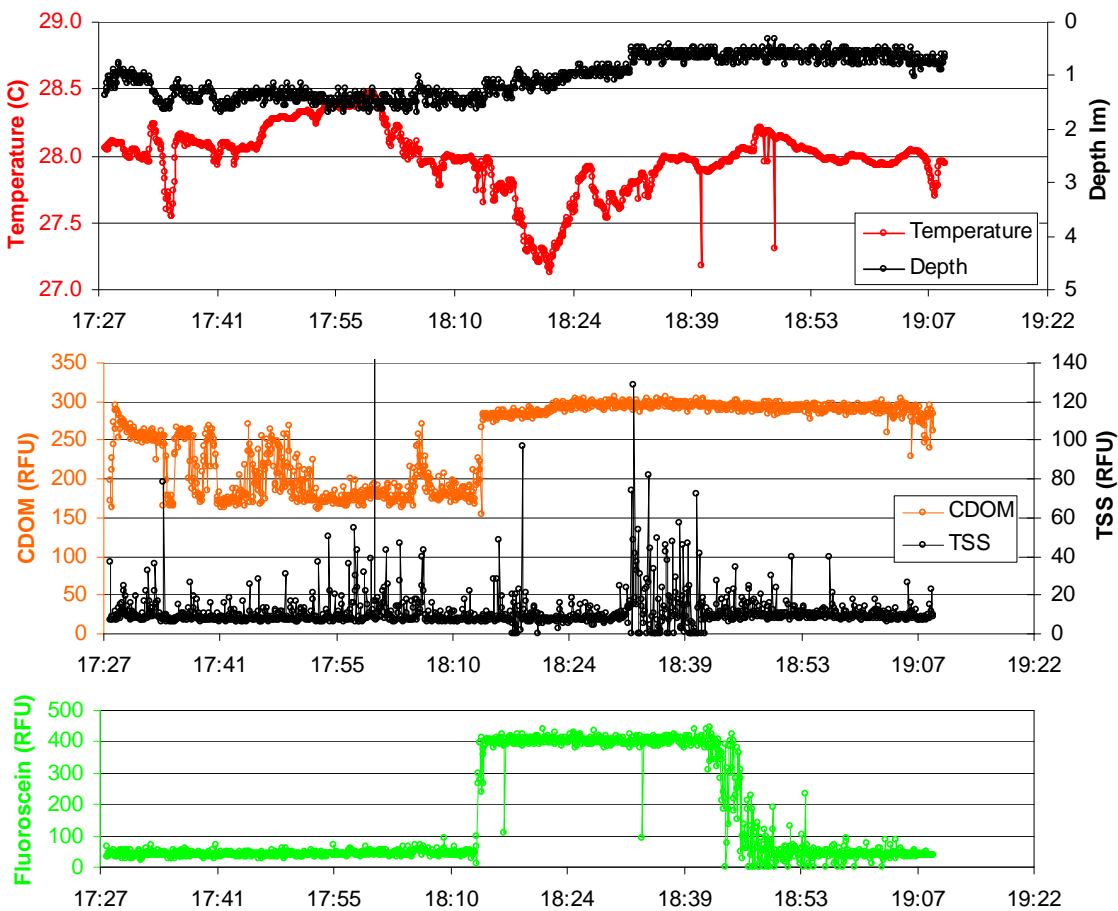
Figure 3: Third and final tow of 20 May of ~90 minutes duration after B37. The ship made a circle around the wellhead site at 1.5 km radius, starting from due south of the wellhead and making a clockwise circle around. Depth started at slightly over 1 m then gradually became shallower to ~0.5 m about $\frac{1}{2}$ way through the tow. Temperature varied in a quasi-cyclical fashion from 27.1 to 28.5 °C. The CDOM (oil) channel varied from ~170 to 300 FSU, with an abrupt increase when we got around the N side of the wellhead. This was when we moved through thick black oil. After this point, the readings stayed ‘pegged’ at 300 even after we moved out of the oil patch. I suspect the window became fouled. The TSS (turbidity) channel was mostly low varying from 5 to 10 FSU with occasional spikes up to ~60-100 FSU. The fluorescein channel started out ~ 50 FSU and then abruptly jumped into a much higher, stable reading of ~400 FSU coinciding with the jump in the CDOM channel and with entering the oil patch. However, in contrast to the CDOM channel, the fluorescein channel dropped back down after leaving the oil patch. Could it be one sensor was fouled but the other one not?
