C3 Fluorometer report and observations
R/V Brooks McCall, 19 May 2010
Michael C. Murrell, Ph.D.

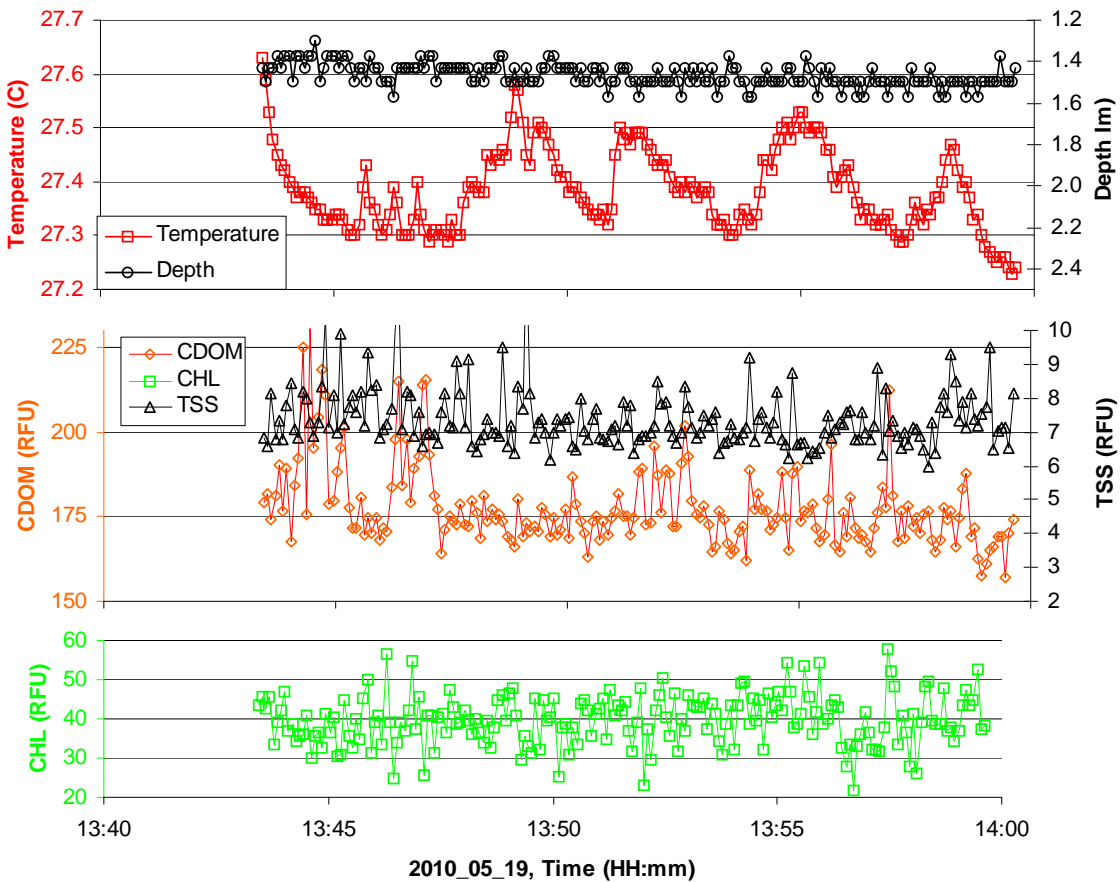
I conducted one successful 15 min deployment today, between stations B31 and B32. It took a couple of tries to get the configuration sequence correctly done. Plotting the data shows relatively little interesting structure. A few spikes in the CDOM channel were evident, but this seemed poorly related to TSS channel, in contrast to prior C3 data report. During the deployment we were moving through patches of brown flocs of oil at the surface. However, the subsurface (~1.5 m down) where the C3 was sampling, the water looked very clear and free of oil flocs. Hence, the spikes in CDOM may have been occasional patches of oil that mixed down. I should also mention that the seas are glassy calm, so very little mixing energy today. Another noteworthy pattern were the temperature excursions during the deployment. While quite small in magnitude (~0.2 C), they had a remarkably regular periodicity (~ 5 min).
