Ryan Chouest Cruise 12 Cumulative Report

Period covered: 2158 08/13/2010 -0220 08/23/2010

The *Ryan Chouest* cruised about 928 nautical miles, from 08/13/10 to 08/23/10, for the completion of Cruise 12. The complete route is shown in Figure 1. The main objective of this cruise is to monitor the surface and shallow water quality along the coast of the Gulf of Mexico.

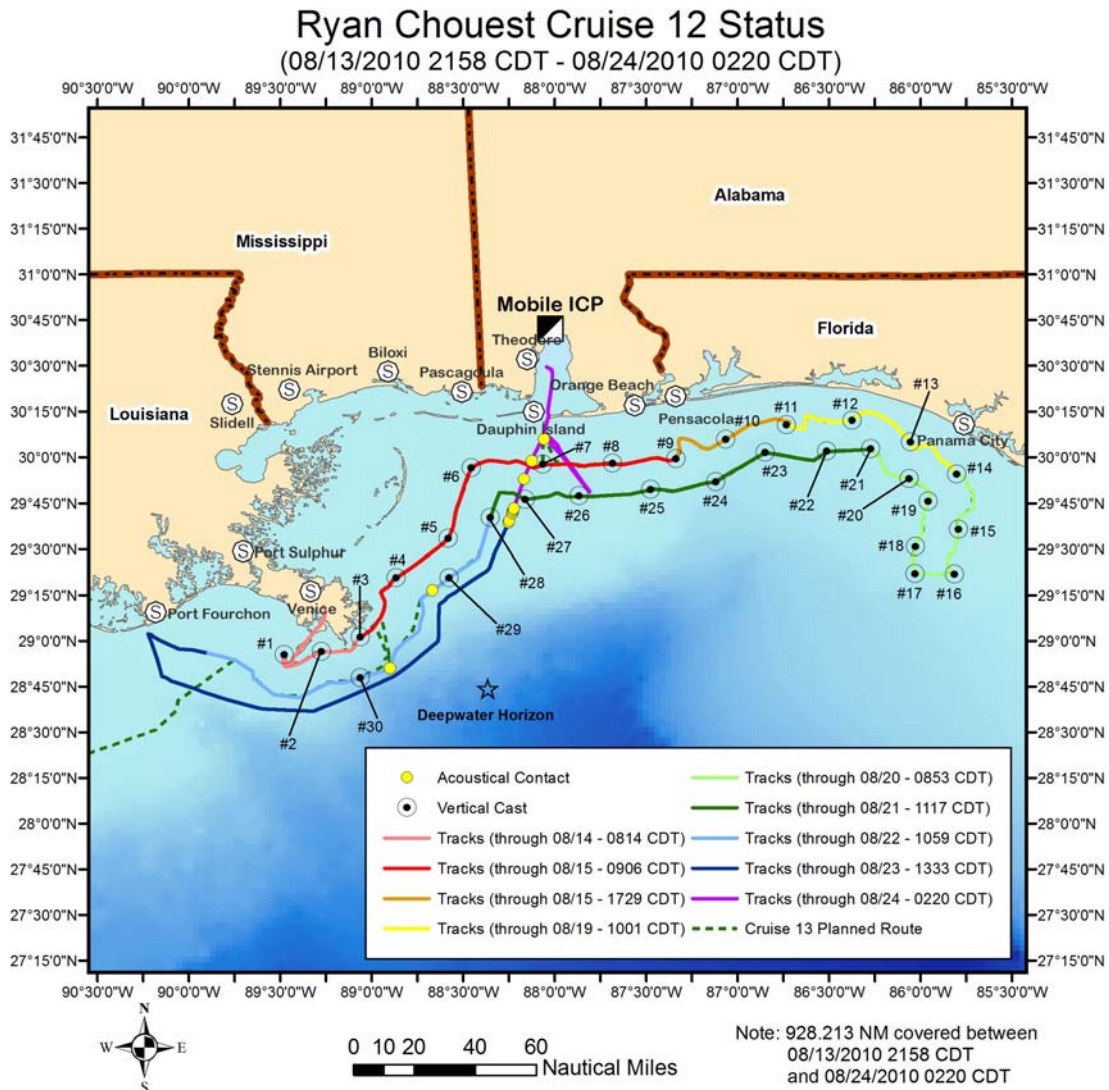
Figure 1: Planned and actual route course of the Ryan Chouest cruise 12 plotted between 08/13 – 08/24. The bull’s-eye represents vertical cast locations. The yellow filled dots represent recorded acoustical contacts.

The ship continued on the planned route eastward along the coastal transect towards and across the western coast of Florida (Figure 1, Track through 8/15).

During the final entry into Theodore on 08/24/10, the ship's captain was informed of a onshore ammonia leak, causing the ship to return to sea (See 8/24 cruise track on Figure 1) and await further information concerning time of re-entry into the port.

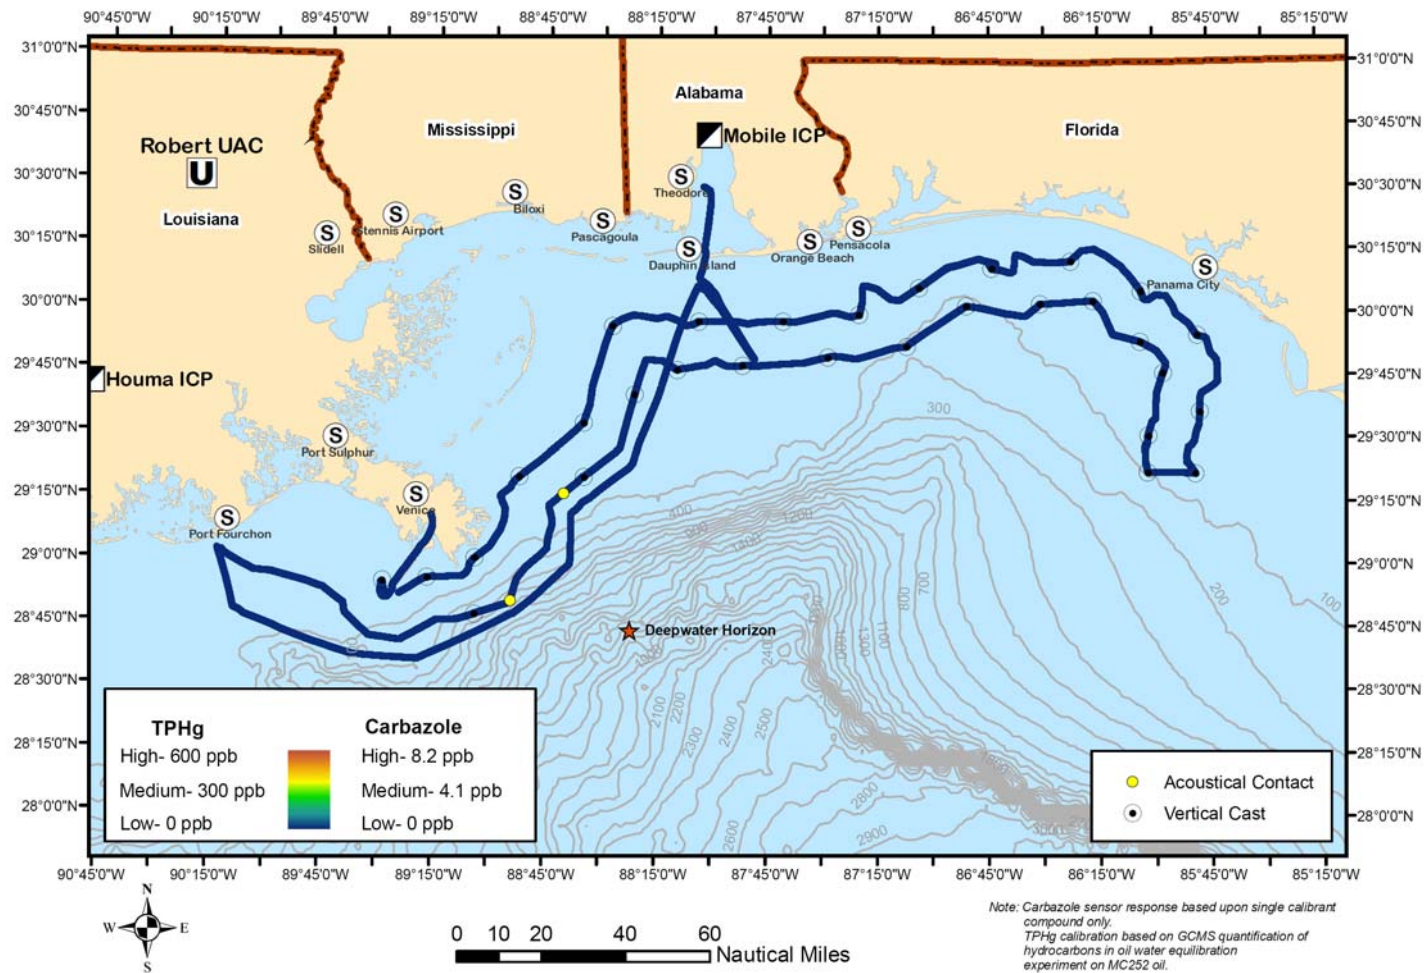
Ryan Chouest Cruise 12 Data
 Chelsea - Fluorometer
 (08/13/2010 2158 CDT - 08/24/2010 0220 CDT)

Figure 2. Chelsea fluorometer results plotted with location on cruise track 12. Breaks in data occur when either data quality is poor or the systems were turned off due to pump problems.

Fluorometry measurements indicate very low to lower-medium inferred hydrocarbon concentrations for the Chelsea, Trios sensors (Figures 2-3). In most places baseline levels were measured by the Chelsea and Trios fluorometers. The Trios sensor, however, detected slightly higher than baseline levels in Mobile Bay and across the Mississippi passes. In contrast, the Contros sensor showed medium levels of inferred hydrocarbons throughout the cruise track. The inconsistency between sensors and the low signal to noise ratio problem continues to be a problem for the Contros sensor, resulting in the suspended usage of the Contros sensor pending instrument change out.

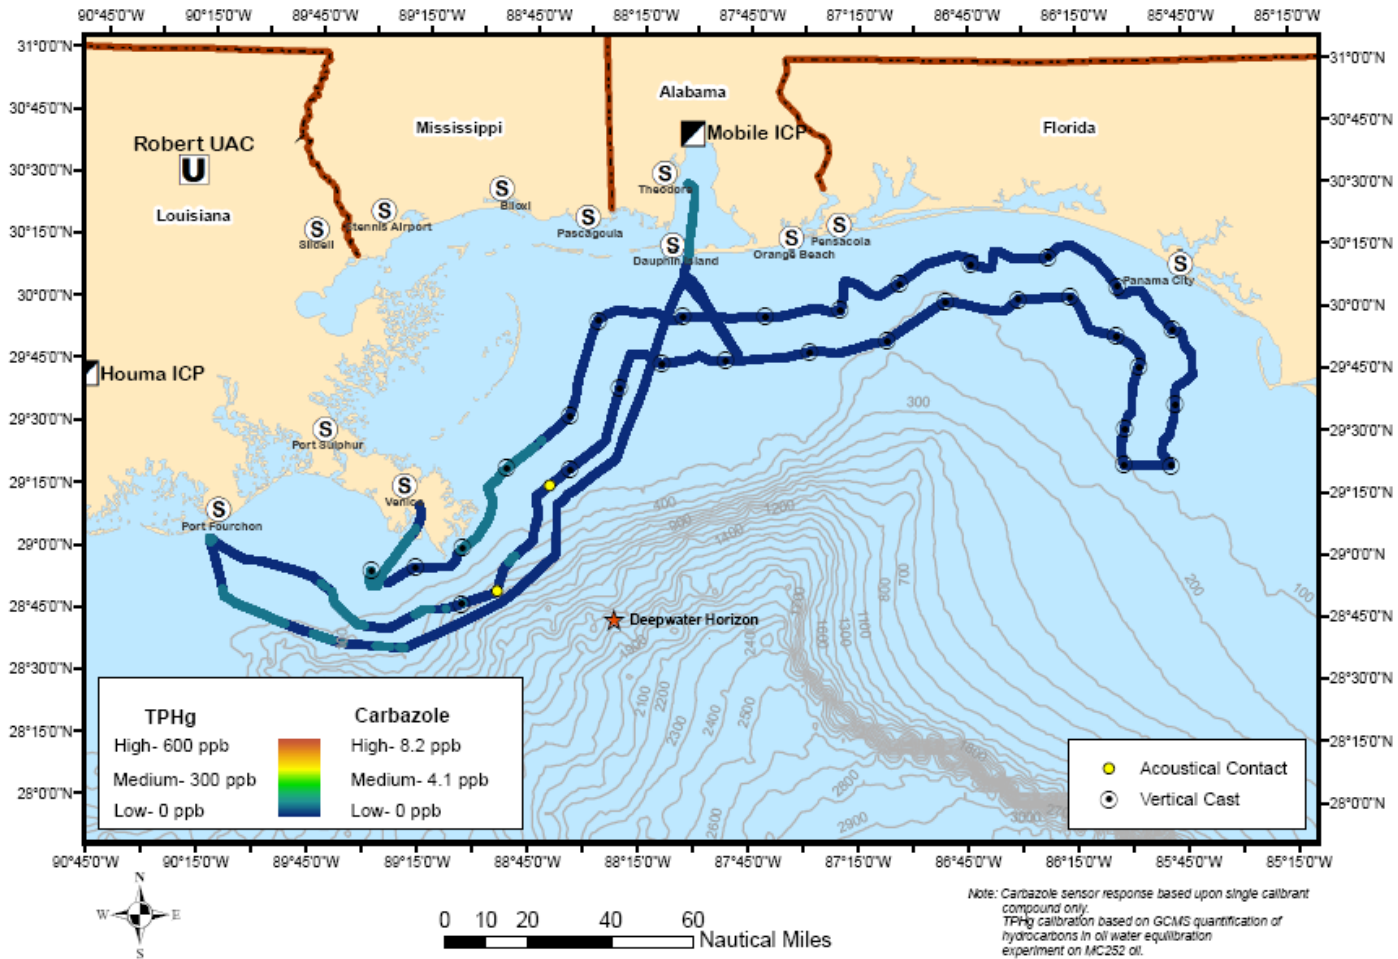
Figure 3. Trios fluorometer results plotted with location on cruise track 12. Breaks in data occur when either data quality is poor or the systems were turned off due to pump problems.

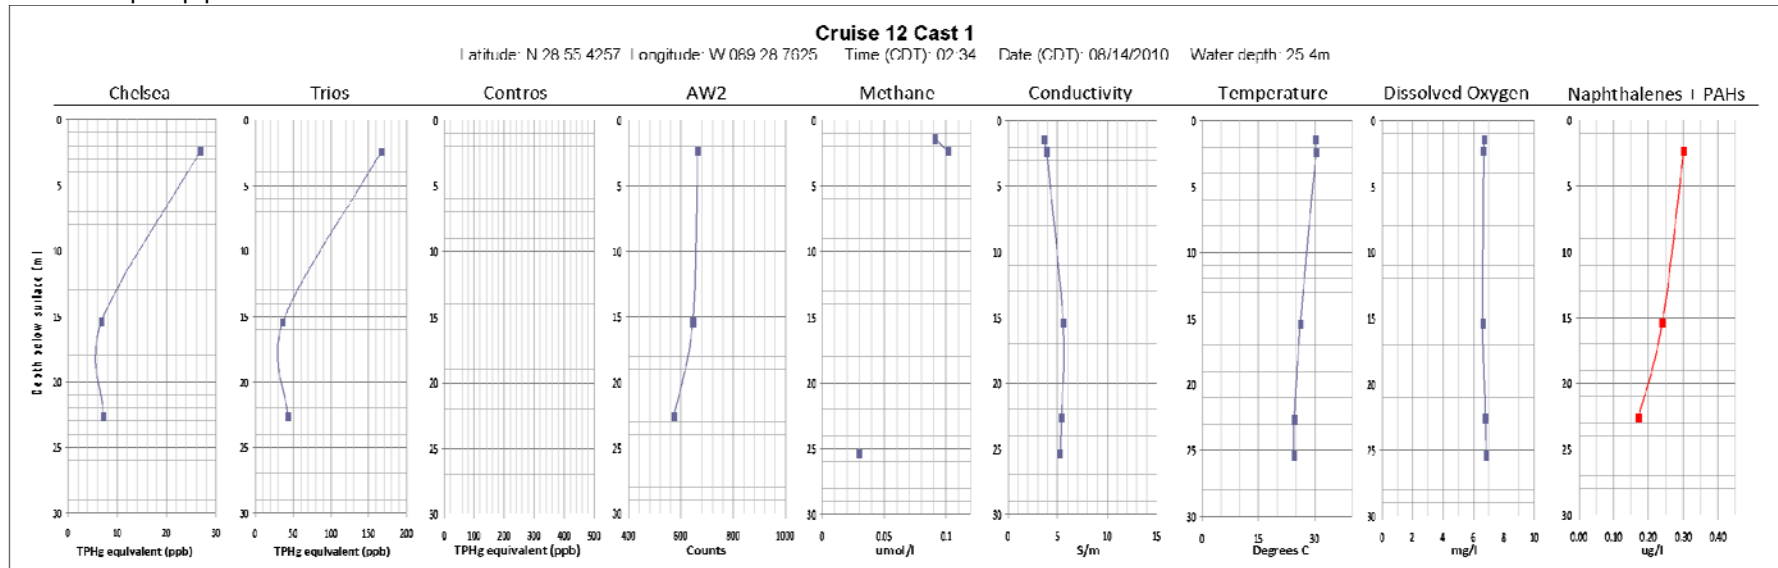
Figure 4. The results obtained for Cruise 12 vertical cast 1 down to 23 m. The sensor fluorometry results for the Chelsea, Trios and Contros sensors and water samples were obtained from waters pumped to the surface. Conductivity, temperature, depth and dissolved oxygen measurements were obtained from a SBE 19+ system and oxygen sensor attached to the submersible pump used to draw the water into the sensor tank on the surface.

30 fluorometry/CTD casts were taken during this report period (Figures 1, Figures 4-33). Overall the sensor readings are in the lower range of the average sensor outputs indicating low levels of Hydrocarbon outputs. The Chelsea and the Trios show slightly increased responses to waters close to the sea surface. The AW2 and the temperature probe both show more apparent increases than the fluorometers. The readings from the fluorometer, the AW2 and the temperature probe follow the same trend along the water column with sensor readings reaching maximum at surface. The dissolved oxygen, on the other hand, displays an opposite trend of lower reading to the surface water than the bottom water. The conductivities are relatively constant along the water columns.

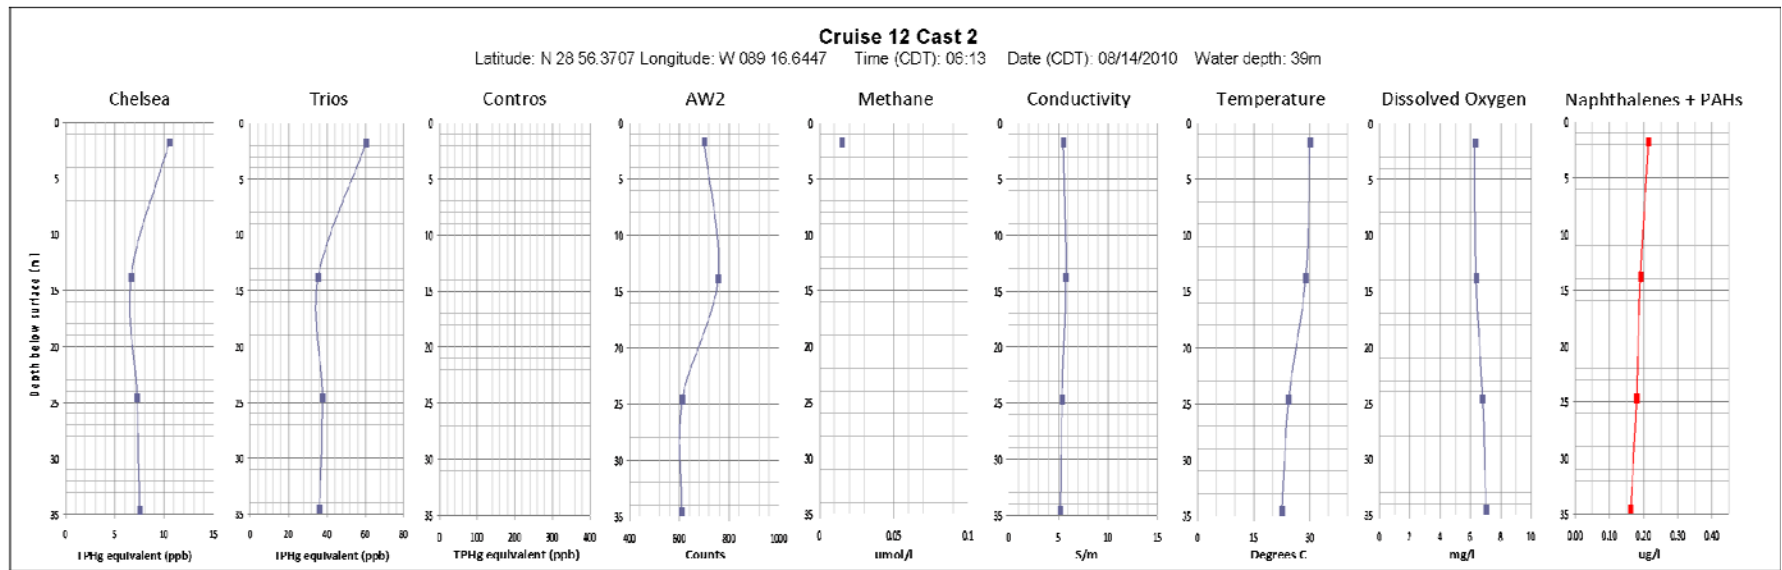
Figure 5. Fluorometer results obtained for the first leg of Cruise 12, 8/14/10, vertical cast 2 down to 35 m. The sensor fluorometry results for the Chelsea, Trios and Contros sensors and water samples were obtained from waters pumped to the surface. Conductivity, temperature, depth and dissolved oxygen measurements were obtained from a SBE 19+ system and oxygen sensor attached to the submersible pump used to draw the water into the sensor tank on the surface. Note questionable data obtained from the Contros sensor.

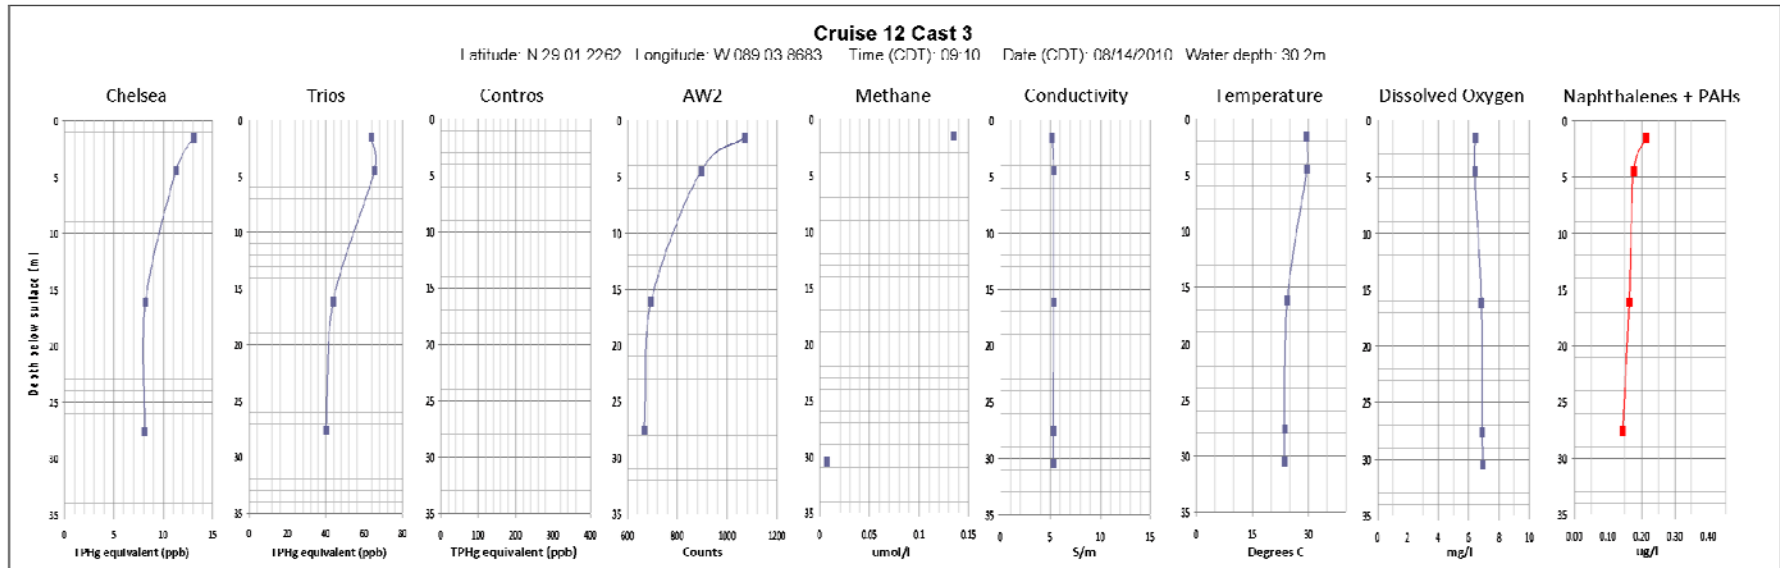
Figure 6. The results obtained for Cruise 12 vertical cast 3 (#3-C12) down to 28 m. The sensor fluorometry results for the Chelsea, Trios and Contros sensors and water samples were obtained from waters pumped to the surface. Conductivity, temperature, depth and dissolved oxygen measurements were obtained from a SBE 19+ system and oxygen sensor attached to the submersible pump used to draw the water into the sensor tank on the surface.

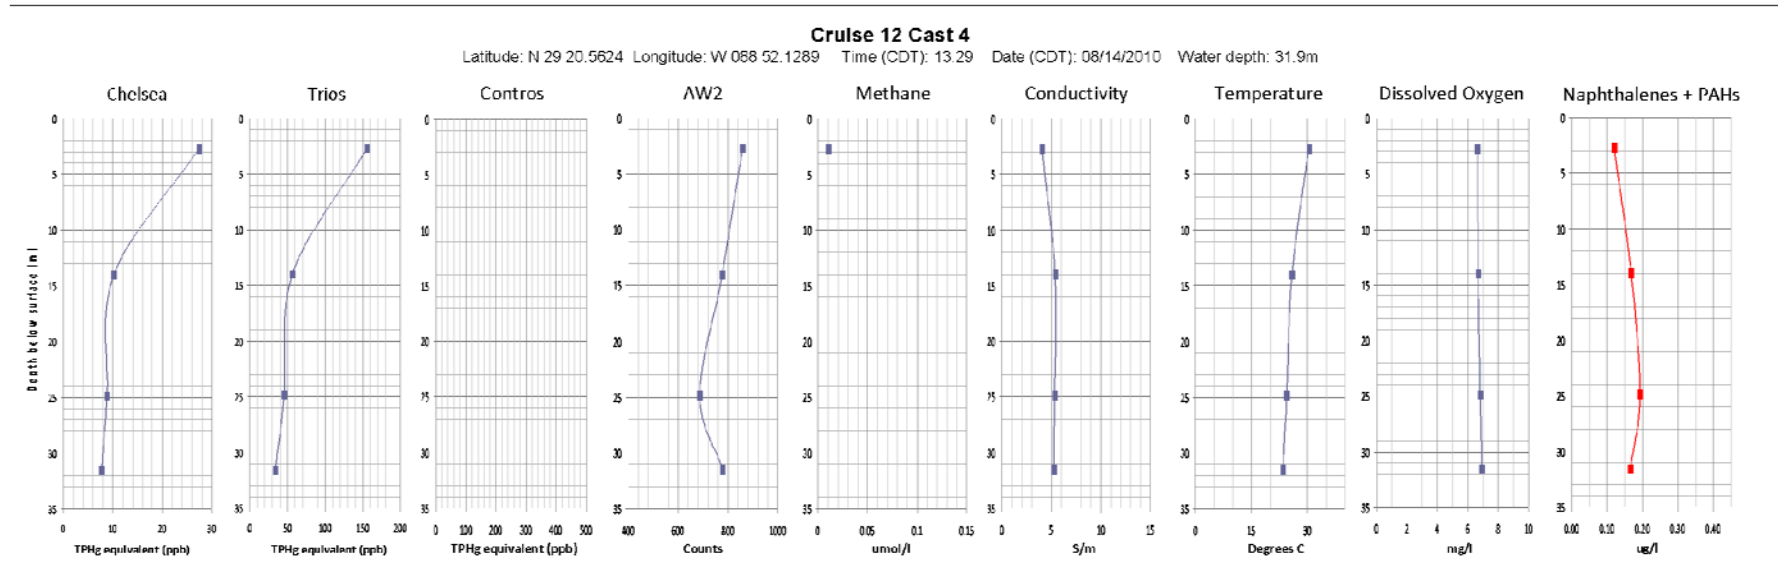
Figure 7. The results obtained for Cruise 12 vertical cast 3 (#4-C12) down to 32 m. The sensor fluorometry results for the Chelsea, Trios and Contros sensors and water samples were obtained from waters pumped to the surface. Conductivity, temperature, depth and dissolved oxygen measurements were obtained from a SBE 19+ system and oxygen sensor attached to the submersible pump used to draw the water into the sensor tank on the surface.

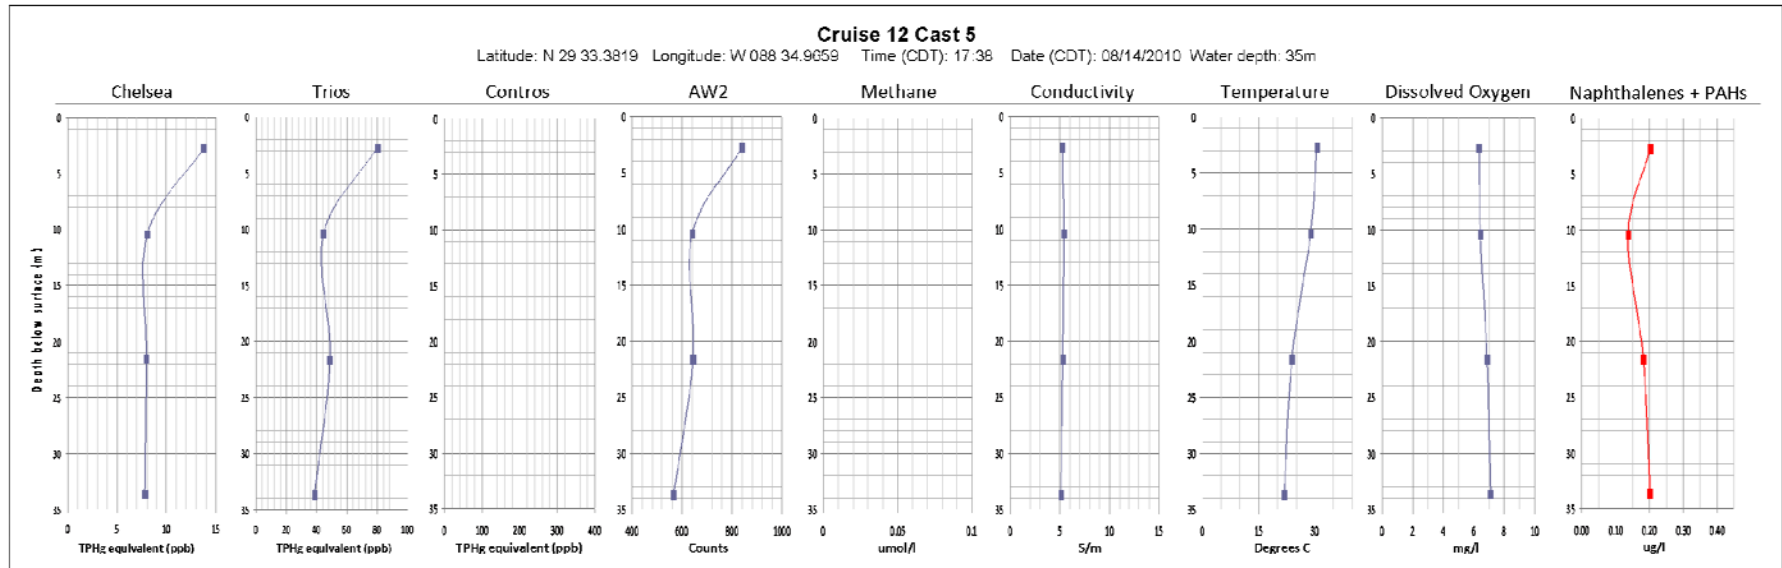
Figure 8. The results obtained for Cruise 12 vertical cast 3 (#5-C12) down to 34 m. The sensor fluorometry results for the Chelsea, Trios and Contros sensors and water samples were obtained from waters pumped to the surface. Conductivity, temperature, depth and dissolved oxygen measurements were obtained from a SBE 19+ system and oxygen sensor attached to the submersible pump used to draw the water into the sensor tank on the surface.

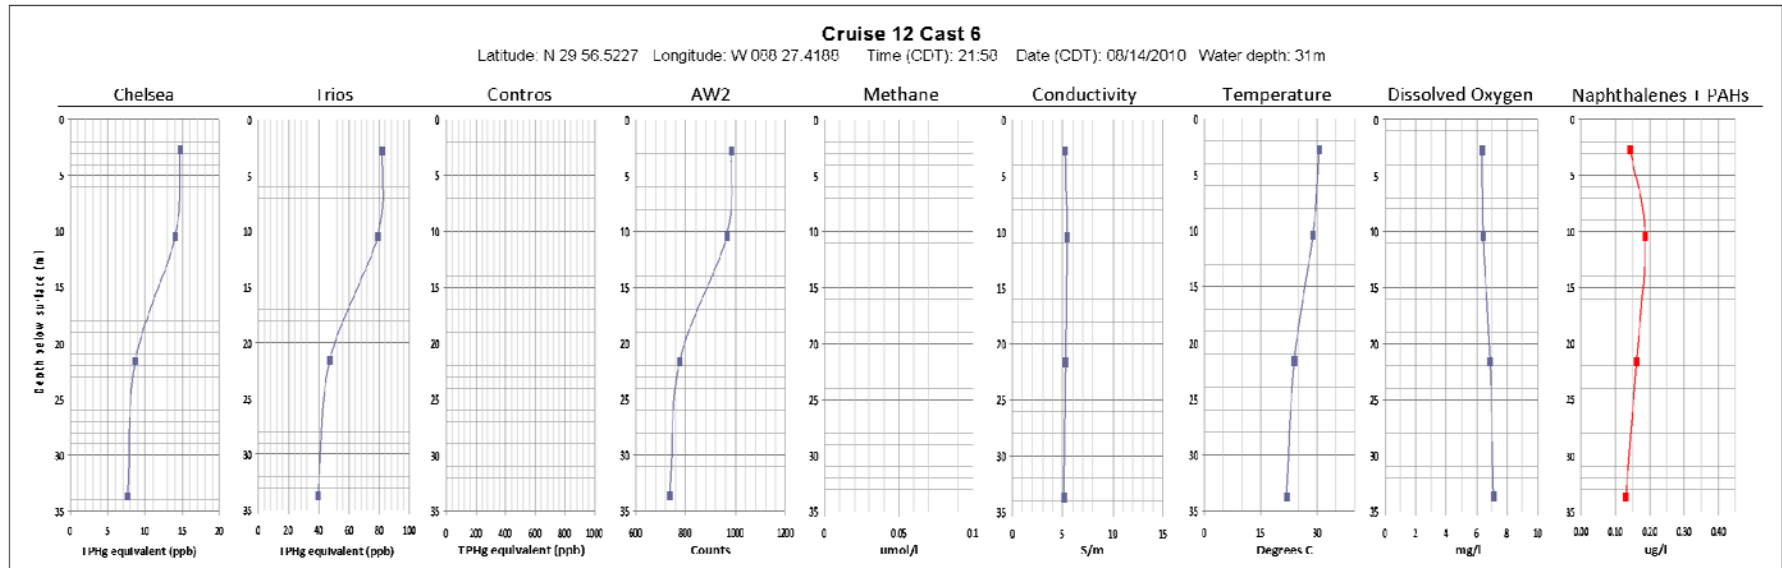
Figure 9. The results obtained for Cruise 12 vertical cast 3 (#6-C12) down to 34 m. The sensor fluorometry results for the Chelsea, Trios and Contros sensors and water samples were obtained from waters pumped to the surface. Conductivity, temperature, depth and dissolved oxygen measurements were obtained from a SBE 19+ system and oxygen sensor attached to the submersible pump used to draw the water into the sensor tank on the surface.

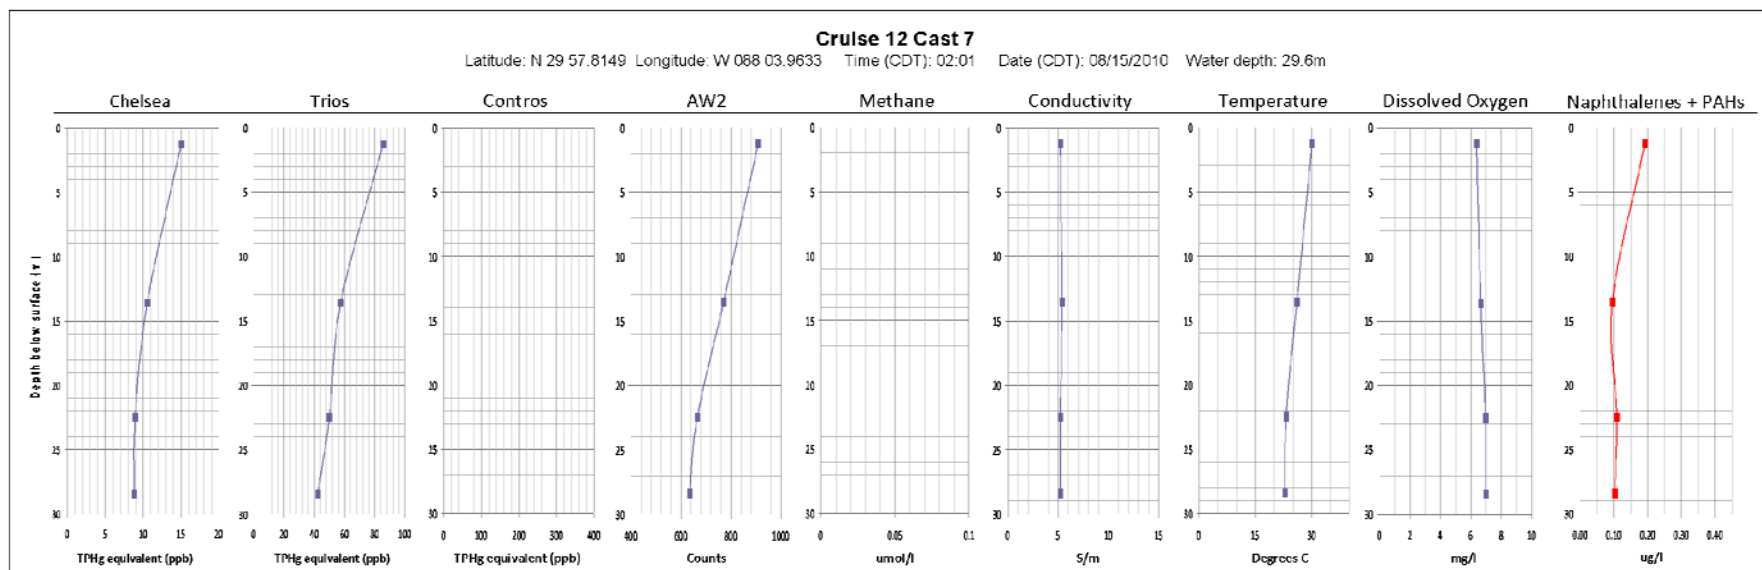
Figure 10. The results obtained for Cruise 12 vertical cast 3 (#7-C12) down to 29 m. The sensor fluorometry results for the Chelsea, Trios and Contros sensors and water samples were obtained from waters pumped to the surface. Conductivity, temperature, depth and dissolved oxygen measurements were obtained from a SBE 19+ system and oxygen sensor attached to the submersible pump used to draw the water into the sensor tank on the surface.

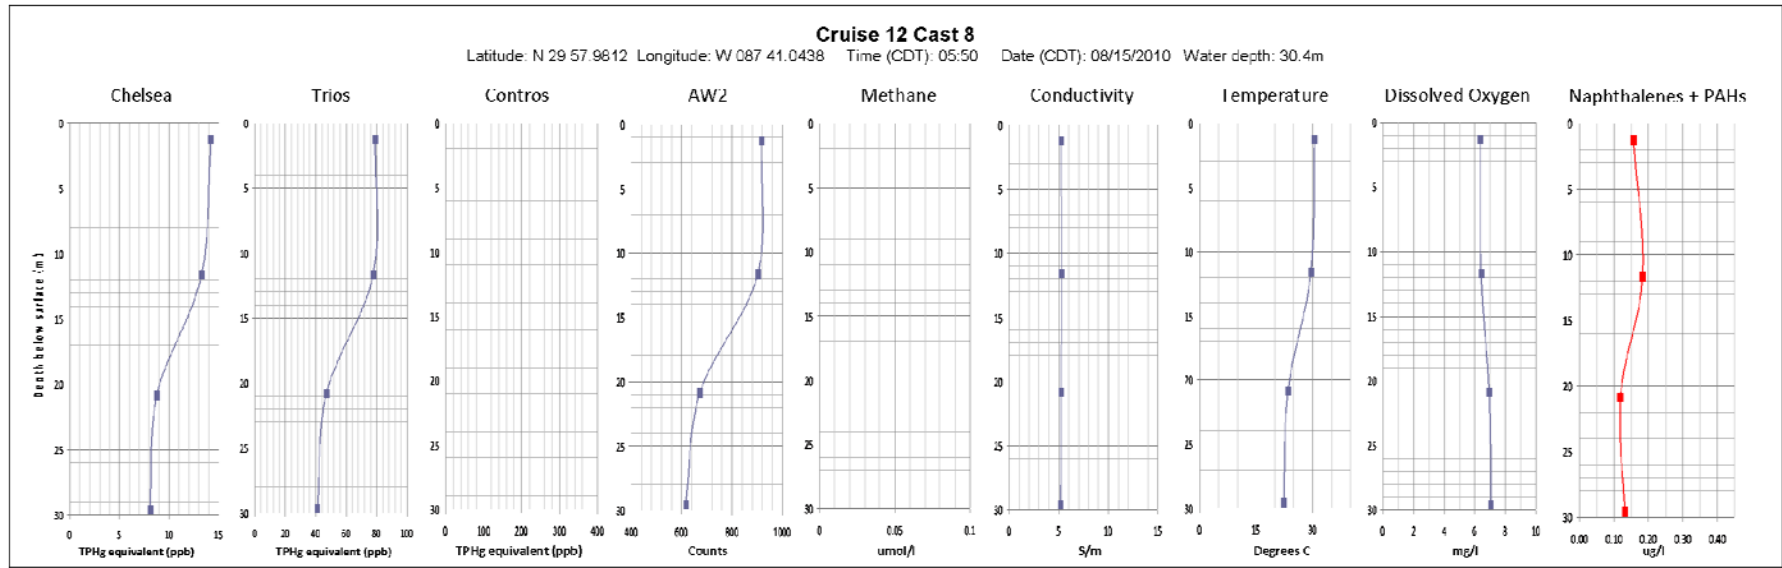
Figure 11. The results obtained for Cruise 12 vertical cast 3 (#8-C12) down to 30 m. The sensor fluorometry results for the Chelsea, Trios and Contros sensors and water samples were obtained from waters pumped to the surface. Conductivity, temperature, depth and dissolved oxygen measurements were obtained from a SBE 19+ system and oxygen sensor attached to the submersible pump used to draw the water into the sensor tank on the surface.

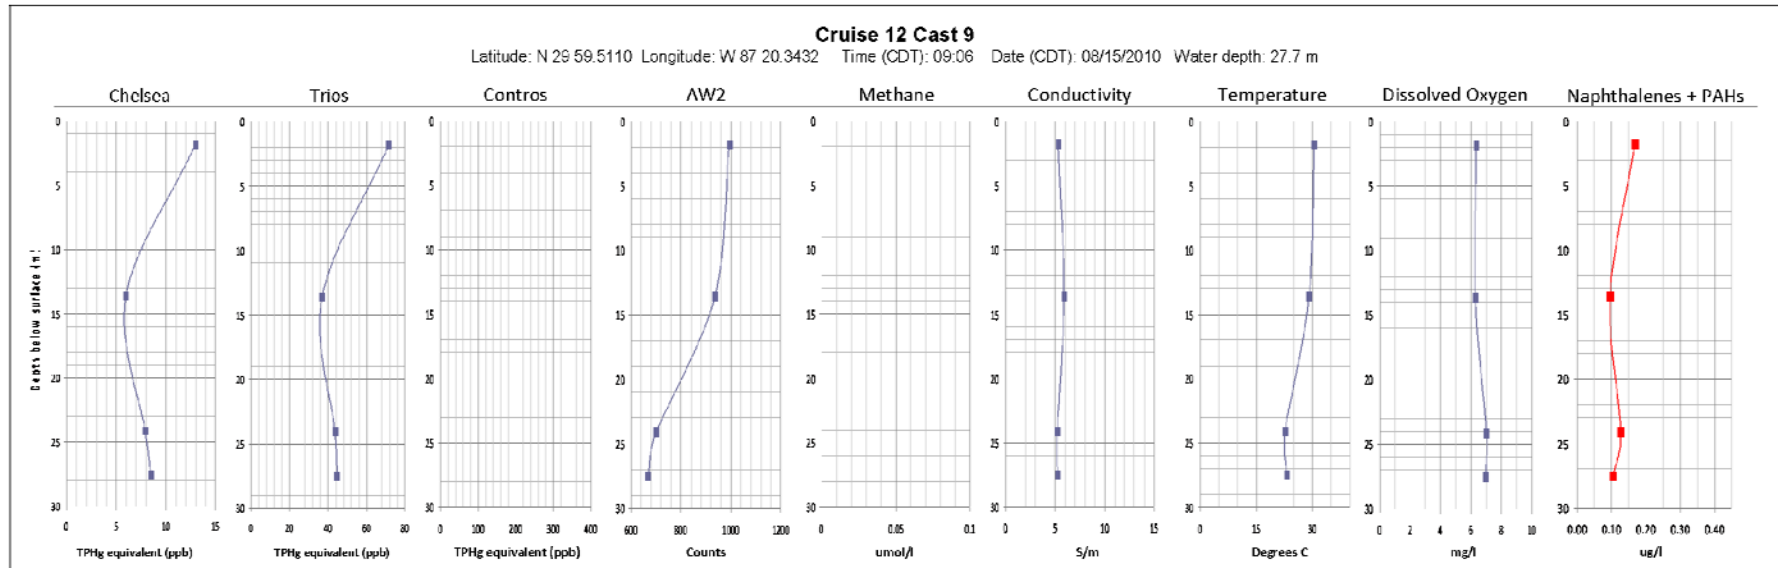
Figure 12. The results obtained for Cruise 12 vertical cast 9 (#9-C12) down to 28 m. The sensor fluorometry results for the Chelsea, Trios and Contros sensors and water samples were obtained from waters pumped to the surface. Conductivity, temperature, depth and dissolved oxygen measurements were obtained from a SBE 19+ system and oxygen sensor attached to the submersible pump used to draw the water into the sensor tank on the surface.

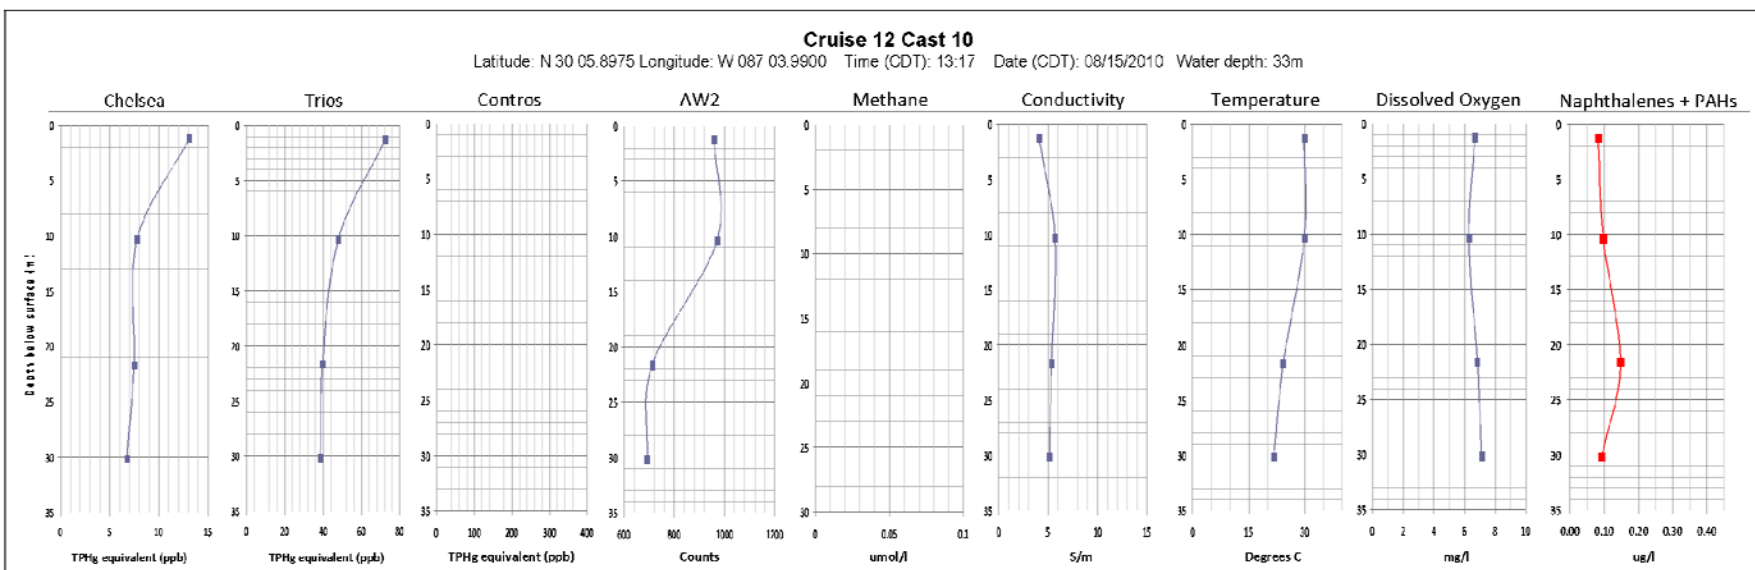
Figure 13. The results obtained for Cruise 12 vertical cast 10 (#10-C12) down to 30 m. The sensor fluorometry results for the Chelsea, Trios and Contros sensors and water samples were obtained from waters pumped to the surface. Conductivity, temperature, depth and dissolved oxygen measurements were obtained from a SBE 19+ system and oxygen sensor attached to the submersible pump used to draw the water into the sensor tank on the surface.

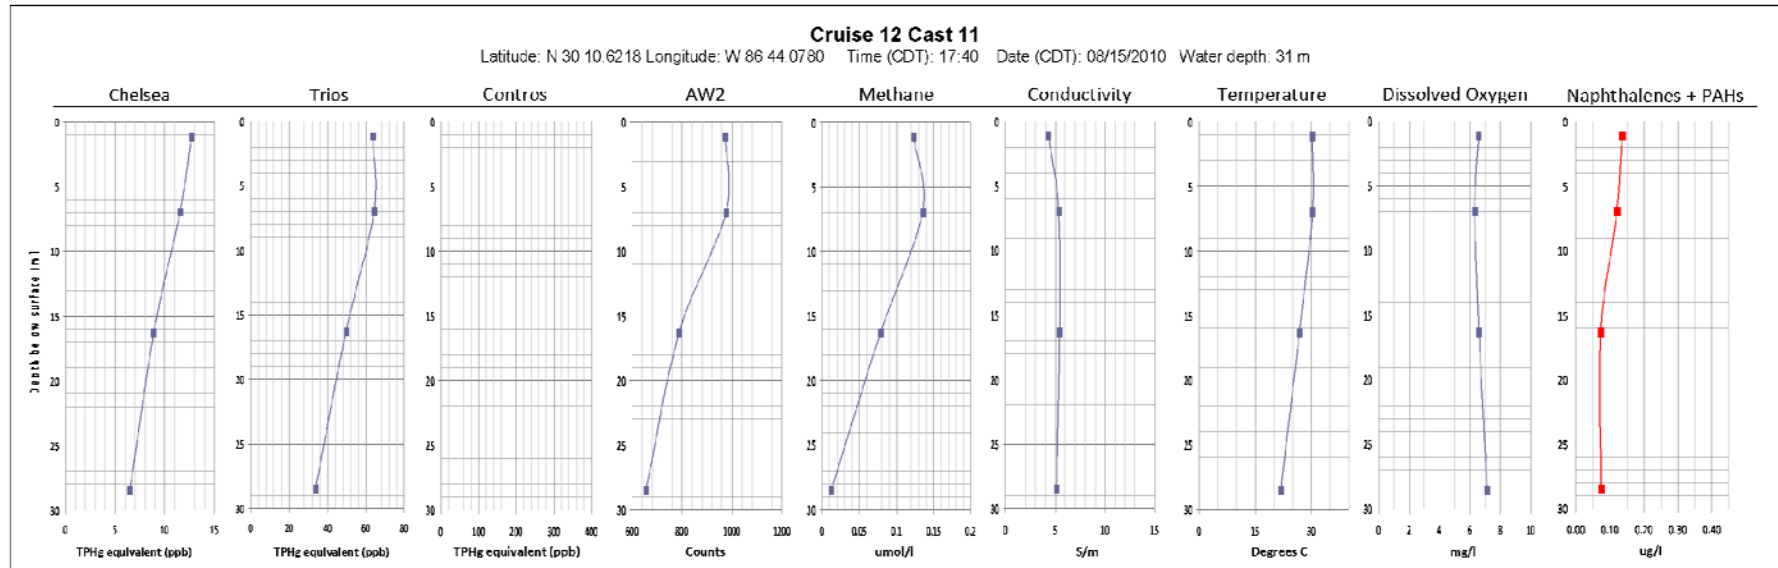
Figure 14. The results obtained for Cruise 12 vertical cast 11 (#11-C12) down to 29 m. The sensor fluorometry results for the Chelsea, Trios and Contros sensors and water samples were obtained from waters pumped to the surface. Conductivity, temperature, depth and dissolved oxygen measurements were obtained from a SBE 19+ system and oxygen sensor attached to the submersible pump used to draw the water into the sensor tank on the surface.

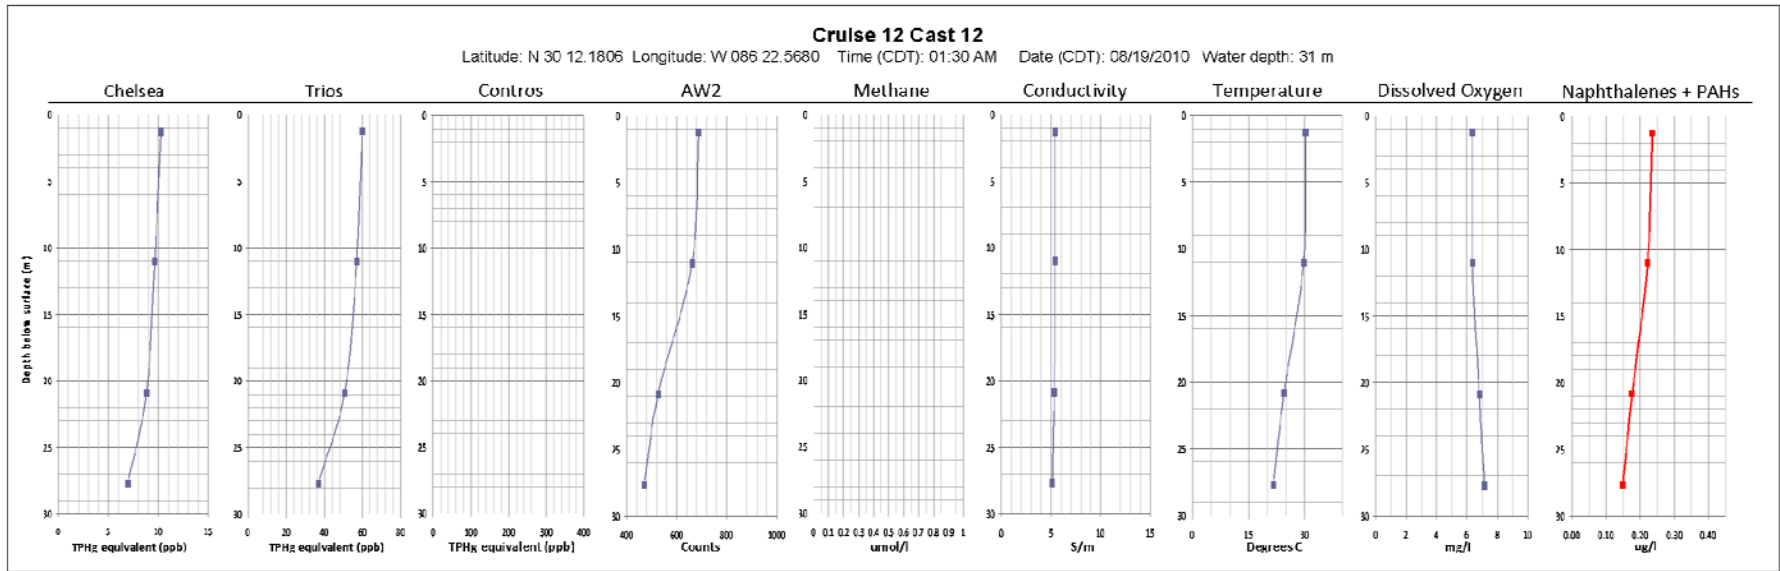
Figure 15. The results obtained for Cruise 12 vertical cast 12 (#12-C12) down to 28 m. The sensor fluorometry results for the Chelsea, Trios and Contros sensors and water samples were obtained from waters pumped to the surface. Conductivity, temperature, depth and dissolved oxygen measurements were obtained from a SBE 19+ system and oxygen sensor attached to the submersible pump used to draw the water into the sensor tank on the surface.

The missing methane concentration values are due to the invalid results returned based on the calculations using the formula provided by the manufacture (Figures 15-33). The invalid values might be because that the actual water temperature falls outside of the range of the calibration temperature (0-20 degree centigrade), hence a new calibration formula (curve) is required in order to predict the actual methane concentration.

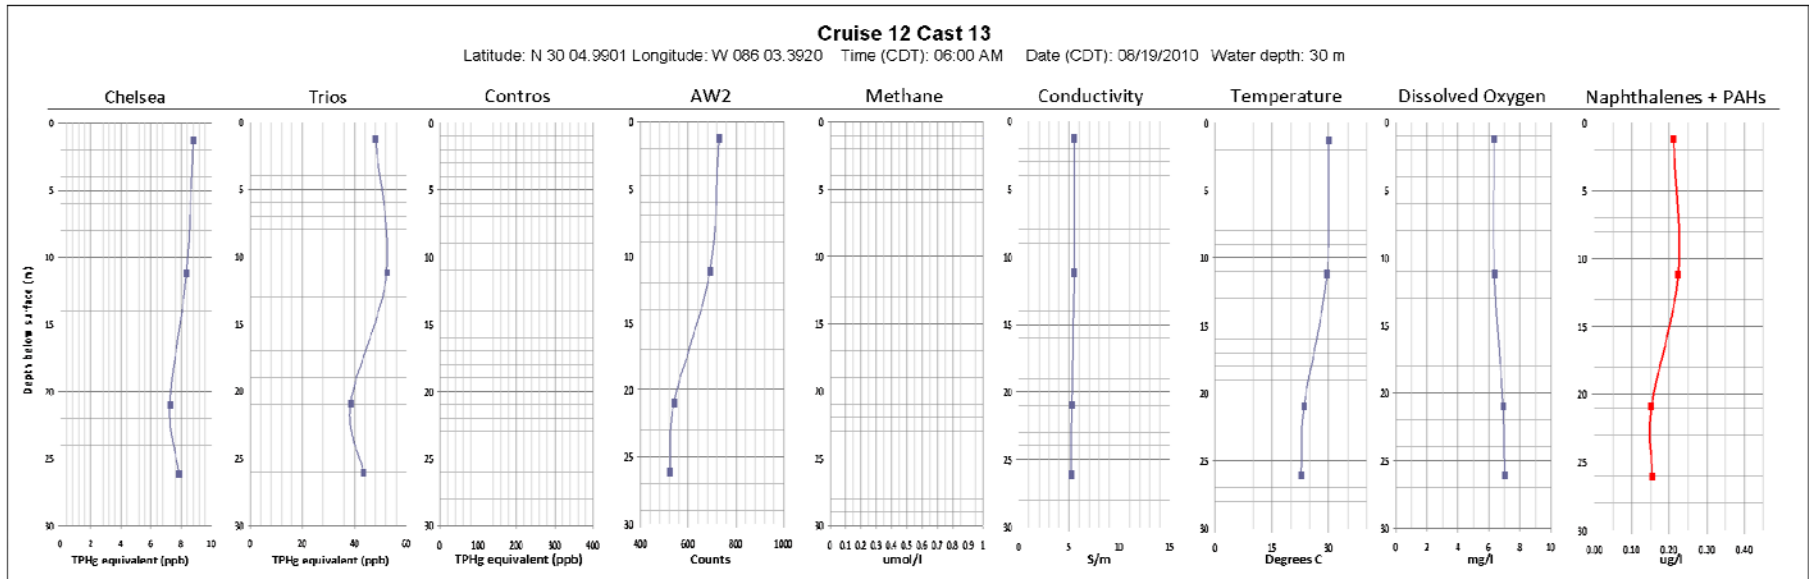
Figure 16. The results obtained for Cruise 12 vertical cast 13 (#13-C12) down to 26 m. The sensor fluorometry results for the Chelsea, Trios and Contros sensors and water samples were obtained from waters pumped to the surface. Conductivity, temperature, depth and dissolved oxygen measurements were obtained from a SBE 19+ system and oxygen sensor attached to the submersible pump used to draw the water into the sensor tank on the surface.

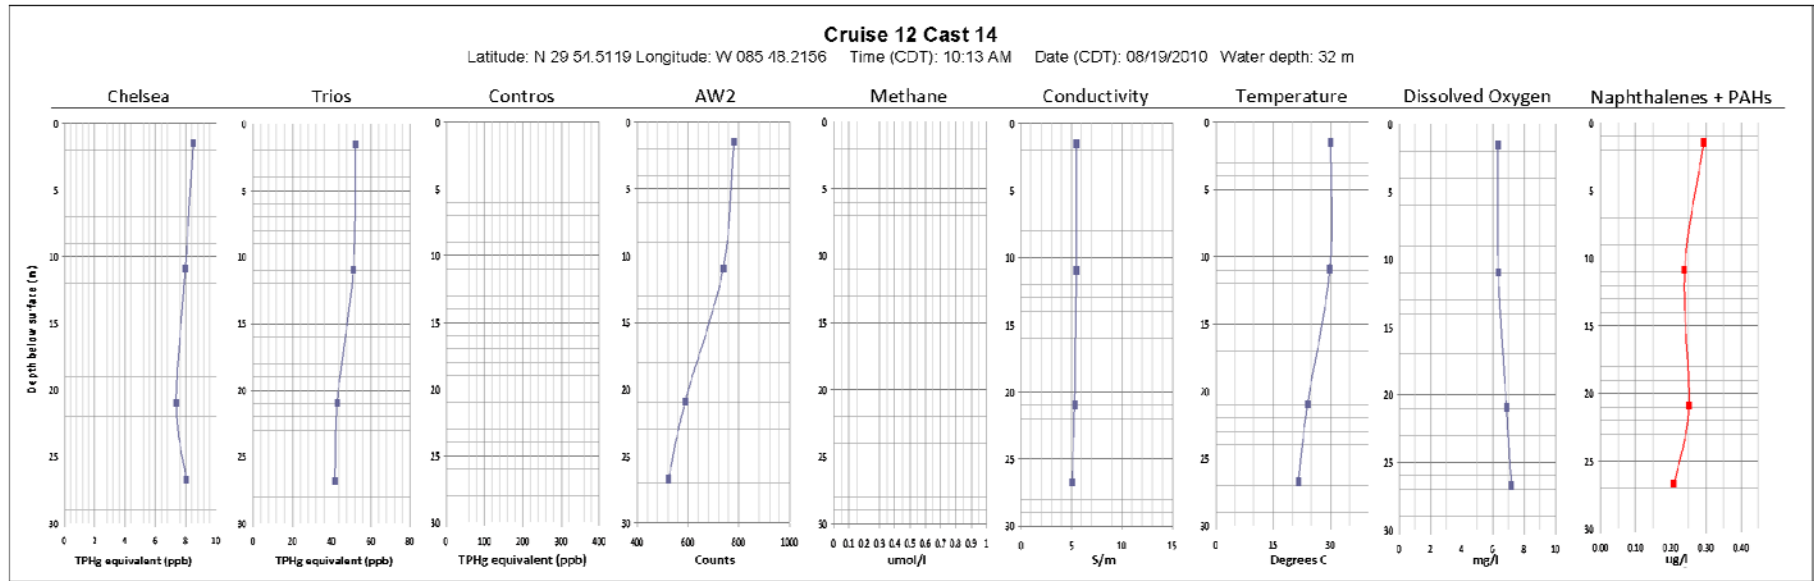
Figure 17. The results obtained for Cruise 12 vertical cast 14 (#14-C12) down to 27 m. The sensor fluorometry results for the Chelsea, Trios and Contros sensors and water samples were obtained from waters pumped to the surface. Conductivity, temperature, depth and dissolved oxygen measurements were obtained from a SBE 19+ system and oxygen sensor attached to the submersible pump used to draw the water into the sensor tank on the surface.

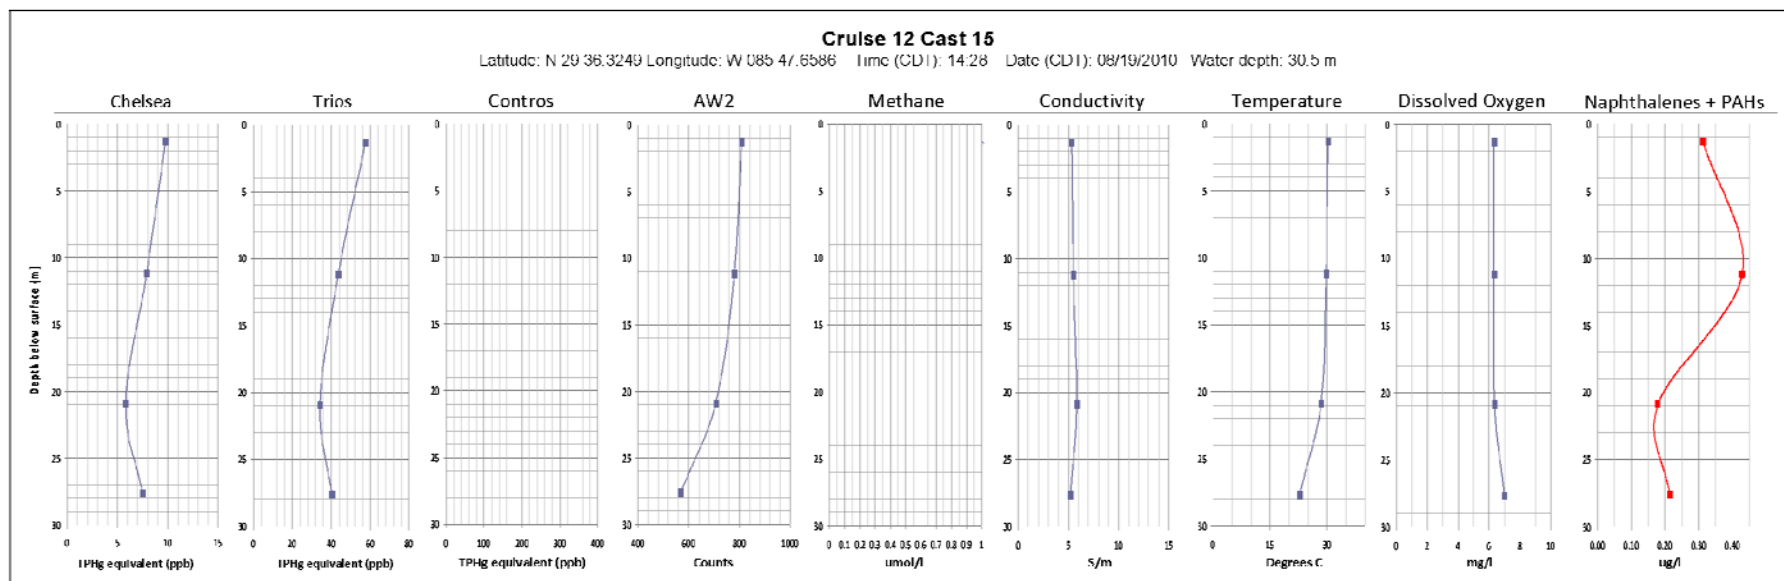
Figure 18. The results obtained for Cruise 12 vertical cast 15 (#15-C12) down to 28 m. The sensor fluorometry results for the Chelsea, Trios and Contros sensors and water samples were obtained from waters pumped to the surface. Conductivity, temperature, depth and dissolved oxygen measurement were obtained from a SBE 19+ system and oxygen sensor attached to the submersible pump used to draw the water into the sensor tank on the surface.
