Ryan Chouest Cruise 12 Cumulative Report

Period covered: 2158 08/13/2010 -0220 08/23/2010

The *Ryan Chouest* cruised about 928 nautical miles, from 08/13/10 to 08/23/10, for the completion of Cruise 12. The complete route is shown in Figure 1. The main objective of this cruise is to monitor the surface and shallow water quality along the coast of the Gulf of Mexico.

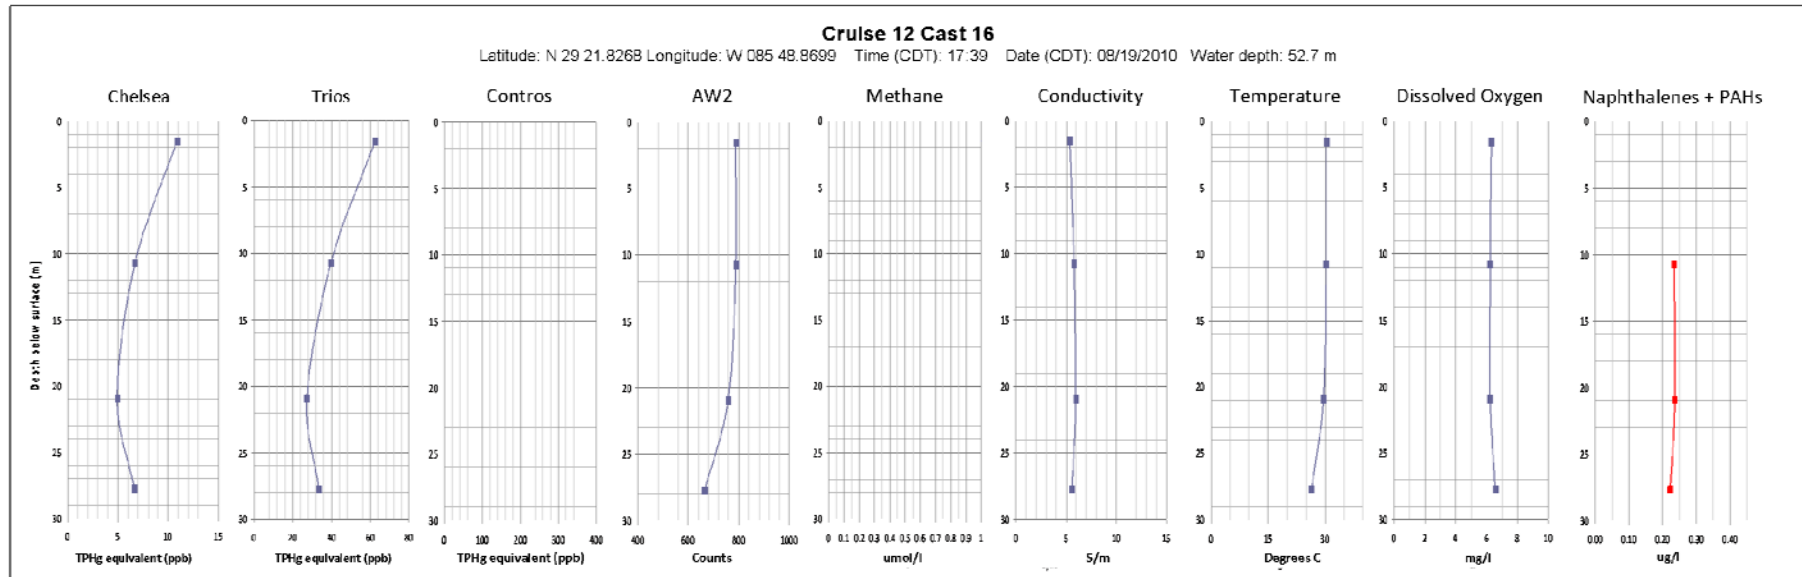
Figure 19. The results obtained for Cruise 12 vertical cast 16 (#16-C12) down to 28 m. The sensor fluorometry results for the Chelsea, Trios and Contros sensors and water samples were obtained from waters pumped to the surface. Conductivity, temperature, depth and dissolved oxygen measurements were obtained from a SBE 19+ system and oxygen sensor attached to the submersible pump used to draw the water into the sensor tank on the surface.

The missing methane concentration values are due to the invalid results returned based on the calculations using the formula provided by the manufacture (Figures 15-33). The invalid values might be because that the actual water temperature falls outside of the range of the calibration temperature (0-20 degree centigrade), hence a new calibration formula (curve) is required in order to predict the actual methane concentration.

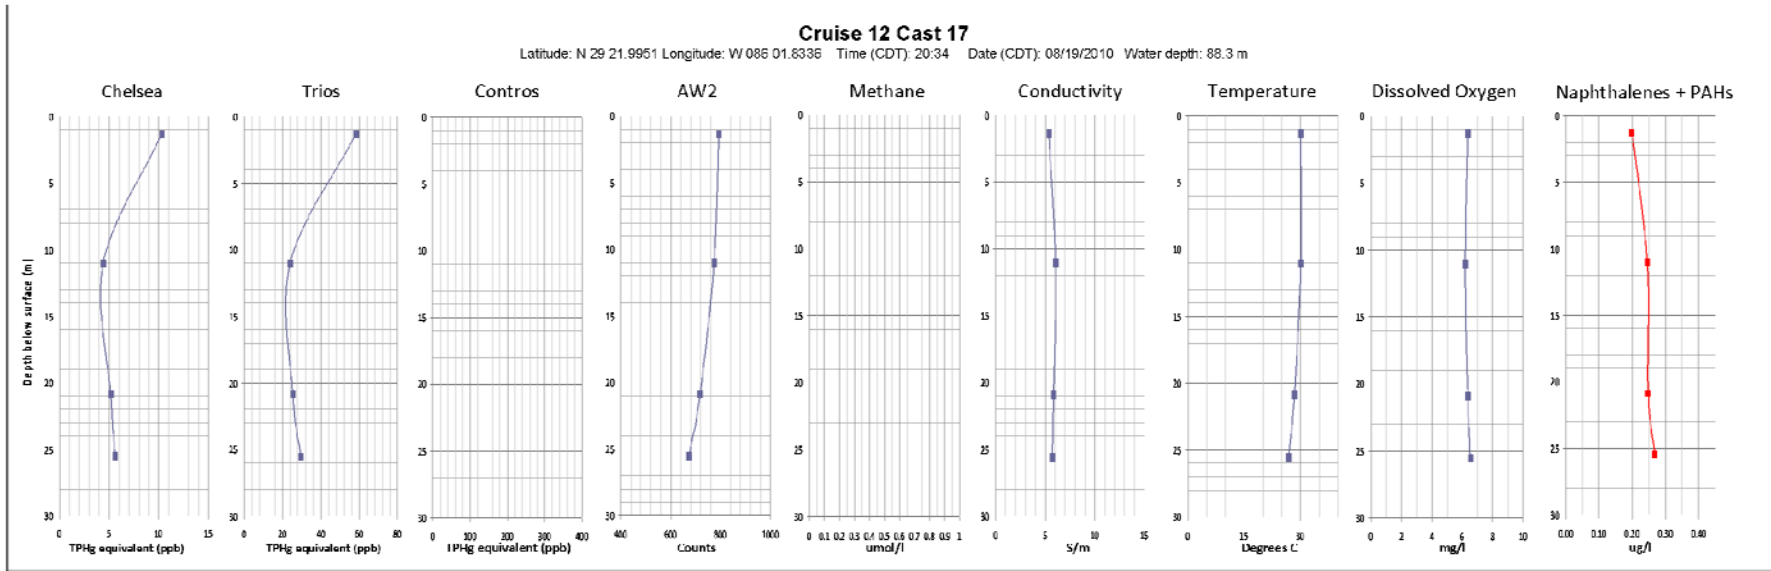
Figure 20. The results obtained for Cruise 12 vertical cast 17 (#17-C12) down to 25 m. The sensor fluorometry results for the Chelsea, Trios and Contros sensors and water samples were obtained from waters pumped to the surface. Conductivity, temperature, depth and dissolved oxygen measurements were obtained from a SBE 19+ system and oxygen sensor attached to the submersible pump used to draw the water into the sensor tank on the surface.

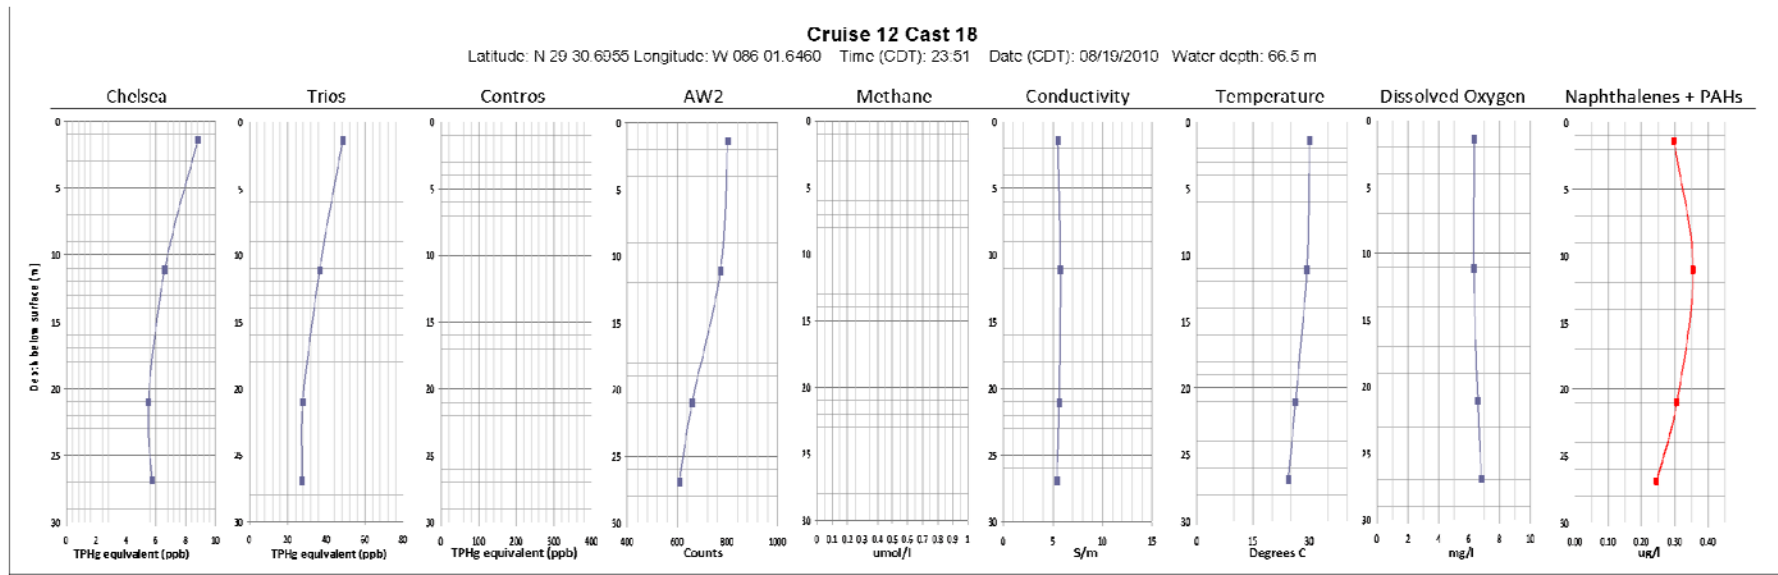
Figure 21. The results obtained for Cruise 12 vertical cast 18 (#18-C12) down to 27 m. The sensor fluorometry results for the Chelsea, Trios and Contros sensors and water samples were obtained from waters pumped to the surface. Conductivity, temperature, depth and dissolved oxygen measurements were obtained from a SBE 19+ system and oxygen sensor attached to the submersible pump used to draw the water into the sensor tank on the surface.

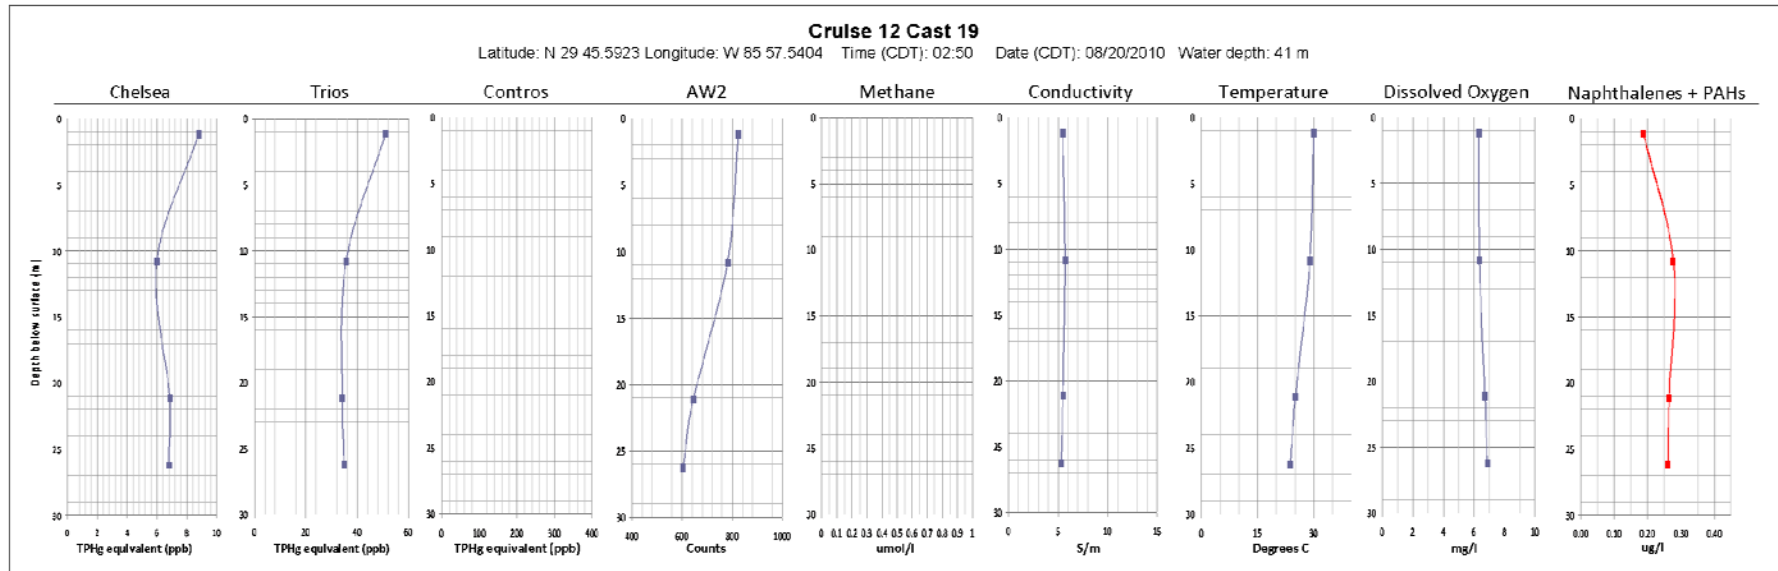
Figure 22. The results obtained for Cruise 12 vertical cast 19 (#19-C12) down to 26 m. The sensor fluorometry results for the Chelsea, Trios and Contros sensors and water samples were obtained from waters pumped to the surface. Conductivity, temperature, depth and dissolved oxygen measurements were obtained from a SBE 19+ system and oxygen sensor attached to the submersible pump used to draw the water into the sensor tank on the surface.

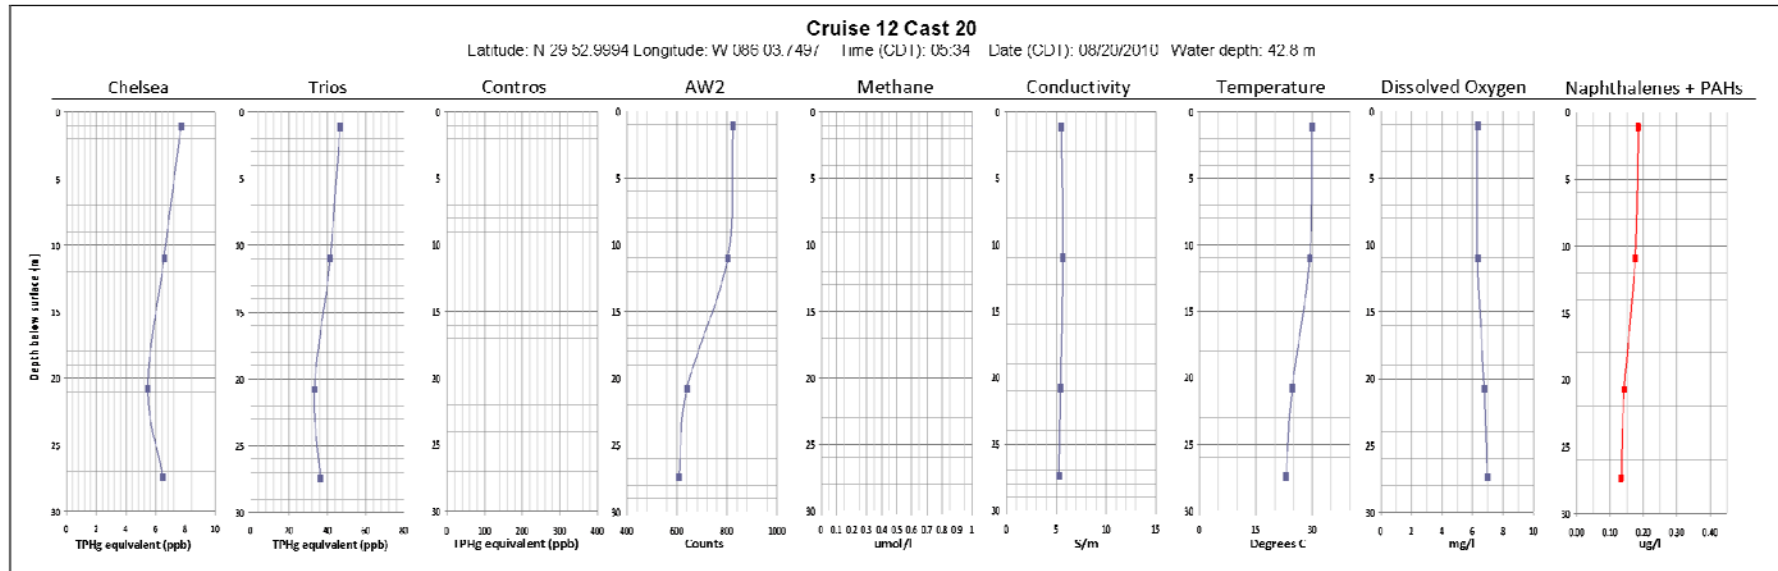
Figure 23. The results obtained for Cruise 12 vertical cast 12 (#20-C12) down to 27 m. The sensor fluorometry results for the Chelsea, Trios and Contros sensors and water samples were obtained from waters pumped to the surface. Conductivity, temperature, depth and dissolved oxygen measurements were obtained from a SBE 19+ system and oxygen sensor attached to the submersible pump used to draw the water into the sensor tank on the surface.

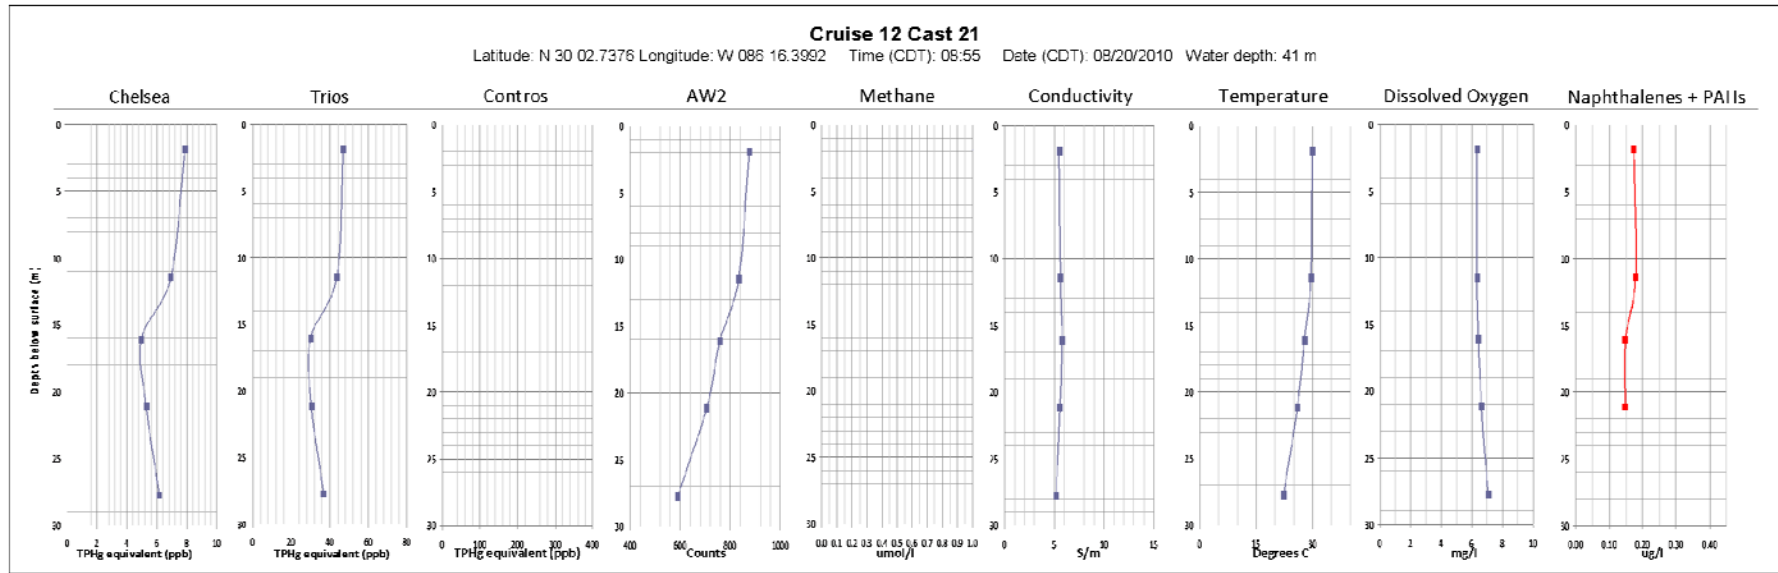
Figure 24. The results obtained for Cruise 12 vertical cast 21 (#21-C12) down to 28 m. The sensor fluorometry results for the Chelsea, Trios and Contros sensors and water samples were obtained from waters pumped to the surface. Conductivity, temperature, depth and dissolved oxygen measurements were obtained from a SBE 19+ system and oxygen sensor attached to the submersible pump used to draw the water into the sensor tank on the surface.

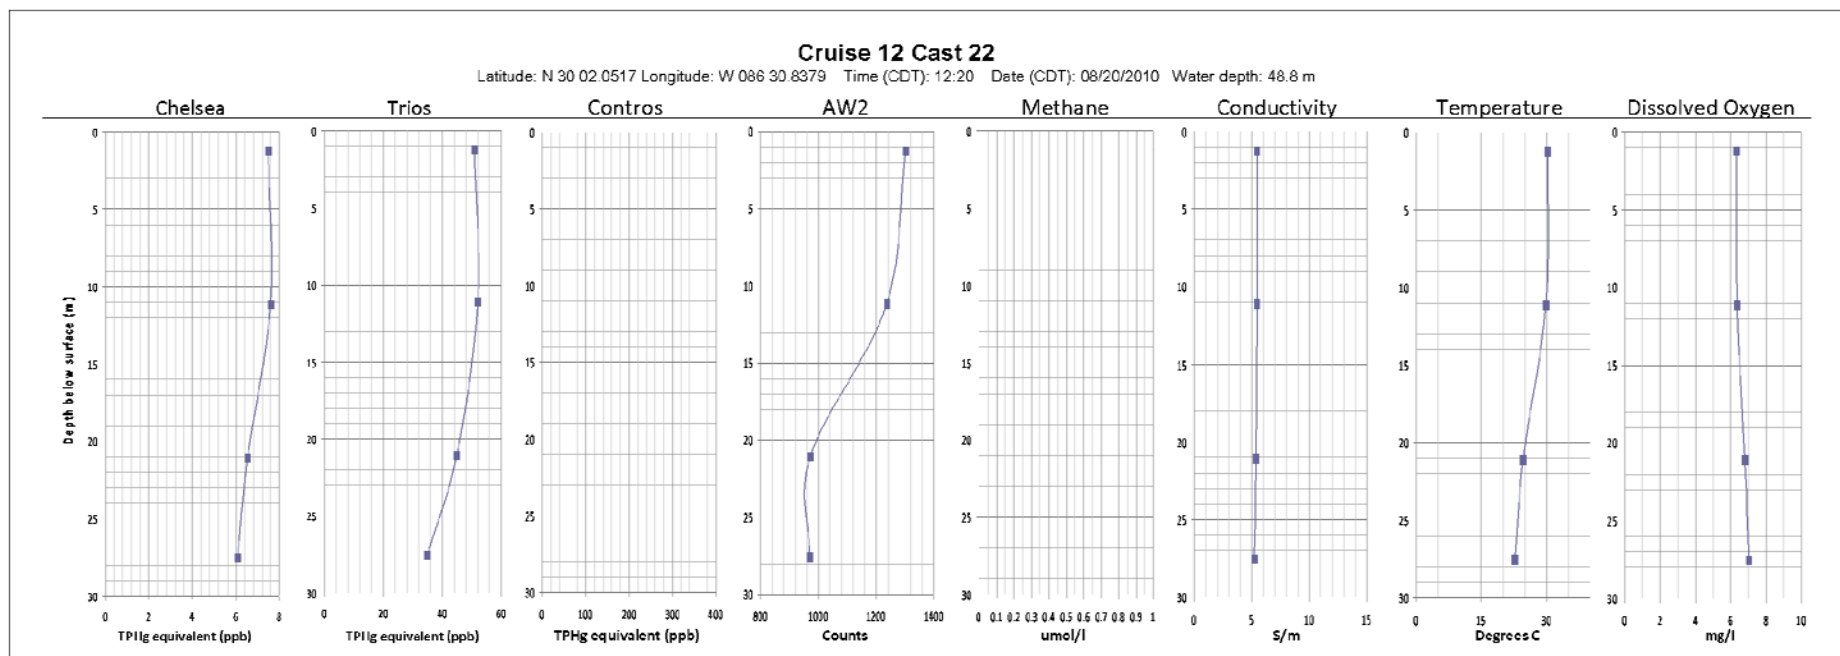
Figure 25. The results obtained for Cruise 12 vertical cast 22 (#22-C12) down to 28 m. The sensor fluorometry results for the Chelsea, Trios and Contros sensors and water samples were obtained from waters pumped to the surface. Conductivity, temperature, depth and dissolved oxygen measurements were obtained from a SBE 19+ system and oxygen sensor attached to the submersible pump used to draw the water into the sensor tank on the surface.

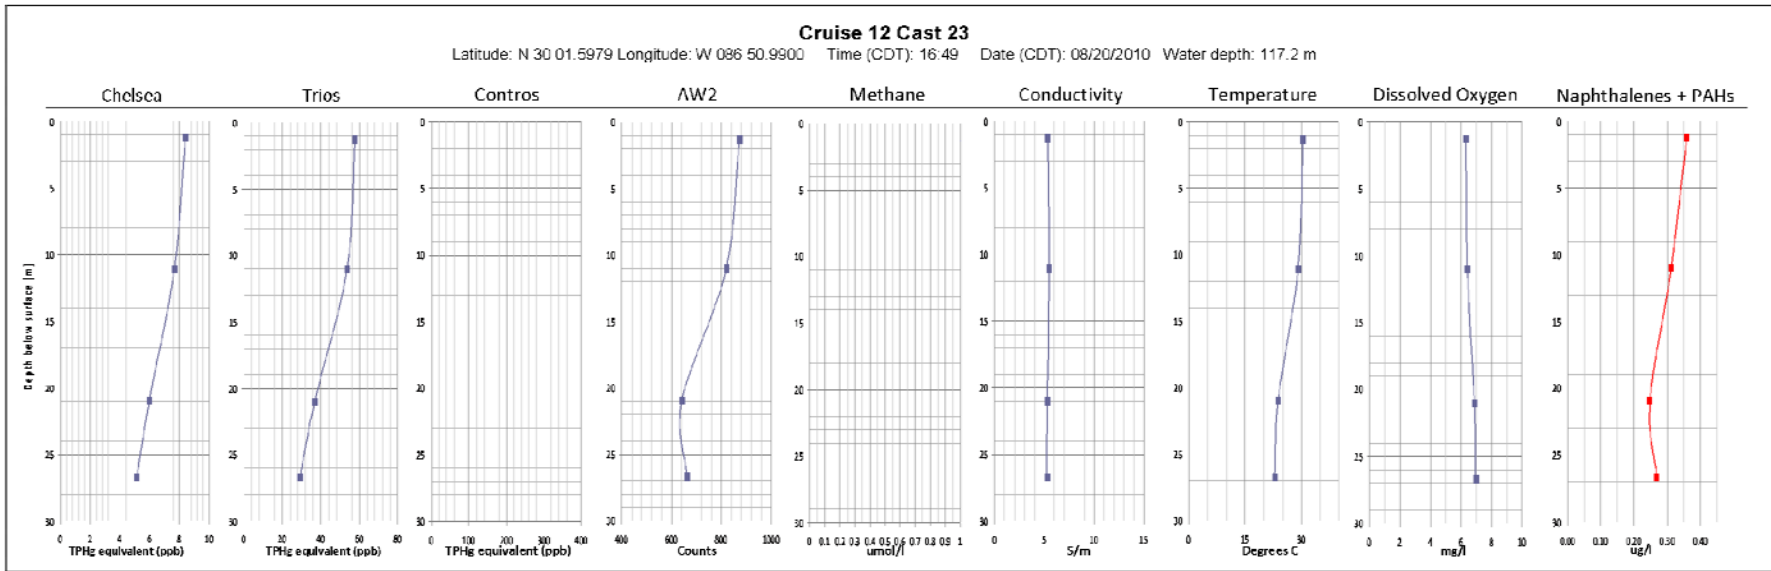
Figure 26. The results obtained for Cruise 12 vertical cast 23 (#23-C12) down to 25 m. The sensor fluorometry results for the Chelsea, Trios and Contros sensors and water samples were obtained from waters pumped to the surface. Conductivity, temperature, depth and dissolved oxygen measurements were obtained from a SBE 19+ system and oxygen sensor attached to the submersible pump used to draw the water into the sensor tank on the surface.

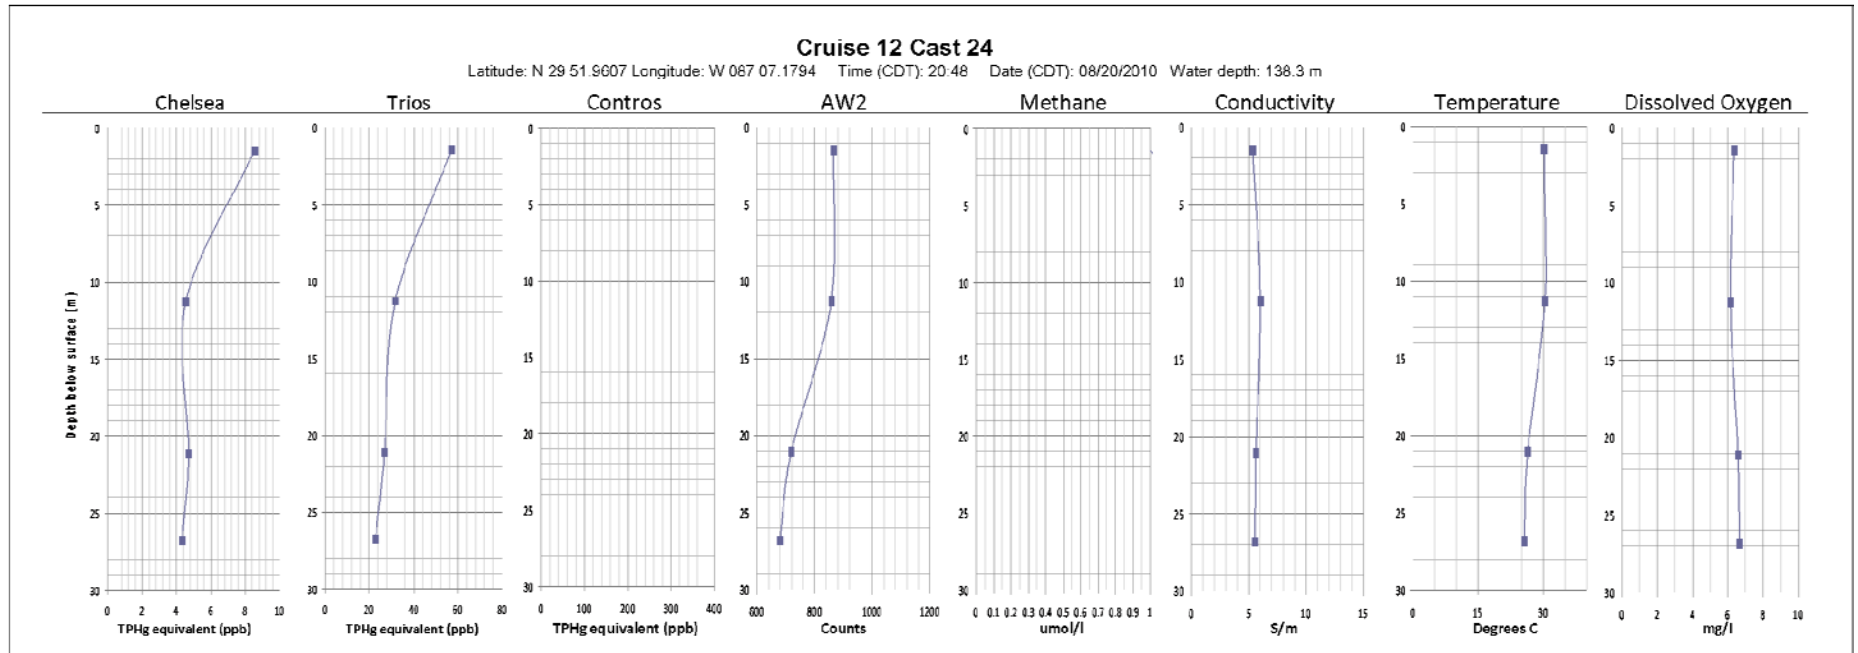
Figure 27. The results obtained for Cruise 12 vertical cast 24(#24-C12) down to 27 m. The sensor fluorometry results for the Chelsea, Trios and Contros sensors and water samples were obtained from waters pumped to the surface. Conductivity, temperature, depth and dissolved oxygen measurements were obtained from a SBE 19+ system and oxygen sensor attached to the submersible pump used to draw the water into the sensor tank on the surface.

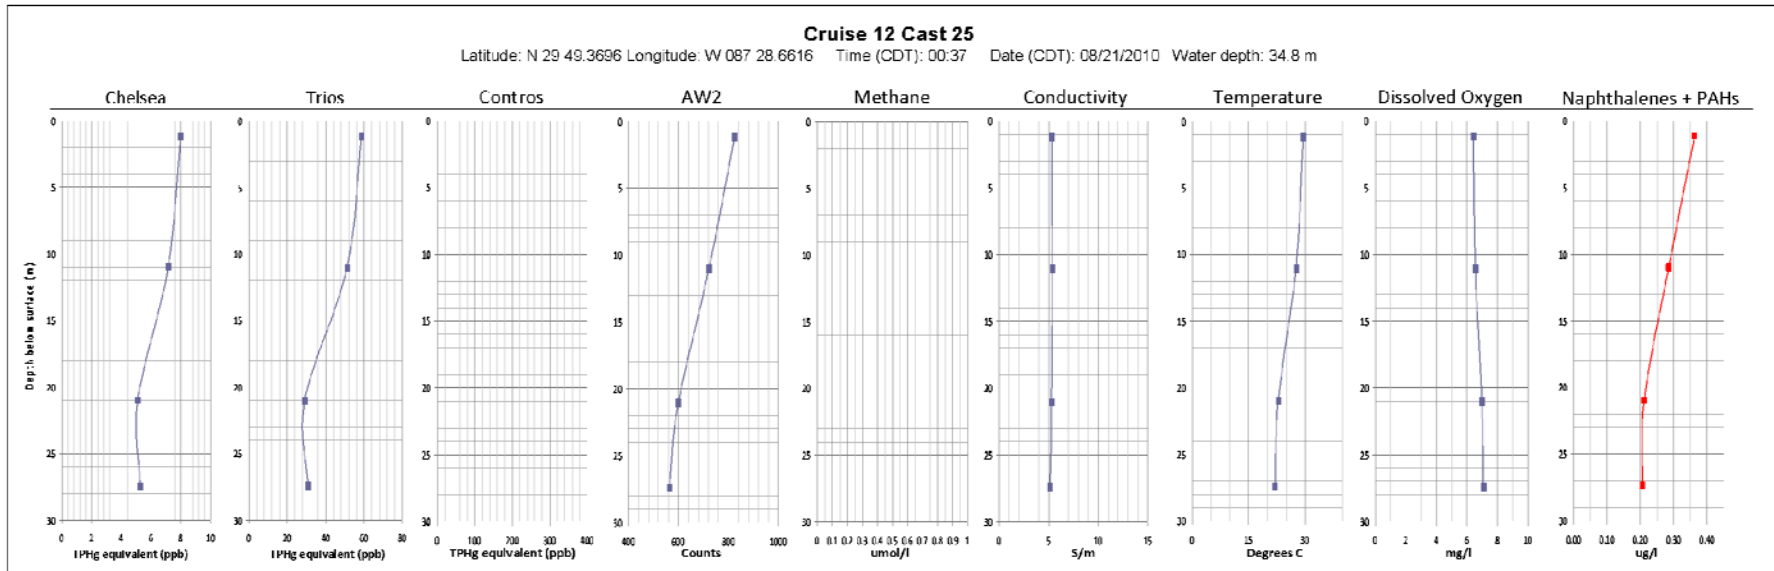
Figure 28. The results obtained for Cruise 12 vertical cast 25 (#25-C12) down to 26 m. The sensor fluorometry results for the Chelsea, Trios and Contros sensors and water samples were obtained from waters pumped to the surface. Conductivity, temperature, depth and dissolved oxygen measurements were obtained from a SBE 19+ system and oxygen sensor attached to the submersible pump used to draw the water into the sensor tank on the surface.

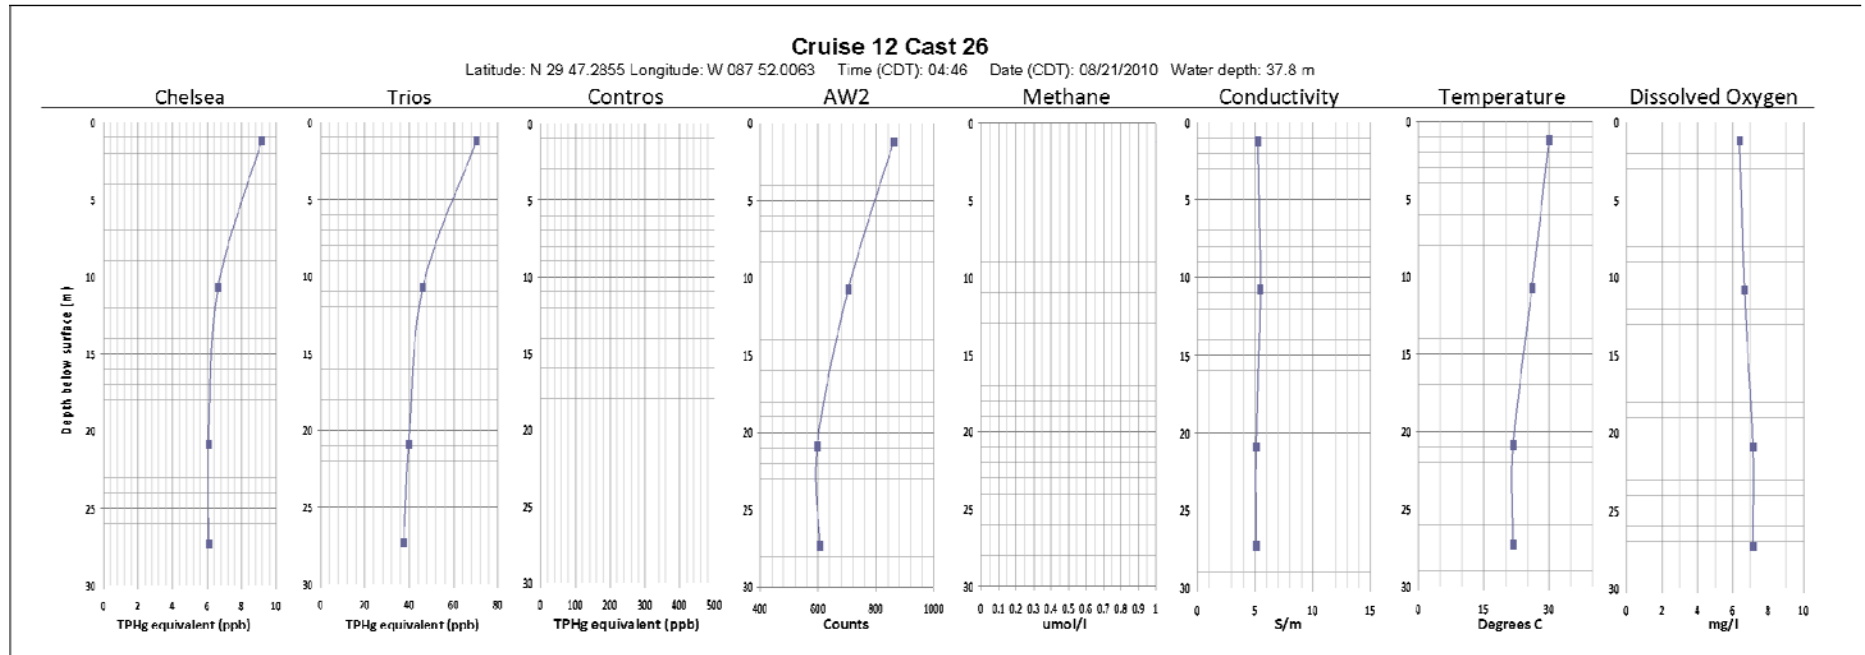
Figure 29. The results obtained for Cruise 12 vertical cast 26 (#26-C12) down to 27 m. The sensor fluorometry results for the Chelsea, Trios and Contros sensors and water samples were obtained from waters pumped to the surface. Conductivity, temperature, depth and dissolved oxygen measurements were obtained from a SBE 19+ system and oxygen sensor attached to the submersible pump used to draw the water into the sensor tank on the surface.

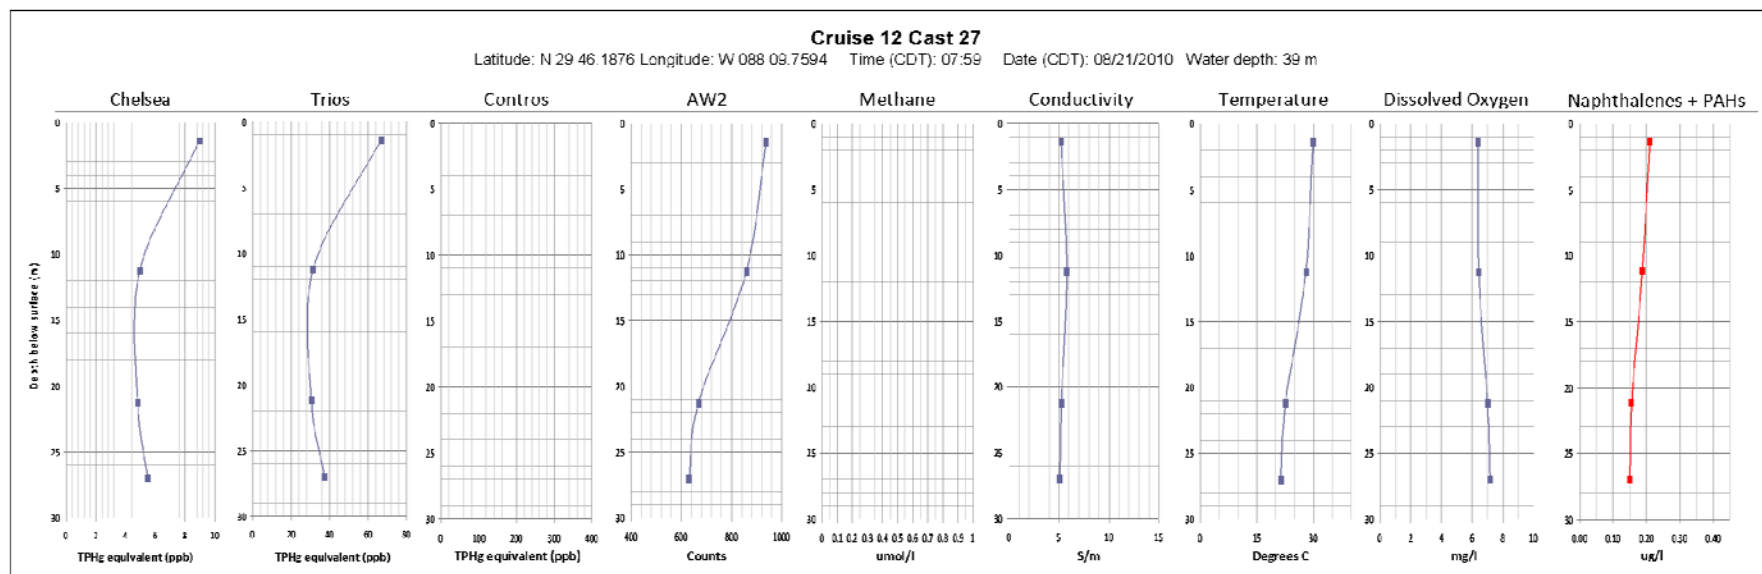
Figure 30. The results obtained for Cruise 12 vertical cast 27 (#27-C12) down to 27 m. The sensor fluorometry results for the Chelsea, Trios and Contros sensors and water samples were obtained from waters pumped to the surface. Conductivity, temperature, depth and dissolved oxygen measurements were obtained from a SBE 19+ system and oxygen sensor attached to the submersible pump used to draw the water into the sensor tank on the surface.

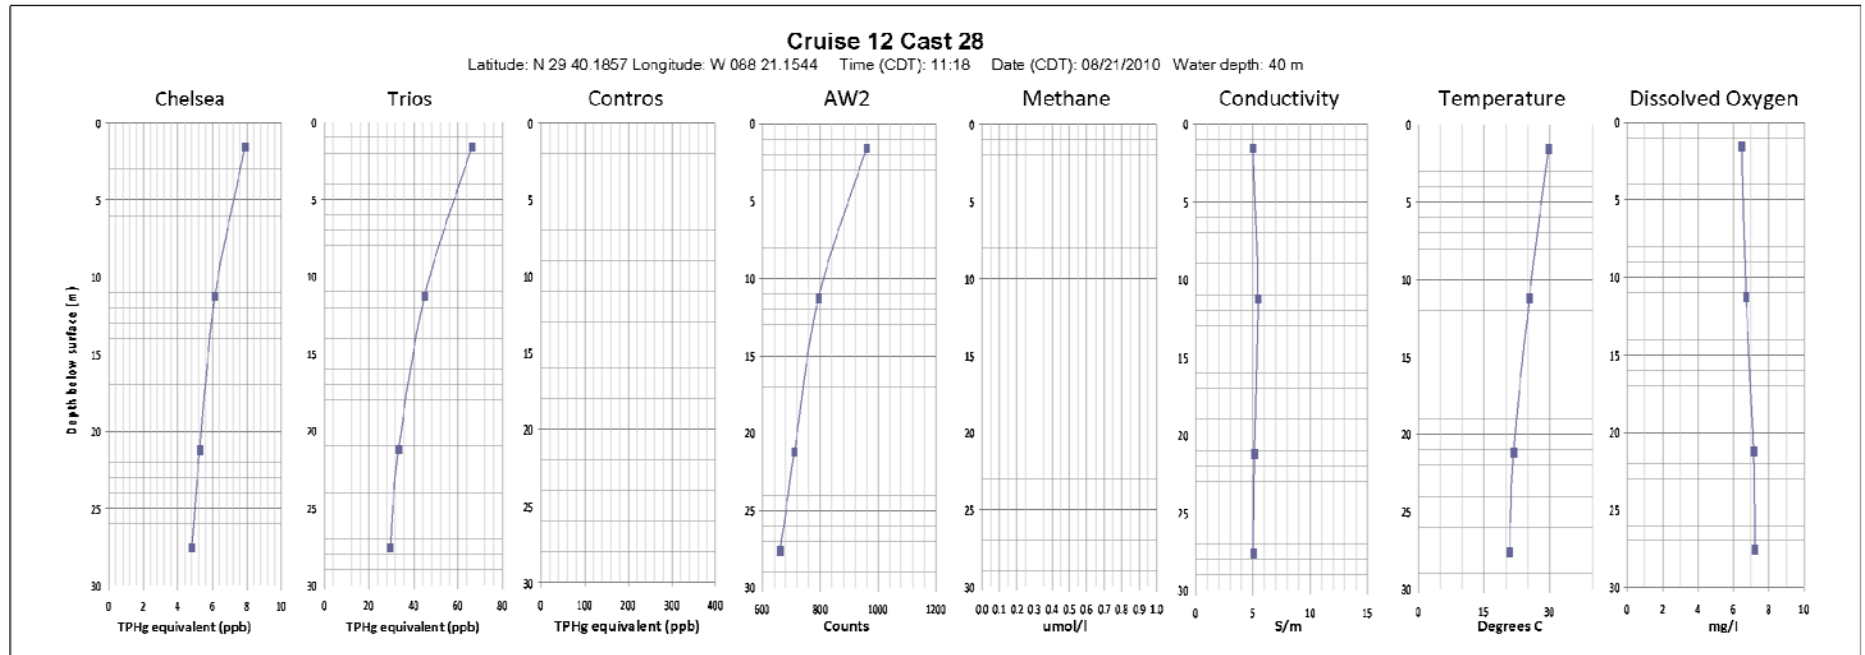
Figure 31. The results obtained for Cruise 12 vertical cast 28 (#28-C12) down to 28 m. The sensor fluorometry results for the Chelsea, Trios and Contros sensors and water samples were obtained from waters pumped to the surface. Conductivity, temperature, depth and dissolved oxygen measurements were obtained from a SBE 19+ system and oxygen sensor attached to the submersible pump used to draw the water into the sensor tank on the surface.

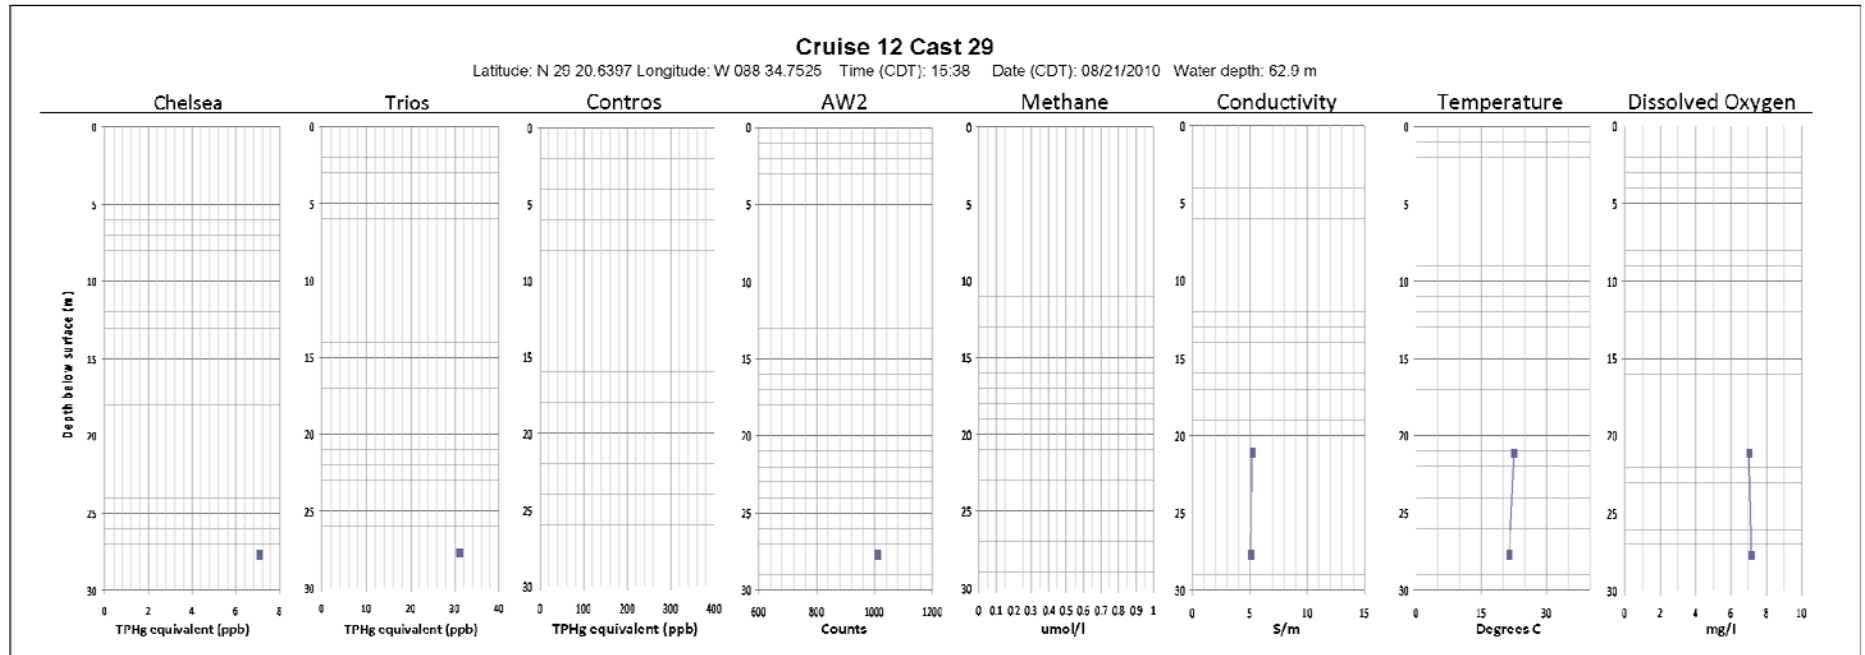
Figure 32. The results obtained for Cruise 12 vertical cast 29 (#23-C12) down to 28 m. The sensor fluorometry results for the Chelsea, Trios and Contros sensors and water samples were obtained from waters pumped to the surface. Conductivity, temperature, depth and dissolved oxygen measurements were obtained from a SBE 19+ system and oxygen sensor attached to the submersible pump used to draw the water into the sensor tank on the surface.

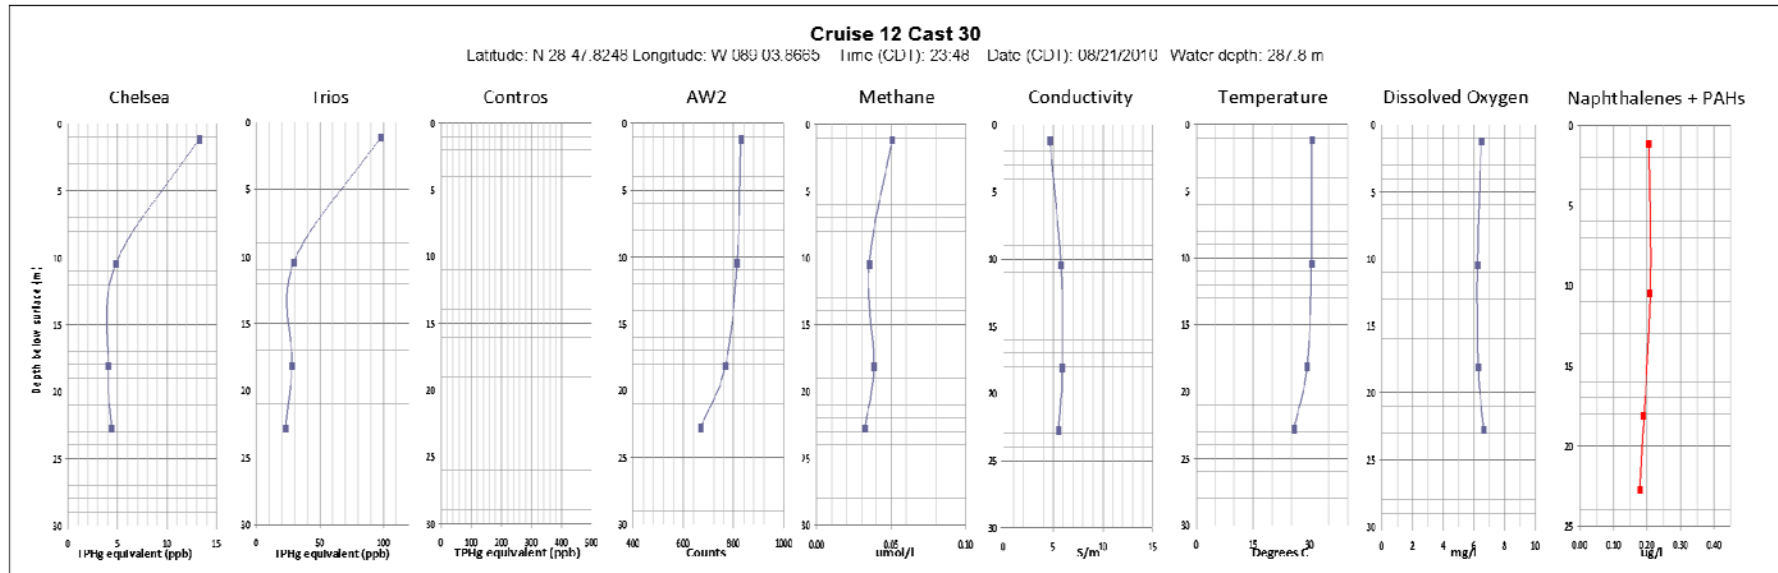
Figure 33. The results obtained for Cruise 12 vertical cast 30(#30-C12) down to 23 m. The sensor fluorometry results for the Chelsea, Trios and Contros sensors and water samples were obtained from waters pumped to the surface. Conductivity, temperature, depth and dissolved oxygen measurements were obtained from a SBE 19+ system and oxygen sensor attached to the submersible pump used to draw the water into the sensor tank on the surface.

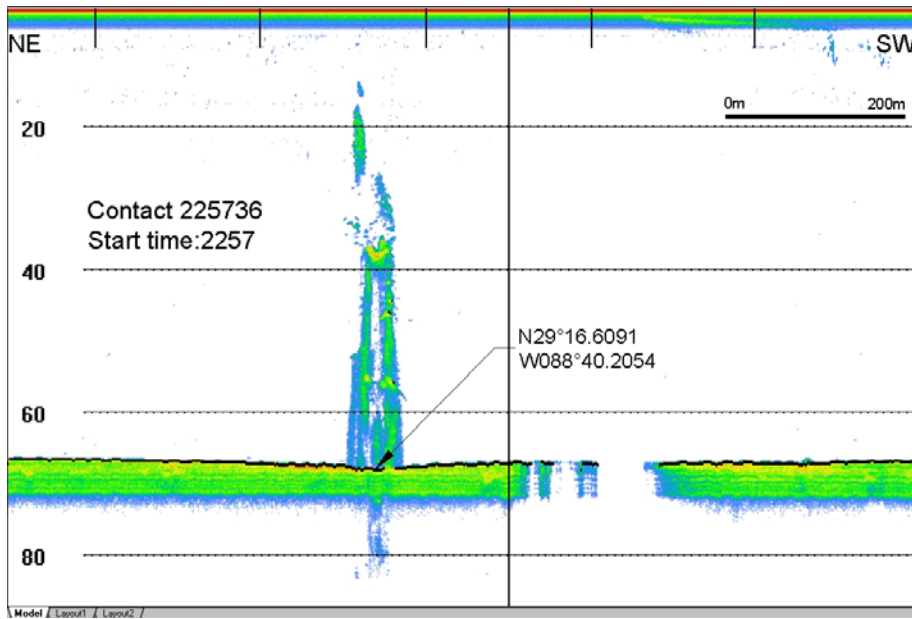
Figure 34. Contact_08212010_225736. Description: Probably biological. Time (CDT): 08/21/2010 1757hrs Location: 29° 16.6091N; 88° 40.2054W. Depth displayed: 16.95m to 66.80m.

During the cruise there were a total of 11 echo sounder contacts identified (Figures 34-41). The first two acoustic contacts were found during the reporting period of 8/21 to 8/22. The first echo sounder contact was in shallow water and is likely of biological origin (Figure 34). The second contact is a natural methane seep in deeper water in front of the Mississippi River delta. The same seep was

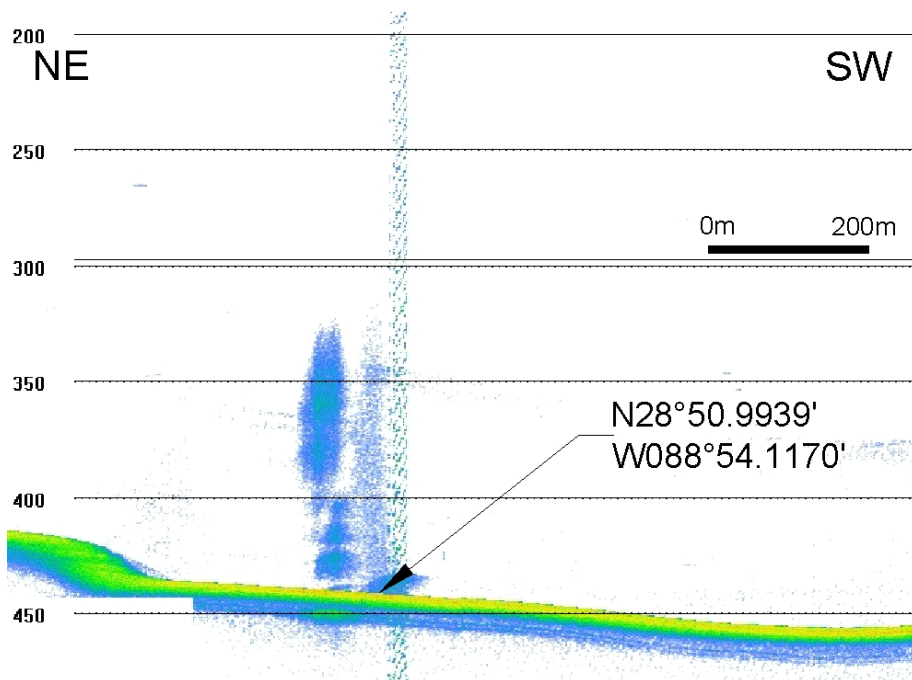
Figure 35. Contact_08222010_031645. Description: Seafloor to midwater previously investigated as a seep (see Contact_08042010_220048 in daily report for 08-05-2010). Time (CDT): 08/21/2010 2216hrs Location: 28° 50.9939N; 88° 54.1170W. Depth displayed: 301.92m to 439.89m. The vertical blue line that extends from the top to the bottom of the figure is an artifact in the data.

observed during cruise 11 (Figure 35; see also daily report for August 5th, Contact_08042010_220048). Besides already being in the vicinity of the seep, our reasons for returning to this location were to determine if it could easily be located a second time on a single pass, and also to determine if it was still active 17 days later. Our successful attempt suggests that not only are some of these features easily reaquired, but also that they are active over relatively longer periods of time. Therefore, some of the seeps found by the *Ryan Chouest* may be suitable candidates for future missions and more detailed study.

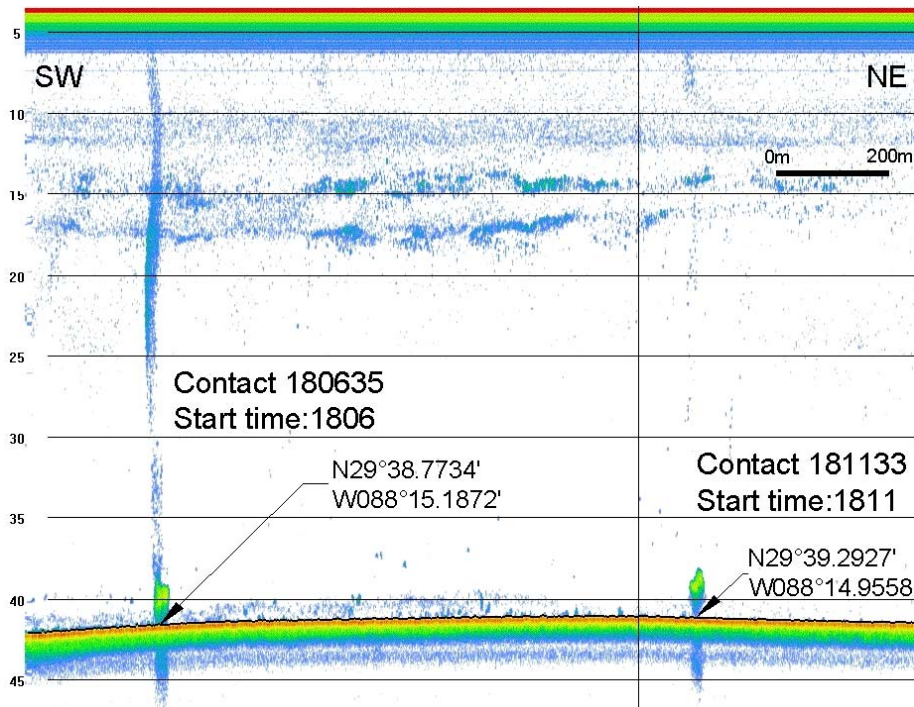
Figure 36. a) Contact_08232010_180635. Description: Bottom to surface contact. Time (CDT): 08/23/2010 1306hrs Location: 29° 64.59003N; 88° 25.32638W. Depth displayed: 5.40m to 40.99m. b) Contact_08232010_181133. Description: Bottom contact with pattern on surface. Time (CDT): 08/23/2010 1311hrs Location: 29° 65.47106N; 88° 24.93381W. Depth displayed: 5.07m to 40.65m.

The remaining acoustic contacts identified were found during the trip back to Theodore. Most were described as bottom to mid surface contacts, with the precise origin of these contacts being unknown.

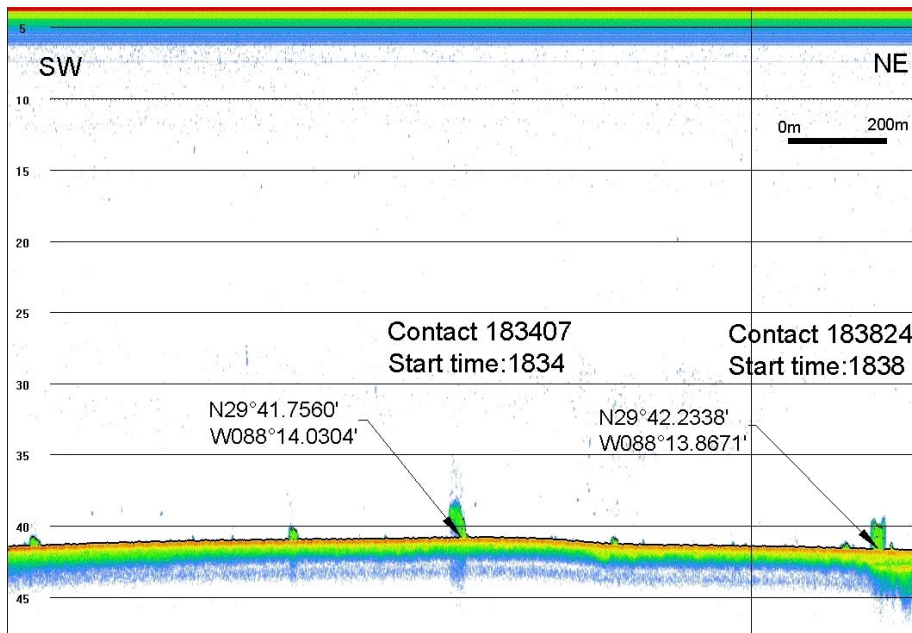
Figure 37 : a) Contact_08232010_183407. Description: Bottom contact. Time (CDT): 08/23/2010 1334hrs Location: 29° 69.57837N; 88° 23.38932W. Depth displayed: 34.91m to 40.48m. b) Contact_08232010_183824. Description: Bottom contact. Time (CDT): 08/23/2010 1338hrs Location: 29° 70.37526N; 88° 23.11674W. Depth displayed: 39.30.07m to 41.49m.

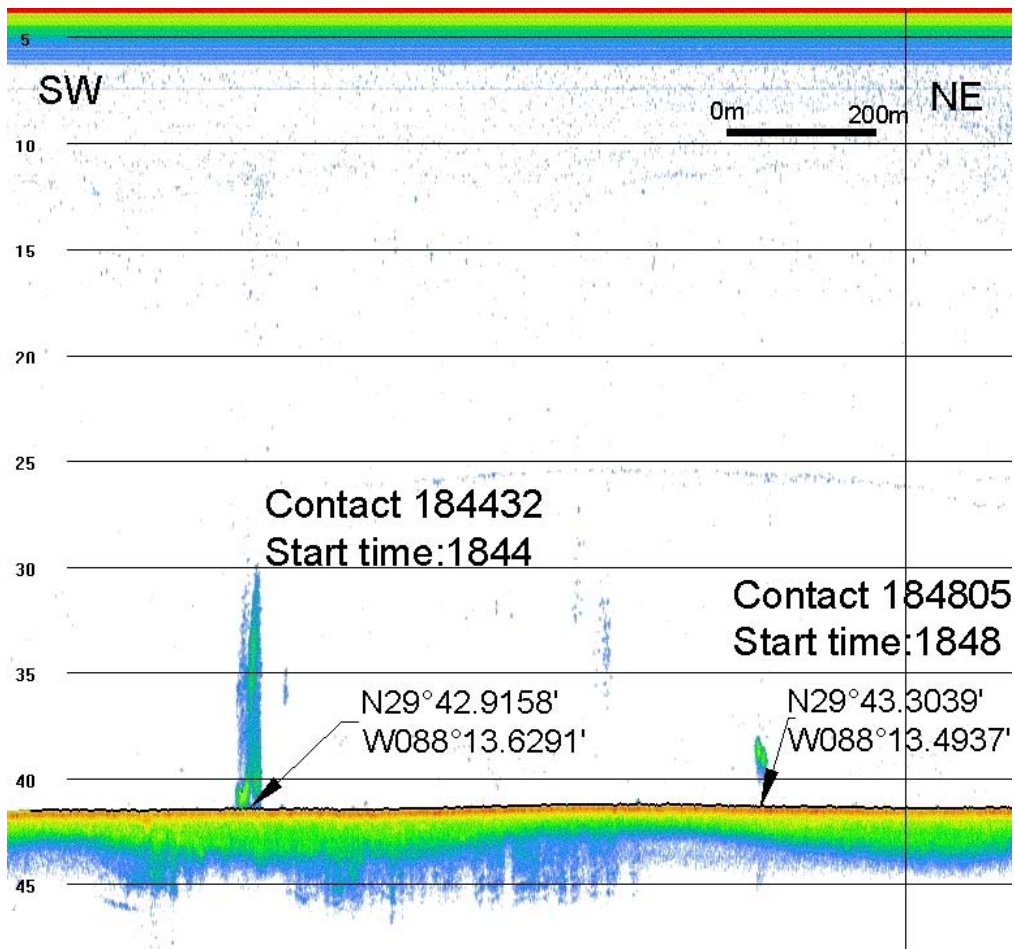
Figure 38: a) Contact_08232010_184432. Description: Bottom to midwater contact with trail to surface. Time (CDT): 08/23/2010 1344hrs Location: 29° 71.50831N; 88° 22.72145W. Depth displayed: 27.50m to 41.15m. b) Contact_08232010_184805. Description: Near bottom contact with trail to midwater. Time (CDT): 08/23/2010 1348hrs Location: 29° 72.18225N; 88° 22.48642W. Depth displayed: 37.61m to 39.31m.
