Ryan Chouest Cruise 12 Cumulative Report

Period covered: 2158 08/13/2010 -0220 08/23/2010

The *Ryan Chouest* cruised about 928 nautical miles, from 08/13/10 to 08/23/10, for the completion of Cruise 12. The complete route is shown in Figure 1. The main objective of this cruise is to monitor the surface and shallow water quality along the coast of the Gulf of Mexico.

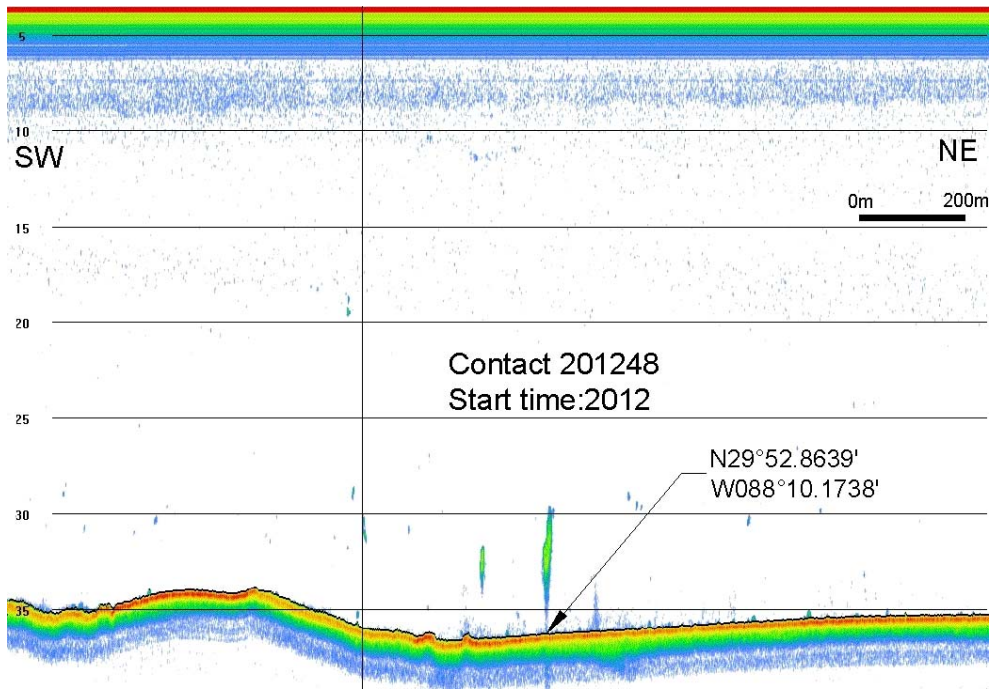
Figure 39: Contact_08232010_201248. Description: Bottom contact. Time (CDT): 08/23/2010 1612hrs Location: 29° 88.09681N; 88° 16.959932W. Depth displayed: 29.55m to 36.35m.

The remaining acoustic contacts identified were found during the trip back to Theodore. Most were described as bottom to mid surface contacts, with the precise origin of these contacts being unknown.

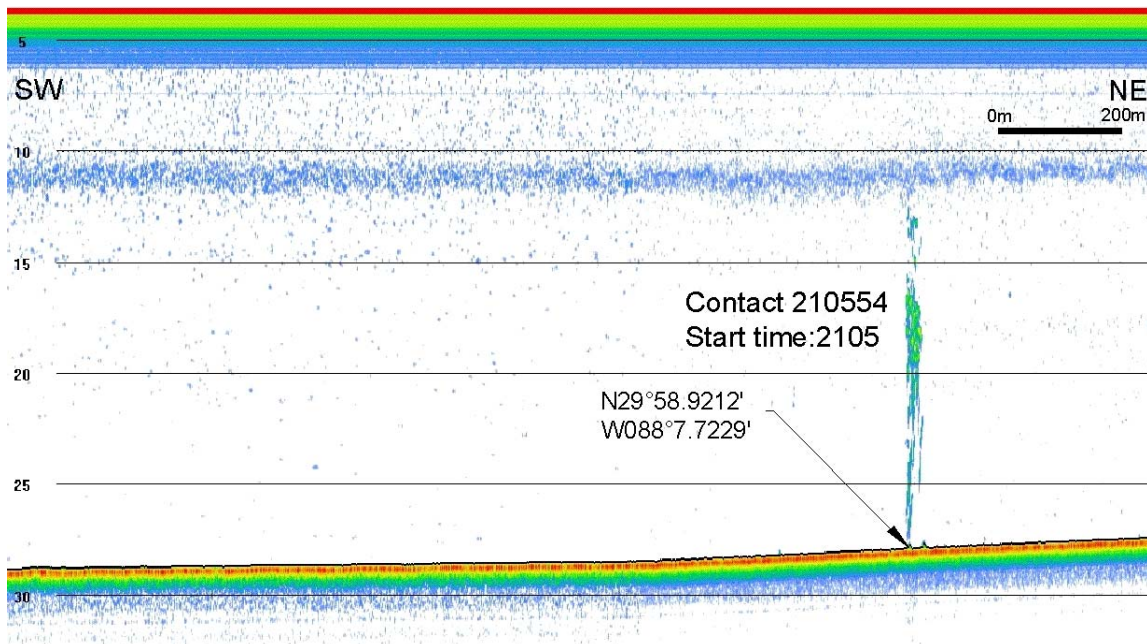
Figure 40: Contact_08232010_210554. Description: Bottom to midwater contact. Time (CDT): 08/23/2010 1605hrs Location: 29° 98.19442N; 88° 12.87506W. Depth displayed: 11.96m to 27.64m.

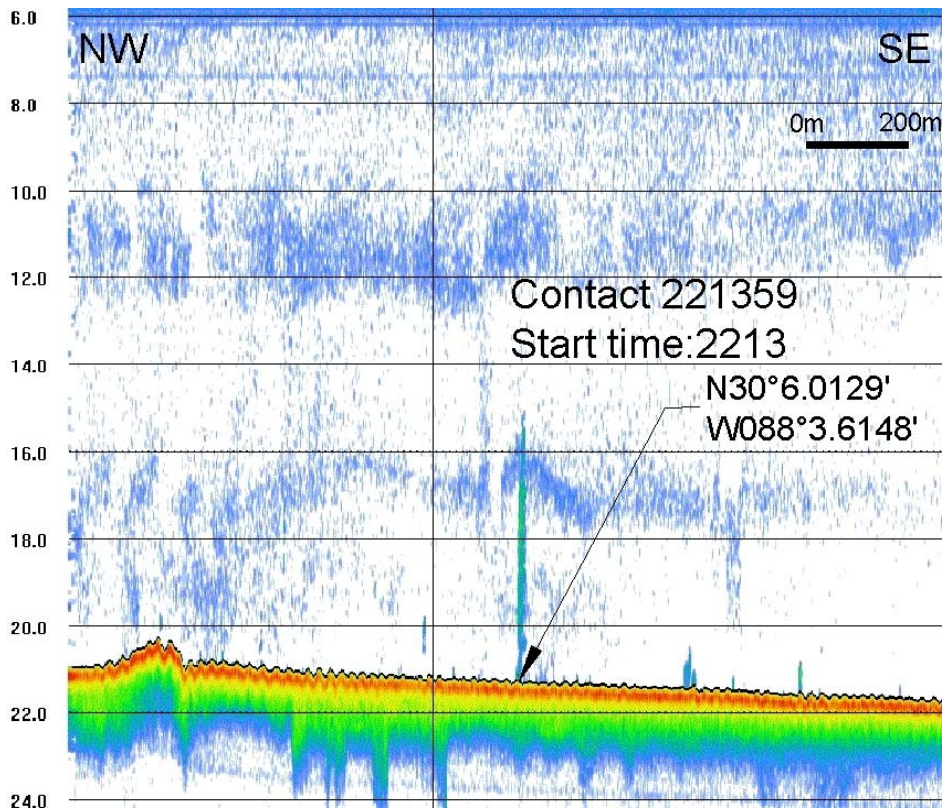
Figure 41: Contact_08232010_221359. Description: Bottom to midwater contact. Time (CDT): 08/23/2010 1713hrs Location: 30° 10.02596N; 88° 06.02960W. Depth displayed: 15.29m to 21.17m.
